Archaeological Desk-Based Assessment, Iver to Egham Trunk Main

Client: Affinity Water Limited
Project: Iver to Egham Trunk Main
Date: December 2024

Project Name	Iver to Egham Trunk Main
Scheme Number	24004343
Report Number	001
BHER Enquiry Reference Number	1575
SHER County Code	CSE6074

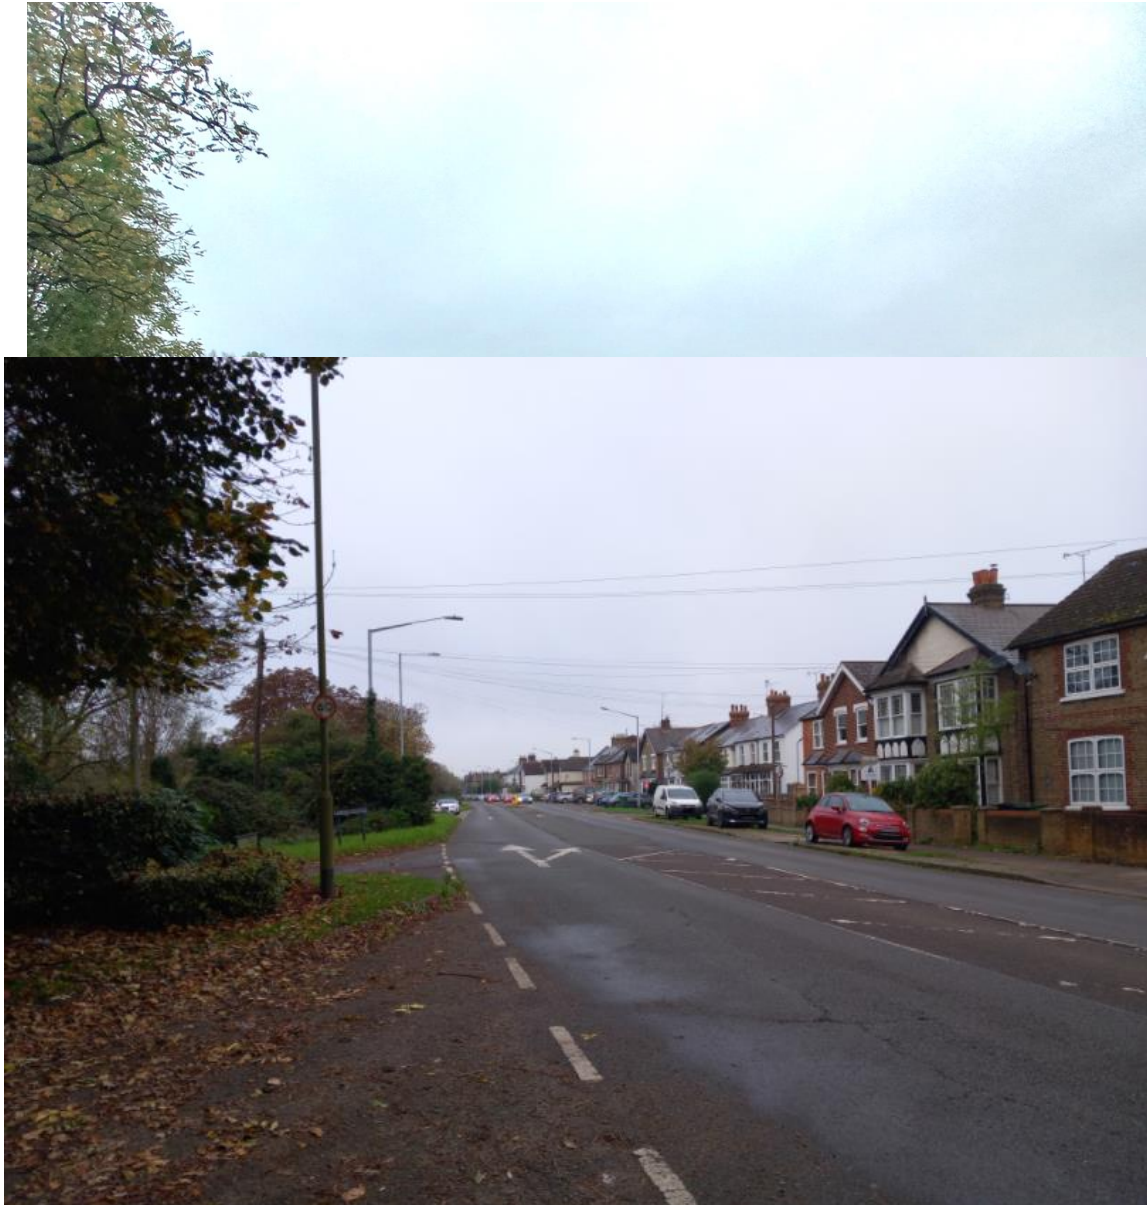
Plate 3: Lamas Road. Photograph taken facing northwest.

- 3.7.5 At the junction with Staines Road (B376) the route turns eastwards and runs within the carriageway. This area comprises early to mid-20th Century residential housing on the northern side and a grass verge on the south with sporadic utilities installations and street furniture (Plate 3).

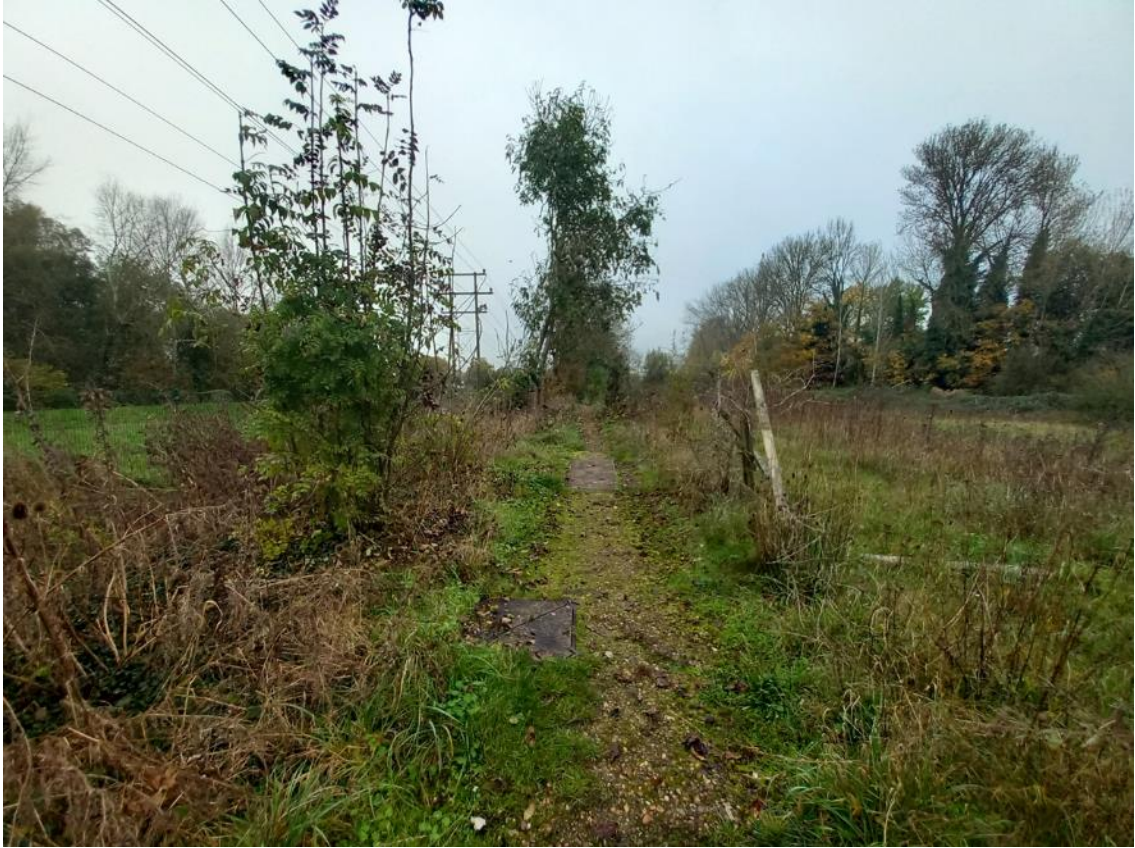
Plate 4: Undeveloped land to the north of the aqueduct, through which the route runs. Photograph taken facing east.

- 3.7.6 The route turns north-northeastwards to the immediate east of the A30/M25 flyover and runs in an easterly direction parallel to the Staines Reservoirs Aqueduct. The route lies within an area of low scrub and unmanaged vegetation. A narrow public footpath also runs parallel with the aqueduct (Plate 4).

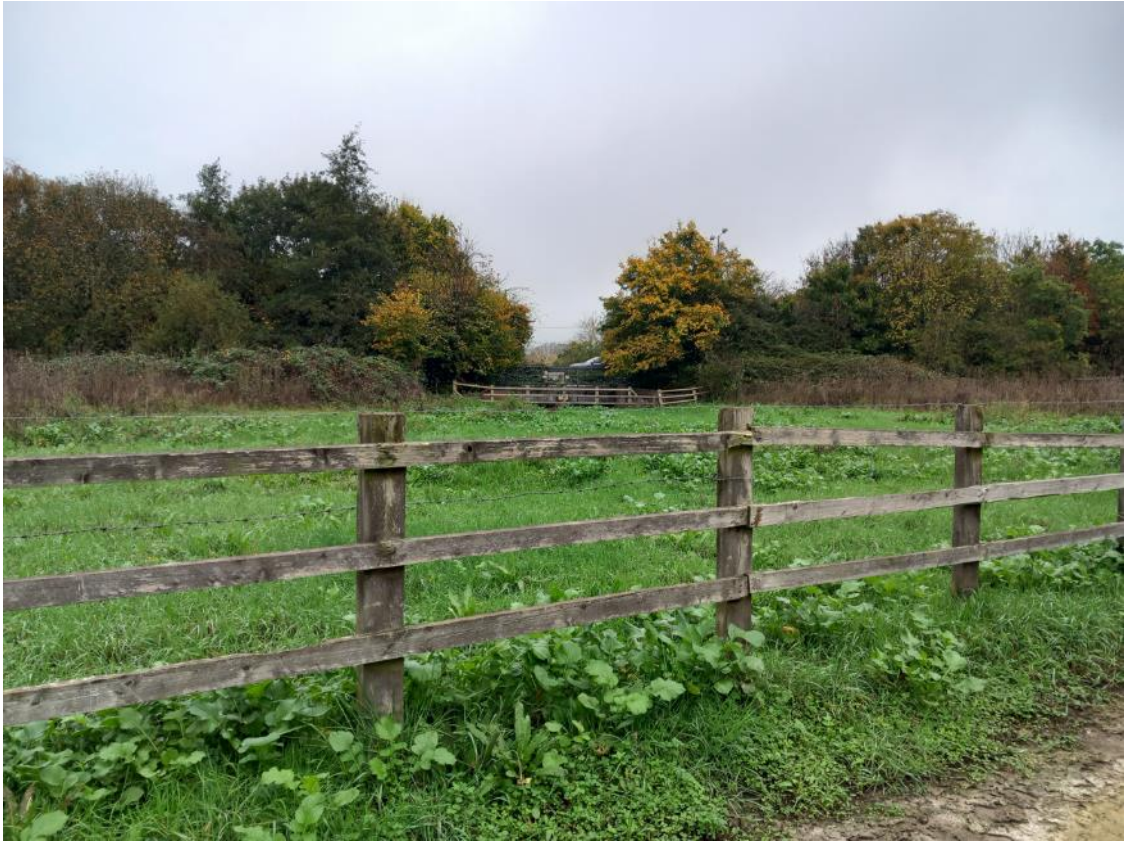
Plate 5: View towards underpass beneath the A30. Photograph taken facing north-northeast.

- 3.7.7 An existing underpass for drainage provides route access beneath the A30 Staines By-Pass (Plate 5). Landscaping indicates some localised truncation. Further truncation was evident on the northern side of the bypass, through construction of a pond at the rear of residential properties fronting Moor Lane (Plate 6). This basin has been cut into the fields and is surrounded by a raised terrace, accessed via a public footpath which runs between land presently in use as paddocks. At the time of the walkover the basin was drained. Concrete kerbs within the raised bank suggest existing services or infrastructure.

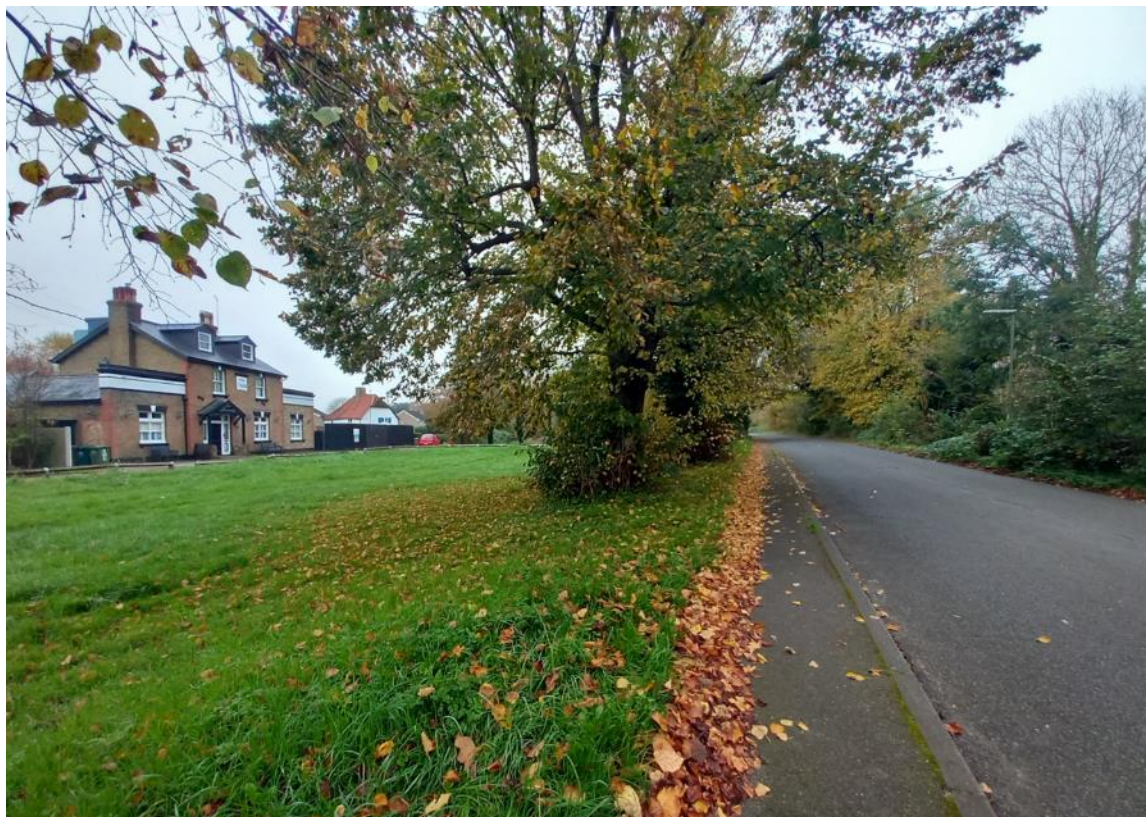
- 3.7.8 A drain was observed at the junction with Moor Lane and running water could be heard, indicative of buried utilities (Plate 7).
- 3.7.9 The route lies c.95m south of the Grade II Listed Building of 'Moor Cottage' (List Entry Number: 1187054). There is no intervisibility between the route and designated heritage asset from the south due to intervening built development (Plate 8).

Plate 8: View of The White House (left of frame, behind hoarding) as seen from Moor Lane, north-west of the proposed route. Photograph taken facing northwest.

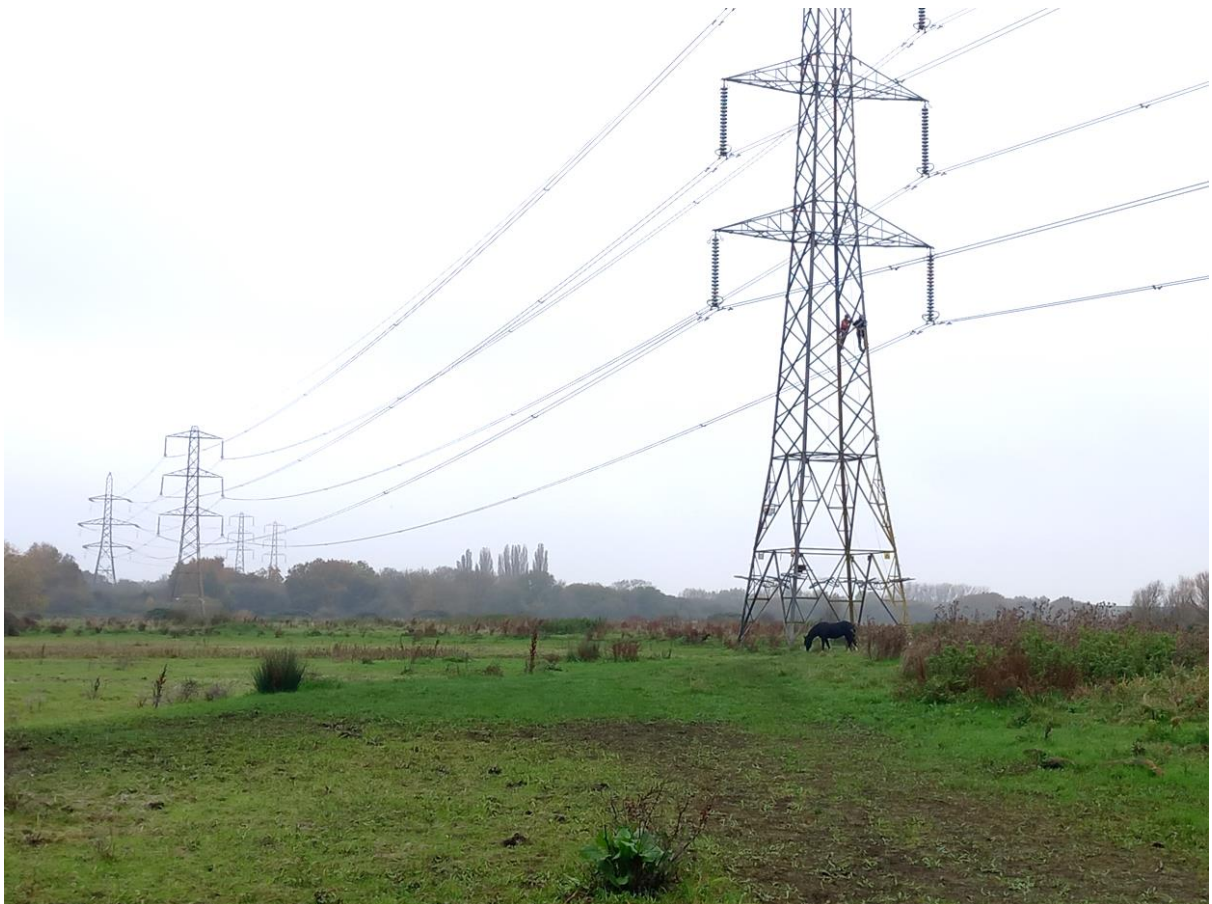
- 3.7.10 The walkover continued on the northeastern side of the railway line, accessed via a public footpath from Moor Lane which runs beneath the A30. The proposed route runs along the western side of Staines Moor. The Moor comprises open, undeveloped moorland populated by frequent scrub and low vegetation (Plates 9 & 10). The area was noted during the walkover as being wet, with frequent areas of standing water and small streams.
- 3.7.11 As a result of this, plus maintenance works being undertaken on existing pylons and presence of cattle and horses, only the southern part of the moor was subject to a walkover a photographic survey.

Plate 9: View of the southern end of Staines Moor, as viewed from a pedestrian underpass below the A30. Photograph taken facing north-northwest.

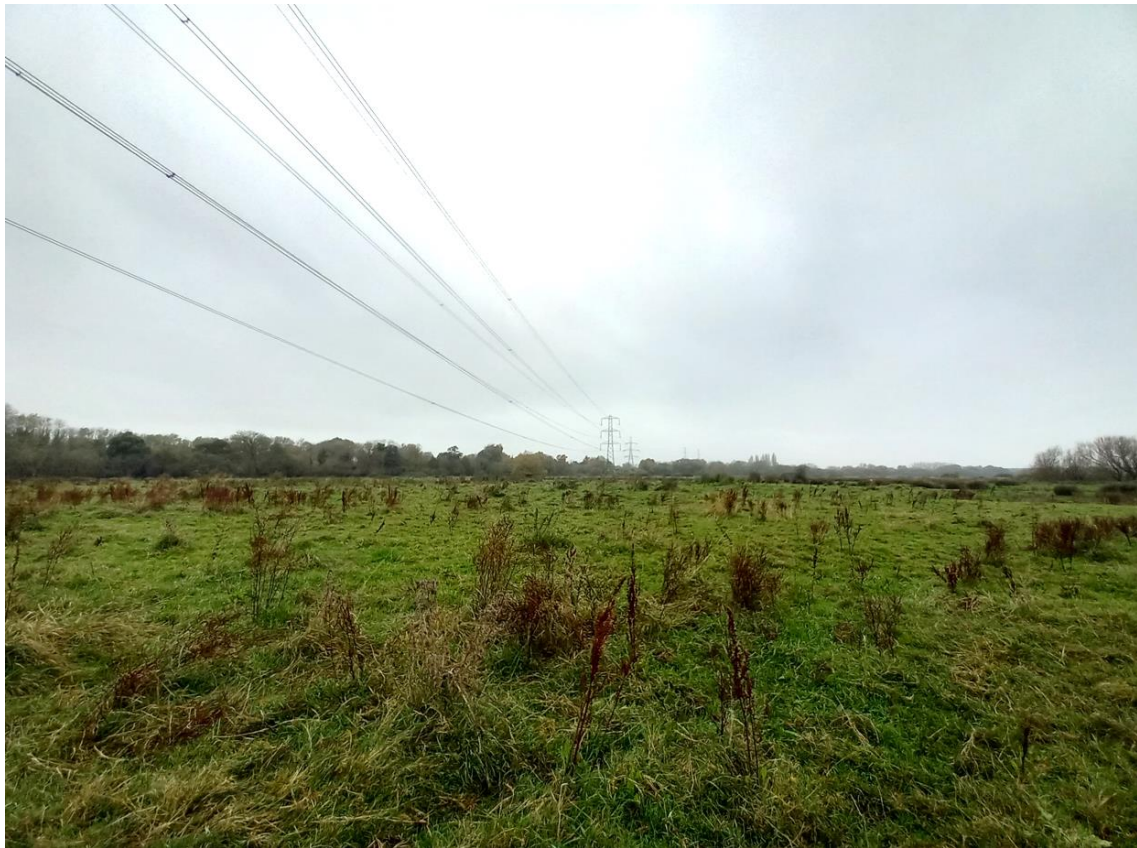
Plate 10: View across the western side of Staines Moor. Photograph taken facing north-northwest.

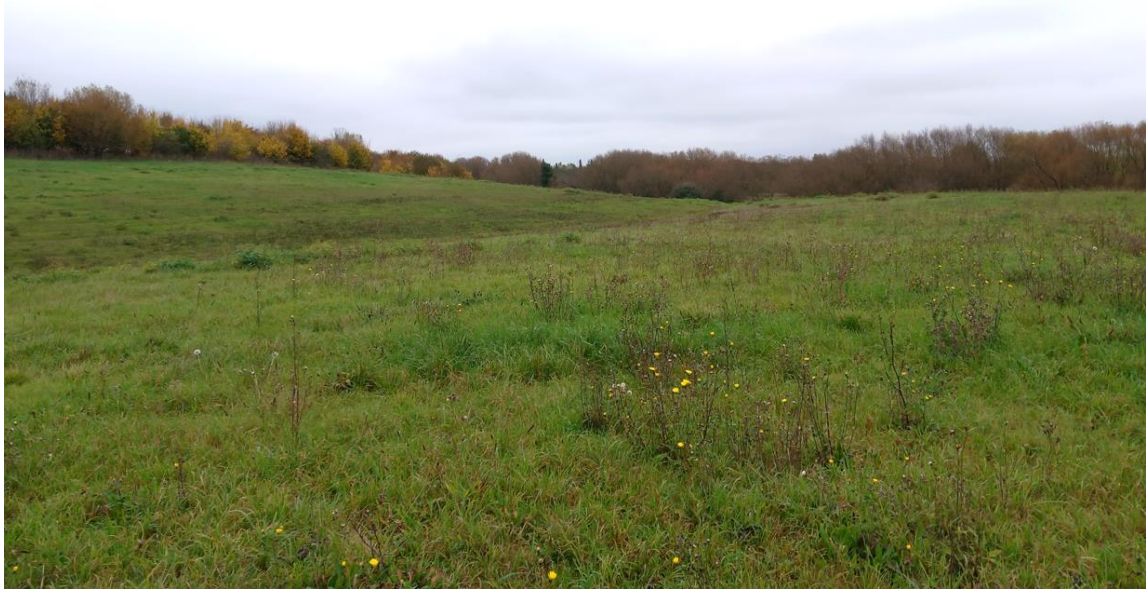
Plate 11: Southern end of the Heathrow Biodiversity Site, as viewed from pedestrian access north of Airport Way. Photograph taken facing north.

- 3.7.12 Towards the northern end of the King George VII Reservoir two route options are proposed, running to the east and west of an area of landfill, south of Beck Aggregates and Quarry. The area of Beck Aggregates has been subject to widespread disturbance consistent with quarrying.
- 3.7.13 The route continues northwards through unmanaged fields. Truncation and large-scale landscaping is evident through construction of Airport Way (A3113). Access was via a public footpath at the northern extent of Horton Road.
- 3.7.14 To the north of the A3133 there are three proposed route options, running through the west, centre and east of Heathrow Biodiversity Site. This area is managed green space, interspersed with matches of meadow, trees and wildflowers (Plate 11).

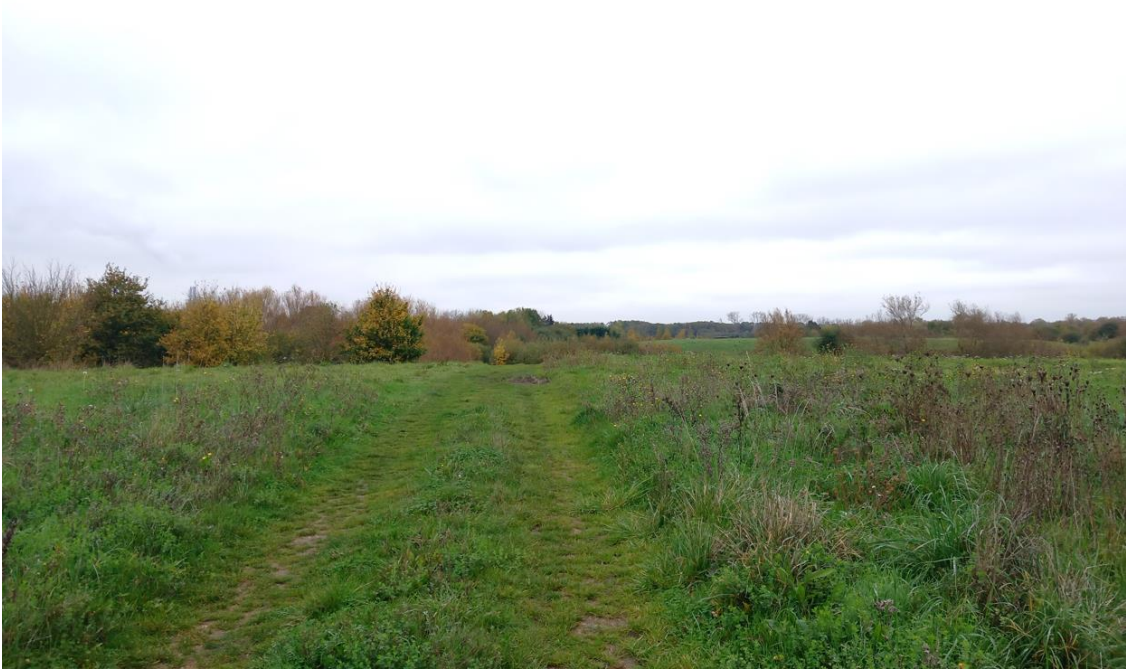
3.7.15 The proposed route converges to the north of the M25 slip road. At the northern end of the Heathrow Biodiversity Site the route passes c.160m east of the Grade II Listed Building 'Milestone at Madbridge' (List Entry Number: 1187016). Due to the undulating topography and mature vegetation screening the south side of Bath Road, the designated heritage asset was not visible from the route (Plate 12).

Plate 12: View of the route from an area of raised ground, looking towards Bath Road. Photograph taken facing north.

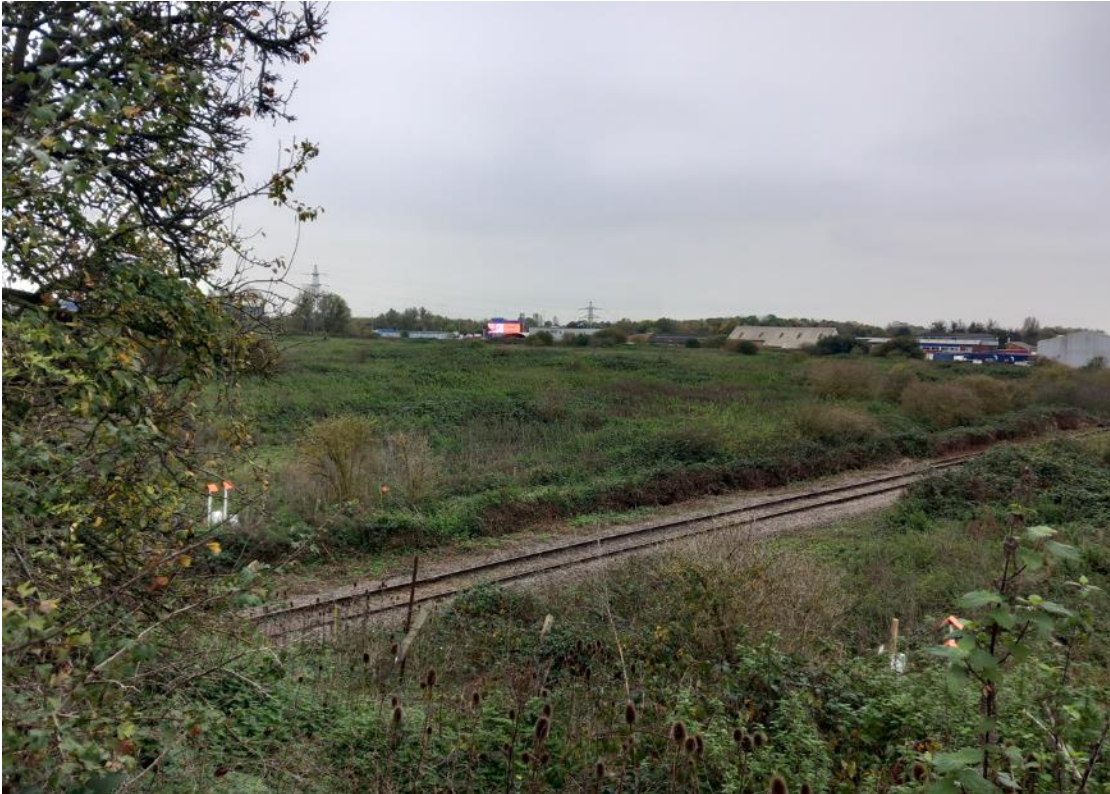
Plate 13: View of the proposed route between the railway line in the west and M25 in the east. Photograph taken facing south-east.

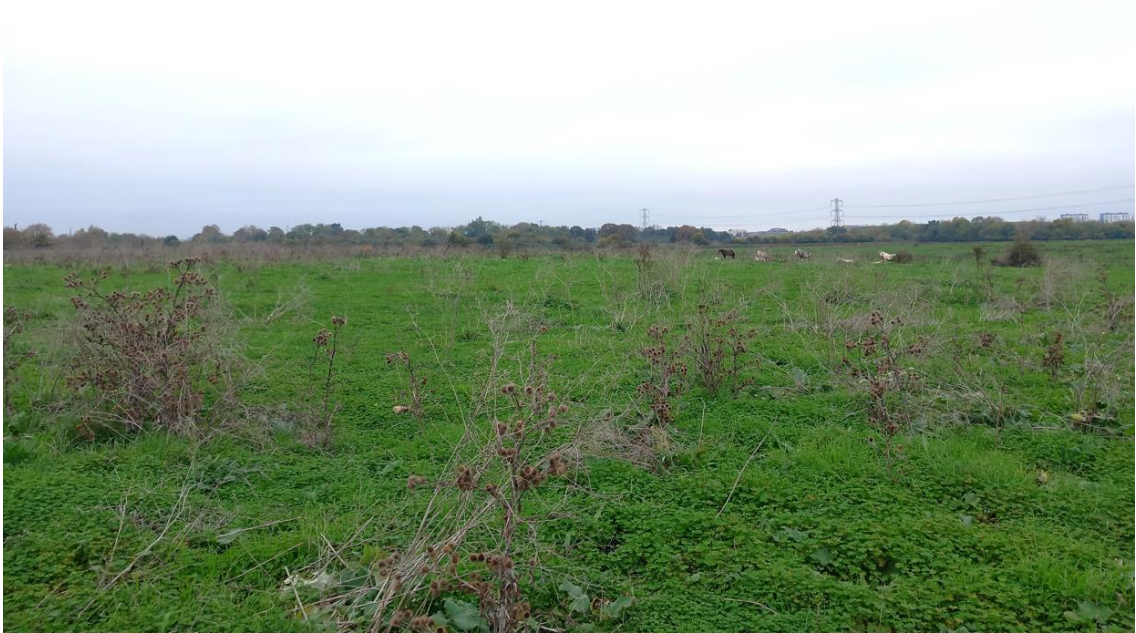
- 3.7.18 Between the Colnbrook By-Pass and M4 motorway the route traverses open land to the southwest of Iver South SDW (Plate 15).

Plate 15: View across field between the A4 and M4, accessed via a pedestrian footpath from Old Slade Lane. Photograph taken facing north-west.

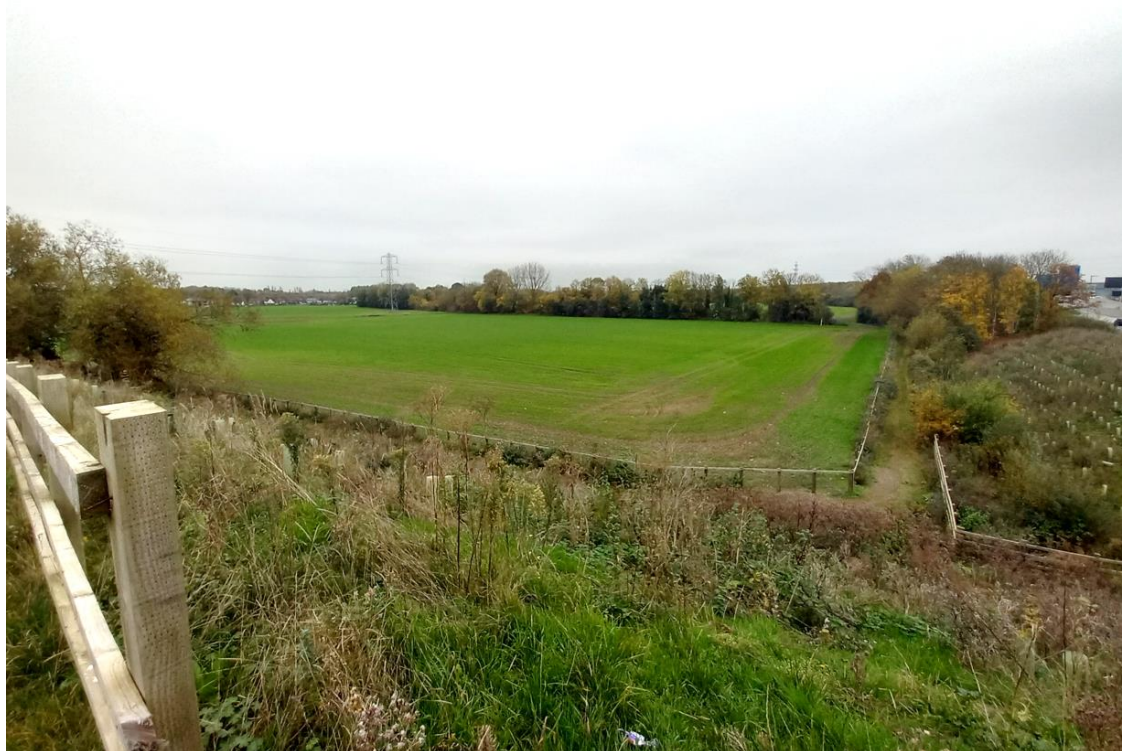
- 3.7.19 To the north of the M4 the route crosses a series of agricultural fields under low crop. Access was via public footpaths to the south of Old Slade Lane and east of The Poynings (Plates 16 & 17).

Plate 16: View across the agricultural fields to the north of the M4, as seen from Old Slade Lane / M4. Photograph taken facing northeast.

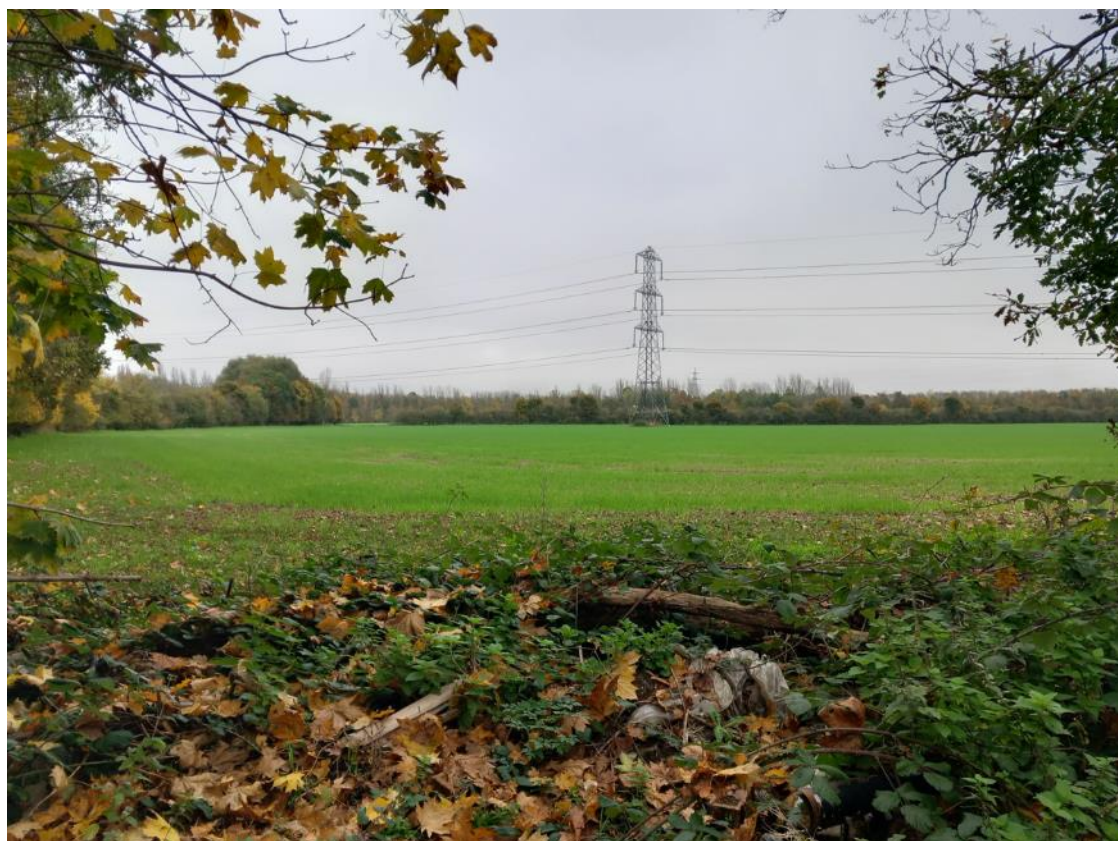
Plate 17: View looking across the northern end of the fields towards the proposed route on the eastern side. Photograph taken from The Poynings, facing northeast-east.

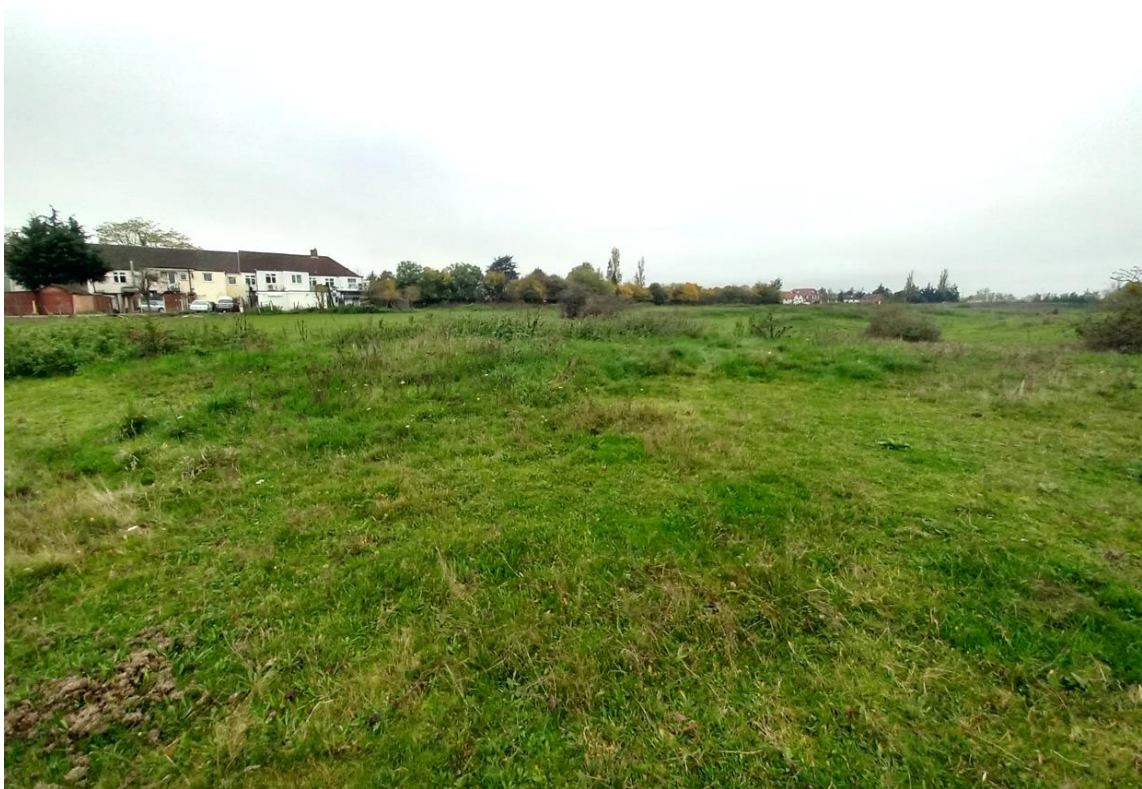
Plate 18: View across Scheduled Monument (List Entry: 1006944) from the southeast side. Photograph taken facing northwest.

- 3.7.21 Towards the northern end of the walkover the proposed route passes within c.30m of the Scheduled Monument ‘Two concentric ditches showing as crop marks at Thorney’ (List Entry Number: 1006944). This Scheduled Monument was observed as an area of slightly raised ground and patches of low vegetation, to the immediate north and east of which the ground drops away creating a terrace to the line of north-south dry channel at the base. Further slight variations in topography were observed in the immediate vicinity (Plates 18 & 19).

The exception to this is the area around Scheduled Monument 'Two concentric ditches showing as crop marks at Thorney' (List Entry: 1006944). Given the high risk of the proposed works impacting features associated with the proposed monument, it is recommended that methodology changes are made to the proposed route, and that directional drilling is undertaken in this area so as to avoid impacting the scheduled monument or its associated features.
