**SCHEME A, FORMER STAR PUBLIC HOUSE,  
HILLINGDON, UB10 0LZ  
Phase 1 Contaminated Land Assessment**

**Client:** Crossier Properties Ltd

**Reference:** TB/CC/P19-1780/04

**Date:** November 2019

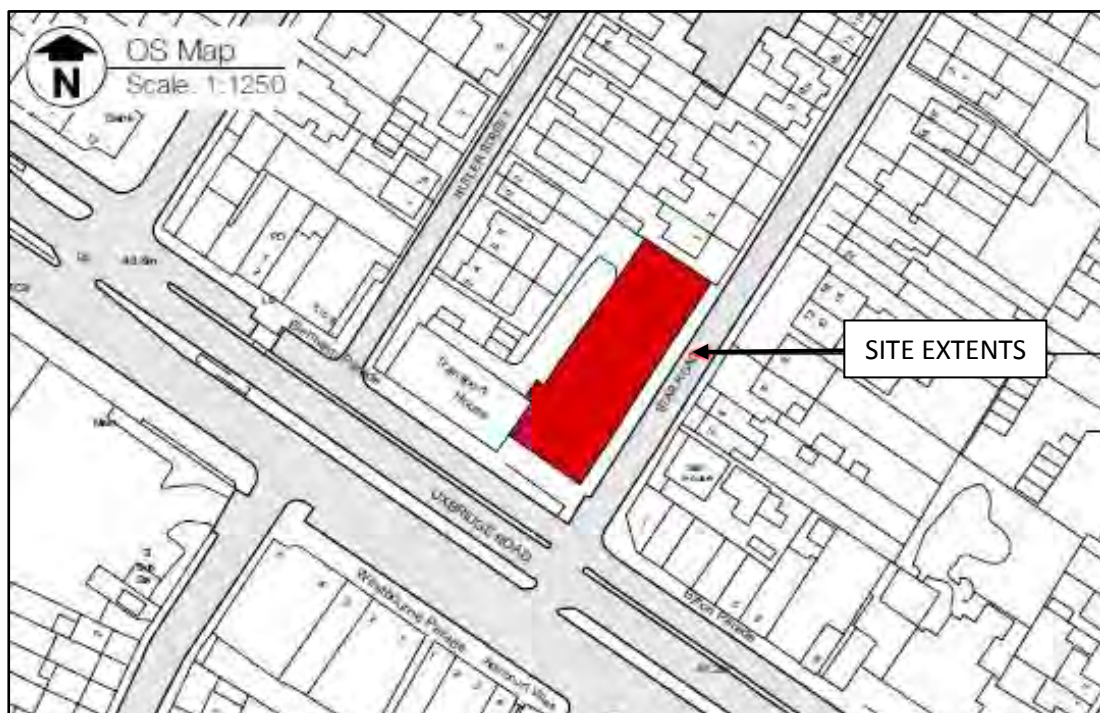
**Figure 1.1: Site Plan (modified extract from Chassay Studio Architects Design and Access Statement, March 2019)**

- 1.3 The Site boundary is included as Figure 1.1 below.

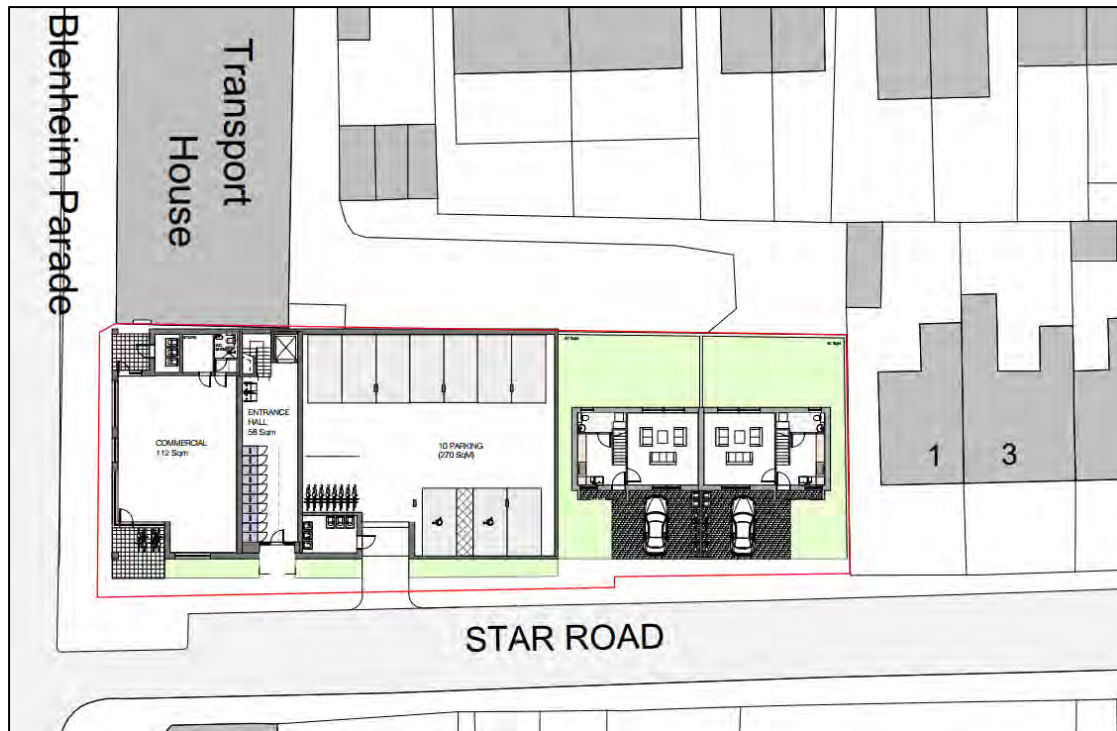
**Figure 1.2: Proposed Site Development (Ground Floor Plan 1664/A/03)**

- 1.4 The Client plans to submit a planning application for a combined commercial and residential development. This would incorporate a four storey building accommodating 10No. flats, commercial space and 2 x 2 storey houses, with car and cycle parking and amenity spaces. The proposed ground floor layout is provided as Figure 1.2 overleaf.

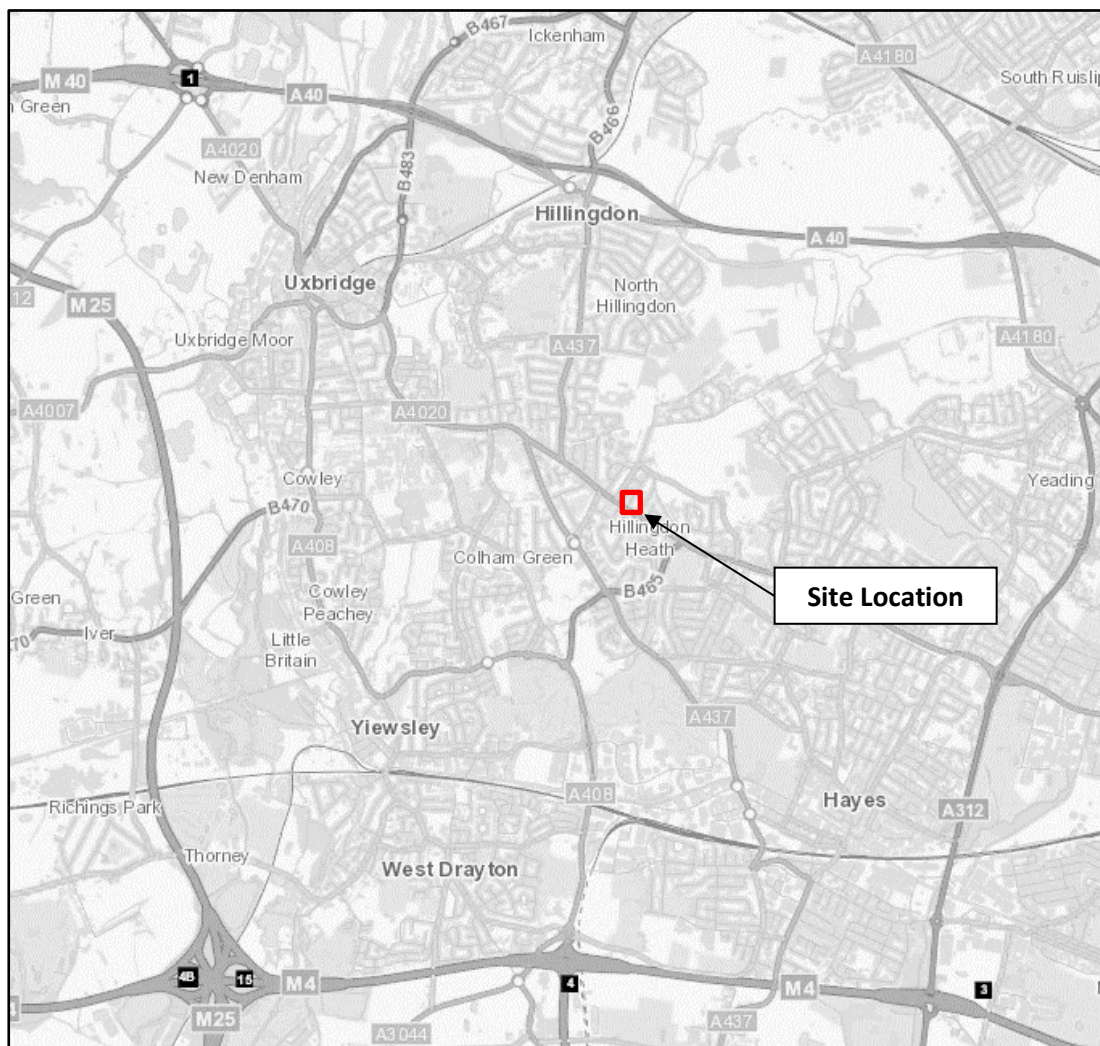
Figure 3.1: Site Location Plan (Geoindex, 2019)

- 3.1 The Site is located in Hillingdon, on the intersection of Uxbridge Road and Star Road, approximately 1km to the north east of Hillingdon Hospital and centred at National Grid reference 507965E, 182311N. The elevation of the Site is approximately 49.0m above Ordnance Datum (aOD).
- 3.2 An approximate Site location plan is provided as Figure 3.1 below.

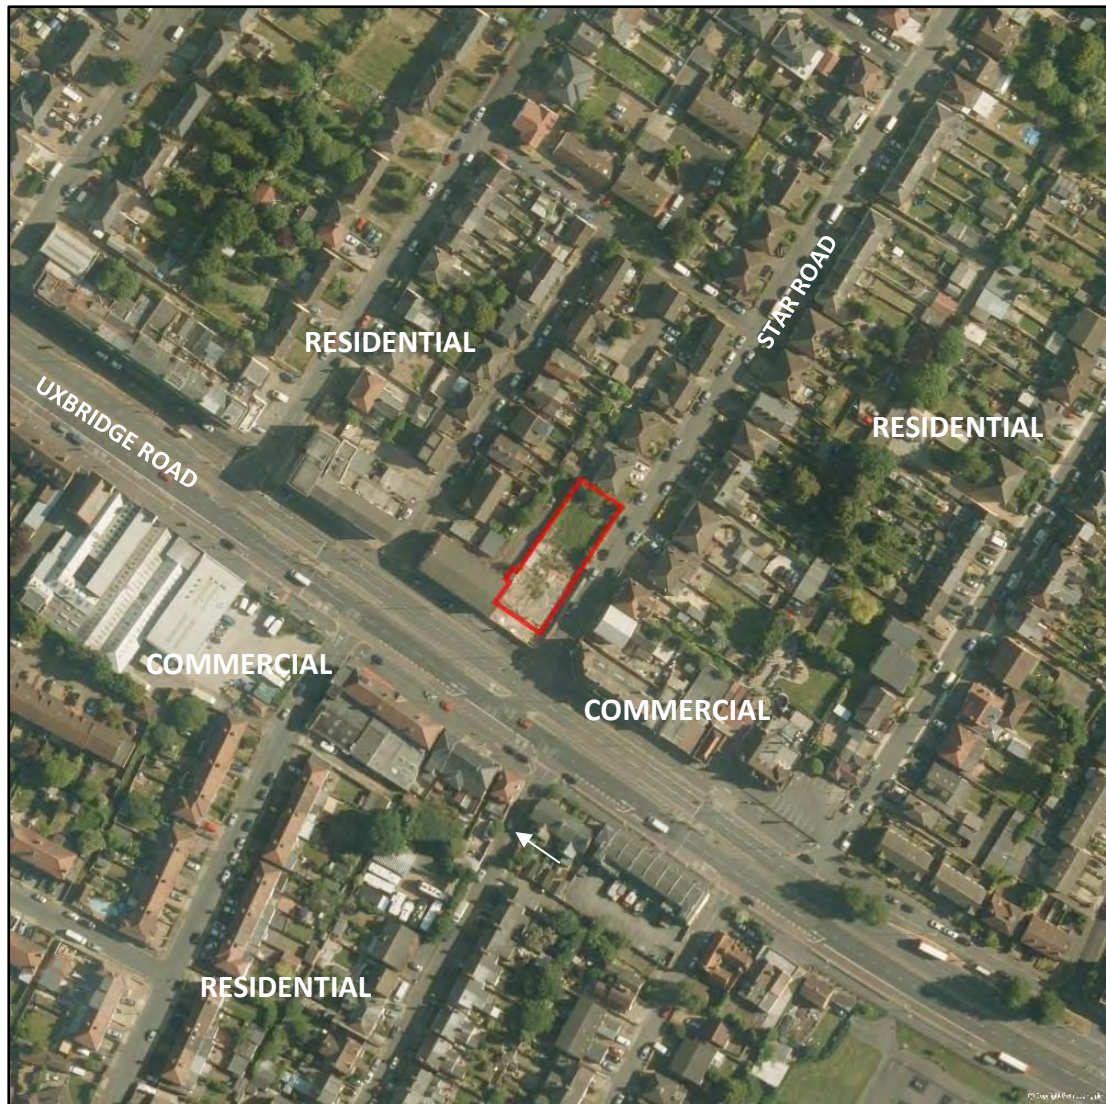
Figure 3.2: Surrounding Land Use Plan (Groundsure, 2019)

- 3.12 The land use around the Site is dominantly residential to the with commercial/retail developments adjacent to the east and west (and south) fronting onto Marlborough Parade / Uxbridge Road
- 3.13 The current surrounding land uses identified are illustrated in Figure 3.2, overleaf.

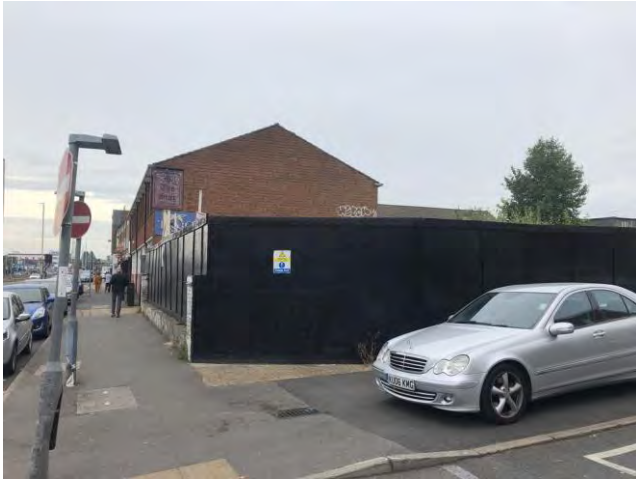
**Photo 1: The front (southwest boundary) of the site with Transport House adjacent to the southwest (looking northwest)**

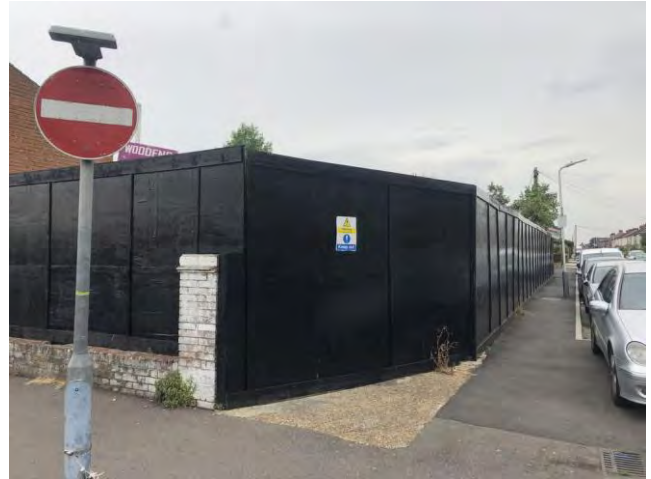
**Photo 2: The southeast boundary of the site adjacent to Star Road (looking northwest)**

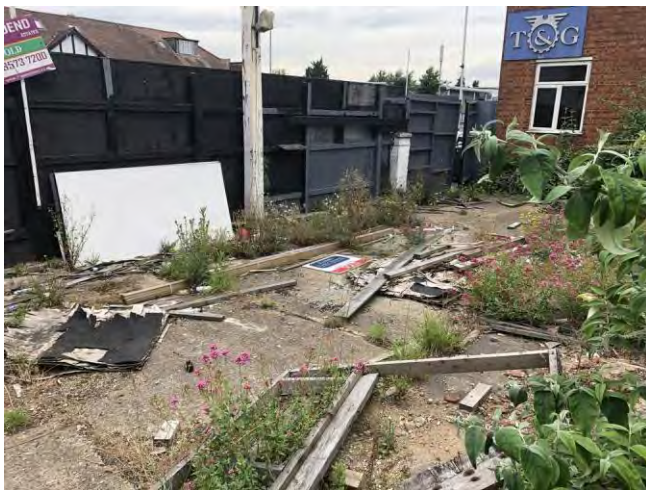
- 3.7 The Site was accessed through a locked gate, bound by a combination of timber and concrete fencing and was generally overgrown. At the front of the Site was concrete hardstanding with waste materials and demolition materials present (see Photo 3, Appendix C). Vegetation was present in the northern part of the Site (and this area was inaccessible during the site walkover) which formed part of the former garden and trees were present along the northeast boundary (see Photo 7, Appendix C). The southern part of the Site generally comprised wooden flooring, hardstanding and building foundations with some semi-mature shrubs and bushes present across this area and along the western and northern boundaries (see Photos 4 and 5, Appendix C).

**Photo 3: The front of the Site covered by hardstanding and waste materials / demolition debris (looking west)**

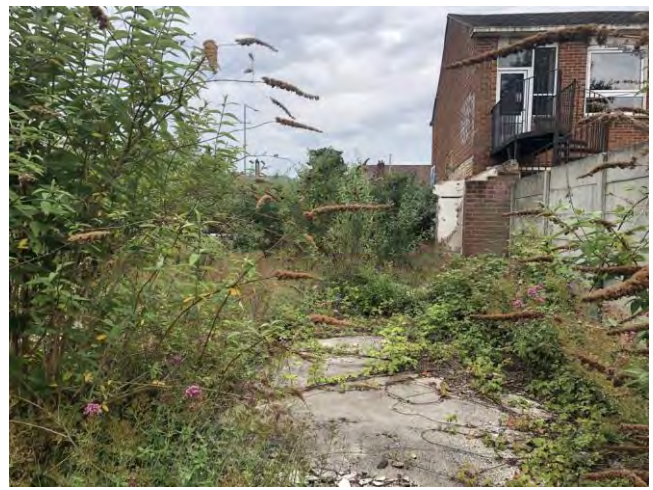
**Photo 4: The south western area of Site with hardstanding and semi-mature shrubs with Transport House beyond (looking southwest)**

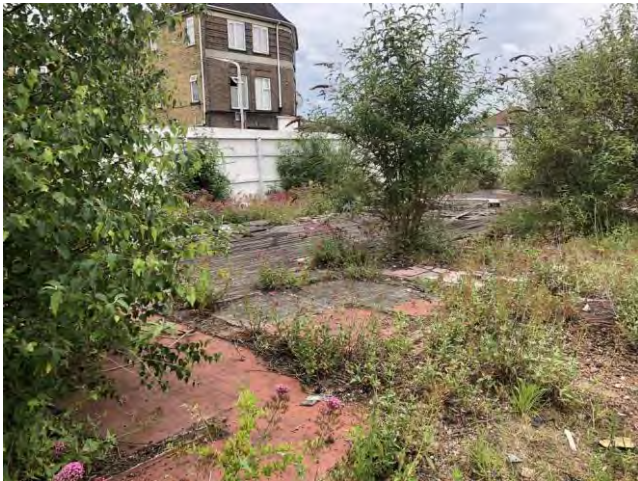
**Photo 5: South eastern area of Site with wood flooring / hardstanding and semi-mature shrubs and retail buildings beyond (looking south)**

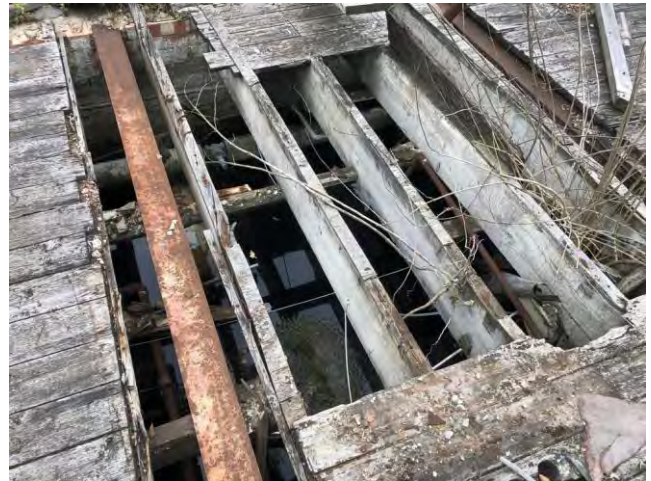
**Photo 6:**

- 3.8 Within the foundation footprint of the former Star Pub, an area of timber flooring was present and, in places, this had broken or been lifted to reveal a flooded sub-floor void and utility pipes (see Photo 6, Appendix C). It was not clear whether there was a basement present beneath the former building on Site. The water within the flooded void had no obvious sheen to it and there was no olfactory sign of contamination noted at the time of the walkover assessment.

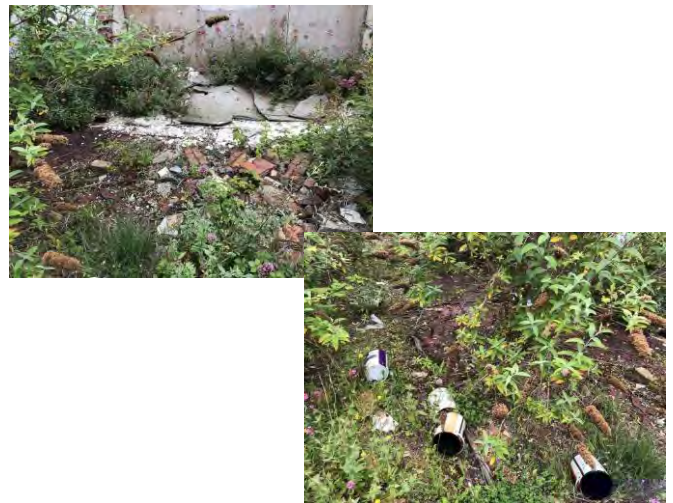
**Photo 8:**

- 3.9 There was some evidence of remaining demolition building materials and miscellaneous waste including paint tins and chemical containers within the Site (see Photo 8, Appendix C).
