HOME FARM,
HAYES

Bat Survey Report

January 2023
10641.BatReport.vf

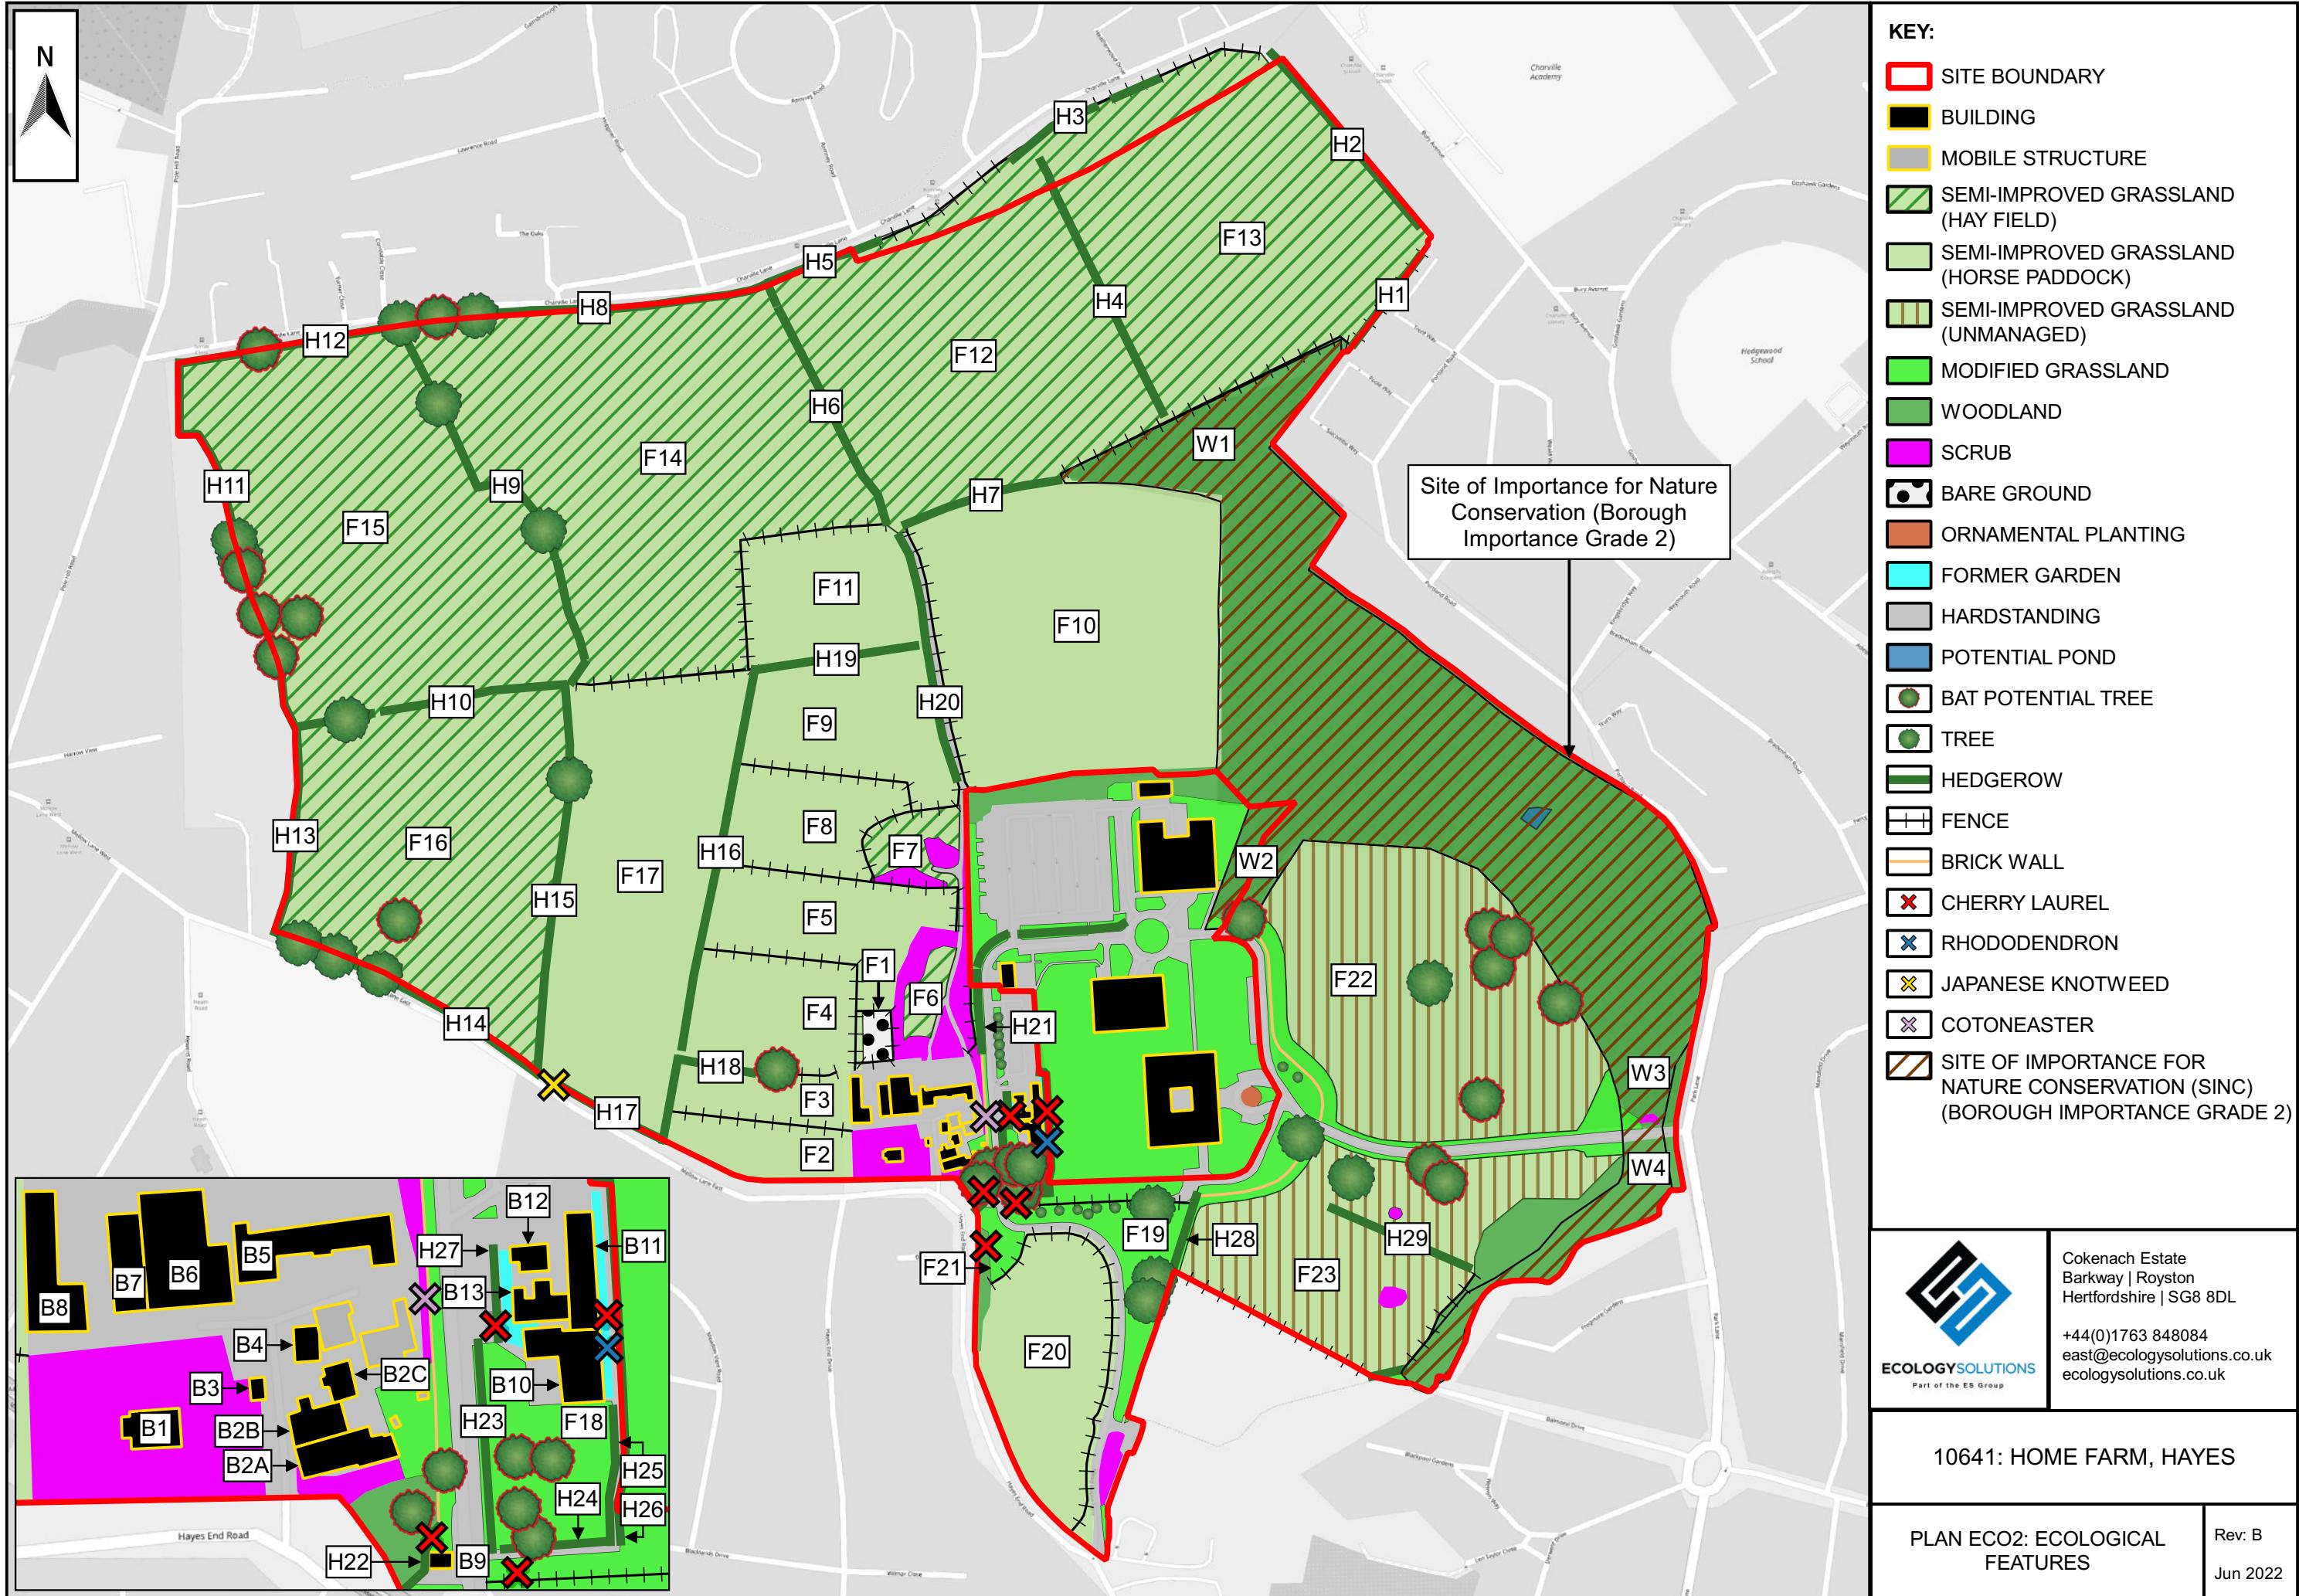
PLAN ECO2

4.1.1. Several buildings (Buildings B1 to B8 – see Plan ECO2) are present in the south of the site, some of which are in a state of disrepair. These structures comprise the former farmhouse (Building B1) and a series of traditional farm buildings (Buildings B2A, B5, B7, B8 and B9), in addition to newer builds used for storage and commercial purposes (Buildings B2B, B2C, B4 and B6). Building B3 is a shed in very poor condition. More temporary structures are also present in this area and include shipping containers. Buildings B9 to B13 are separated from the other buildings by a brick wall where non-native *Cotoneaster* sp. is present. Building B9 (a former guard house), Building B10 (a former residential cottage) and Buildings B11 and B13, which adjoin B10, are vacant and deteriorating in condition. Building B12 is actively used as a workshop.

Ecological Features

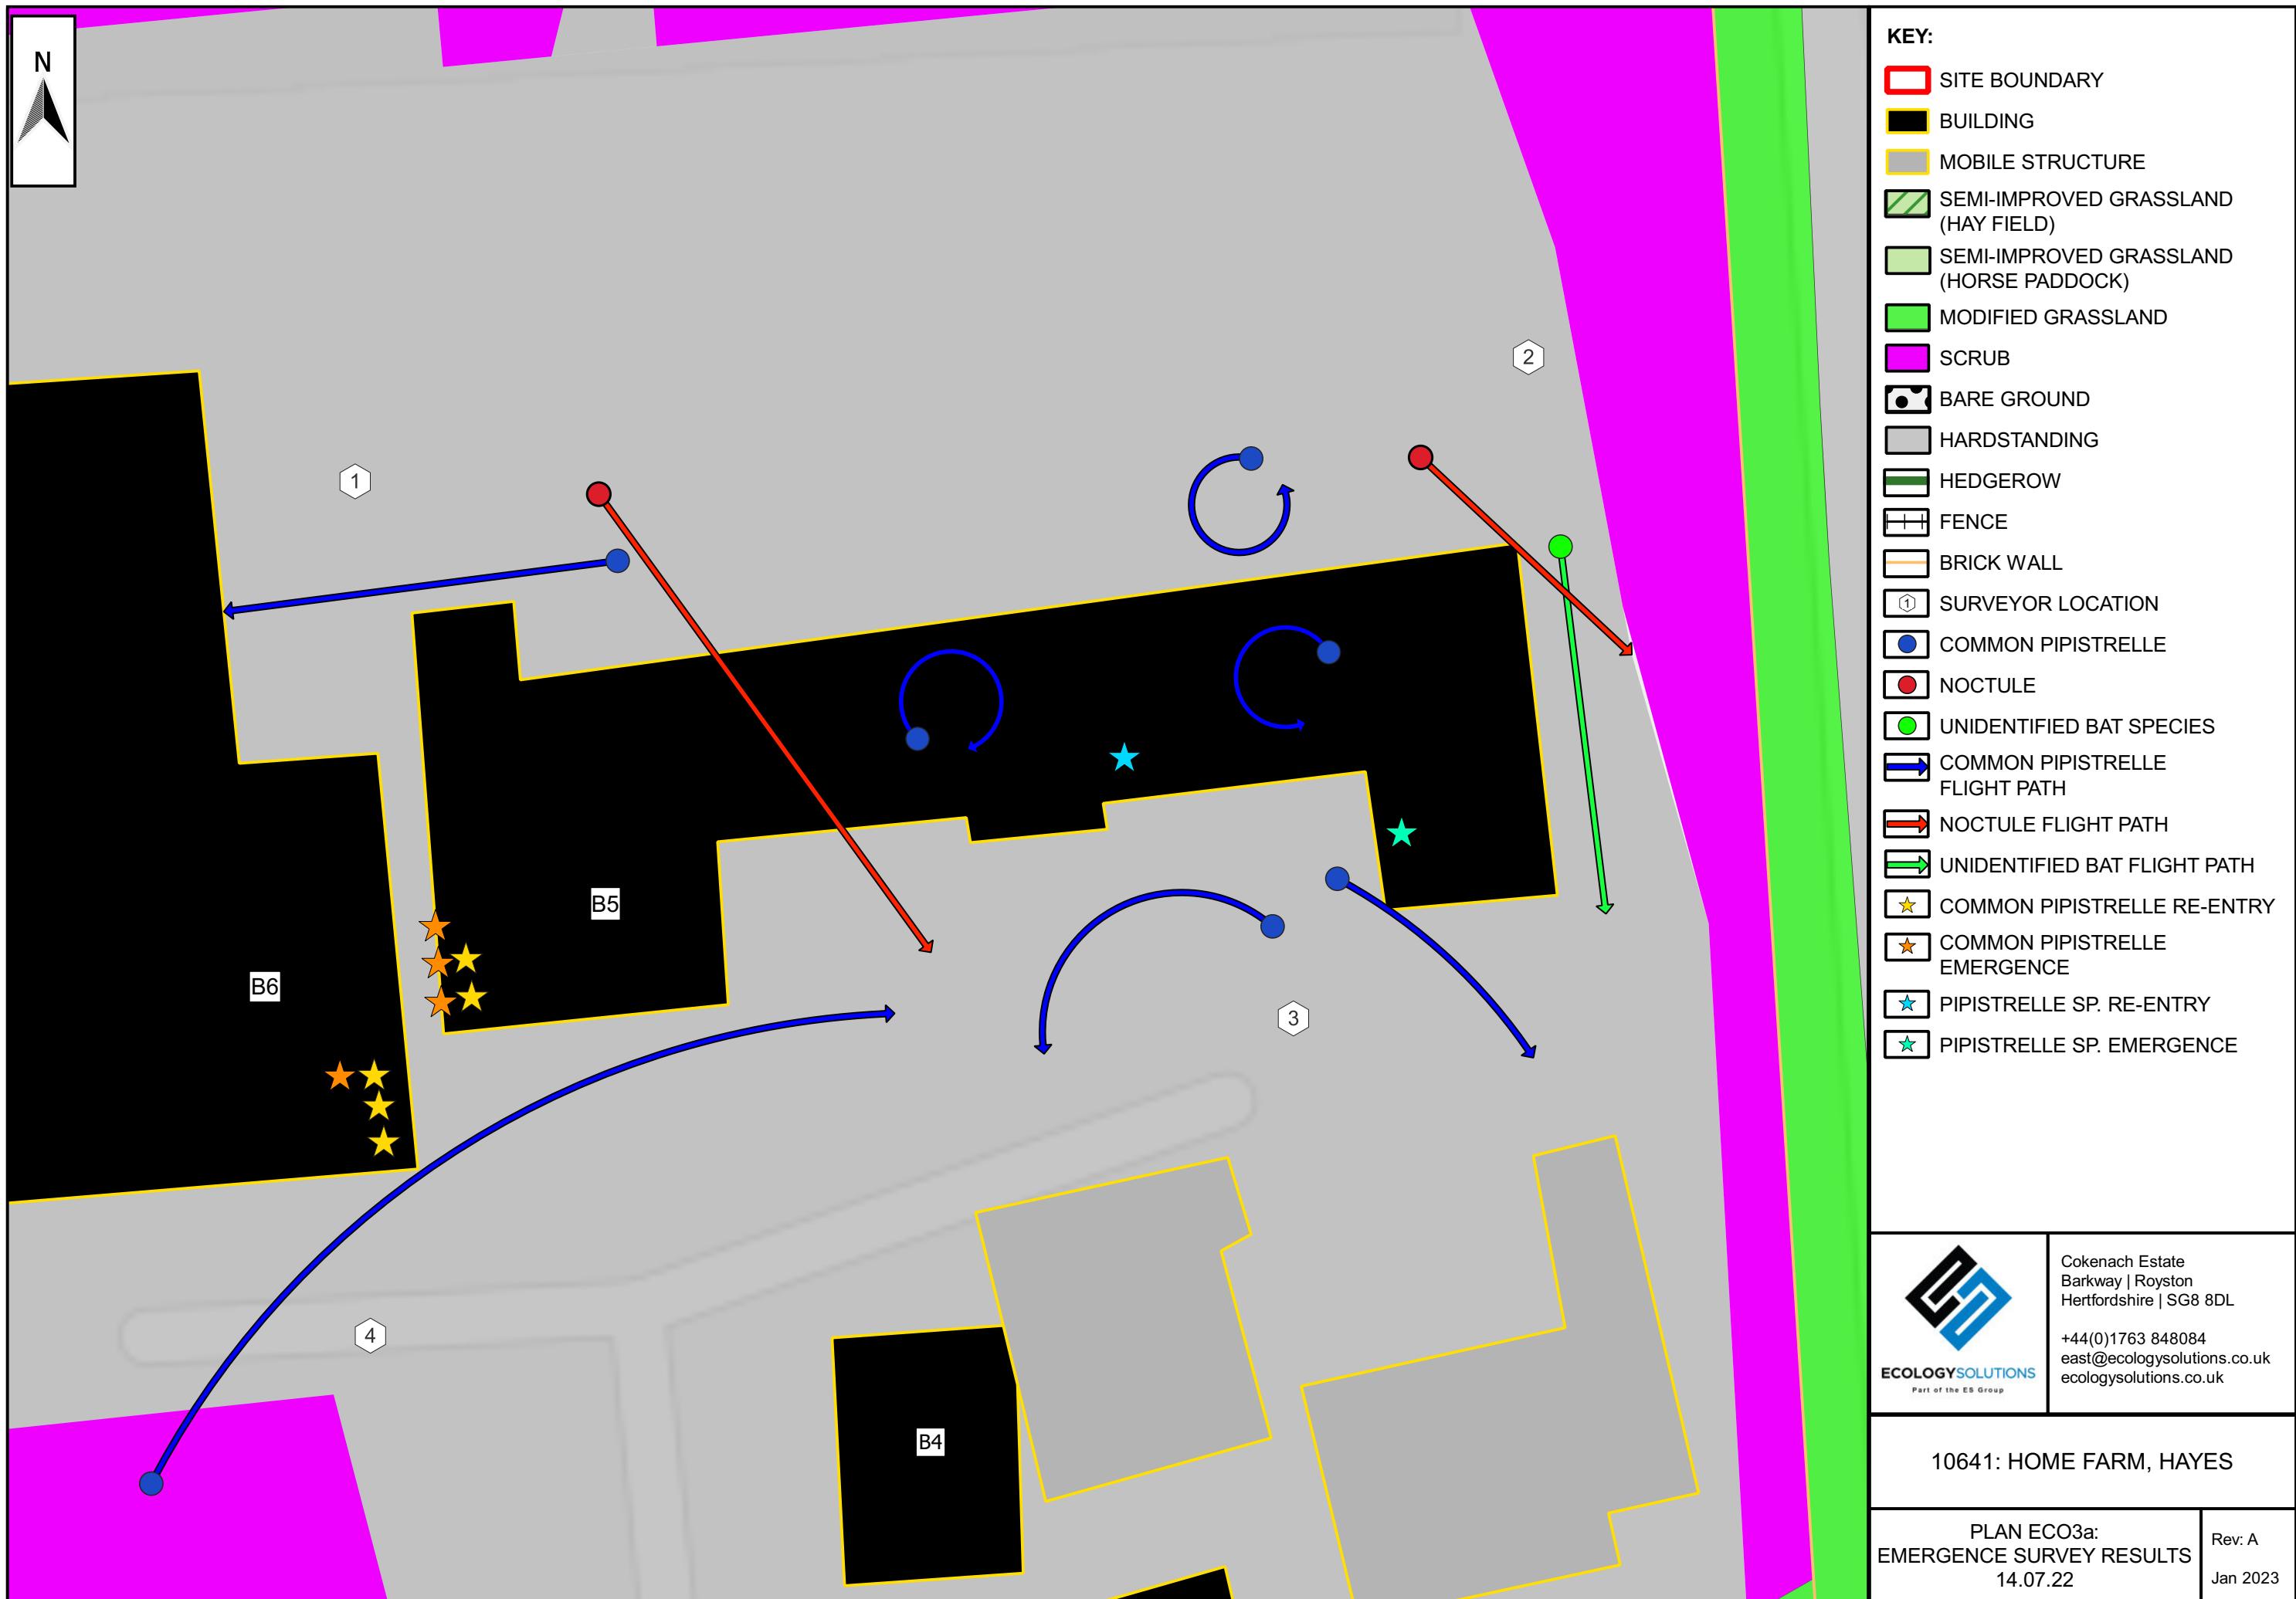
PLAN ECO3a

- 5.3.2. The results of the emergence survey are summarised below and in Table 5.2. The results are also illustrated on Plan ECO3a.
- 5.3.3. Five emergences and six re-entries were recorded during this survey. All confirmed emergences can be attributed to Common Pipistrelle. Bats were

observed emerging from the south-western corner of Building B5 and subsequently re-entering into the south-eastern corner of Building B6 and vice versa. In total, three emergences and two re-entries were recorded for the southwestern corner of Building B5 and one emergence and three re-entries recorded for Building B6. In addition, one re-entry of an unidentified Pipistrelle sp. was recorded on the south side of Building B5 and one unidentified Pipistrelle emergence was recorded on the south-eastern section of the building. A maximum of two bats were seen emerging and re-entering at any one time and it is considered at least three individuals were moving between Buildings B5 and B6.

Emergence Survey Results 14.07.22

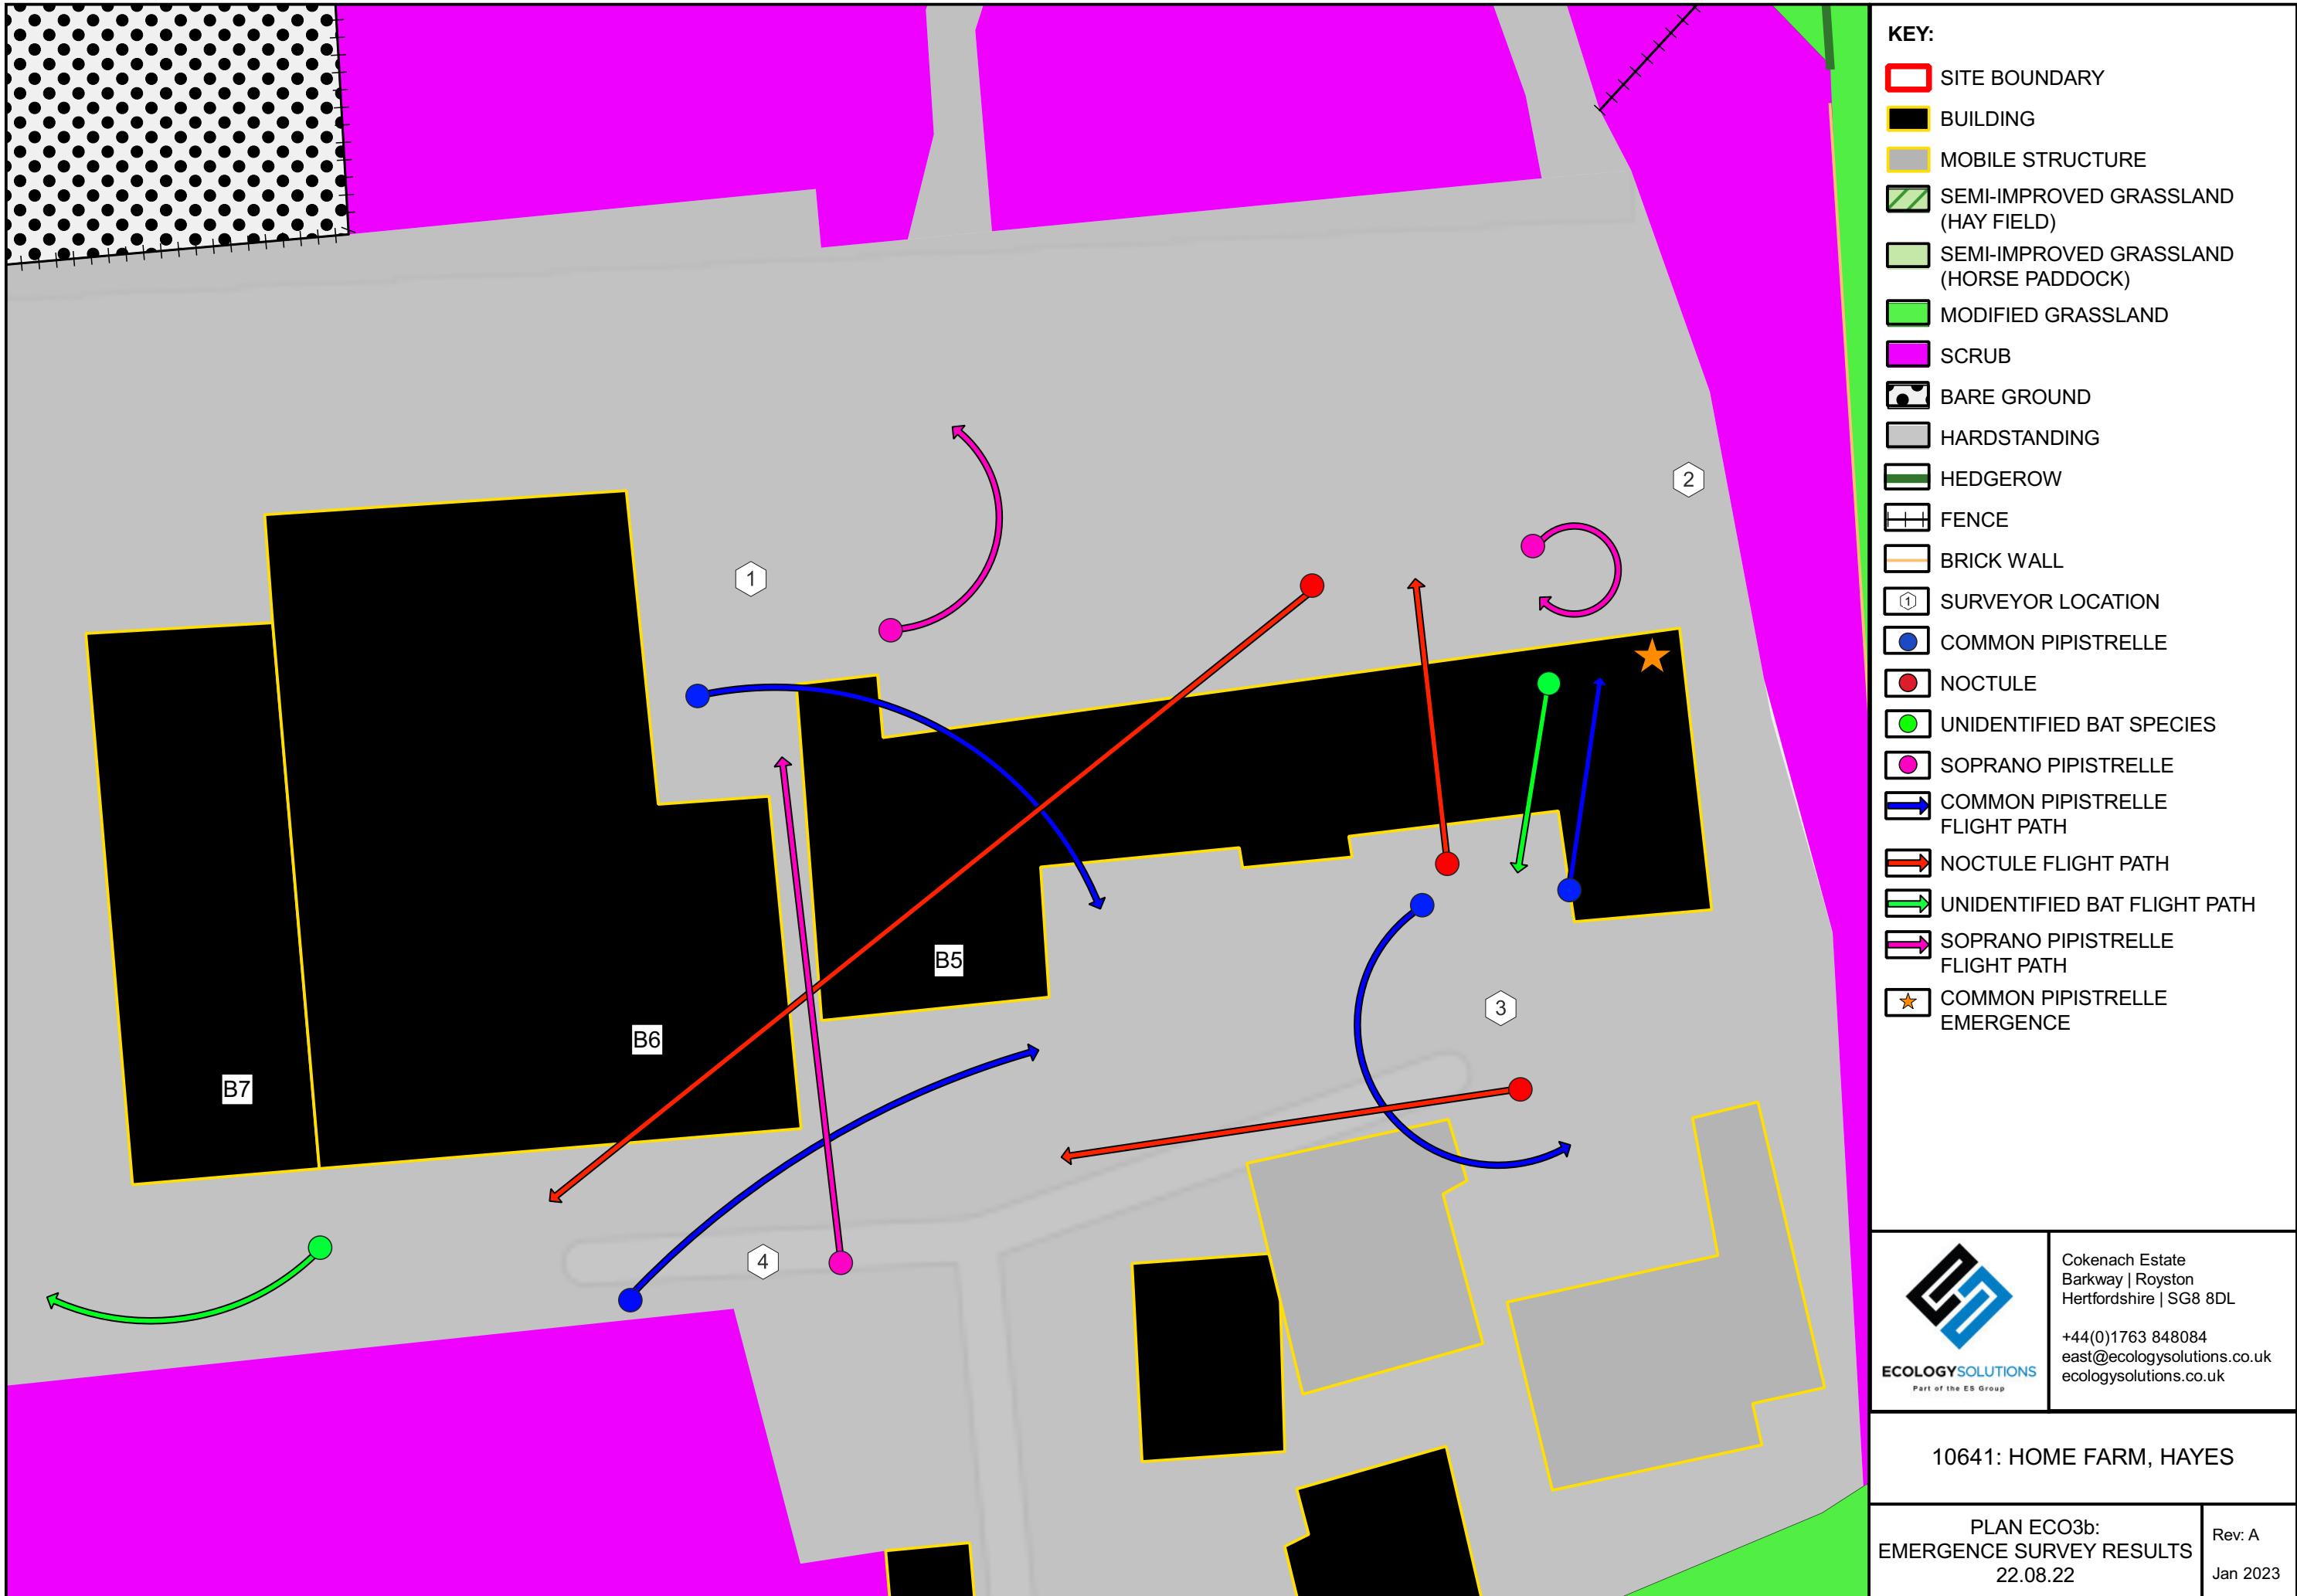
PLAN ECO3b

5.3.5. The results of the emergence survey are summarised below and in Table 5.4. The results are also illustrated on Plan ECO3b.

5.3.6. One observed instance of an emergence was recorded. This pertained to a Common Pipistrelle emerging from the north-eastern corner of B5.

Emergence Survey Results 22.08.22

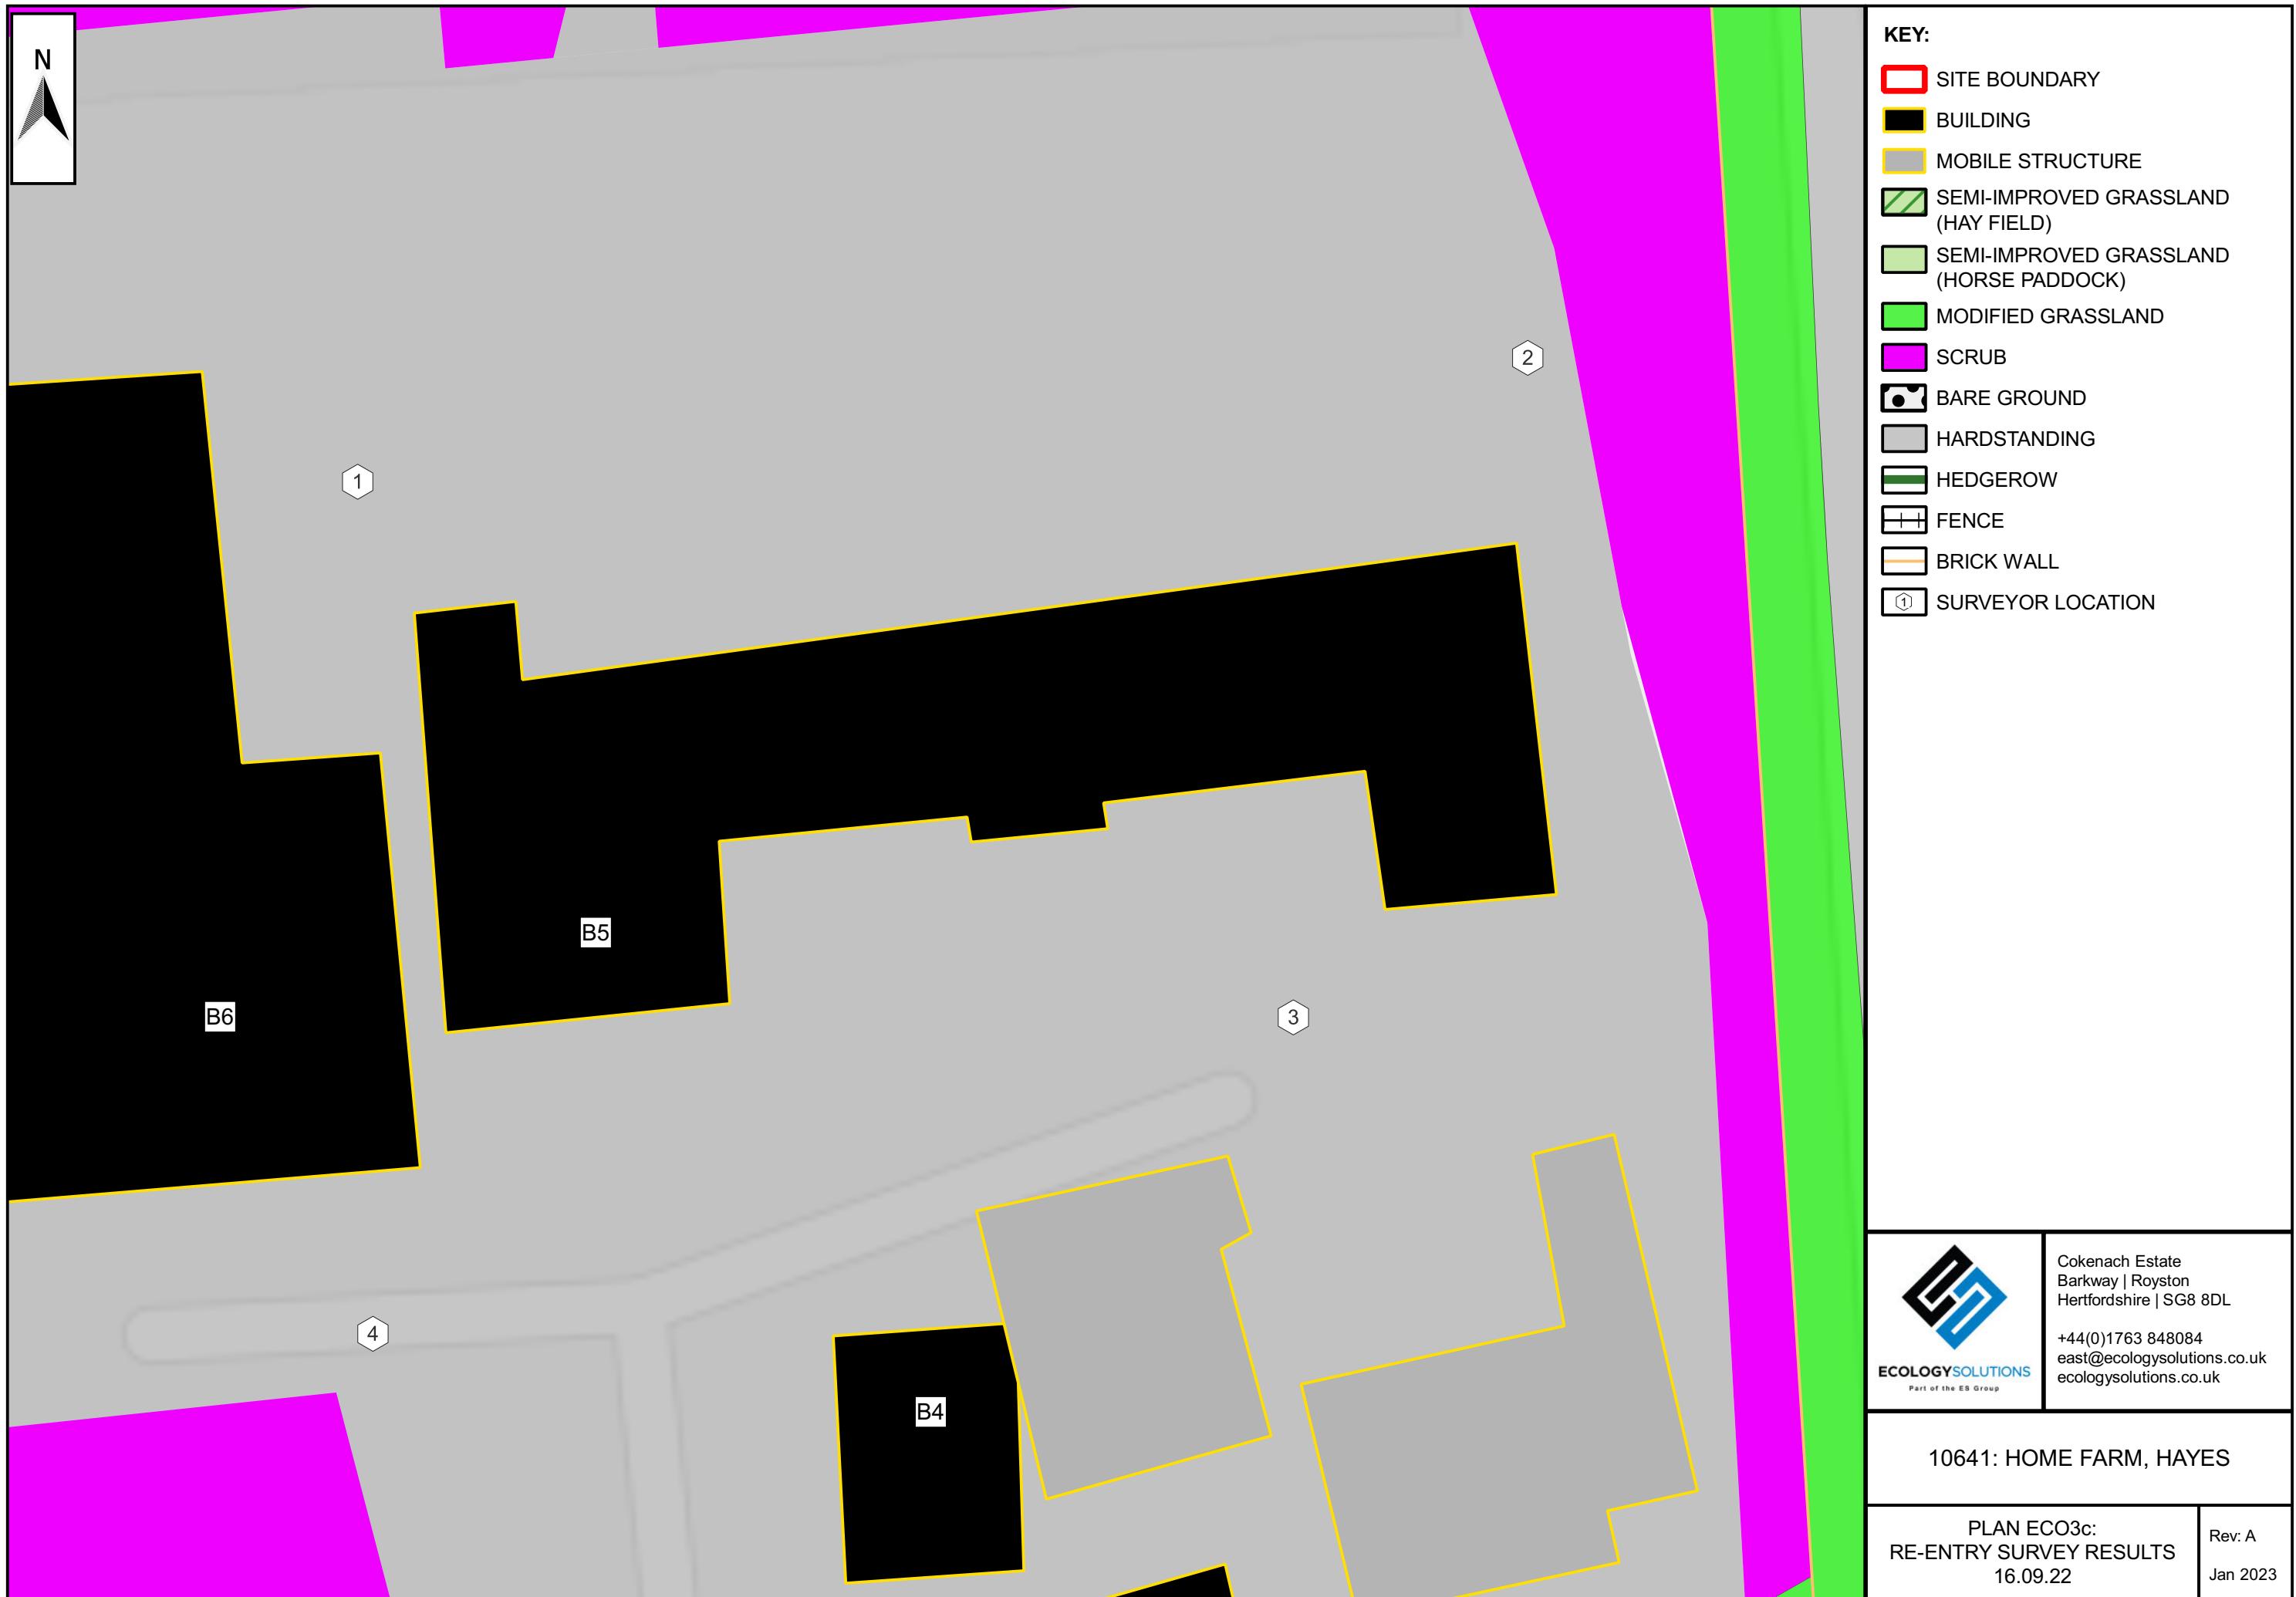
PLAN ECO3c

5.3.1. The results of the re-entry survey are summarised below and in Table 5.6. The results are also illustrated on Plan ECO3c.

5.3.2. No bats were observed emerging from or re-entering the building.

Re-Entry Survey Results 16.09.22

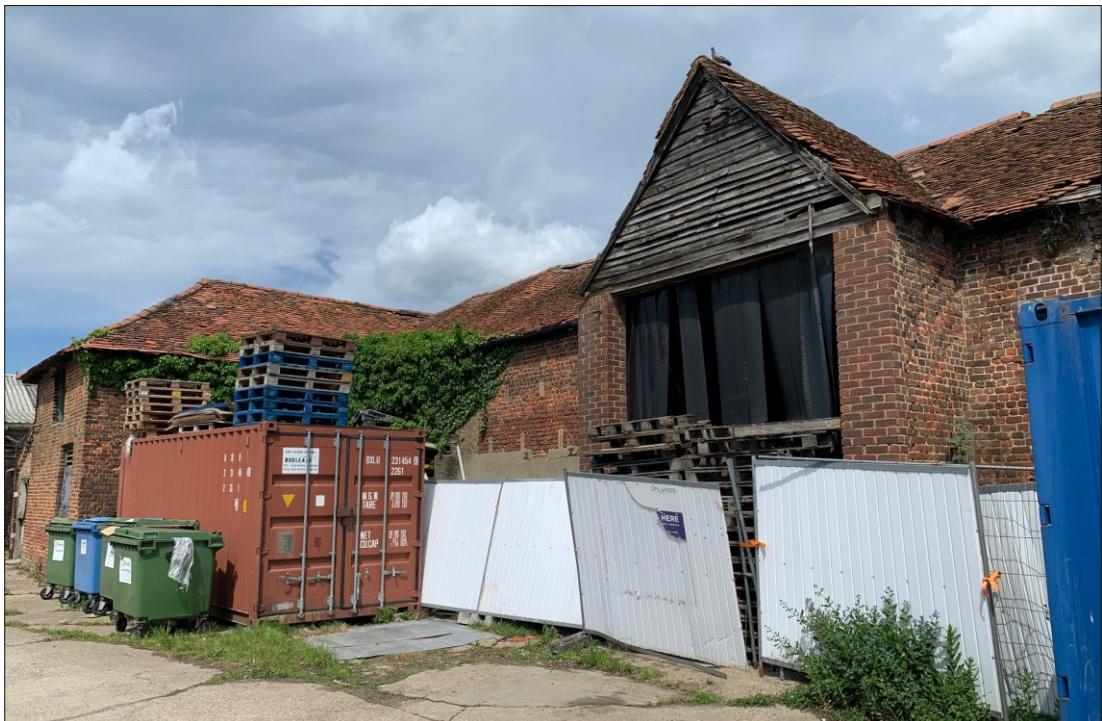
4.1.2. The focus for the survey was Building B5 (Photograph 1). This is a single-storey, double-height barn in a poor state of repair. The building is constructed of red brick and cinder blocks with a wooden gable end on the southern aspect. The hipped roof comprises clay tiles, many of which are missing or have broken, resulting in many access points. There is notable warping of the roof with a collapse on the eastern and north-western corners (Photograph 2). Several boarded windows are present on its north and south faces (Photograph 3) but a large open entrance with strip curtains provides another large entry point to the building from the south. Significant ivy *Hedera helix* growth is present on the southwest of the structure and gaps are present under the eaves. The building is surrounded by an area of hardstanding, with two storage containers present on its southern side (Photograph 4).

PHOTOGRAPH 1: Building B5 (south side)

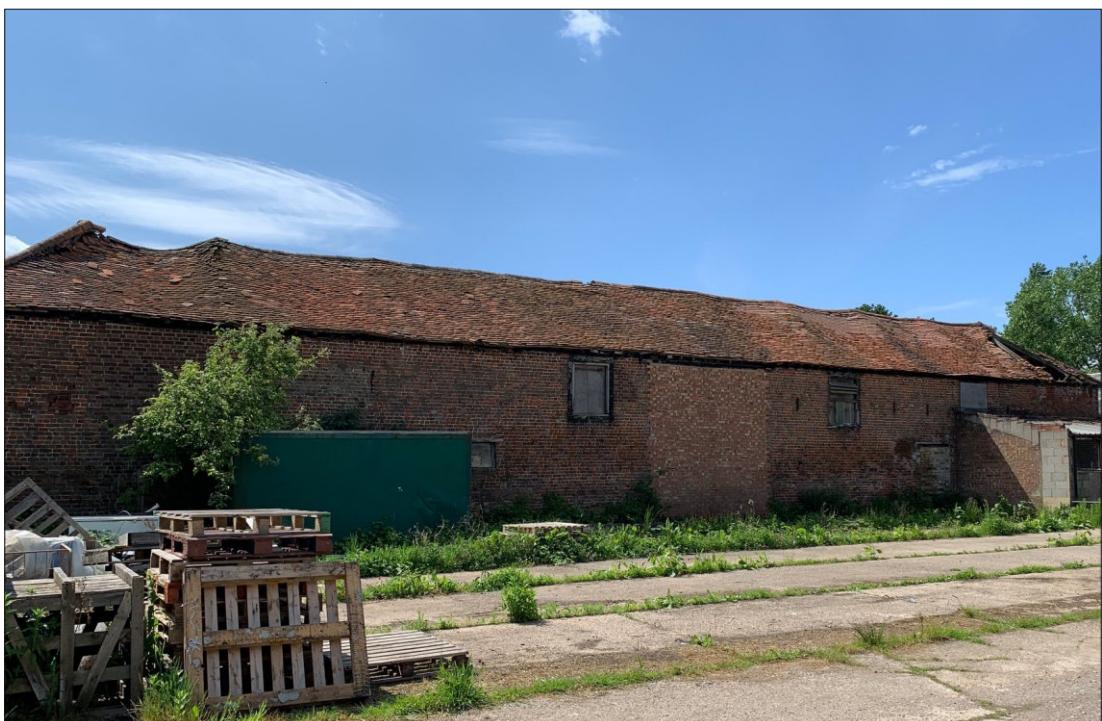
- 5.2.1. Upon inspection, Building B5 was determined to exhibit high bat roosting potential in the form of raised roof tiles, gaps under the lead flashing and the partial collapse of the roof, which provides a significant entry point. Additionally, vegetation growth may conceal further entry points.

PHOTOGRAPH 2: Building B5 (roof collapse and warping on north side)

- 6.2.1. Building B5 is structurally unsafe and will be demolished on the basis of health and safety concerns. Common Pipistrelle roosts will be subsequently lost.

6.3.9. Due to the presence of roosting bats, a soft-strip demolition will be required, with works to proceed under the supervision of an Ecological Clerk of Works (ECoW). This will involve careful removal of the roof tiles to avoid any bats being injured or killed during destruction of the roof. Any bats encountered during this work will be moved to bat boxes installed on retained trees in the wider site ownership.

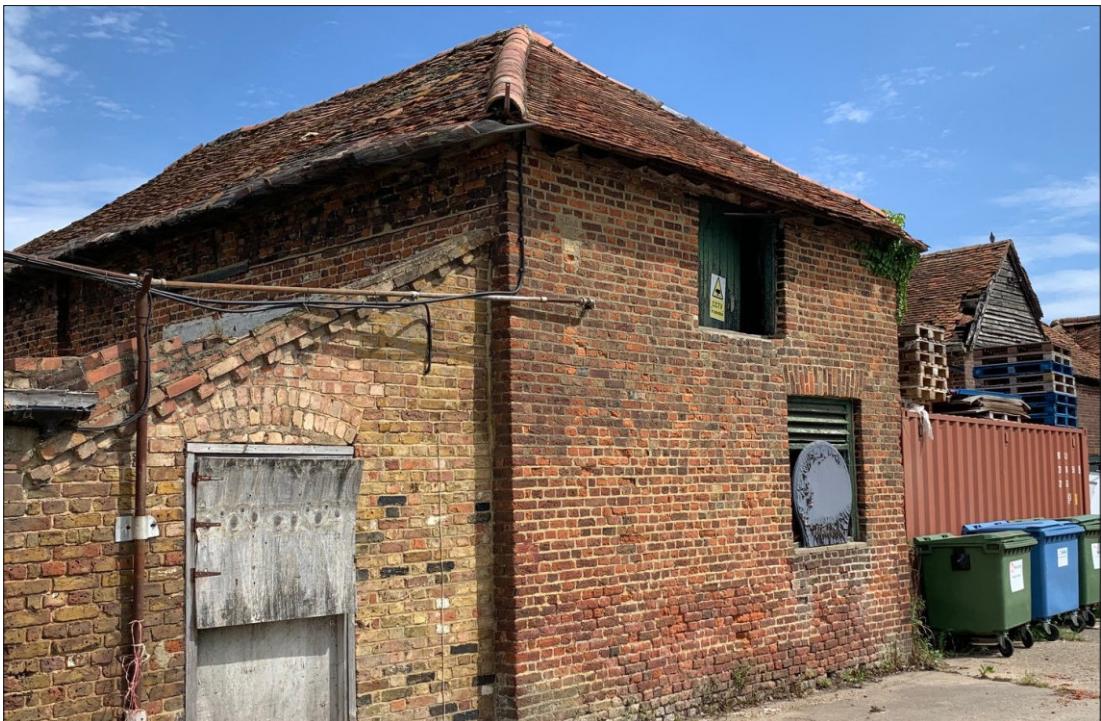
PHOTOGRAPH 3: Building B5 (boarded windows on southwest corner)

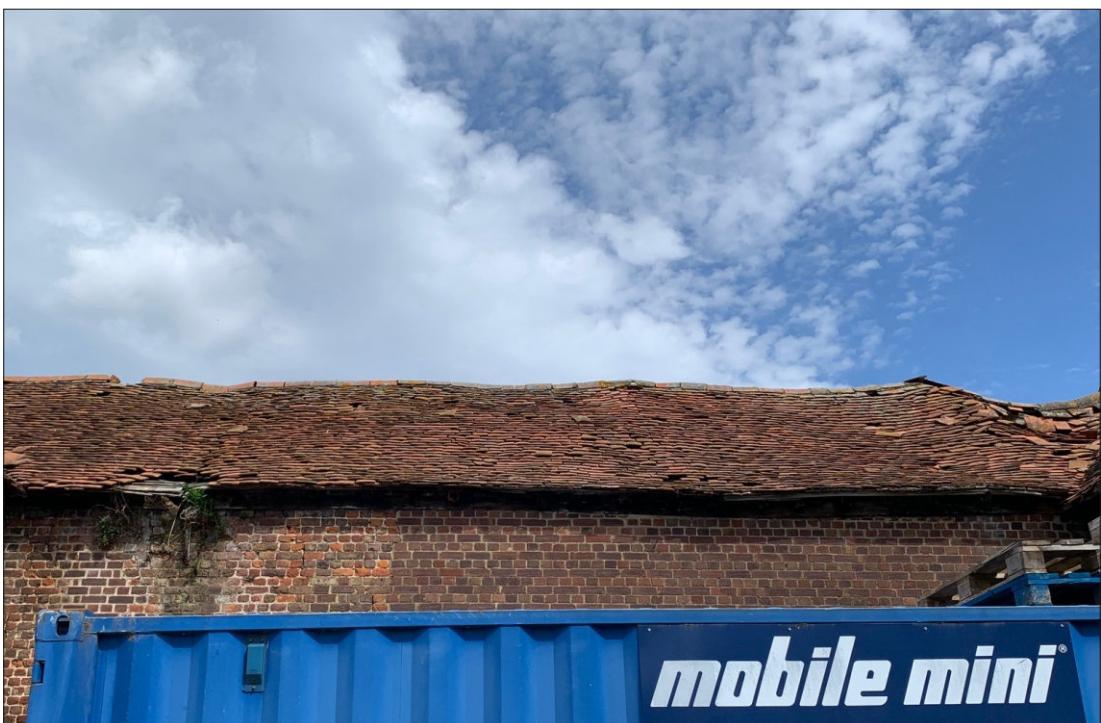
PHOTOGRAPH 4: Building B5 (storage container and roof on south side)
