TECHNICAL NOTE TN01

Former Nestle Site, Nestle Avenue, Hayes,

PERS AUDIT

Project No. 16018-01

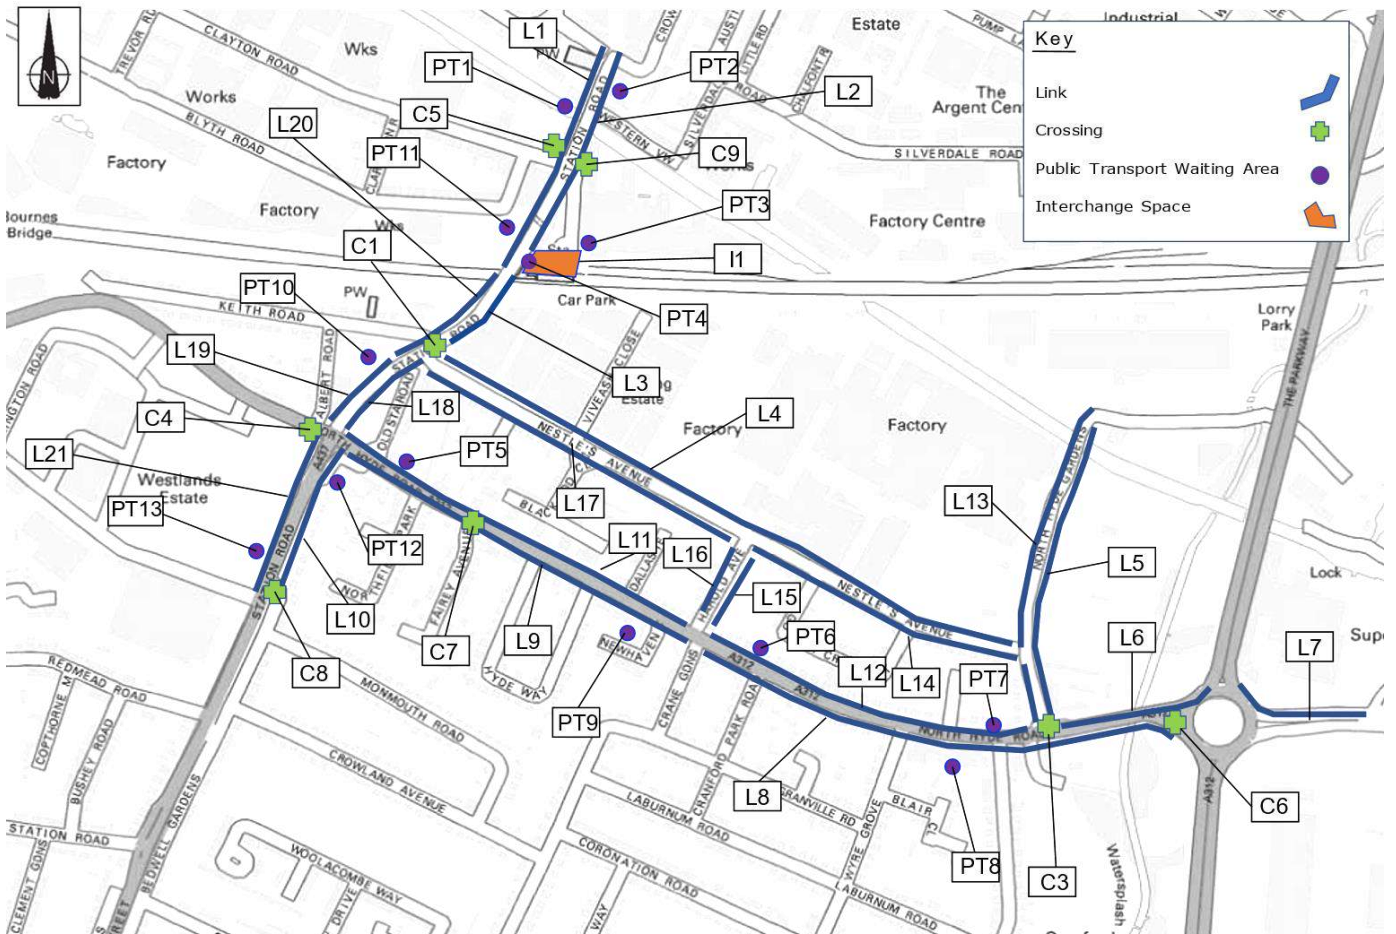
Figure 3.1 – Identified Route and Audit Material

3.1 The routes, links, crossings and public transport waiting areas assessed in the PERS audit are shown in **Figure 3.1** below.

3.2 The name, ID code and location of each audit point in **Figure 3.1** is shown in **Table 3.1** below:
