**SUBJECT**  
**Response to Drainage Planning questions –**  
**Warrender Primary School**

**CLIENT**  
 London Borough of Hillingdon

**DATE**  
 01 February 2017

**PROJECT NUMBER**  
 35311100

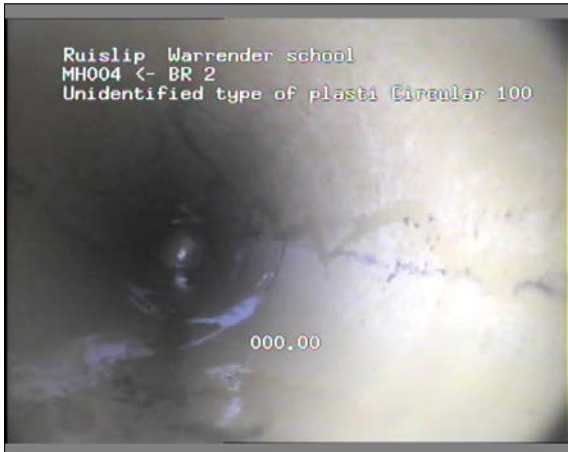
Photo: 11\_11\_42\_A.JPG  
 0m, Start node type, manhole, reference number : MH004

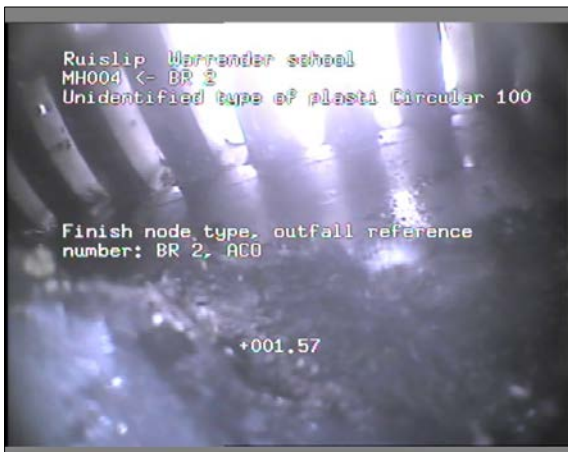
Photo: 11\_11\_44\_A.JPG  
 1.57m, Finish node type, outfall reference number: BR 2

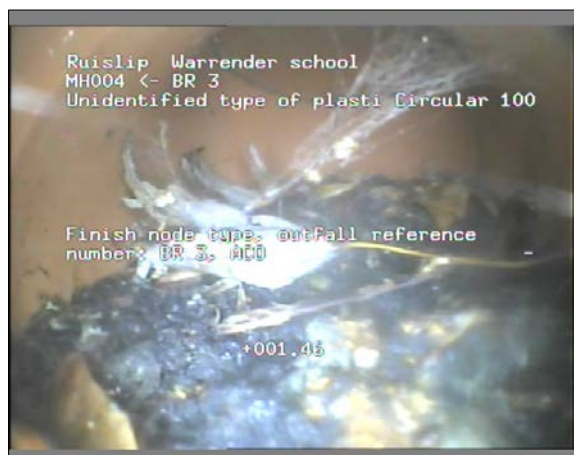
Photo: 12\_12\_47\_A.JPG  
 1.46m, Finish node type, outfall reference number: BR 3

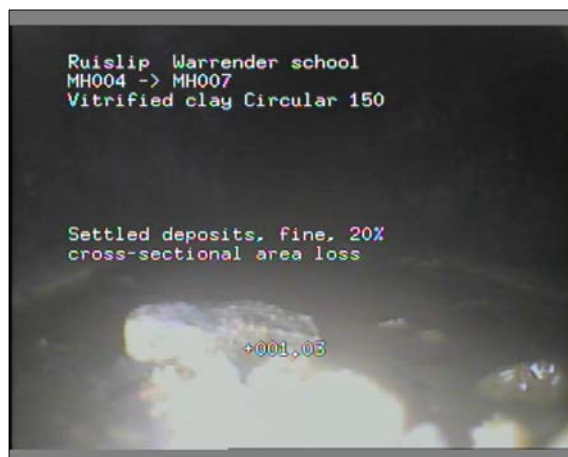
Photo: 13\_13\_51\_A.JPG  
 1.03m, Settled deposits, fine, 20% cross-sectional area loss

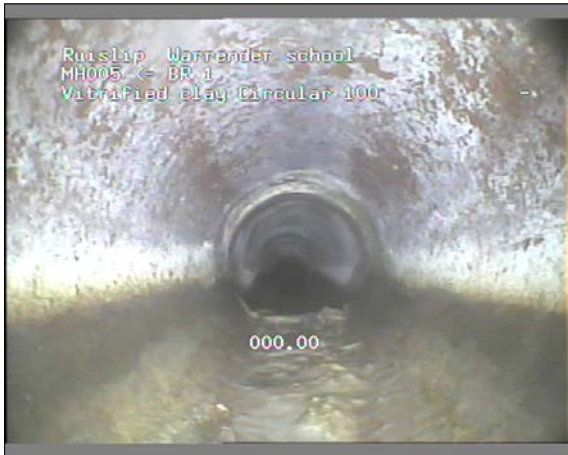
Photo: 14\_14\_53\_A.JPG  
 0m, Start node type, manhole, reference number : MH005

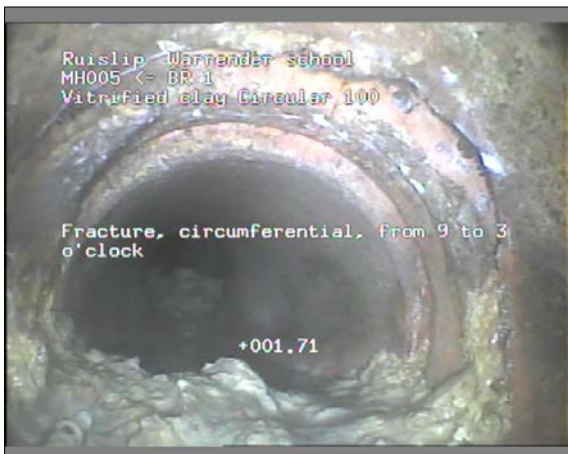
STR no def	STR peak	STR mean	STR total	STR grade	SER no def	SER peak	SER mean	SER total	SER grade
1	40	21.74	40	3	1	5	2.72	5	4

Photo: 14\_14\_55\_A.JPG  
 1.71m, Fracture, circumferential, from 9 to 3 o'clock

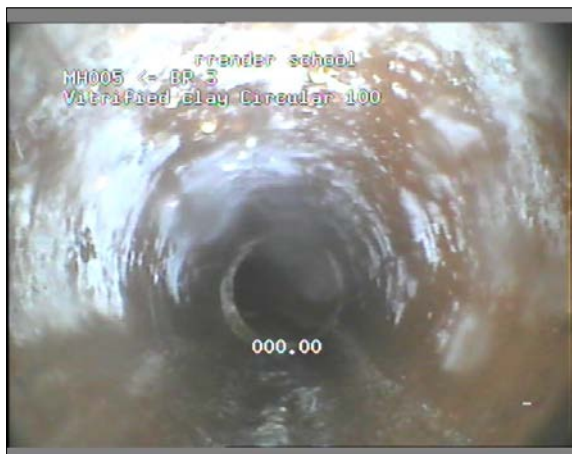
Photo: 16\_16\_62\_A.JPG  
 0.19m, Start node type, manhole, reference number : MH005

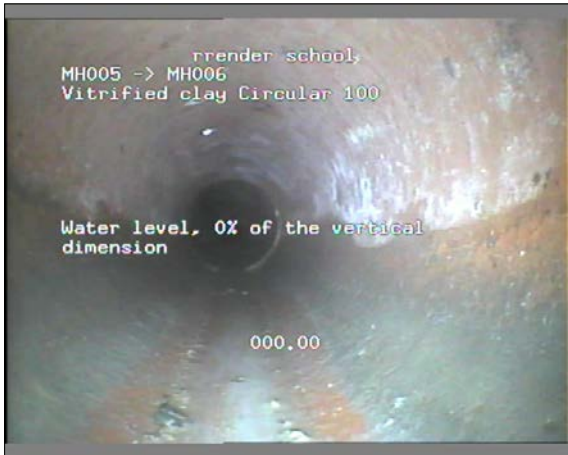
Photo: 17\_17\_66\_A.JPG  
 0m, Start node type, manhole, reference number : MH005

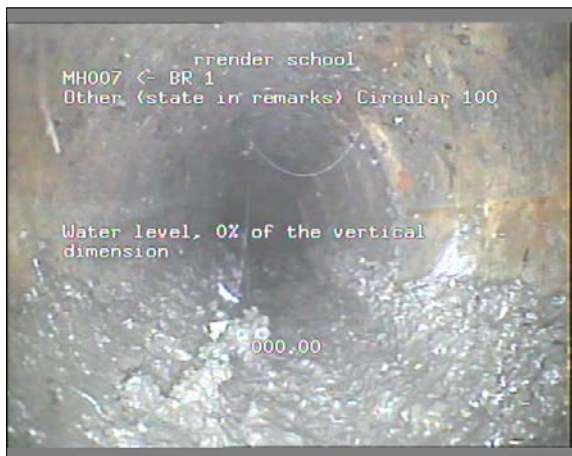
Photo: 18\_18\_69\_A.JPG  
 0m, Start node type, manhole, reference number : MH007

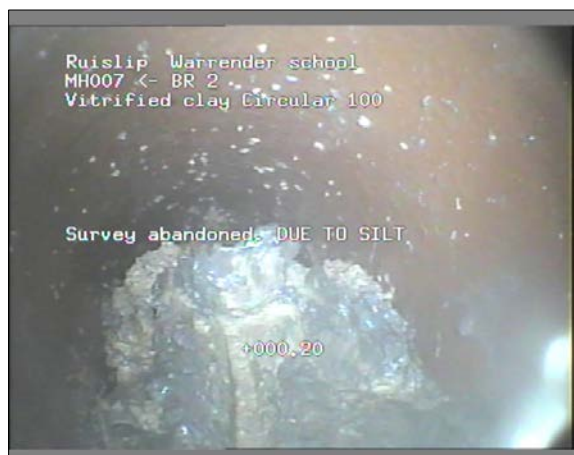
Photo: 19\_19\_75\_A.JPG  
0.2m, Settled deposits, fine, 90% cross-sectional area loss

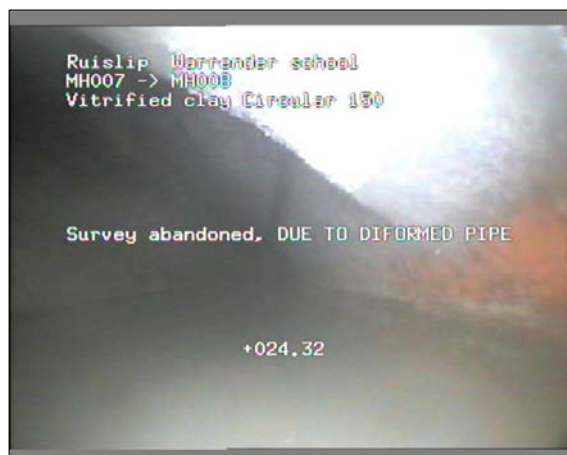
Photo: 21\_21\_87\_A.JPG  
24.32m, Deformed sewer/drain, 60%

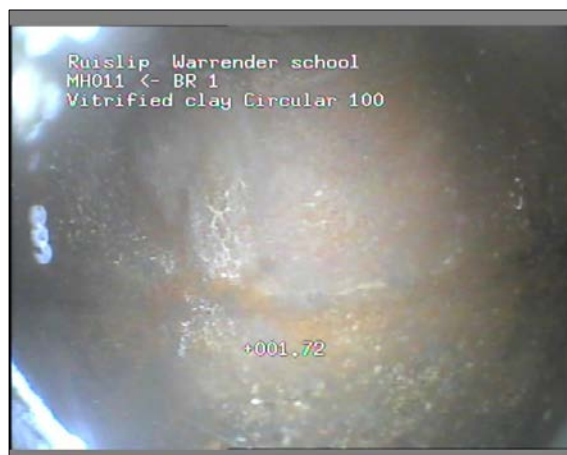
Photo: 27\_27\_111\_A.JPG  
 1.72m, Finish node type, outfall reference number: BR 1

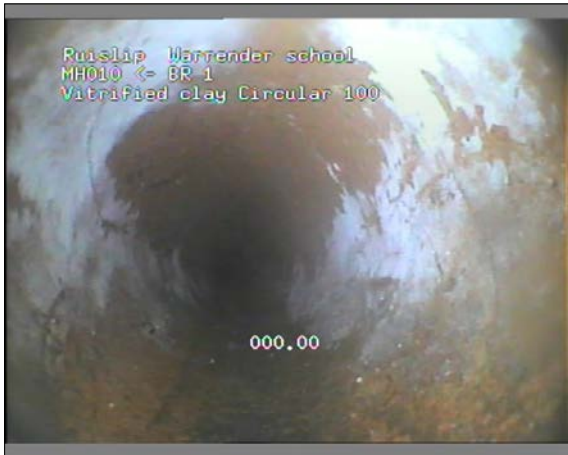
Photo: 29\_29\_115\_A.JPG  
 0m, Start node type, manhole, reference number : MH010

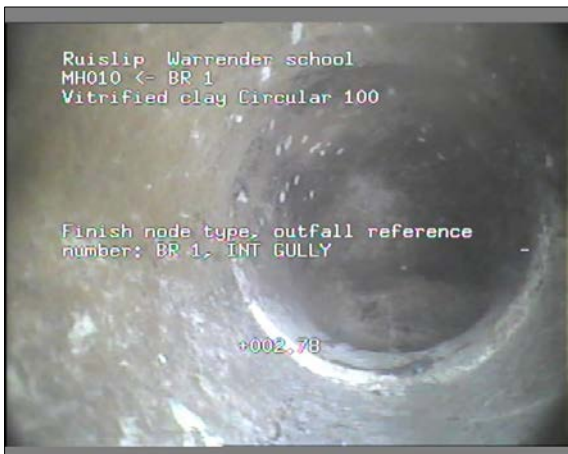
Photo: 29\_29\_117\_A.JPG  
 2.78m, Finish node type, outfall reference number: BR 1

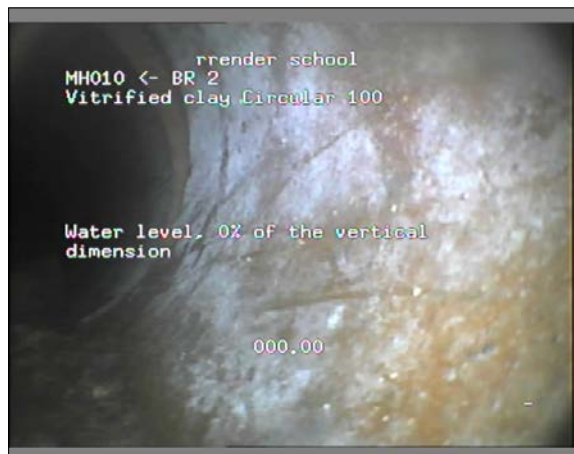
Photo: 30\_30\_118\_A.JPG  
0m, Start node type, manhole, reference number : MH010

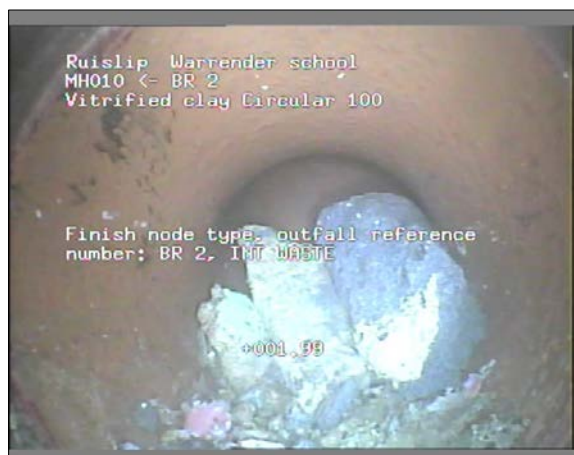
Photo: 30\_30\_120\_A.JPG  
1.99m, Finish node type, outfall reference number: BR 2

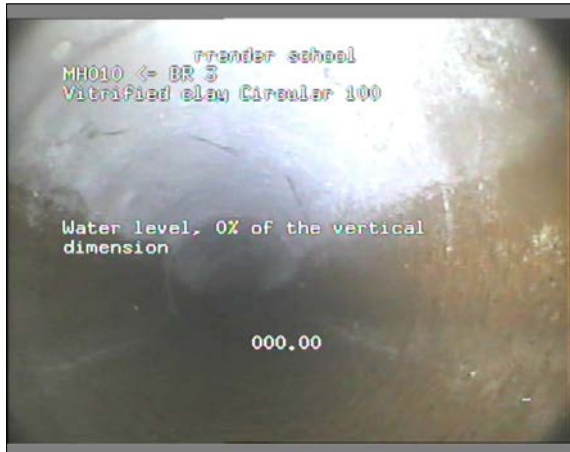
Photo: 31\_31\_121\_A.JPG  
0m, Start node type, manhole, reference number : MH010

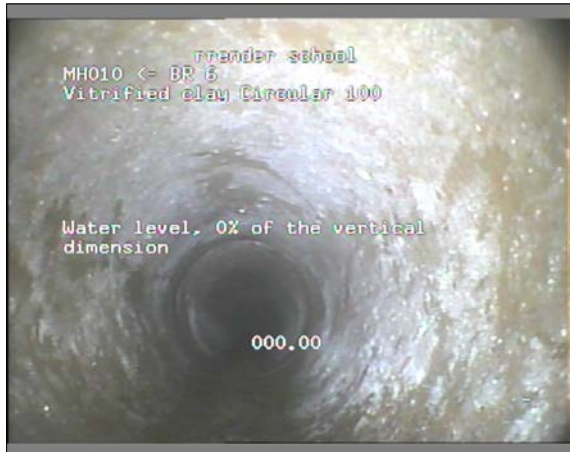
Photo: 34\_34\_131\_A.JPG  
 0m, Start node type, manhole, reference number : MH010

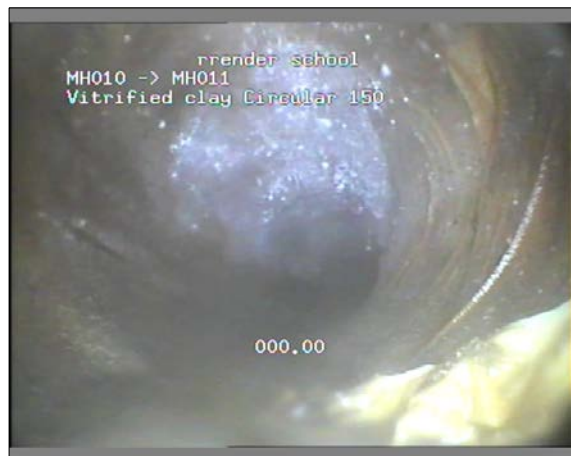
Photo: 35\_35\_135\_A.JPG  
-0.56m, Start node type, manhole, reference number : MH010

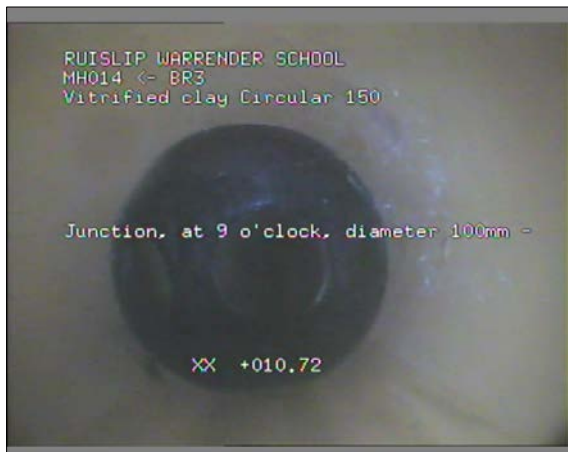
Photo: 50\_50\_192\_A.jpg  
 10.72m, Junction, at 3 o'clock, diameter 100mm

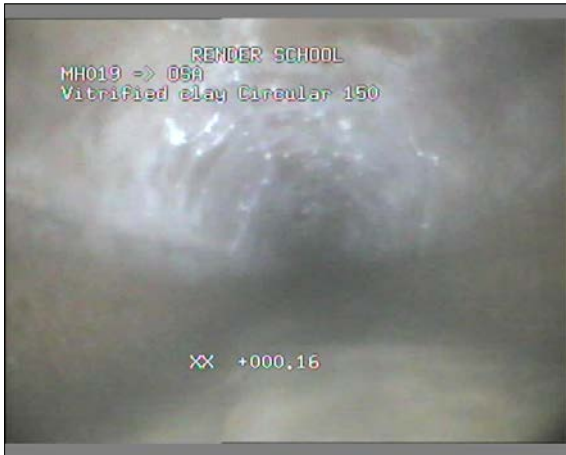
Photo: 57\_57\_214\_A.jpg  
 0.07m, Start node type, manhole, reference number : MH019
