Site Vision Surveys

Warrender School

19 December 2016

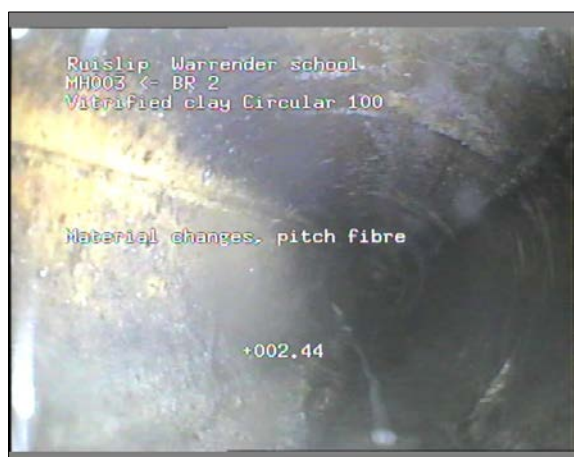
Photo: 8\_8\_32\_A.JPG  
 2.44m, Material changes, pitch fibre

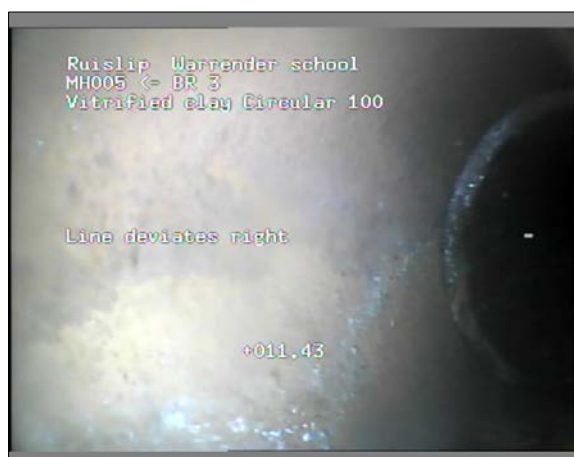
Photo: 16\_16\_64\_A.JPG  
 11.43m, Line deviates right

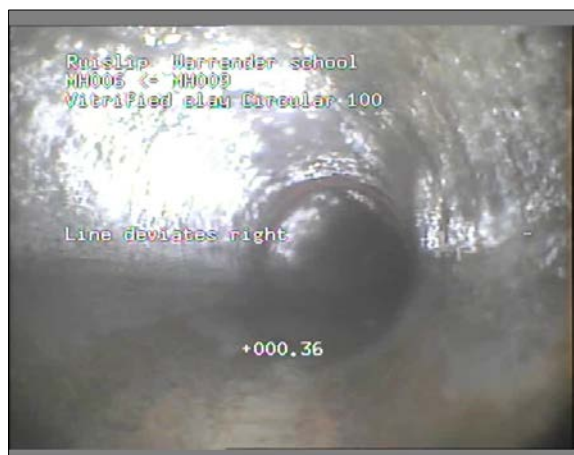
Photo: 22\_22\_91\_A.JPG  
 0.36m, Line deviates right

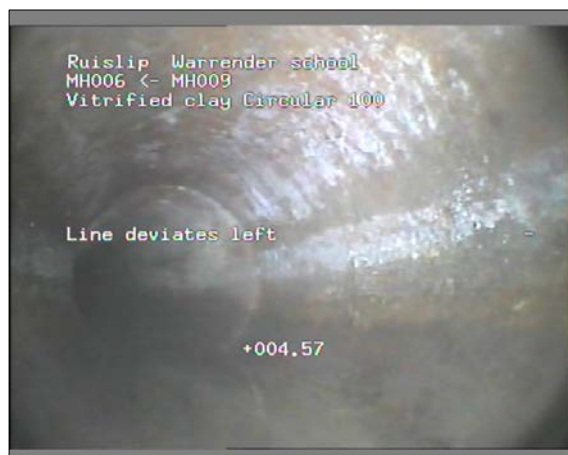
Photo: 22\_22\_92\_A.JPG  
 4.57m, Line deviates left

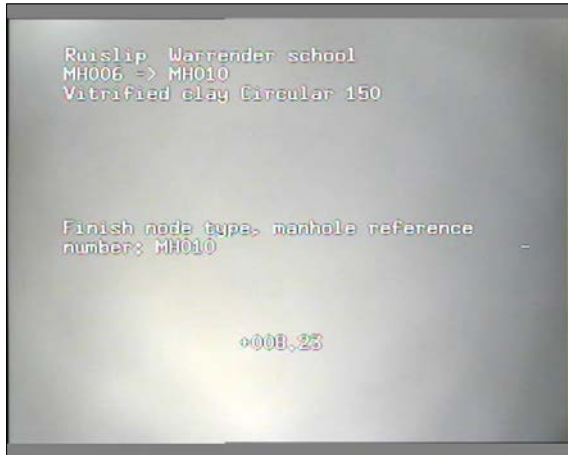
Photo: 26\_26\_107\_A.JPG  
 8.24m, Finish node type, manhole reference number: MH010

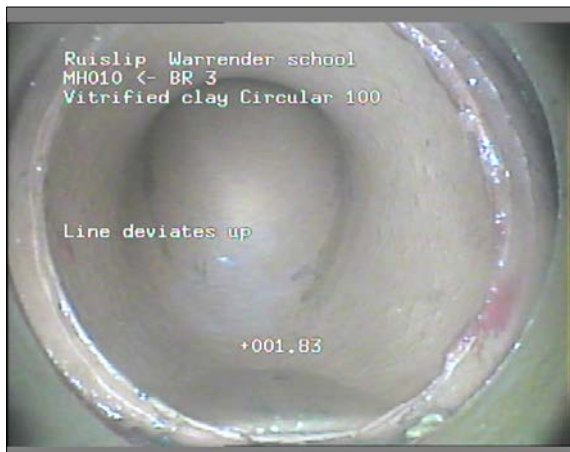
Photo: 31\_31\_123\_A.JPG  
1.83m, Line deviates up

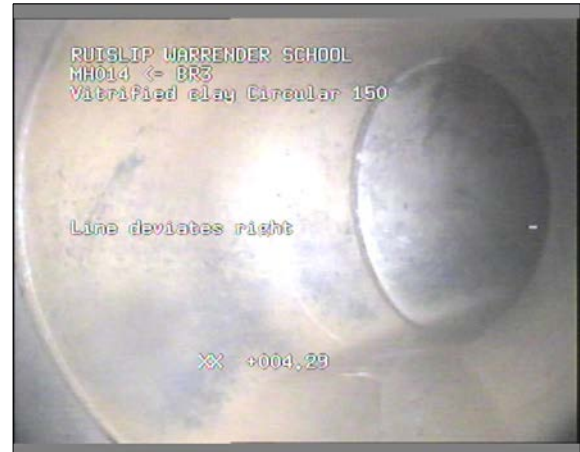
Photo: 50\_50\_191\_A.jpg  
 4.29m, Line deviates right

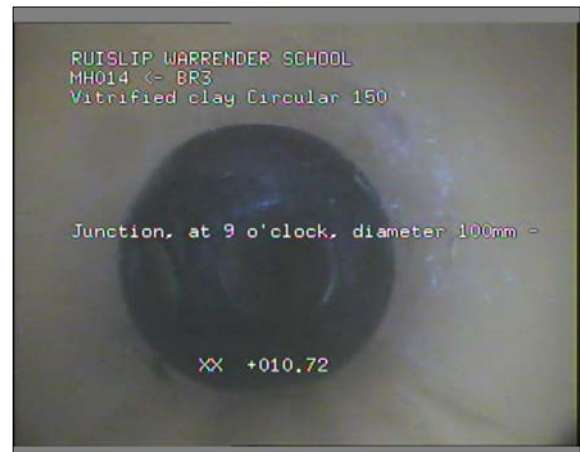
Photo: 50\_50\_193\_A.jpg  
 10.72m, Junction, at 9 o'clock, diameter 100mm
