# Drainage Report

**Uxbridge College**  
**Uxbridge**

**1ST CALL DRAIN CLEARANCE & TECHNICAL SERVICES LTD**

## Uxbridge College 31 07 19 - CCTV Survey Report : 31/07/19

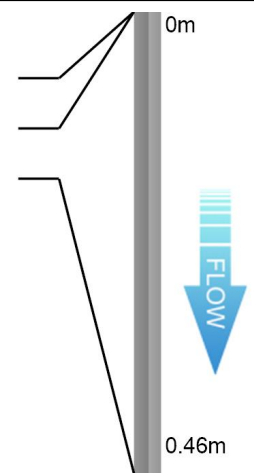
| Position | Code | Description | CD | Pic | Video Ref | |
|---|---|---|---|---|---|--|
| 00.00m | WL | Water level 0% | | | 0:00:00 | |
| 00.46m | OCF | Finish node type, other special chamber | | 1_99 | | |

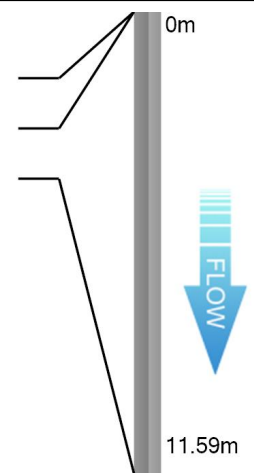
**Section 3**

| Position | Code | Description | CD | Pic | Video Ref | |
|---|---|---|---|---|---|--|
| 00.00m | GY | Start node type Gully | | | | |
| 00.00m | WL | Water level 0% | | | 0:00:00 | |
| 11.59m | MHF | Finish node type, manhole | | 2_99 | | |

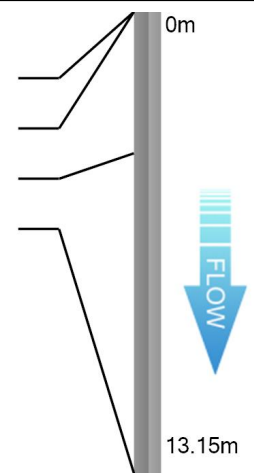
| Position | Code | Description | CD | Pic | Video Ref | |
|---|---|---|---|---|---|--|
| 04.03m | R | Roots | | 3_2 | 0:00:22 | |
| 13.15m | MHF | Finish node type, manhole | | 3_99 | | |

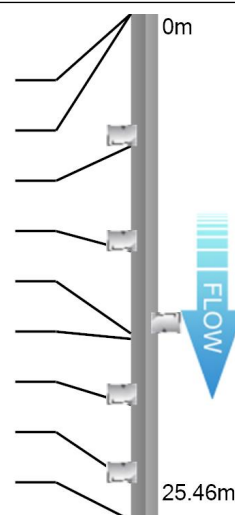
| Position | Code | Description | CD | Pic | Video Ref | |
|---|---|---|---|---|---|--|
| 23.56m | CN | Connection other than junction 03 : 0mm | 4_7 | | 0:04:01 | |
| 25.46m | MHF | Finish node type, manhole | 4_99 | | | |

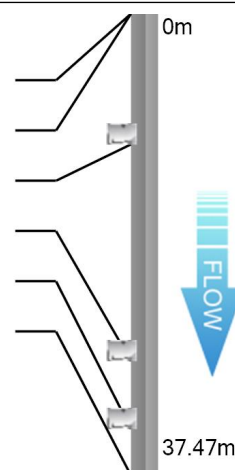
| Position | Code | Description | CD | Pic | Video Ref | |
|---|---|---|---|---|---|--|
| 33.71m | CN | Connection other than junction 01 : 100mm | | | 0:01:58 | |
| 37.47m | MHF | Finish node type, manhole | 5_99 | | | |
