# **Former Anglers Retreat Public House, Cricketfield Road, West Drayton**

## **Level 1 Historic Building Record**

Project Ref: 33116 | Rev: AA | Date: December 2017

# **Masonry Condition Report**

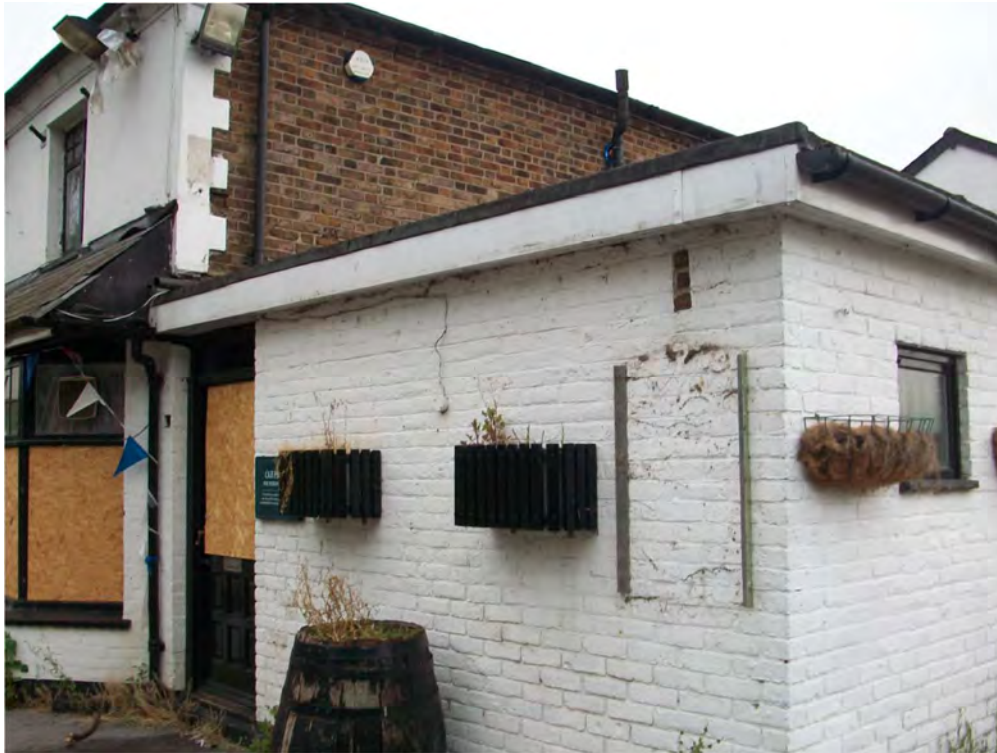
- 2.4.4 By 2013, the building had a number of extensions which were physically linked to the existing structure. These extensions were undertaken in a manner which damaged the original fabric of the building on three of its four elevations. The photographs below show the state of the building as it was in 2013:

Figure 2-8 Photograph of the modern western extension meeting the original building

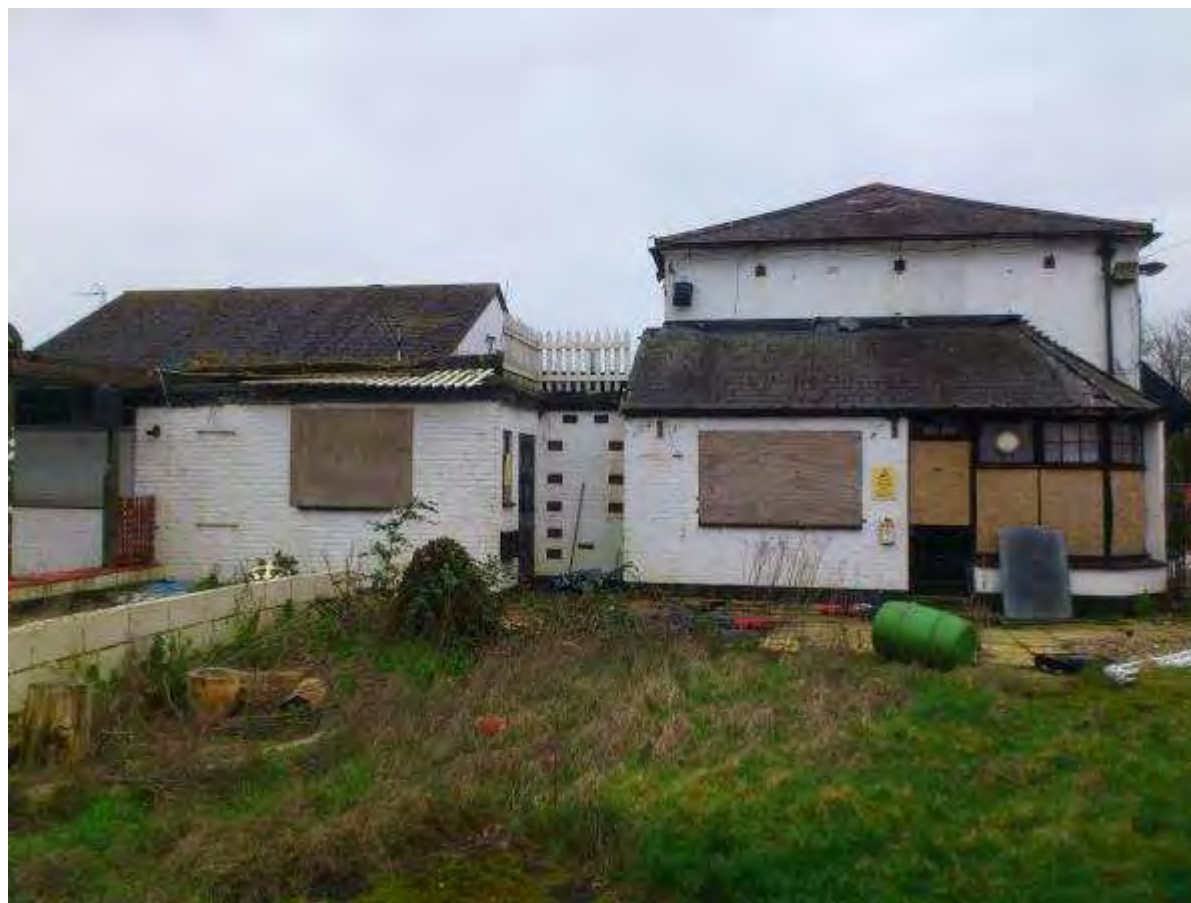
**Figure 3 East elevation with extensions (February 2014)**

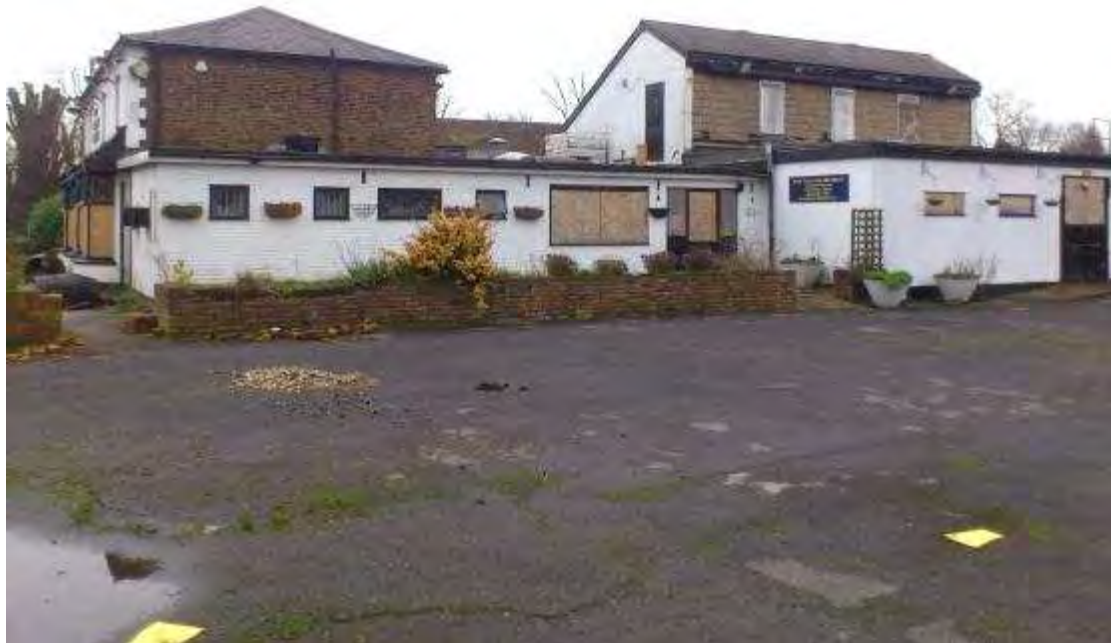
**Figure 4 West elevation with extensions (February 2014)**

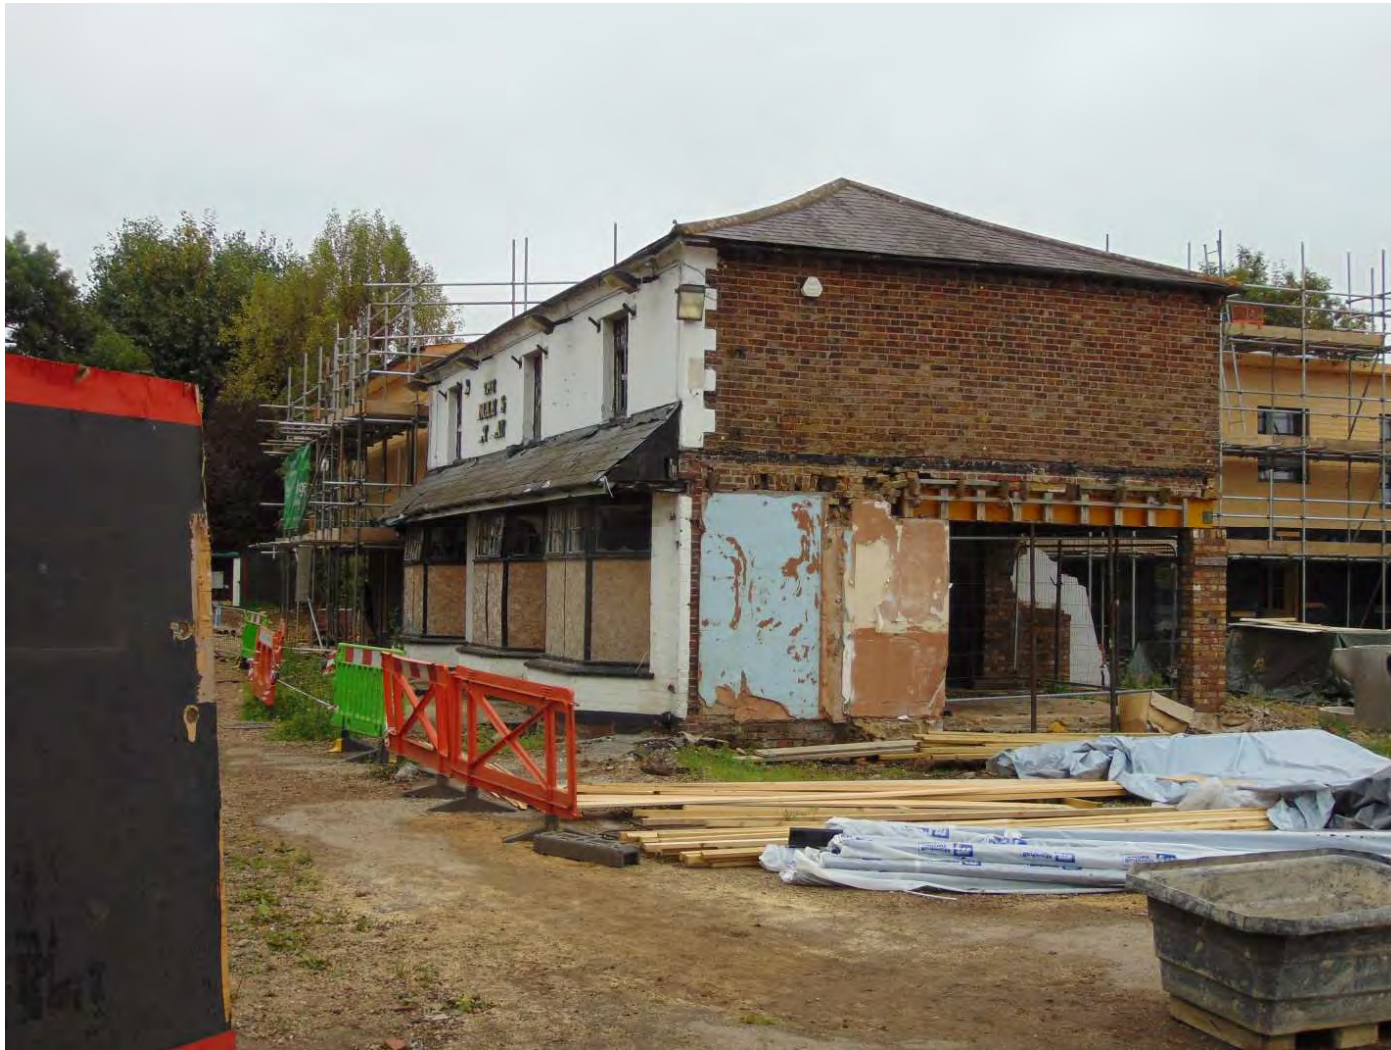
The survey of the masonry was undertaken when the former public house had been reduced to the bare bones of the original structure. As can be seen from figure 5, the post 1965 additions have been demolished leaving large steel supporting beams to the rear, west and East elevations. Internally the building has been stripped out leaving a hollow shell, without floor coverings or ceilings. A number of trial holes to check foundations were visible which helped contribute to the overall assessment of the structure.

**Figure 5 Existing building as it stands in September 2016: extensions demolished and internal space stripped out**

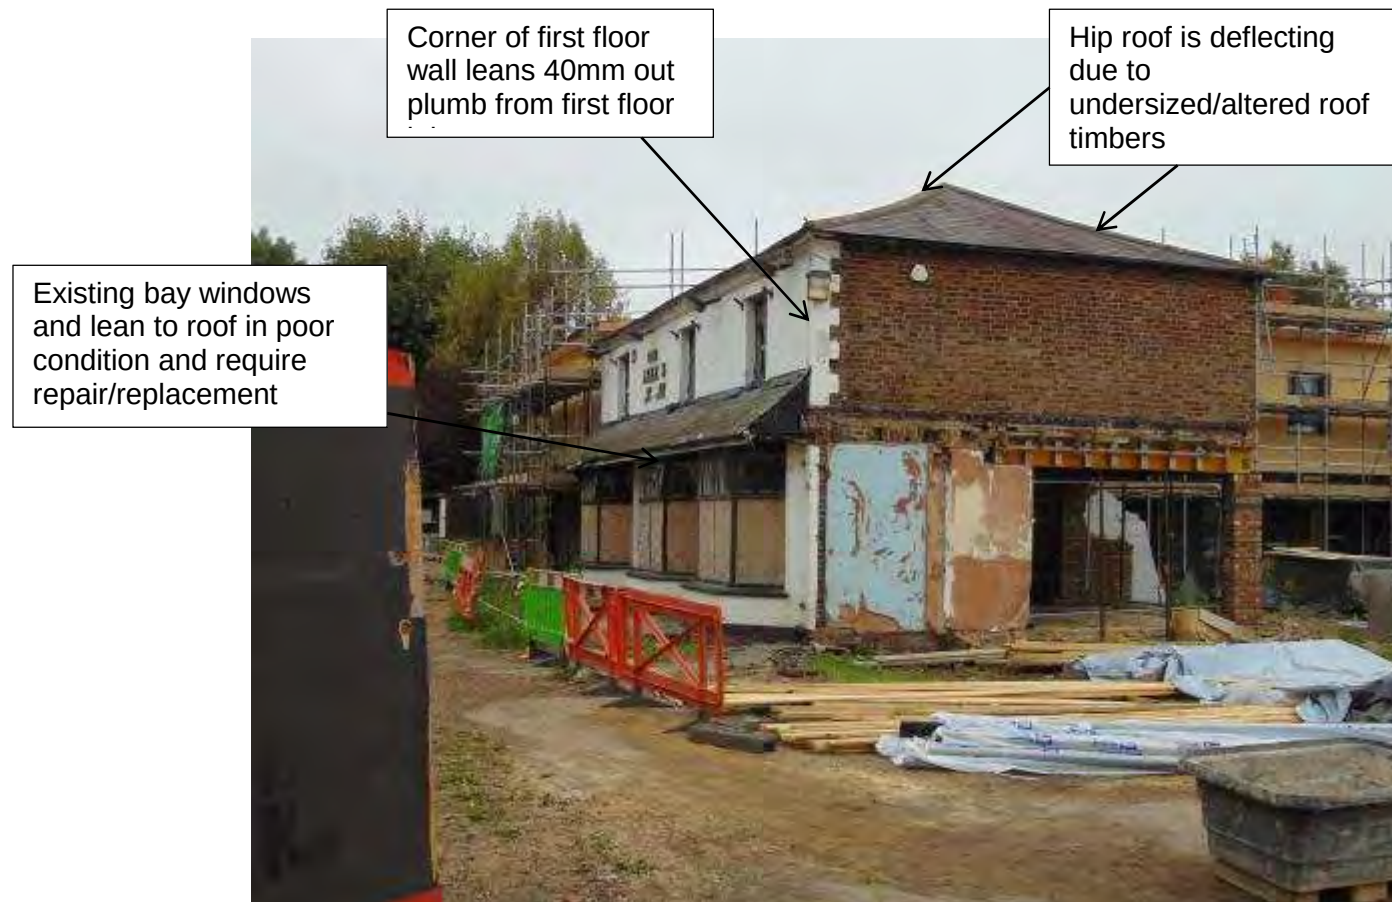
The front elevation is very much in its original form as can be seen from figures 6 and 7. However the ground level brickwork to the front façade, which encompasses the bay windows, was rebuilt prior to the building's documentary evidence from 1965. This assessment has been made based upon the change of bond and bedding mortar evident in the bay windows and surrounding piers. The upper floor of the elevation has been built using London stocks to the pattern of Flemish bond and bedded in lime mortar; this is indicative of the architectural period in which the building was built. The ground floor of the front elevation is built in a red stock brick (see figure 8) in the pattern of stretcher bond laid in cement mortar, which was not adopted into mainstream construction until after the First World War at the earliest. This raises the fact that the lower part of the front façade is not part of the original building; this is further reinforced by the use of common Fletton bricks internally to the bays as can be seen in figure 10.

In terms of structural integrity, the ground floor part of the elevation falls within current standards of verticality. The fact that it has been painted in white masonry paint prevented moisture readings being taken for the bricks or the mortar.

The upper first storey brickwork, whilst built in the original London stock brick, has been rendered externally and plastered with sand and cement internally. This made it very difficult to access the structural integrity of the masonry; however several surface cracks were evident, as can be seen in figure 9, indicating thermal movement in the masonry.

**Figure 6 Front elevation with new development to the rear**

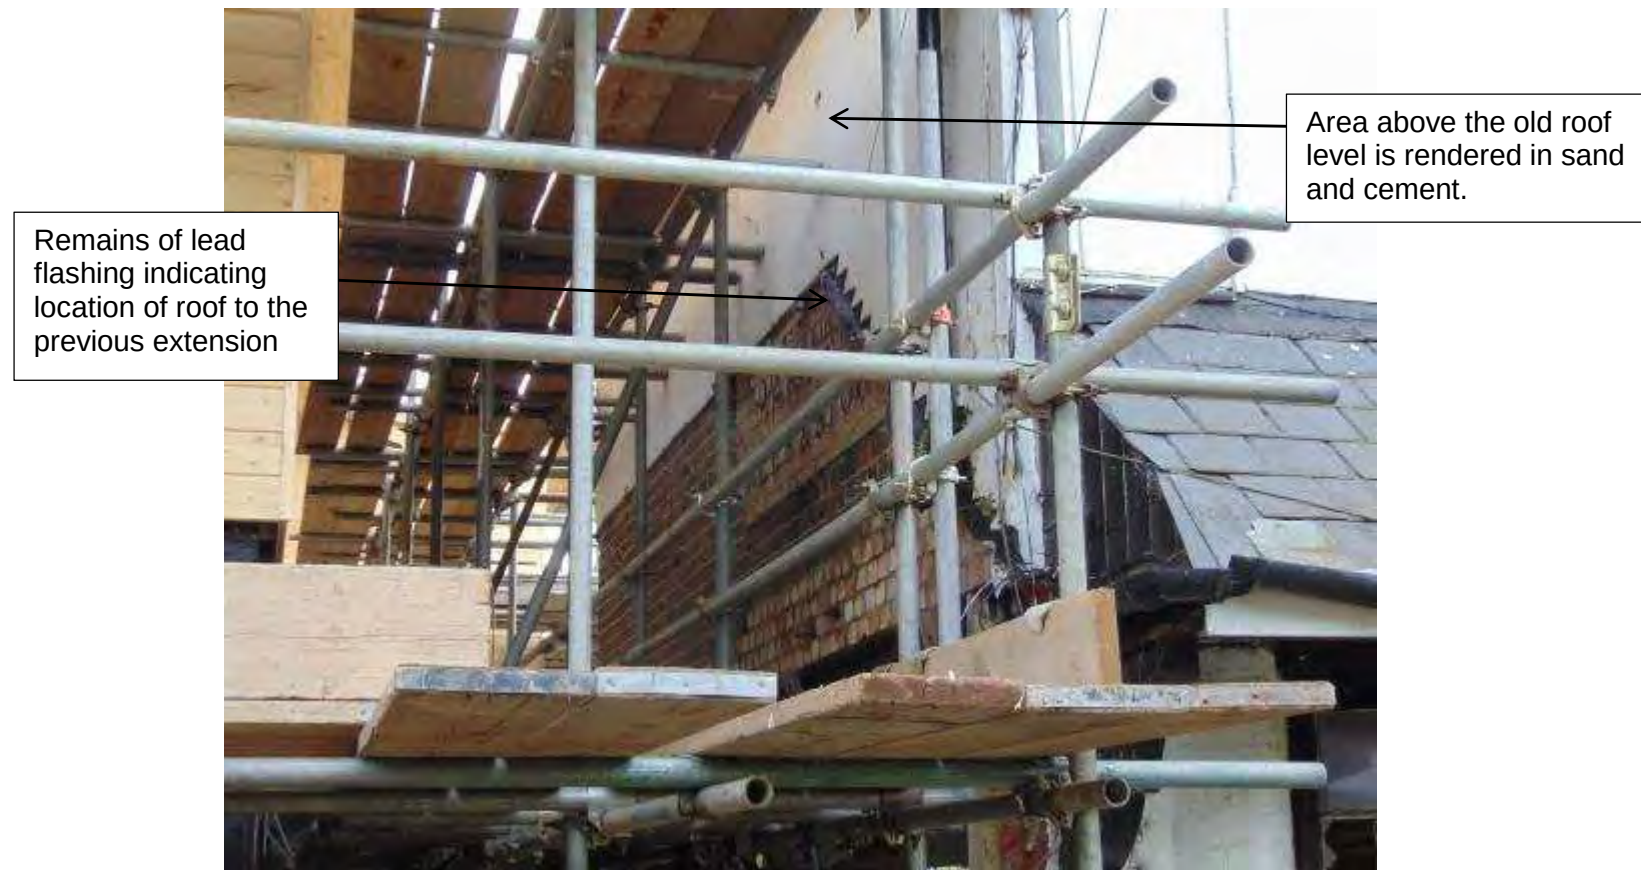
The first floor of the East elevation of the building is supported by a large steel beam that is being held up with temporary propping. Once again this is a result of the previous side extension being demolished as can be seen in figures 21 and 22. The first floor elevation is a combination of original London stock brickwork with cement rendering above and exhibits the same moisture problems as the West elevation as can be seen in figure 23 and 24. It is worth noting that the structural report by Peter Dann Consulting Engineers raises concerns regarding the structural stability of the wall if the elevation is not restrained by another structure.

**Figure 21 Showing the East elevation and its proximity to the new development**

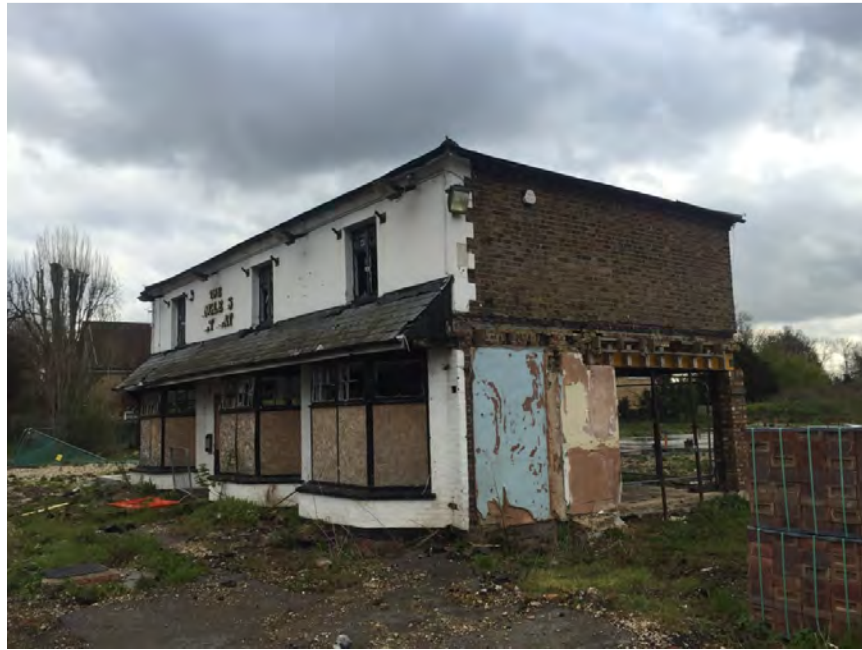
**Figure 2:** Existing Building following strip out and demolition of extensions

It is our view that the superstructure in its entirety should be demolished and the existing foundations removed in order to be able to rebuild a new structure which both complies with current codes and regulations and is suitable for its proposed purpose.

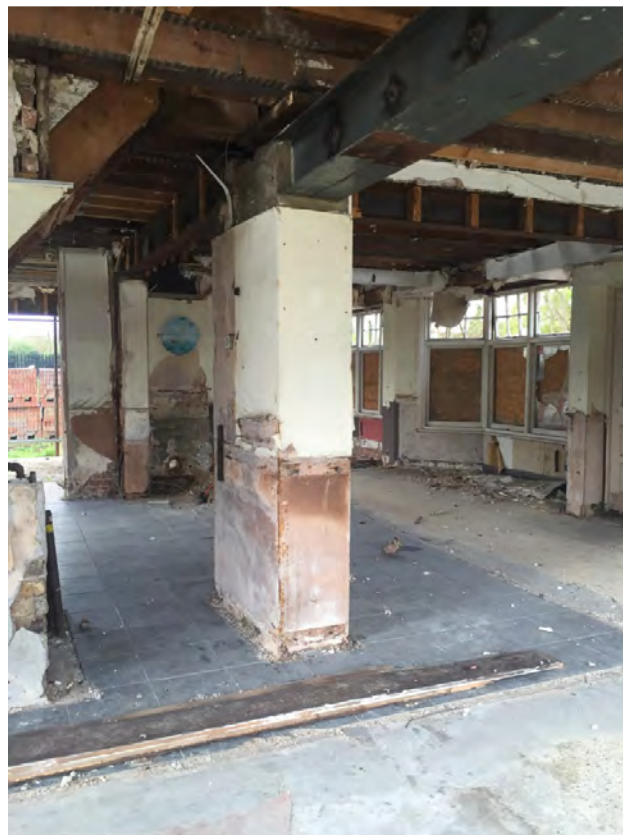
In order to create the spaces required for the proposed accommodation within the building, support will need to be removed from these joists and rather than attempt remedial works and timber splicing it is therefore recommended that they should be removed and replaced with more substantial timber members in order to comply with building regulations. Figure 3 in the

**Figure 3:** Internal view showing timber floor supported on steel beams and masonry piers
