# Arboricultural Appraisal Report

## Subsidence Damage Investigation at:

6 Windrush Close  
Ickenham  
Uxbridge  
UB10 8EJ

CLIENT: Davies Group Ltd  
CLIENT REF: 72229022  
MWA REF: SUB230724-13845  
MWA CONSULTANT: Andy Clark  
REPORT DATE: 03/10/2023

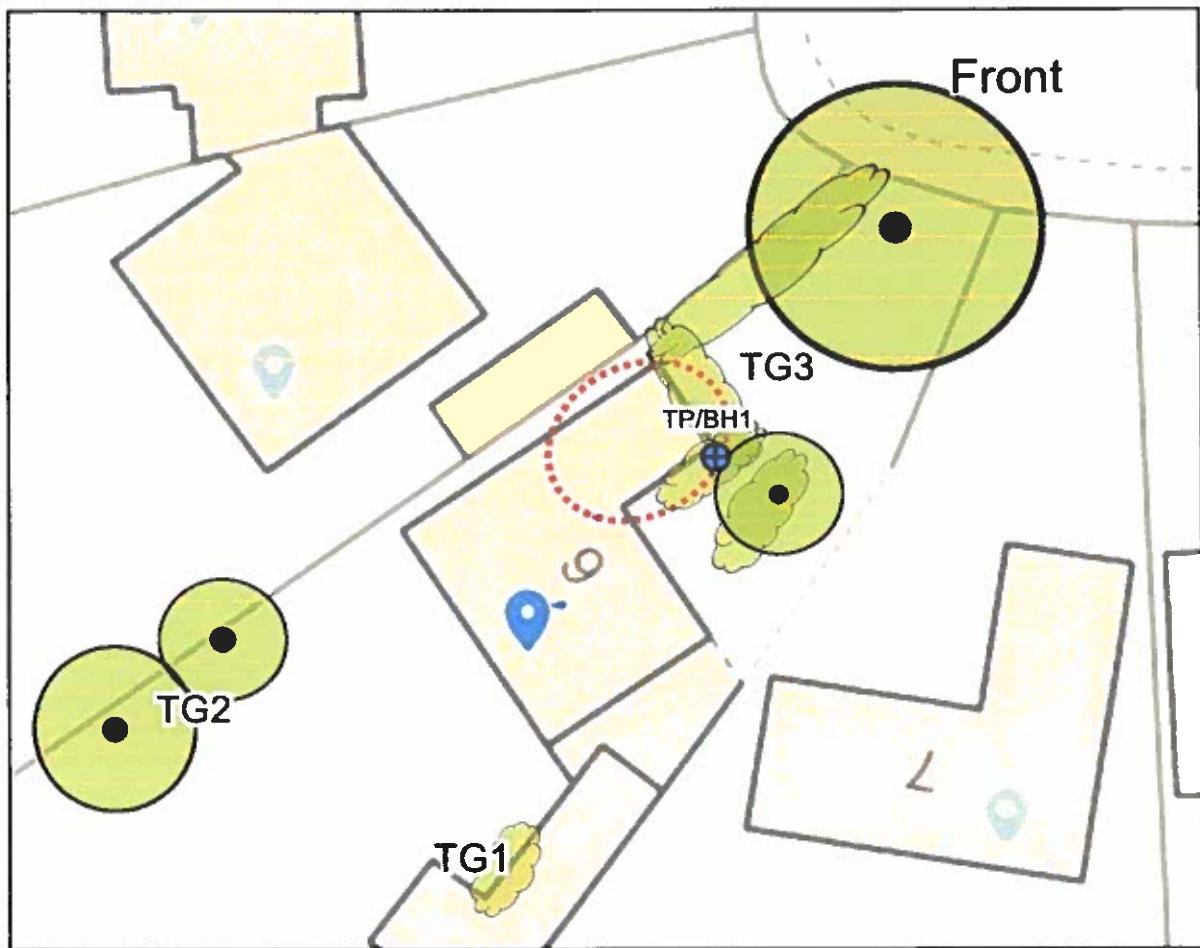
Site Plan

**Roots were observed to a depth of 2.5m bgl in TP/BH1 and recovered samples have been tentatively identified (using anatomical analysis) as possibly Rosoideae gp., similar to Caprifoliaceae spp. and similar to either Cedrus spp. or Pinus spp.; the origins of which will be the nearby shrubs and the Pine of TG3 group at the property frontage, confirming their influence on the soils below the foundations.**

**If an arboricultural solution is to be implemented to mitigate the influence of the implicated trees/vegetation we recommend that the nearby shrubs and the Pine of TG3 group are removed. Other vegetation recorded presents a potential future risk to building stability and management is therefore recommended. Recommended tree works may however be subject to change upon receipt of additional information.**
