SITE INVESTIGATION FACTUAL REPORT

Client: The Davies Group

Our Reference Number: HH/23/70036

Site Crew	P. Chapmas / D. Jones
Site Address & Postcode	6 Windrush Close, Ickenham, Uxbridge, UB10 8EJ
Date	07/02/2023

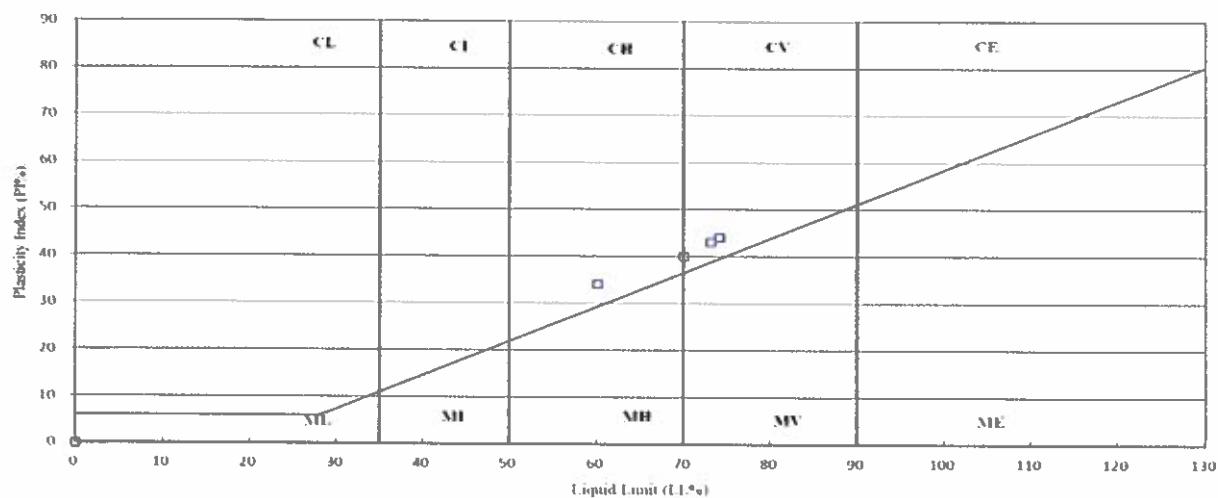
PLASTICITY CHART FOR CASAGRANDE CLASSIFICATION.

Moisture contents in TP/BH1 are approaching or below both the plastic limit and 40% of the Liquid limit. It is therefore likely that the ground has attained desiccation in this area. Oedometer strain test results are indicative of this showing potential heave of 52.6mm.
