# CANTEEN BUILDING NESTLE HAYES

22878

Tuesday, 10 November 2020

Prepared For Barratt West London

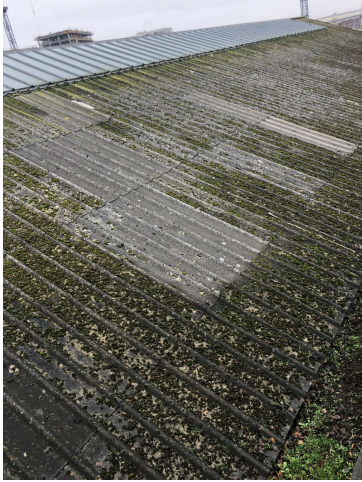
Gutters require thorough cleaning to inspect condition closely.

Options to supply and install a purpose built lightweight gutter liner, if gutter brackets are in a sound condition, these may need to be replaced or repaired.

Alternatively gutters can be re-lined with a liquid or felt membrane, dependent upon condition.
