**Former Nestle Canteen Building, Hayes**

**Report on the Investigation of Certain  
Façade Steel Frame Elements**

**Final Report – 5049**

**Barratt London**

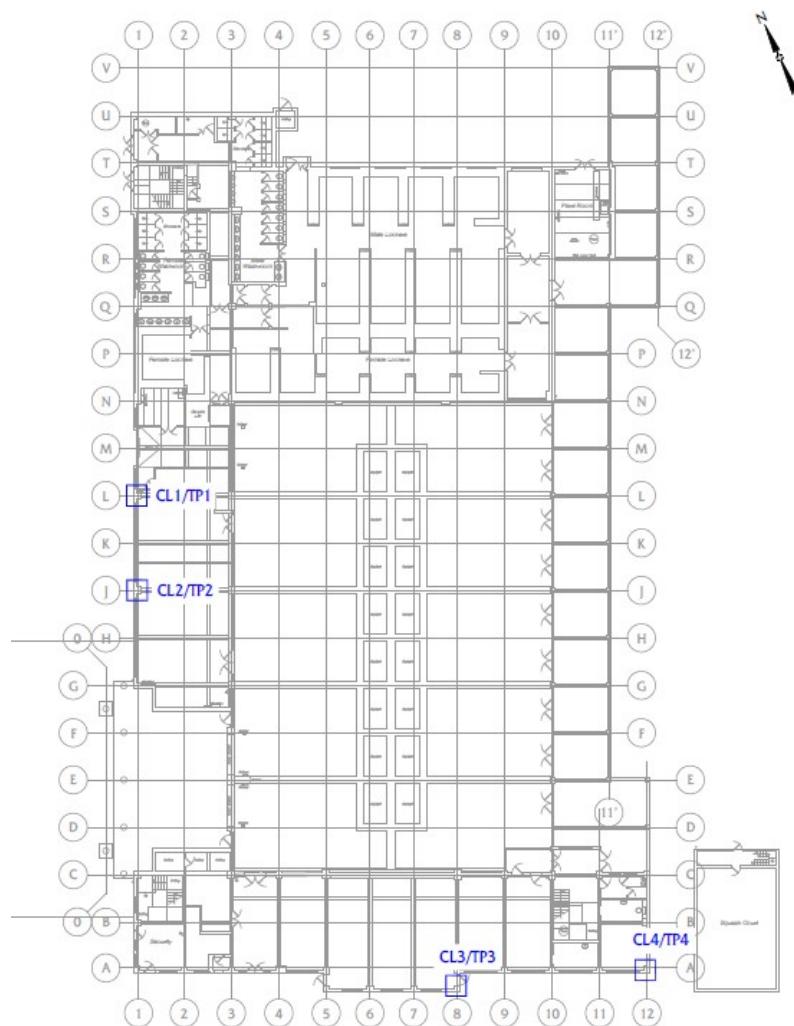
FIG.1: PLAN OF GROUND FLOOR SHOWING LOCATIONS OF COLUMNS SURVEYED NOT TO SCALE

A total of 4No. steel façade columns (CL1 to 4) were selected for investigation based on the areas identified by the Client's Design Team, where cracking had been observed to the external render finish/masonry. Columns CL1 and CL2 were selected on the western façade whilst CL3 and CL4 were selected on the southern façade. Initially, each of the columns were locally exposed for inspection at a height of around 1m above ground f.f.l, prior to carry out a trial pit excavation and localised exposure of the base of each column at the interface with the concrete foundation.

The steel columns locally exposed above ground level on the western façade (CL1 and CL2) exhibited no more than light surface corrosion.

On the southern façade, the steel column locally exposed above ground at CL3 exhibited moderate surface corrosion (further developed surface corrosion, but no measurable section loss), whilst the column locally exposed at CL4 exhibited moderate to heavy surface corrosion (heavy corrosion deposits and flaking evident, with onset of section loss, <10%).

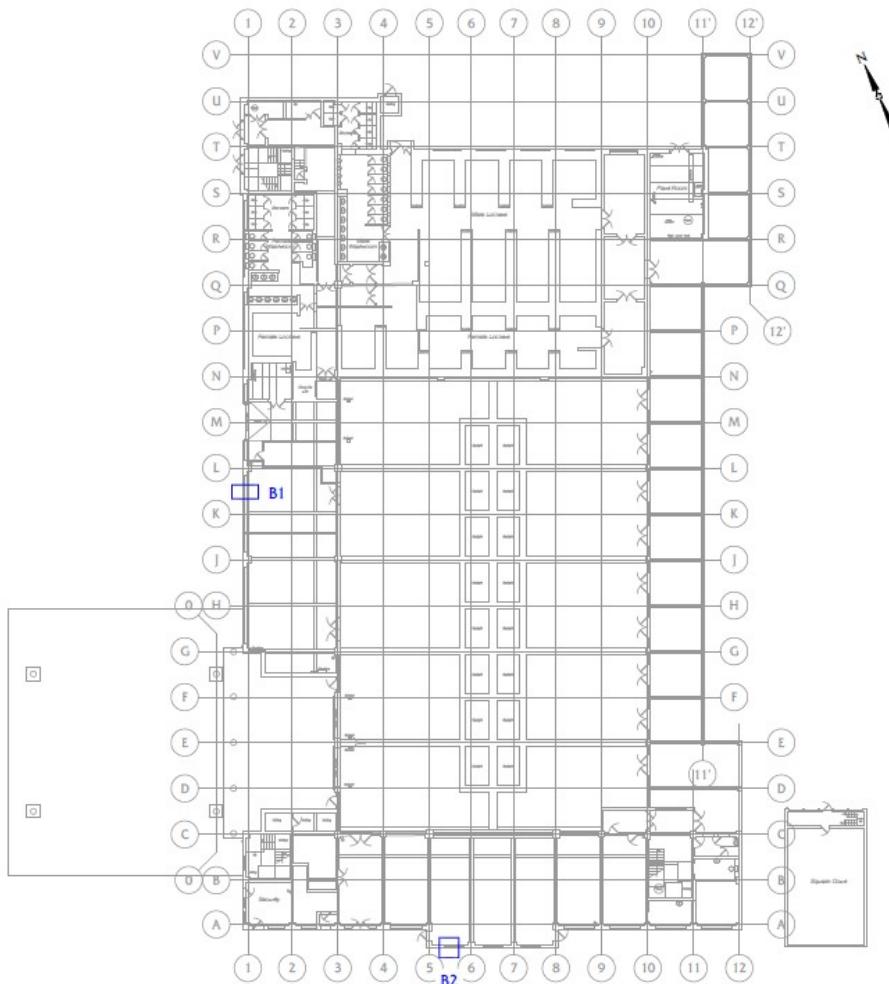
FIG.3: PLAN OF GROUND FLOOR SHOWING LOCATIONS OF BEAMS SURVEYED NOT TO SCALE

A total of 2No. first floor steel façade beams (B1 and 2) were selected for investigation based on the areas identified by the Client's Design Team, where cracking had been observed to the external render finish. Beam B1 was on the western façade whilst beam B2 was on the southern façade. Each of the beams were locally exposed for inspection.

Each of the beams were found to be encased in concrete, with a render finish to the external façade.

The steel beams locally exposed (B1 and 2) exhibited no more than light surface corrosion.

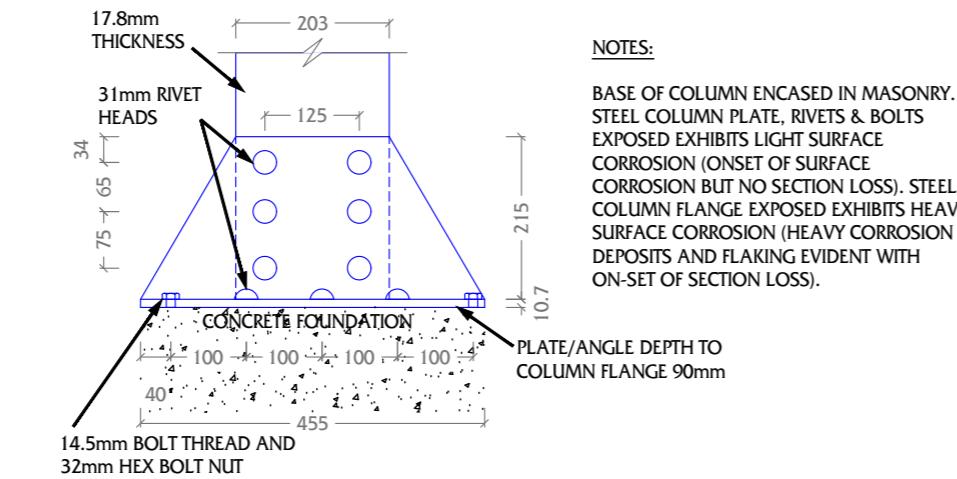
FIG.2a: PART ELEVATION SHOWING COLUMN CL1 DETAILS AND CONDITION (BELOW GROUND AT TRIAL PIT TP1) SCALE 1:10

At each of the four locations the gusset plates/angles and connecting rivet and bolt heads exposed (typically encased in concrete) exhibited no more than light surface corrosion. However, the base of the column sections typically exhibited moderate surface corrosion (further developed surface corrosion, but no measurable section loss). The base of the column section at location CL1 exhibited heavy surface corrosion (heavy corrosion deposits and flaking evident, with onset of section loss, <10%).
