FORMER NESTLE FACTORY, HAYES
Demolition Report – Former Canteen Block

Project: **Former Nestle Factory, Hayes**Job No: **W1965**Title: **Demolition Report – Former Canteen Block**

**Report on the Investigation of Certain
Façade Steel Frame Elements**

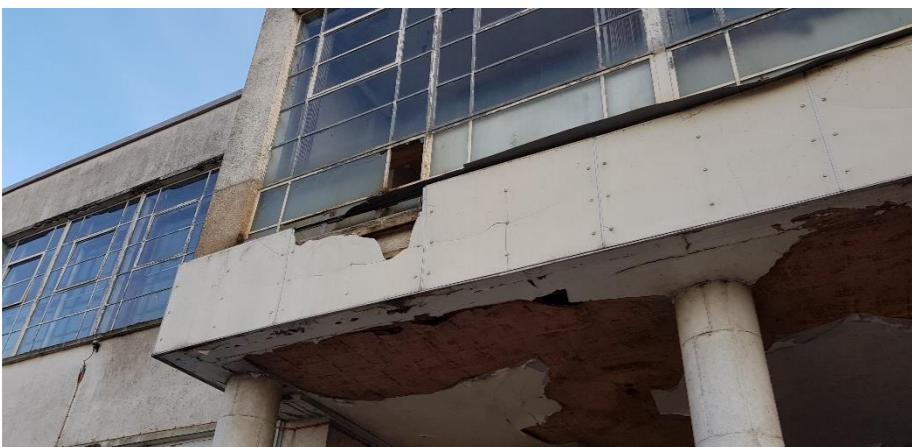
Photo 1: Projecting slab on west elevation

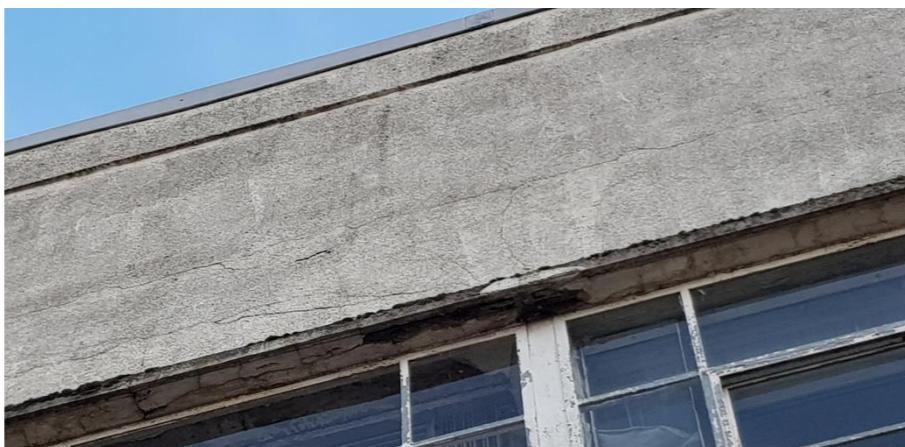
Photo 2: Rendered parapet wall

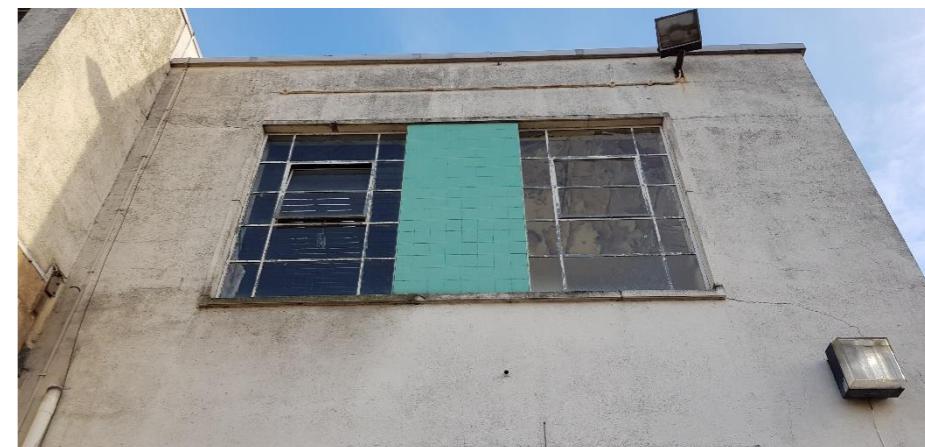
Photo 3: Typical rendered façade wall and window

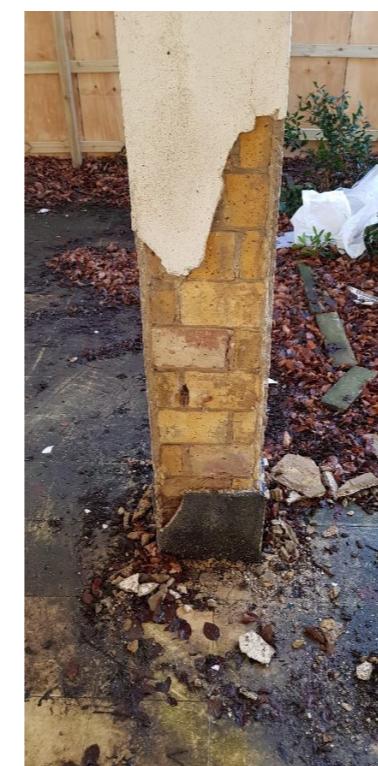
Photo 8: Colonnade column

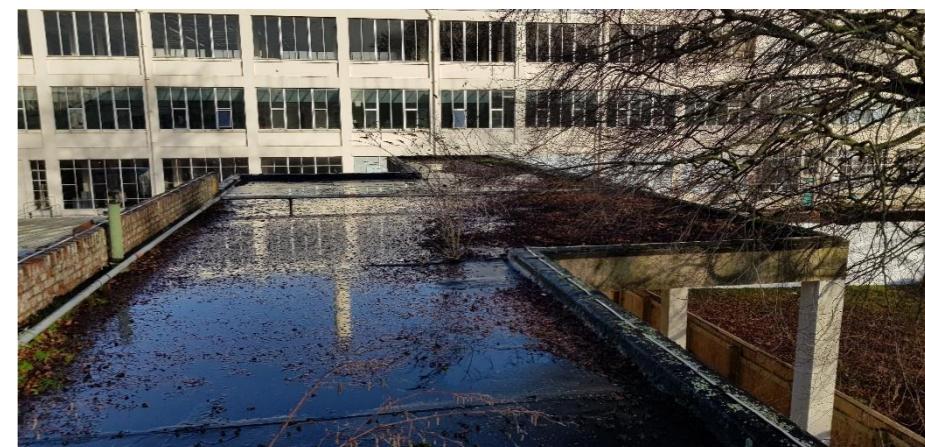
There were areas of widespread water ingress through the roof structure due to the failure of the waterproofing membrane and blocked rainwater outlets.

Photo 9: Colonnade flat roof.

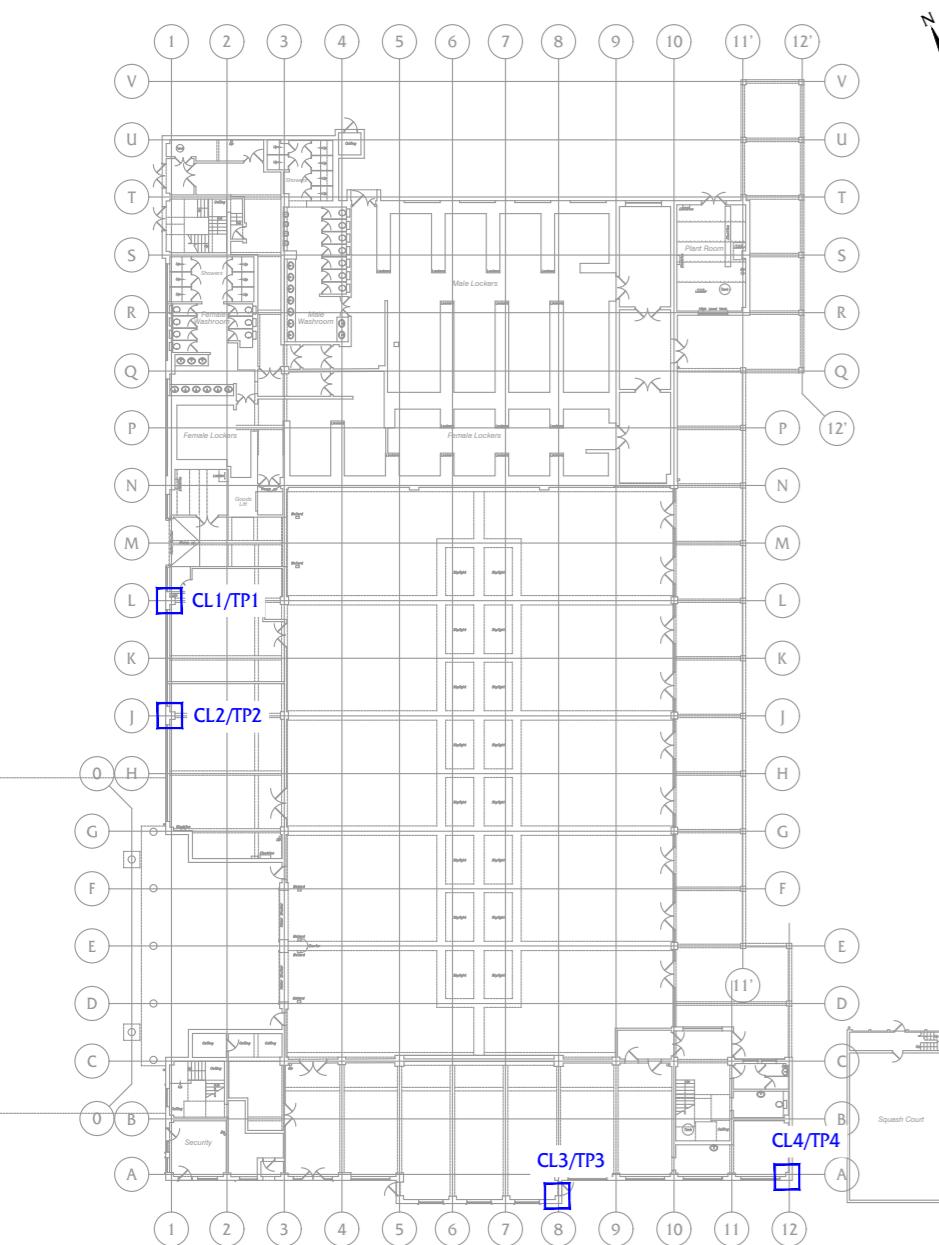
FIG.1a: PART PLAN SHOWING COLUMN CL1 CONSTRUCTION DETAILS AND CONDITION (1m ABOVE GROUND F.F.L.) SCALE 1:10

CRACKING OBSERVED TO RENDER. STEEL COLUMN SECTION EXPOSED EXHIBITS MODERATE TO HEAVY SURFACE CORROSION (HEAVY CORROSION DEPOSITS AND FLAKING EVIDENT IN PLACES WITH ONSET OF SECTION LOSS)
