FORMER NESTLE CANTEEN

Facade retention study - REV A

April 2022

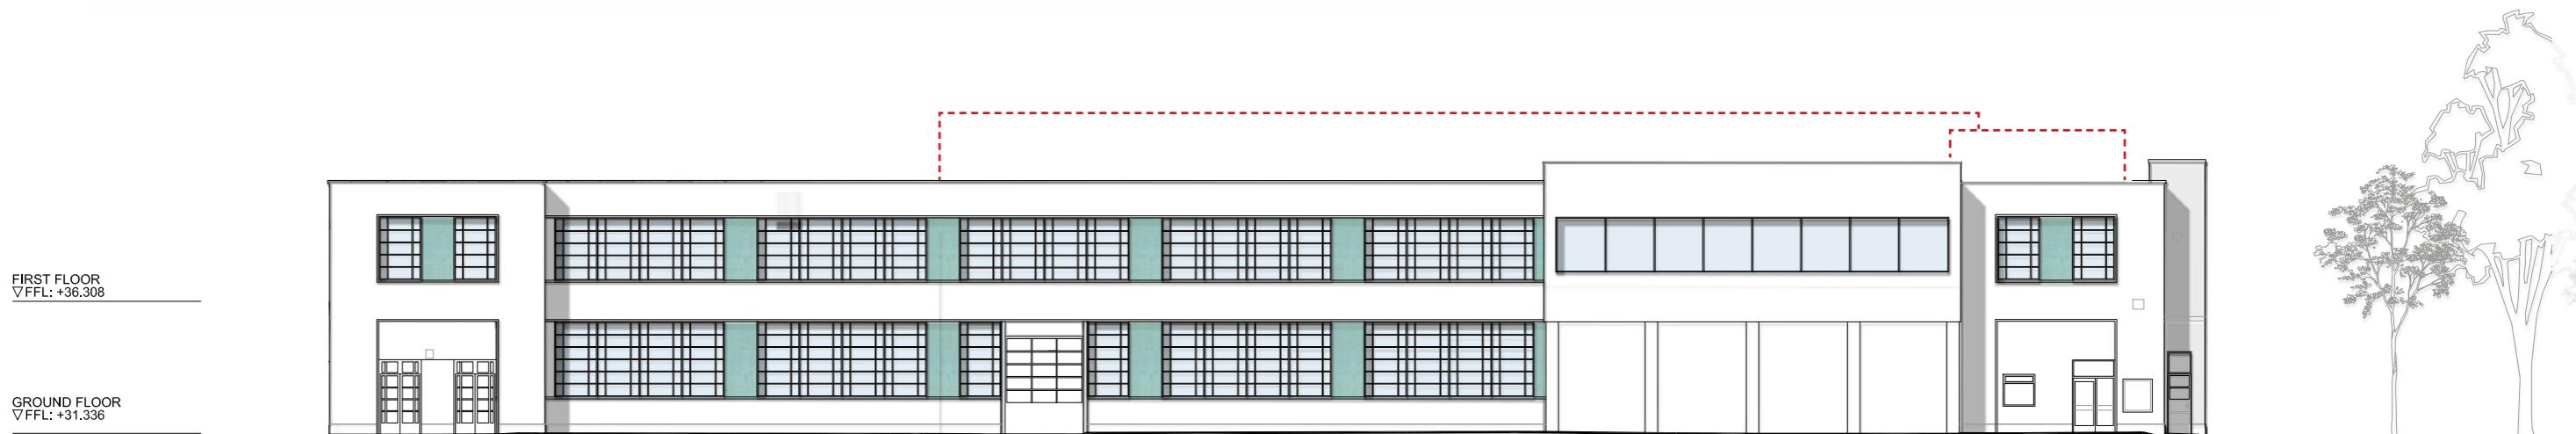
West Elevation

End nib removed for Block H

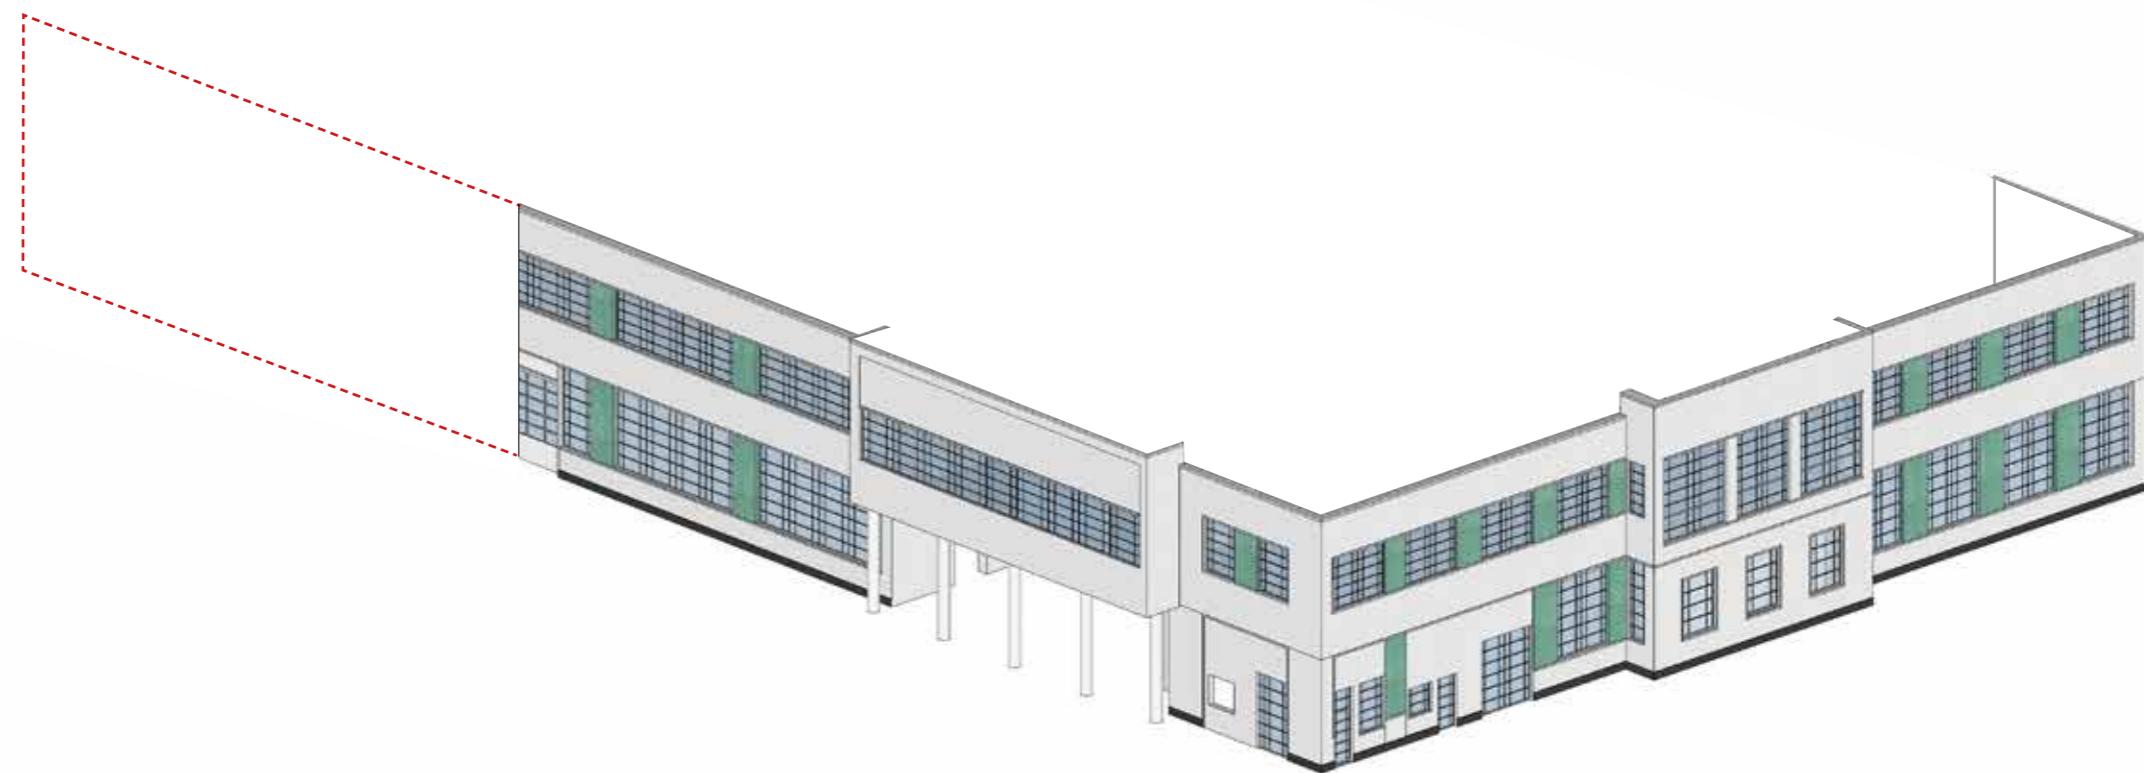
West Elevation

Single-glazed windows to be replaced

1. The existing windows are single-glazed steel framed, and need to be replaced with thermally broken double glazed in order to meet the NHS requirements of a sustainable BREEAM excellent medical centre. The proposal is for the same crittal style aluminium window frames used on blocks F1 and G, which appear in keeping with the original aesthetic.

2. To facilitate the medical centre design and room sizes, the existing window spans on the West facing elevation will need to be subdivided by half; the junction of wall to window detail draws from the original design, using a vertical green tile panel junction.

3. The existing green tiles are damaged or missing in areas; to ensure consistency with the new panels, all the tiles are to be removed and replaced with new green tiles, using the same product and supplier as the tiles used on blocks G and F1; these three buildings will complete the composition around Wallis Gardens

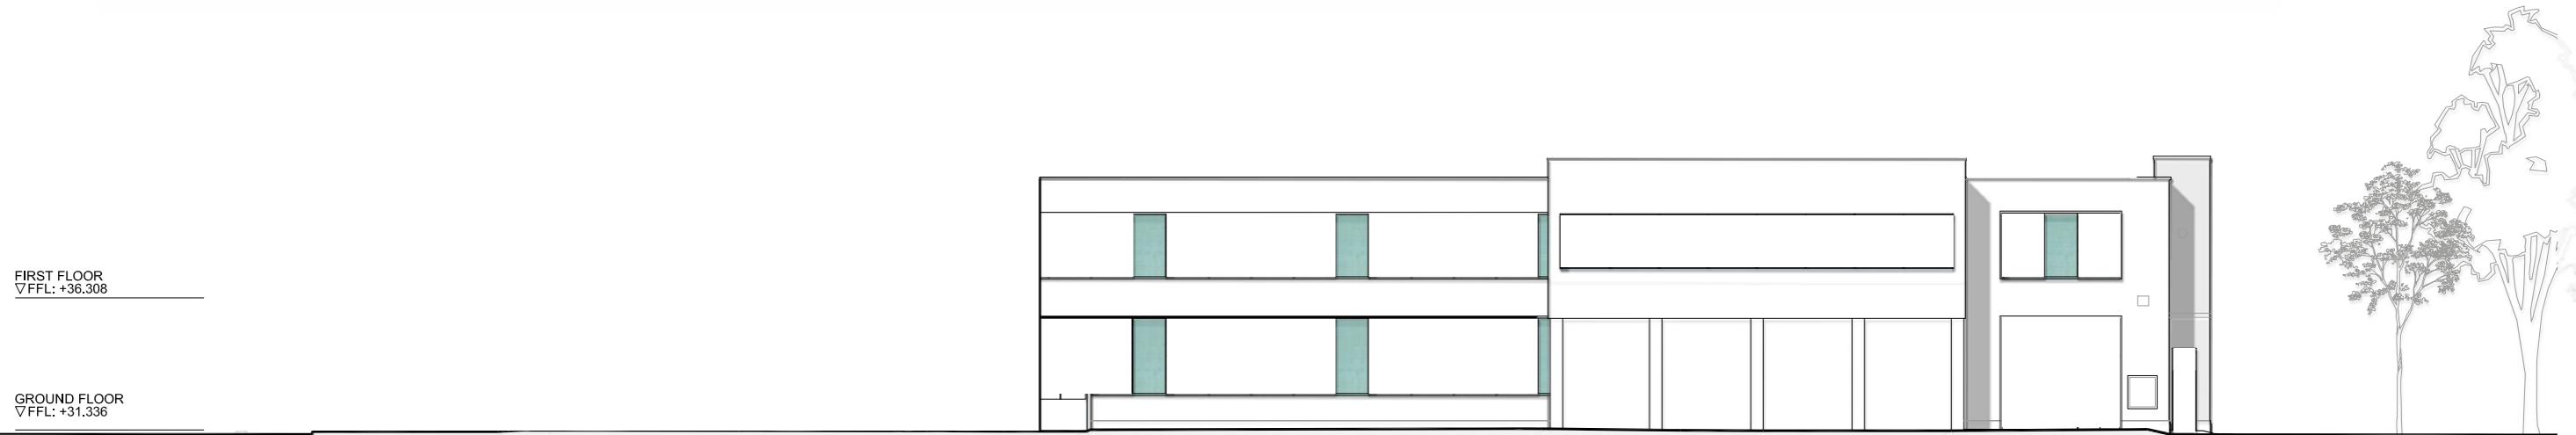
West Elevation

Corroded steel structure embedded in brick facade

The steel beams and columns are encased in brickwork. This detail was typical during midcentury construction - particularly as a way of creating a modernist concrete aesthetic - but is now understood as a poor detail due that allows water ingress to damage the steelwork, often creating structural damage referred to as 'Regents street disease.' By today's standards, any retained steelwork would be categorised as primary structural elements, and would therefore need to provide a 60 year minimum lifespan.

This option relies upon a sealant applied to the outer layers of render to prevent future moisture ingress. However, initial comments from NHBC is that relying on, "a paint-on solution requires periodical application and may affect how the building breaths (interstitial and surface condensation). Any periodical maintenance required would need to be done by operatives who are suitably trained in the product and this is likely to be part of a condition of warranty - for example similarly to the repeat painting of timber windows. Given the end user and possible cost, this is a risk and is not a robust solution."

In order to achieve a robust remedial detail to retain the steels and provide a 60 year lifespan that would satisfy the NHBC warranty, it is likely that the steels would need to be fully exposed in order to provide repairs and protection from future moisture. This would require the removal of all the brickwork shown in red opposite, to be rebuilt.
