CRANFORD HOUSE CELLARS, CRANFORD PARK, LONDON BOROUGH OF HILLINGDON: HISTORIC BUILDING SURVEY

AOC Project No: 34326

Date: May 2022

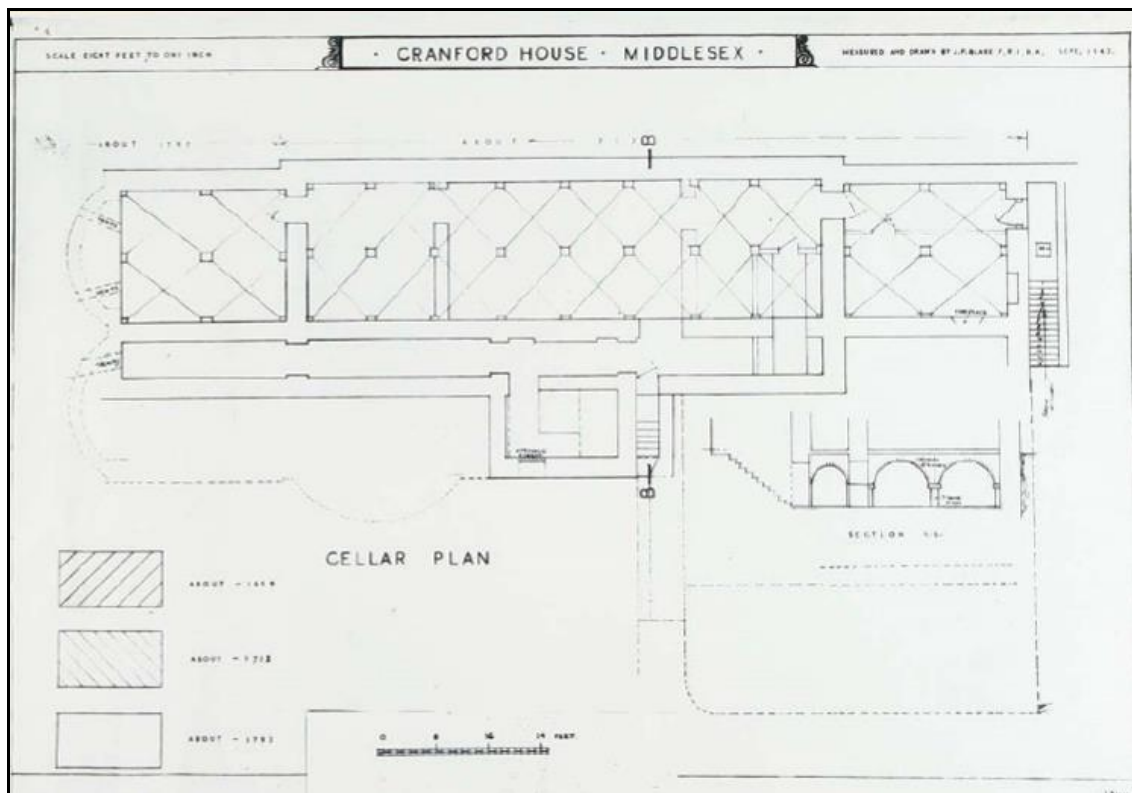
Plate 1: Cellar Plan of Cranford House

- 4.11 Cranford House was never re-occupied after the First World War, and by the time it was taken over by the Council in the 1930's, it had fallen into disrepair. A survey of the cellars was made in 1943 (Plate 1). After the demolition of the house in 1944, only the extensive brick vaulted 17th cellars survived. The stable block, dating from the 1740's, comprises two, two storey blocks, with the original stalls and fittings, linked by a single storey section, with central clock tower. A wing to the south, alongside the wall to St. Dunstan's Church, was demolished in 1944.

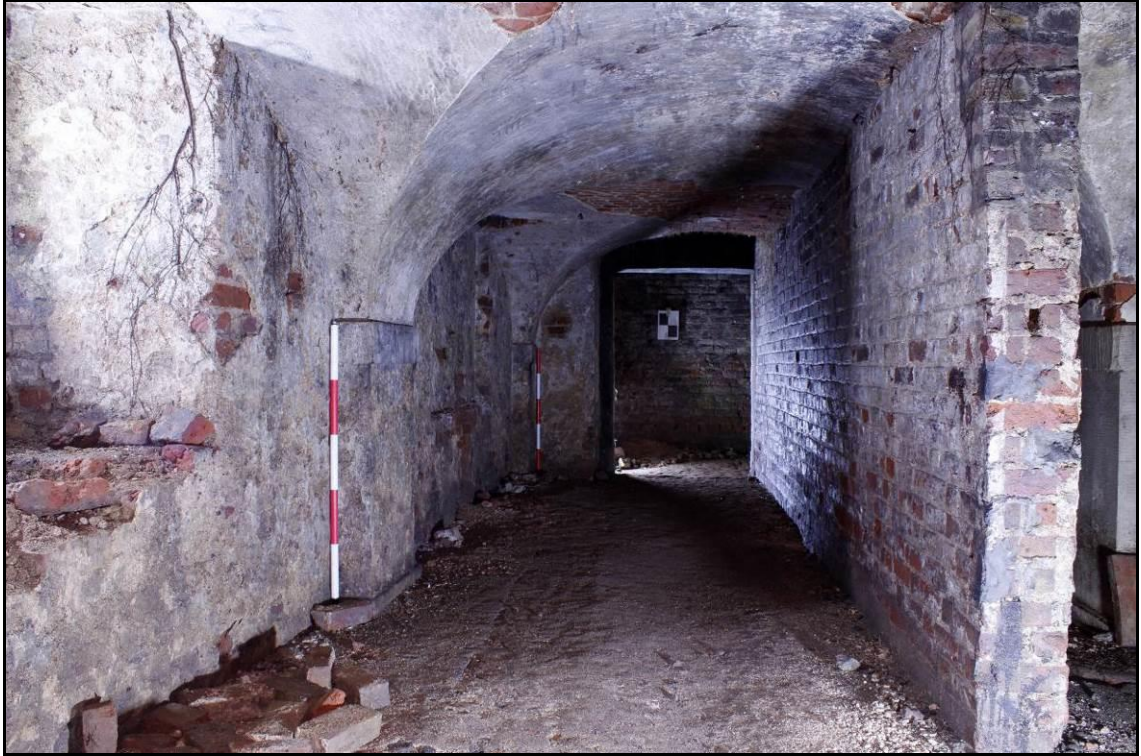
Plate 23: Room 2 looking north

- 6.17 Minor alterations mark the third Phase of the cellars, rather than significant building episodes. These comprise a partition wall being built across the west side of the kitchen, forming a narrow corridor (Room 2) just 1.75m wide (Plates 23 and 24). The new wall is built off the east jamb of the northern wall, and has an untidy southern end, where the entrance to Room 4 has the opening on a different alignment, and has been partially blocked, by the necessity of attempting to build a straight wall between two uneven points.
