**Ashby Farm
Bat Survey Report
Holland and Holland
06 March 2026**

Project information
File reference	DWE 0975
Document title	Ashby Farm Bat Report
Client	Holland and Holland
Date	06 March 2026
Status	Issued
Survey by	Andrew Latham ACIEEM and David Kent MCIEEM
Prepared by	Andrew Lathan ACIEEM and Roisin Jones ACIEEM
Reviewed by	Diane Davidson-Watts MCIEEM

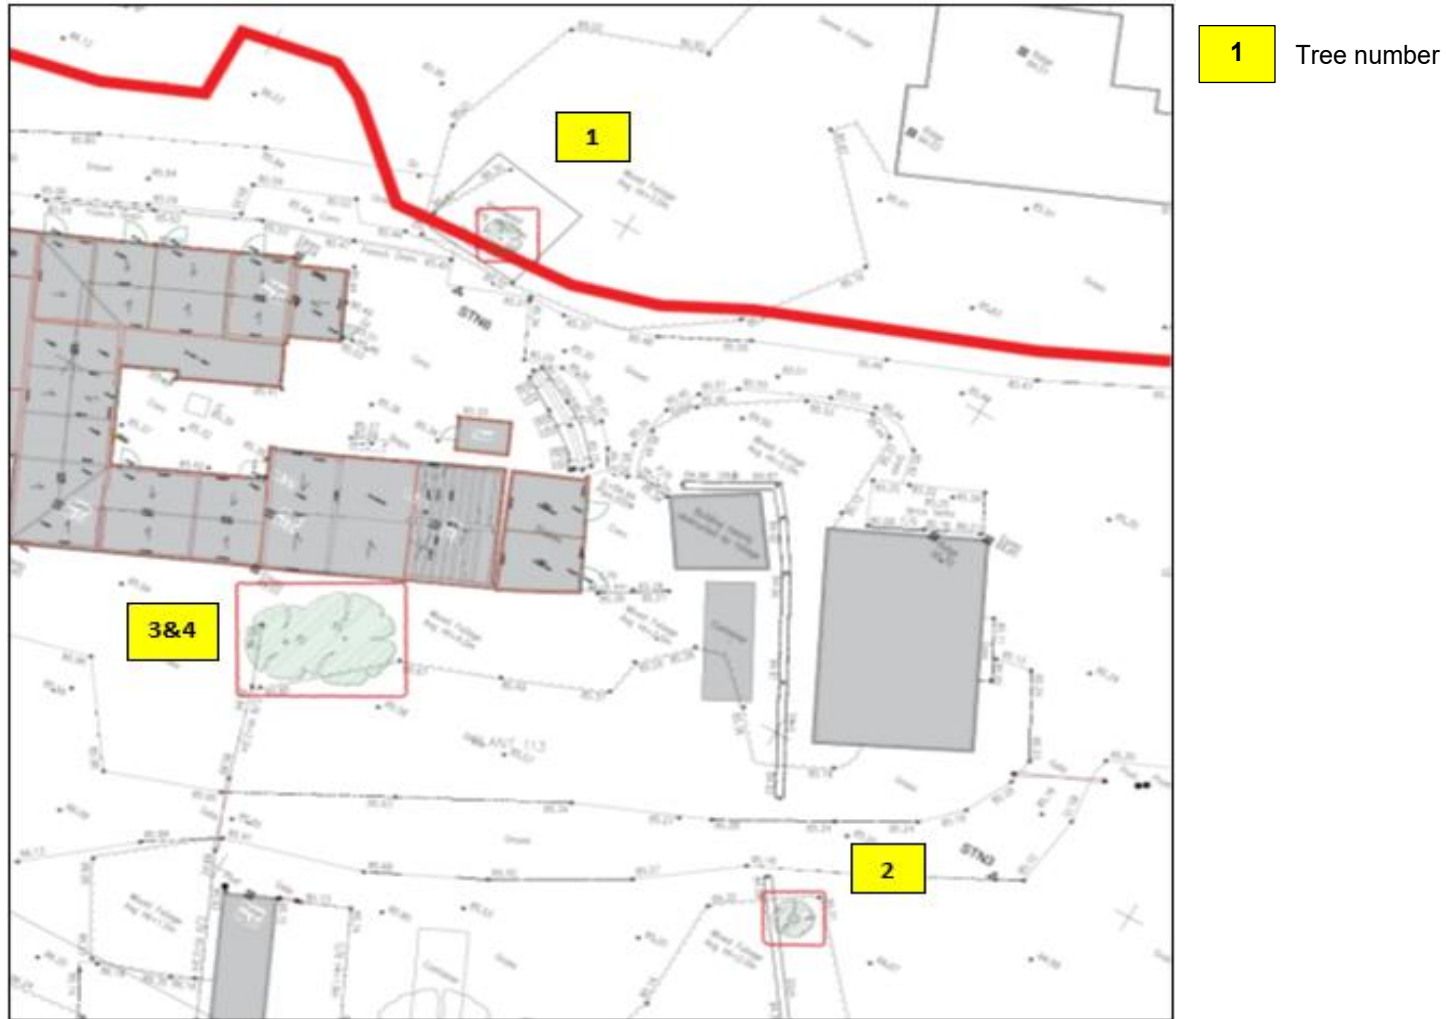
Figure 6 Location of trees assessed in GLTA

- 5.6.1 Ground level tree assessments (GLTA's) were undertaken on the 14th August 2025 of four trees that were identified as being proposed for removal as a result of the proposed development.
- 5.6.2 Four trees were assessed with the tree locations and tree reference numbers provided in Figure 6. The corresponding tree report references are also included in Figure 6 as taken from the Arboricultural Report to BS 5837: 2012 for Holland and Holland: Ashby Farm, HA6 2SS (17 October 2025).
- 5.6.3 The surveys classified three of the trees (T1, T3 and T4) as having **Negligible** suitability for roosting bats.
- 5.6.4 A single tree, T2, was classified as **PRF-I**, with the feature noted as the ivy which covers the dead elm tree stem. Full details of the GLTA results are in Table 7 and no further surveys are required prior to planning approval.

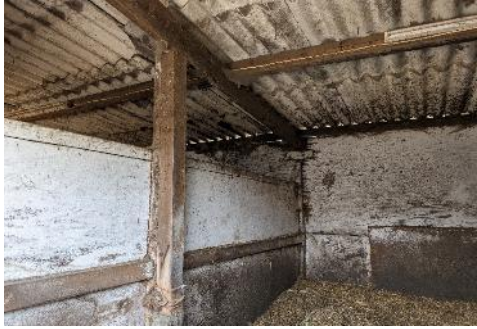
3	1

The eastern courtyard also has stable blocks, sub-divided into units. These have a more basic design, with a simple flat timber frame, plywood board walls and an entirely flat roof, directly overlain by corrugated metal sheeting [Plate 3]. The units are only partially sealed from each other and have a more open appearance. Each unit is accessed by a typical stable door, as with the western courtyard stables. This block is also in consistent use and undergoes regular disturbance, as with the western courtyard stables.

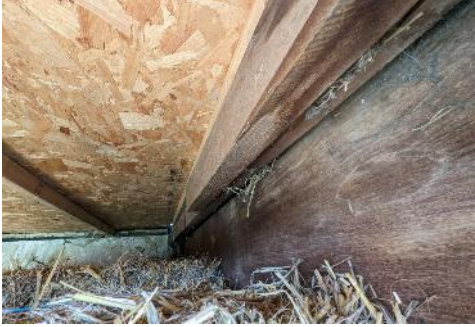
<p>5</p>	<p>1</p>

relatively sheltered conditions, particularly the larger of the two, with the combination of the bitumen roof and hay accumulation creating a notably warmer microclimate within these areas. A partially cluttered but extended gap is present between a timber support and the ply wall [Plate 5]. An assumed equivalent gap at the other end of this outbuilding could not be viewed up close due to the hay storage impeding access. The eastern courtyard stables of Building 1 appear to have less PRFs suitability, with the basic internal timber frame joins well fitted and the sheet roof panelling directly adjoined to it without obvious gaps

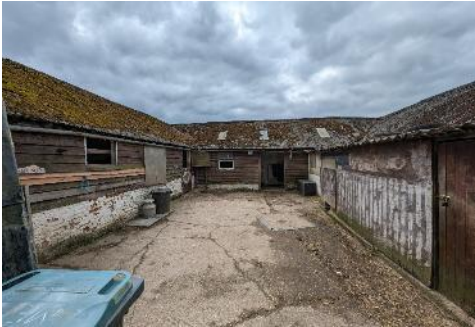
<p>6</p>	<p>2</p>

Building 2 collectively comprises a single-storey 'U'-shaped stable block, adjoining Building 3, located in the centre of the survey area and which seems to pre-date in appearance the more modern stable units comprising Building 1 [Plate 6]. The Building 2 courtyard stables are sub-divided into eight units of varying dimensions, but each approximately 6m in height with a timber-framed support enclosed by a steeply-pitched roof, comprised of corrugated cement sheeting. There are three sealed skylights on the roof. The structures are brick-built at the base and have a mixture of timber panel and ply sheet walls above. As with Building 1, each unit is accessed by a typical stable door, the lower half used for entry and the upper half presenting an entirely open entry point for birds and/or bats. A barn swallow nest was noted inside one of these.

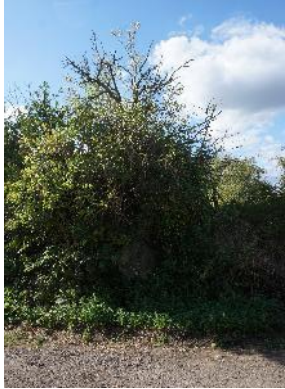
Reference	Tree species	GPS	PRF details, narrative	Image reference
1 (Tree report ref unclassified)	Dead Apple tree <i>Malus domestica</i>	TQ 07663 90015	Dead fruit tree situated in a clump of laurel, elder and blackthorn DBH – 40cm, H 7m Negligible status - no features are present.

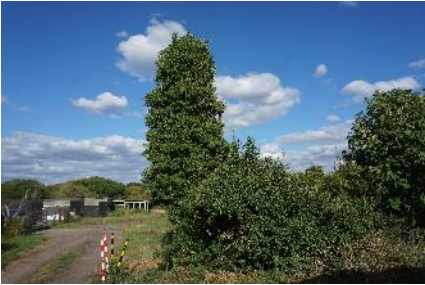
2 (Tree report ref T022)	Dead elm <i>Ulmus sp</i>	TQ 07688 89996	Tree is dead with ivy cover with narrow stems present DBH – 20cm H 8m Features only suitable for PRF I roosting opportunity, if that.

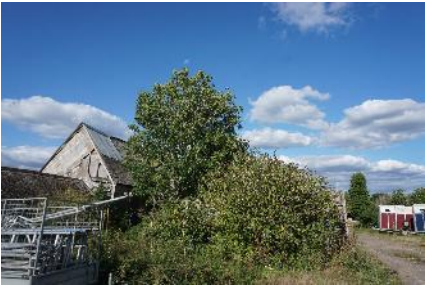
3 and 4 (tree report G)25)	Group of young Ash <i>Fraxinus excelsior</i>	TQ07664 89994	The 3 ash trees are all multi-stem young trees do not have features. All DBH values are for all stems. Tree 1 DBH 40cm H 12m Tree 2 DBH 60cm H 12m Tree 3 DBH 40cm H 12m Negligible status all trees- no features are present.
