# BS5837:2012

## Tree Survey

44 Murray Road  
Northwood HA6 2YL

Date: 26/03/2025  
Job number: 2707  
Report reference: TGA.2707.TreeSurvey

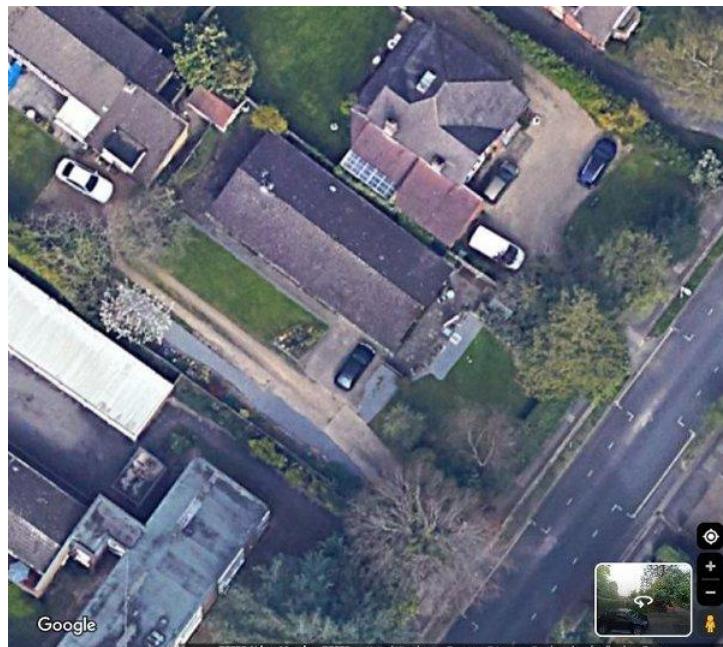
3.1. The site comprises a single residential address with a detached house as can be seen in the aerial image below.

Overview of site included in survey – Google imagery

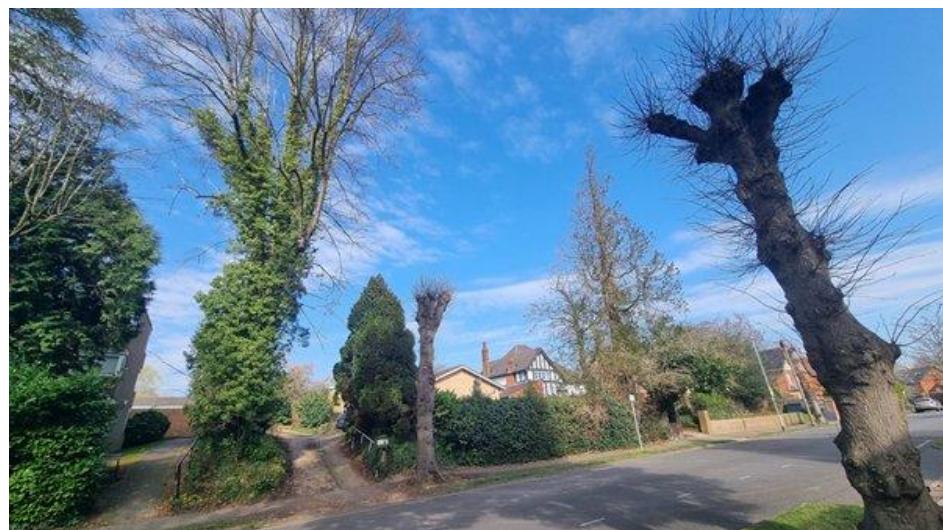
View of site from Murray Road
