Landmark Trees

### ARBORICULTURAL IMPACT ASSESSMENT REPORT:

Proposed Lidl Store  
Former Hayes Swimming Pool Site  
Botwell Lane  
Hayes  
Middlesex

**Ref:** LUK/BLH/AIA/03a

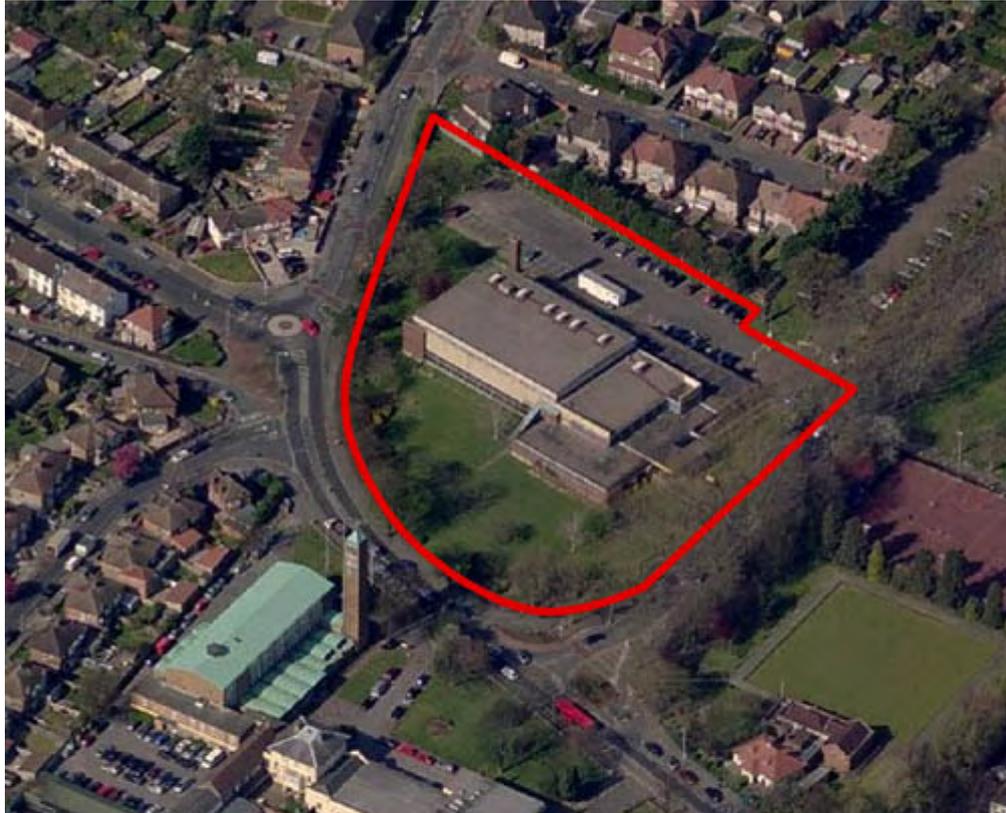
Photograph 1: Former Hayes Swimming Pool Site, Botwell Lane, Hayes, Middlesex

- 3.1.1 The site is located within the defined town centre boundary of Hayes. It is bordered to the south by Botwell Lane and Central Avenue to the east. The site area is 0.971 ha.

- 3.1.2 The site is relatively level.
- 3.1.3 In terms of the British Geological Survey, the site overlies the London Clay Formation, with superficial deposits of Langley Silt Member (see indicated location on Fig.1 plan extract below). The associated soils are generally, highly shrinkable clay; e.g. slowly permeable seasonally waterlogged fine silt over clay. Such highly plastic soils are prone to movement: subsidence and heave. The actual distribution of the soil series are not as clearly defined on the ground as on plan and there may be anomalies in the actual composition of clay, silt and sand content.
