REFURBISHMENT SURVEY

Site Name: Bungalow , London meat company , Sheds, Two storey storage unit, Veterinary Clinic

Site address: The Elms, 371A High Street, Harlington, Hayes, Greater London, UB3 5DQ

Report Ref: J043984

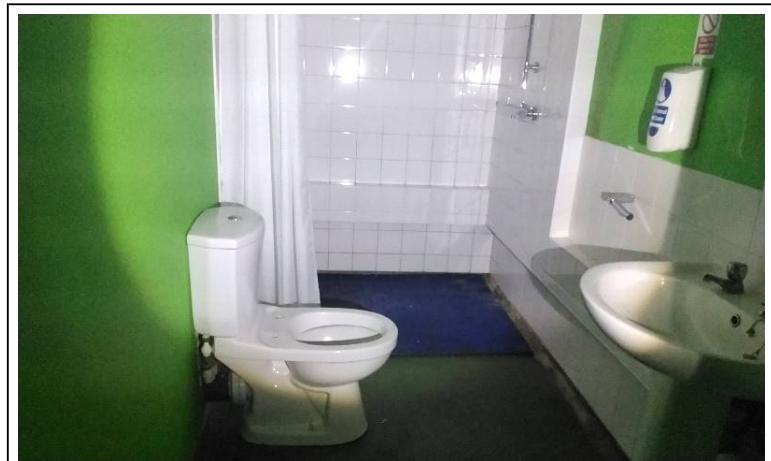
Report No	J043984	Site	London meat company	Date	20 July 2023
Inspection No	6	Level of Identification:		No suspect materials found	
Description	Concrete identified below flooring				
Building	London meat company				
Floor	Ground Floor				
Room Area	WC2				
Position	N/A				
Quantity	N/A				
Accessibility	N/A

Room consists of a plasterboard ceiling with modern flat finish plaster, masonry walls with modern flat finish plaster and a concrete floor with modern vinyl. Timber door and frame, .

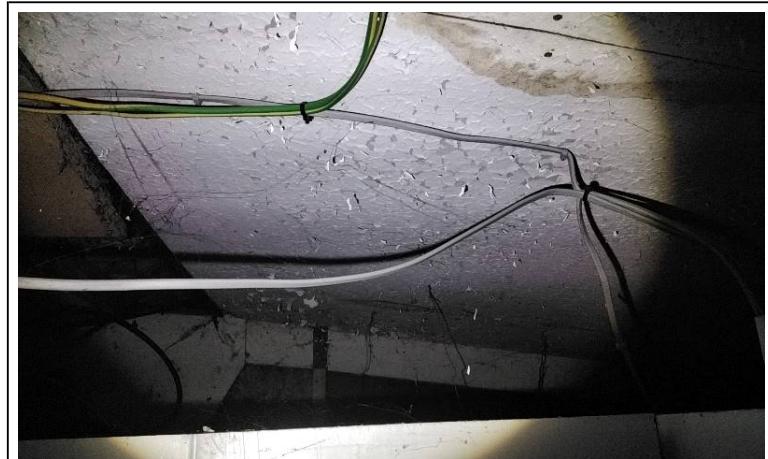
Report No	J043984	Site	London meat company	Date	20 July 2023
Inspection No	37	Level of Identification:		No suspect materials found	
Description	Concrete identified below flooring				
Building	London meat company				
Floor	Ground Floor				
Room Area	Canteen				
Position	N/A				
Quantity	N/A				
Accessibility	N/A

Suspended ceiling tile grid, inspection above revealed timber flat roofing, copper and plastic pipework. Metal hygiene wall panels and a compressed concrete floor.

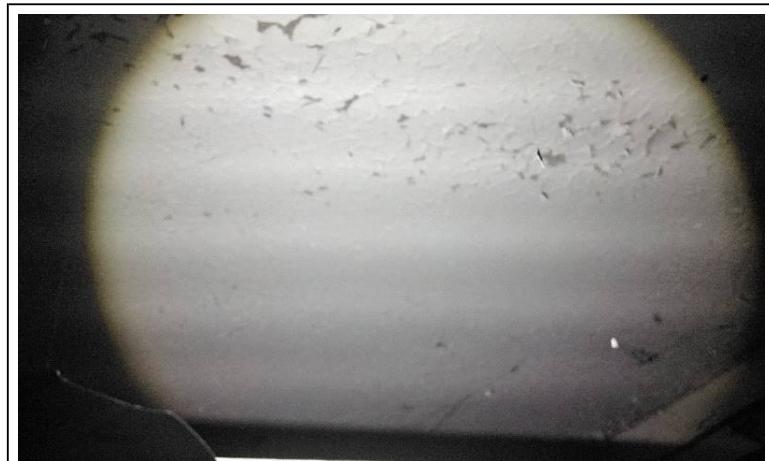
Report No	J043984	Site	London meat company	Date	20 July 2023
Inspection No	40	Level of Identification:		No suspect materials found	
Description	Inspection above ceiling tiles				
Building	London meat company				
Floor	Ground Floor				
Room Area	Store1				
Position	N/A				
Quantity	N/A				
Accessibility	N/A

Suspended ceiling tile grid, inspection above revealed timber flat roofing, copper and plastic pipework. Metal hygiene wall panels and a compressed concrete floor.

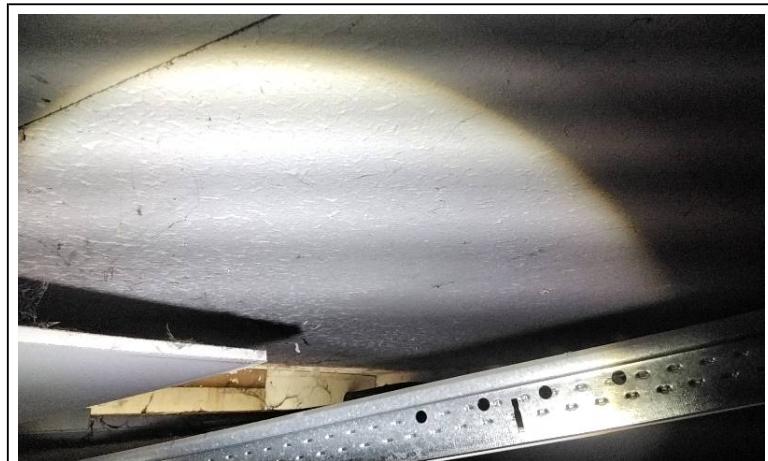
Report No	J043984	Site	London meat company	Date	20 July 2023
Inspection No	41	Level of Identification:		No suspect materials found	
Description	Inspection above ceiling tiles				
Building	London meat company				
Floor	Ground Floor				
Room Area	Store2				
Position	N/A				
Quantity	N/A				
Accessibility	N/A

Suspended ceiling tile grid, inspection above revealed timber flat roofing, copper and plastic pipework. Metal hygiene wall panels and a compressed concrete floor.

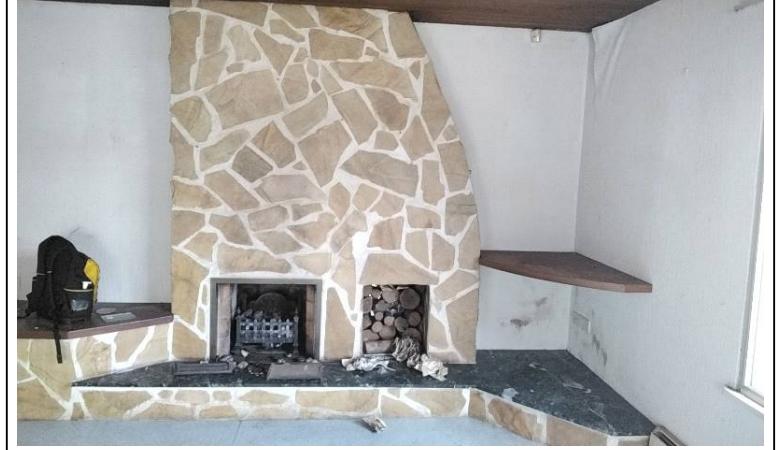
Report No	J043984	Site	Bungalow	Date	20 July 2023
Inspection No	7	Level of Identification:		No suspect materials found	
Description	Solid masonry chimney stack				
Building	Bungalow

Floor	Ground Floor				
Room Area	Lounge				
Position	N/A				
Quantity	N/A				
Accessibility	N/A				
MATERIAL RISK ASSESSMENT					
Product Type	Condition	Surface Treatment	Asbestos Type	Material Risk Score	Risk Category
N/A (0)	(0)	(0)	No Asbestos Detected (0) (0)	N/A	N/A
Comments:					
General Observations:					
<p>Room consists of a plasterboard ceiling with timber cladding, masonry walls with decorative finish paper and a concrete floor with modern vinyl. Timber door and frame, Metal window and frame with timber sill, modern mastic and masonry reveals.</p>

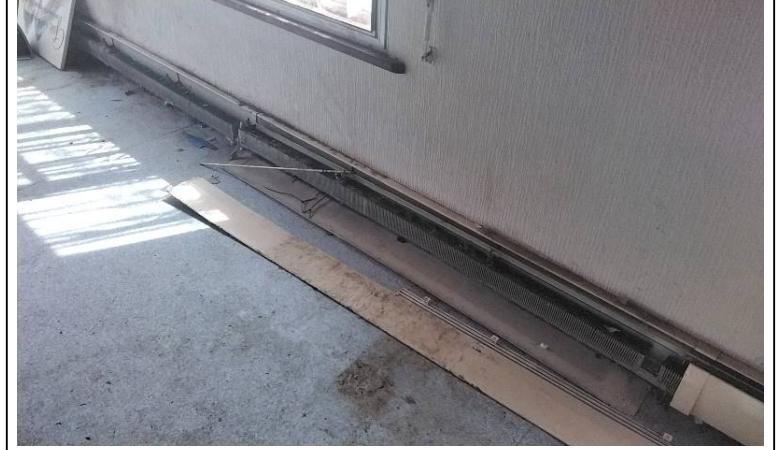
Report No	J043984	Site	Bungalow	Date	20 July 2023
Inspection No	8	Level of Identification:		No suspect materials found	
Description	Low level metal radiators				
Building	Bungalow

Floor	Ground Floor				
Room Area	Lounge				
Position	N/A				
Quantity	N/A				
Accessibility	N/A				
MATERIAL RISK ASSESSMENT					
Product Type	Condition	Surface Treatment	Asbestos Type	Material Risk Score	Risk Category
N/A (0)	(0)	(0)	No Asbestos Detected (0) (0)	N/A	N/A
Comments:					
General Observations:					
Room consists of a plasterboard ceiling with timber cladding, masonry walls with decorative finish paper and a concrete floor with modern vinyl. Timber door and frame, Metal window and frame with timber sill, modern mastic and masonry reveals.

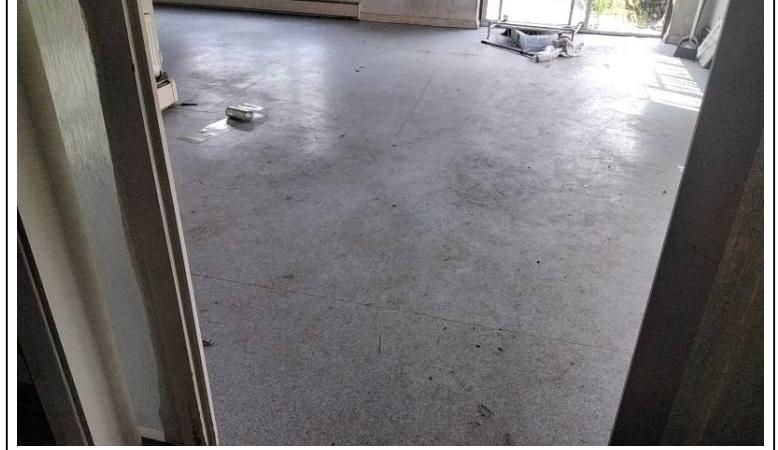
Report No	J043984	Site	Bungalow	Date	20 July 2023
Inspection No	9	Level of Identification:		No suspect materials found	
Description	Screed identified below flooring, inspected in various areas				
Building	Bungalow

Floor	Ground Floor				
Room Area	Lounge				
Position	N/A				
Quantity	N/A				
Accessibility	N/A				
MATERIAL RISK ASSESSMENT					
Product Type	Condition	Surface Treatment	Asbestos Type	Material Risk Score	Risk Category
N/A (0)	(0)	(0)	No Asbestos Detected (0) (0)	N/A	N/A
Comments:					
General Observations:					
Room consists of a plasterboard ceiling with timber cladding, masonry walls with decorative finish paper and a concrete floor with modern vinyl. Timber door and frame, Metal window and frame with timber sill, modern mastic and masonry reveals.

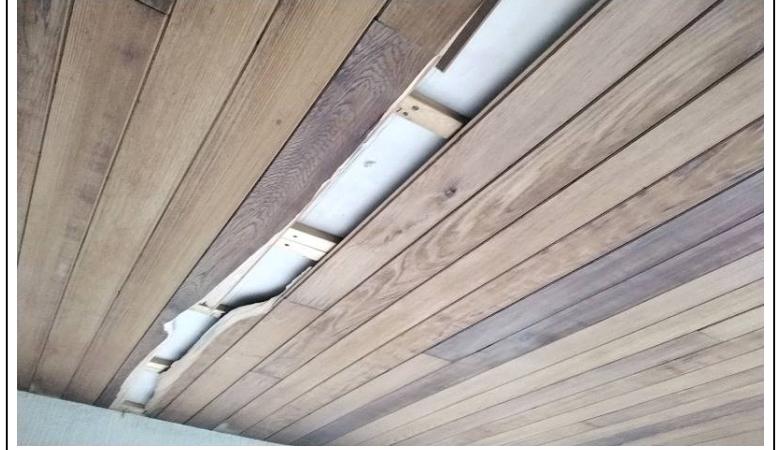
Report No	J043984	Site	Bungalow	Date	20 July 2023
Inspection No	10	Level of Identification:		No suspect materials found	
Description	Plasterboard ceiling identified above timber cladding				
Building	Bungalow

Floor	Ground Floor				
Room Area	Lounge				
Position	N/A				
Quantity	N/A				
Accessibility	N/A				
MATERIAL RISK ASSESSMENT					
Product Type	Condition	Surface Treatment	Asbestos Type	Material Risk Score	Risk Category
N/A (0)	(0)	(0)	No Asbestos Detected (0) (0)	N/A	N/A
Comments:					
General Observations:					
Room consists of a plasterboard ceiling with timber cladding, masonry walls with decorative finish paper and a concrete floor with modern vinyl. Timber door and frame, Metal window and frame with timber sill, modern mastic and masonry reveals.

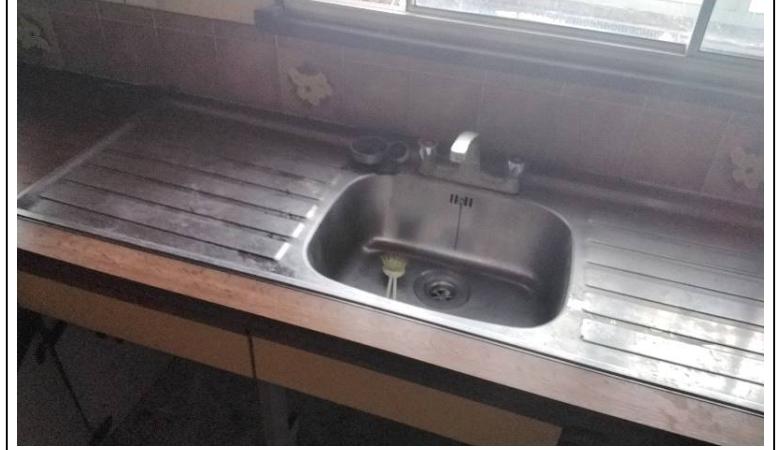
Report No	J043984	Site	Bungalow	Date	20 July 2023
Inspection No	11	Level of Identification:		No suspect materials found	
Description	No sink pads present				
Building	Bungalow

Floor	Ground Floor				
Room Area	Kitchen				
Position	N/A				
Quantity	N/A				
Accessibility	N/A				
MATERIAL RISK ASSESSMENT					
Product Type	Condition	Surface Treatment	Asbestos Type	Material Risk Score	Risk Category
N/A (0)	(0)	(0)	No Asbestos Detected (0) (0)	N/A	N/A
Comments:					
General Observations:					
Room consists of a plasterboard ceiling with timber cladding, masonry walls with ceramic tiles and a concrete floor with ceramic tiles. Timber door and frame, Metal window and frame with timber sill, modern mastic and masonry reveals.

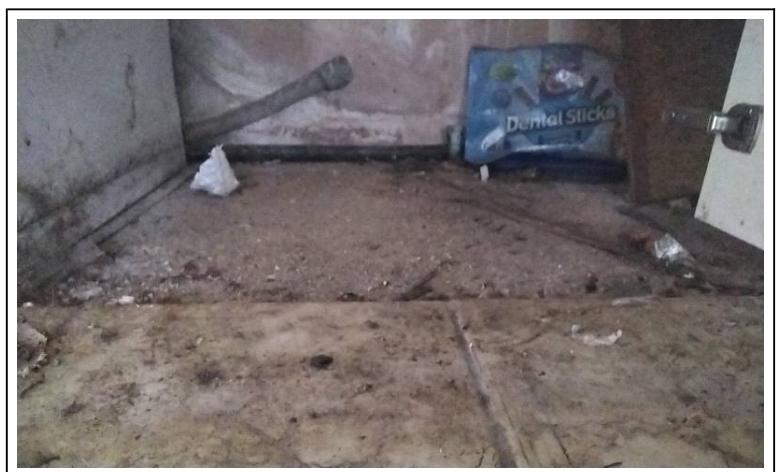
Report No	J043984	Site	Bungalow	Date	20 July 2023
Inspection No	12	Level of Identification:		No suspect materials found	
Description	Inspection below kitchen units				
Building	Bungalow

Floor	Ground Floor				
Room Area	Kitchen				
Position	N/A				
Quantity	N/A				
Accessibility	N/A				
MATERIAL RISK ASSESSMENT					
Product Type	Condition	Surface Treatment	Asbestos Type	Material Risk Score	Risk Category
N/A (0)	(0)	(0)	No Asbestos Detected (0) (0)	N/A	N/A
Comments:					
General Observations:					
<p>Room consists of a plasterboard ceiling with timber cladding, masonry walls with ceramic tiles and a concrete floor with ceramic tiles. Timber door and frame, Metal window and frame with timber sill, modern mastic and masonry reveals.</p>

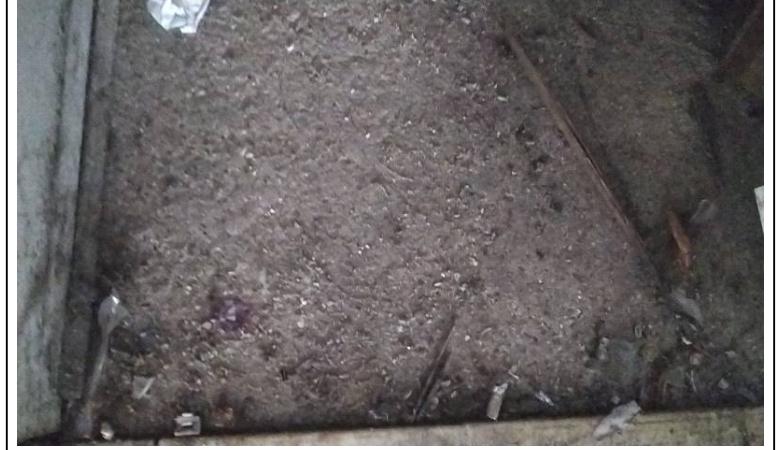
Report No	J043984	Site	Bungalow	Date	20 July 2023
Inspection No	13	Level of Identification:		No suspect materials found	
Description	Screed identified below flooring, inspected in various areas				
Building	Bungalow

Floor	Ground Floor				
Room Area	Kitchen				
Position	N/A				
Quantity	N/A				
Accessibility	N/A				
MATERIAL RISK ASSESSMENT					
Product Type	Condition	Surface Treatment	Asbestos Type	Material Risk Score	Risk Category
N/A (0)	(0)	(0)	No Asbestos Detected (0) (0)	N/A	N/A
Comments:					
General Observations:					
Room consists of a plasterboard ceiling with timber cladding, masonry walls with ceramic tiles and a concrete floor with ceramic tiles. Timber door and frame, Metal window and frame with timber sill, modern mastic and masonry reveals.

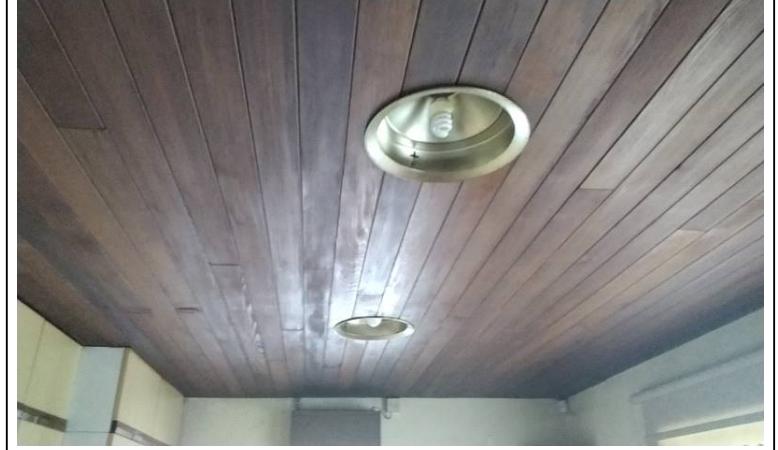
Report No	J043984	Site	Bungalow	Date	20 July 2023
Inspection No	14	Level of Identification:		No suspect materials found	
Description	Plasterboard ceiling identified above timber cladding				
Building	Bungalow

Floor	Ground Floor				
Room Area	Kitchen				
Position	N/A				
Quantity	N/A				
Accessibility	N/A				
MATERIAL RISK ASSESSMENT					
Product Type	Condition	Surface Treatment	Asbestos Type	Material Risk Score	Risk Category
N/A (0)	(0)	(0)	No Asbestos Detected (0) (0)	N/A	N/A
Comments:					
General Observations:					
Room consists of a plasterboard ceiling with timber cladding, masonry walls with ceramic tiles and a concrete floor with ceramic tiles. Timber door and frame, Metal window and frame with timber sill, modern mastic and masonry reveals.

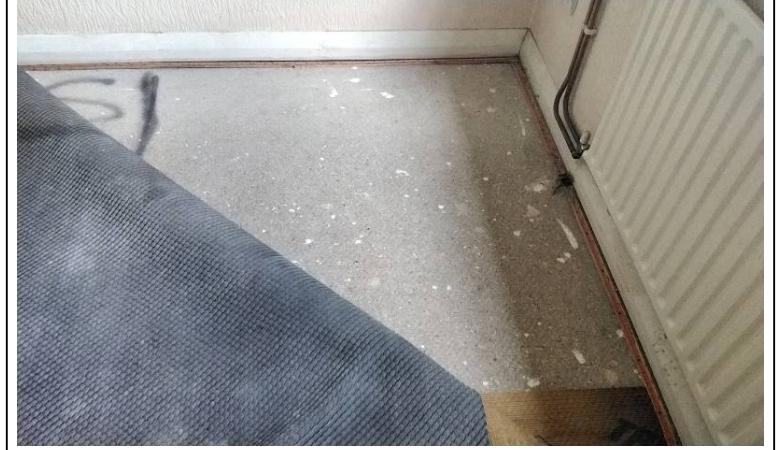
Report No	J043984	Site	Bungalow	Date	20 July 2023
Inspection No	15	Level of Identification:		No suspect materials found	
Description	Inspection below flooring				
Building	Bungalow

Floor	Ground Floor				
Room Area	Bedroom 1				
Position	N/A				
Quantity	N/A				
Accessibility	N/A				
MATERIAL RISK ASSESSMENT					
Product Type	Condition	Surface Treatment	Asbestos Type	Material Risk Score	Risk Category
N/A (0)	(0)	(0)	No Asbestos Detected (0) (0)	N/A	N/A
Comments:					
General Observations:					
Room consists of a plasterboard ceiling, masonry walls with modern flat finish plaster and a concrete floor with carpet. Timber door and frame, Metal window and frame with timber sill, modern mastic and masonry reveals.

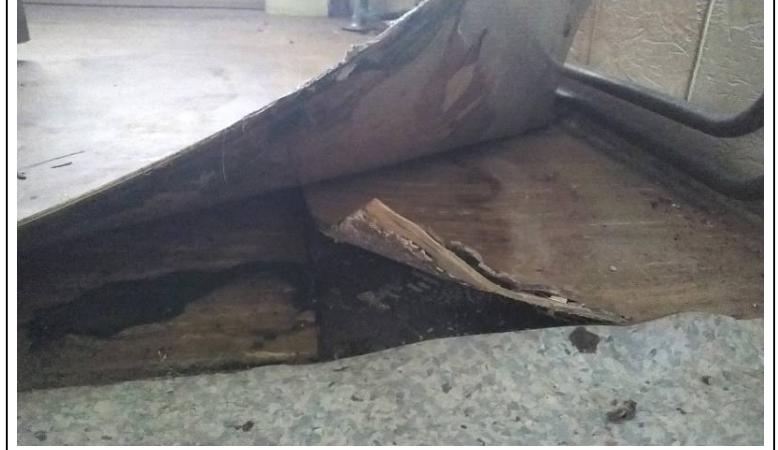
Report No	J043984	Site	Bungalow	Date	20 July 2023
Inspection No	17	Level of Identification:		No suspect materials found	
Description	Inspection below flooring, further vinyl identified				
Building	Bungalow

Floor	Ground Floor				
Room Area	Bathroom				
Position	N/A				
Quantity	N/A				
Accessibility	N/A				
MATERIAL RISK ASSESSMENT					
Product Type	Condition	Surface Treatment	Asbestos Type	Material Risk Score	Risk Category
N/A (0)	(0)	(0)	No Asbestos Detected (0) (0)	N/A	N/A
Comments:					
General Observations:					
Room consists of a plasterboard ceiling, masonry walls with modern flat finish plaster and a concrete floor with modern vinyl. Timber door and frame, Metal window and frame with timber sill, modern mastic and masonry reveals.

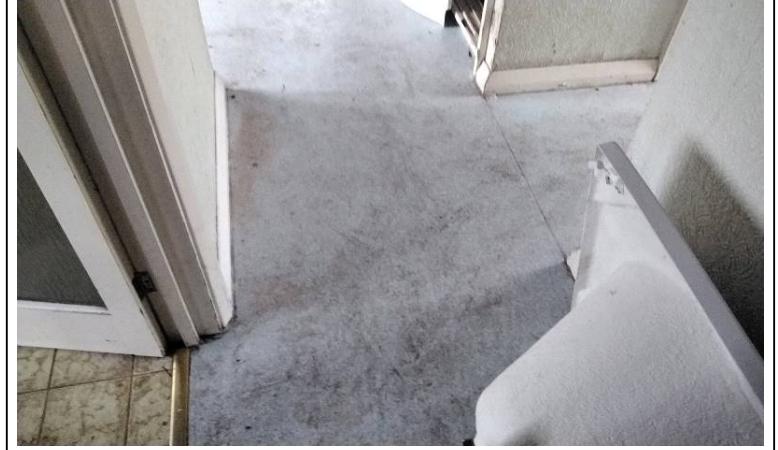
Report No	J043984	Site	Bungalow	Date	20 July 2023
Inspection No	23	Level of Identification:		No suspect materials found	
Description	Screed identified below flooring, inspected in various areas				
Building	Bungalow

Floor	Ground Floor				
Room Area	Hall				
Position	N/A				
Quantity	N/A				
Accessibility	N/A				
MATERIAL RISK ASSESSMENT					
Product Type	Condition	Surface Treatment	Asbestos Type	Material Risk Score	Risk Category
N/A (0)	(0)	(0)	No Asbestos Detected (0) (0)	N/A	N/A
Comments:					
General Observations:					
Room consists of a plasterboard ceiling with timber cladding, masonry walls with decorative finish paper and a concrete floor with modern vinyl. Timber door and frame, Metal window and frame with timber sill, modern mastic and masonry reveals.

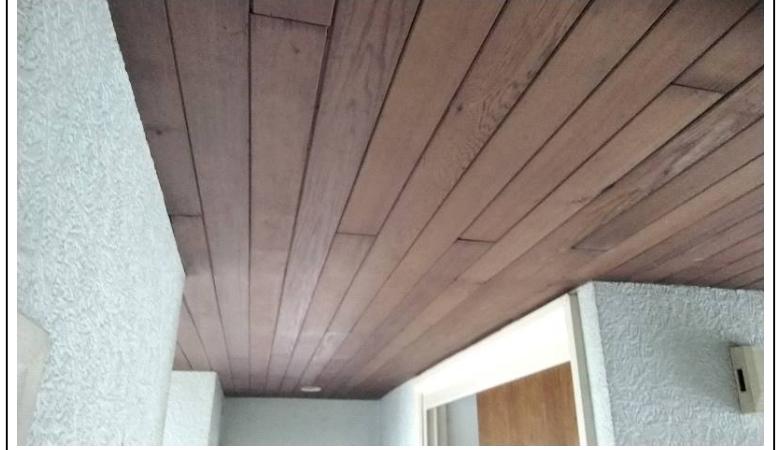
Report No	J043984	Site	Bungalow	Date	20 July 2023
Inspection No	24	Level of Identification:		No suspect materials found	
Description	Plasterboard ceiling identified above timber cladding				
Building	Bungalow

Floor	Ground Floor				
Room Area	Hall				
Position	N/A				
Quantity	N/A				
Accessibility	N/A				
MATERIAL RISK ASSESSMENT					
Product Type	Condition	Surface Treatment	Asbestos Type	Material Risk Score	Risk Category
N/A (0)	(0)	(0)	No Asbestos Detected (0) (0)	N/A	N/A
Comments:					
General Observations:					
Room consists of a plasterboard ceiling with timber cladding, masonry walls with decorative finish paper and a concrete floor with modern vinyl. Timber door and frame, Metal window and frame with timber sill, modern mastic and masonry reveals.

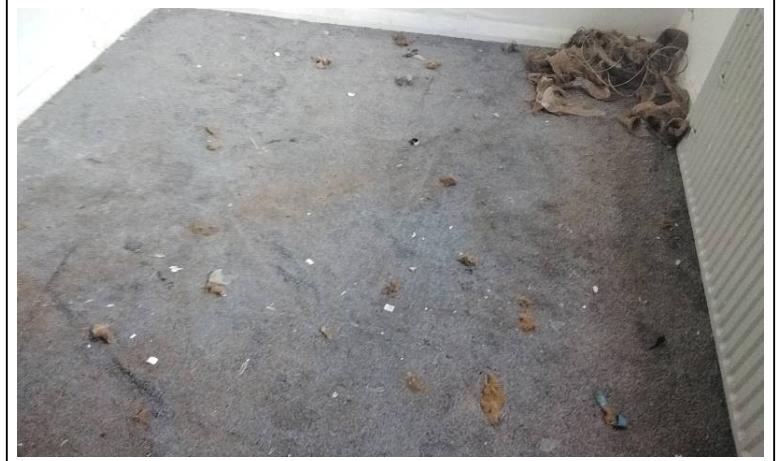
Report No	J043984	Site	Bungalow	Date	20 July 2023
Inspection No	25	Level of Identification:		No suspect materials found	
Description	Inspection below flooring				
Building	Bungalow

Floor	Ground Floor				
Room Area	Bedroom 3				
Position	N/A				
Quantity	N/A				
Accessibility	N/A				
MATERIAL RISK ASSESSMENT					
Product Type	Condition	Surface Treatment	Asbestos Type	Material Risk Score	Risk Category
N/A (0)	(0)	(0)	No Asbestos Detected (0) (0)	N/A	N/A
Comments:					
General Observations:					
Room consists of a plasterboard ceiling, masonry walls with modern flat finish plaster and a concrete floor with carpet. Timber door and frame, Metal window and frame with timber sill, modern mastic and masonry reveals.

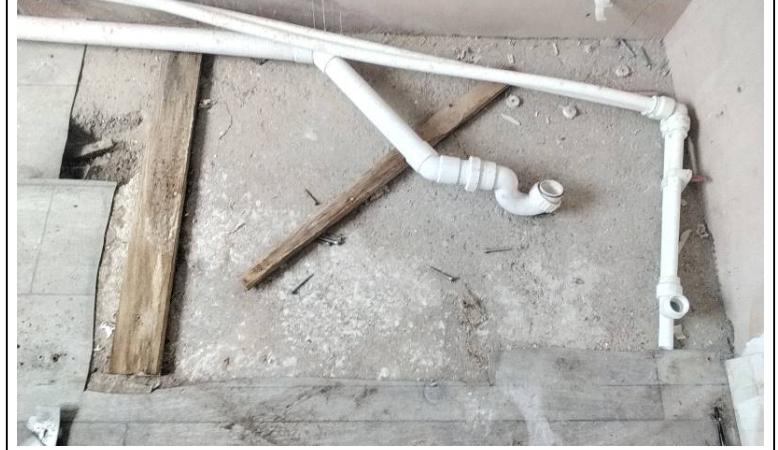
Report No	J043984	Site	Bungalow	Date	20 July 2023
Inspection No	27	Level of Identification:		No suspect materials found	
Description	Inspection below flooring,				
Building	Bungalow

Floor	Ground Floor				
Room Area	Bathroom 2				
Position	N/A				
Quantity	N/A				
Accessibility	N/A				
MATERIAL RISK ASSESSMENT					
Product Type	Condition	Surface Treatment	Asbestos Type	Material Risk Score	Risk Category
N/A (0)	(0)	(0)	No Asbestos Detected (0) (0)	N/A	N/A
Comments:					
General Observations:					
Room consists of a plasterboard ceiling, masonry walls with modern flat finish plaster and a concrete floor with modern vinyl. Timber door and frame, Metal window and frame with timber sill, modern mastic and masonry reveals.

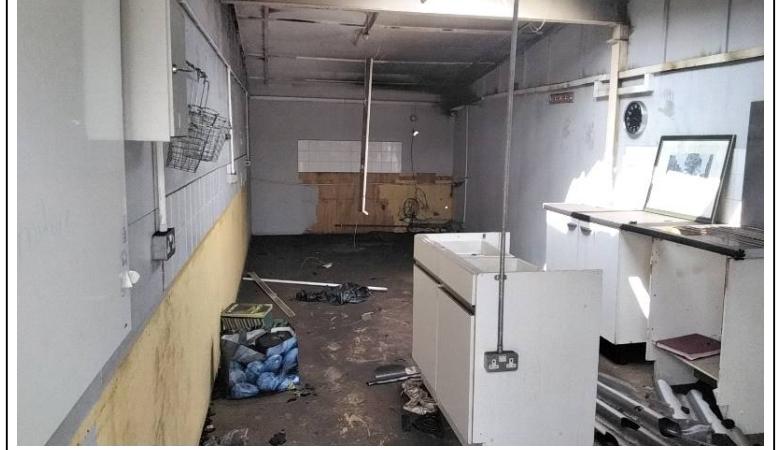
Report No	J043984	Site	Sheds	Date	21 July 2023
Inspection No	55	Level of Identification:		No suspect materials found	
Description	No suspect materials found				
Building	Sheds

Floor	Ground Floor				
Room Area	Shed 1				
Position	N/A				
Quantity	N/A				
Accessibility	N/A				
MATERIAL RISK ASSESSMENT					
Product Type	Condition	Surface Treatment	Asbestos Type	Material Risk Score	Risk Category
N/A (0)	(0)	(0)	No Asbestos Detected (0) (0)	N/A	N/A
Comments:					
General Observations:					
Timber built structure with plasterboard cladding to internal walls and a timber base.

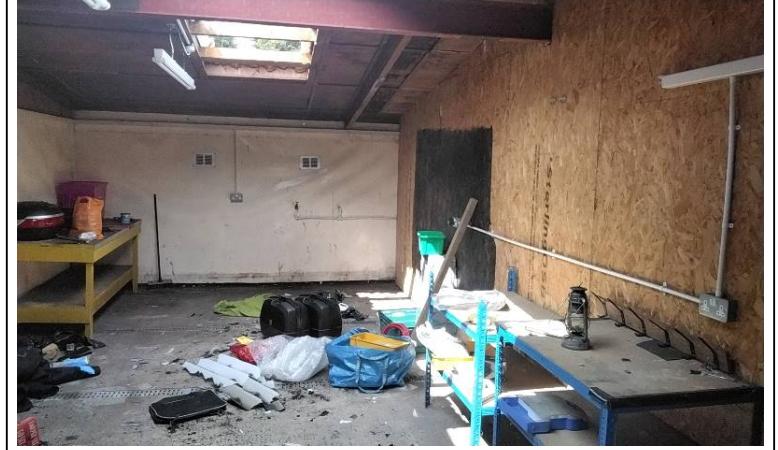
Report No	J043984	Site	Sheds	Date	21 July 2023
Inspection No	56	Level of Identification:		No suspect materials found	
Description	No suspect materials found				
Building	Sheds

Floor	Ground Floor				
Room Area	Shed 2				
Position	N/A				
Quantity	N/A				
Accessibility	N/A				
MATERIAL RISK ASSESSMENT					
Product Type	Condition	Surface Treatment	Asbestos Type	Material Risk Score	Risk Category
N/A (0)	(0)	(0)	No Asbestos Detected (0) (0)	N/A	N/A
Comments:					
General Observations:					
Timber built structure with plasterboard cladding to internal walls and a timber base.

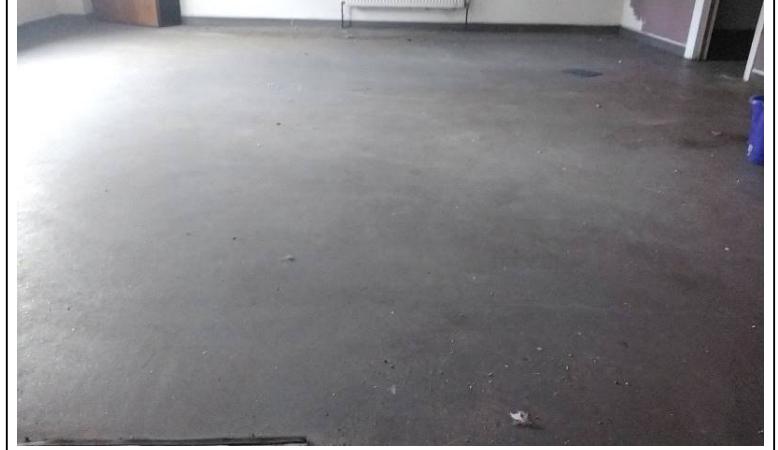
Report No	J043984	Site	Veterinary Clinic	Date	21 July 2023
Inspection No	58	Level of Identification:		No suspect materials found	
Description	Concrete identified below flooring				
Building	Veterinary Clinic

Floor	Ground Floor				
Room Area	Waiting room				
Position	N/A				
Quantity	N/A				
Accessibility	N/A				
MATERIAL RISK ASSESSMENT					
Product Type	Condition	Surface Treatment	Asbestos Type	Material Risk Score	Risk Category
N/A (0)	(0)	(0)	No Asbestos Detected (0) (0)	N/A	N/A
Comments:					
General Observations:					
Room consists of a suspended ceiling tile grid with Masonry and plasterboard walls and a concrete floor with modern vinyl

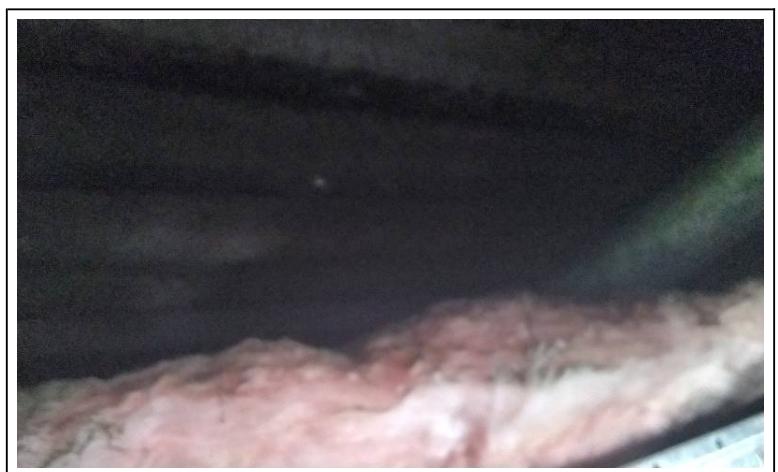
Report No	J043984	Site	Veterinary Clinic	Date	21 July 2023
Inspection No	59	Level of Identification:		No suspect materials found	
Description	Mmmf insulation identified within ceiling void				
Building	Veterinary Clinic

Floor	Ground Floor				
Room Area	Waiting room				
Position	N/A				
Quantity	N/A				
Accessibility	N/A				
MATERIAL RISK ASSESSMENT					
Product Type	Condition	Surface Treatment	Asbestos Type	Material Risk Score	Risk Category
N/A (0)	(0)	(0)	No Asbestos Detected (0) (0)	N/A	N/A
Comments:					
General Observations:					
Room consists of a suspended ceiling tile grid with Masonry and plasterboard walls and a concrete floor with modern vinyl

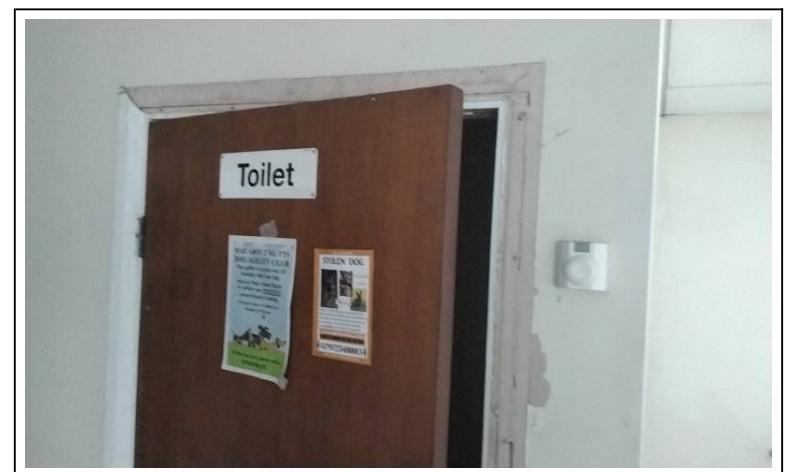
Report No	J043984	Site	Veterinary Clinic	Date	21 July 2023
Inspection No	60	Level of Identification:		No suspect materials found	
Description	Door frame inspection				
Building	Veterinary Clinic

Floor	Ground Floor				
Room Area	Waiting room				
Position	N/A				
Quantity	N/A				
Accessibility	N/A				
MATERIAL RISK ASSESSMENT					
Product Type	Condition	Surface Treatment	Asbestos Type	Material Risk Score	Risk Category
N/A (0)	(0)	(0)	No Asbestos Detected (0) (0)	N/A	N/A
Comments:					
General Observations:					
Room consists of a suspended ceiling tile grid with Masonry and plasterboard walls and a concrete floor with modern vinyl

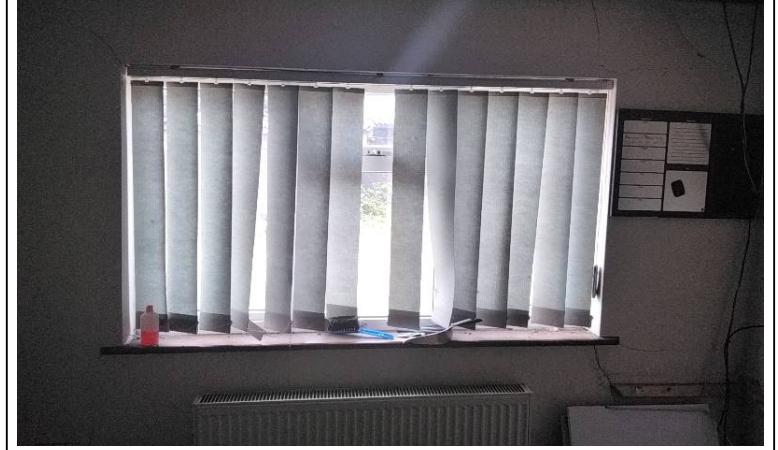
Report No	J043984	Site	Veterinary Clinic	Date	21 July 2023
Inspection No	61	Level of Identification:		No suspect materials found	
Description	Upvc window and frame with timber sill				
Building	Veterinary Clinic

Floor	Ground Floor				
Room Area	Waiting room				
Position	N/A				
Quantity	N/A				
Accessibility	N/A				
MATERIAL RISK ASSESSMENT					
Product Type	Condition	Surface Treatment	Asbestos Type	Material Risk Score	Risk Category
N/A (0)	(0)	(0)	No Asbestos Detected (0) (0)	N/A	N/A
Comments:					
General Observations:					
Room consists of a suspended ceiling tile grid with Masonry and plasterboard walls and a concrete floor with modern vinyl

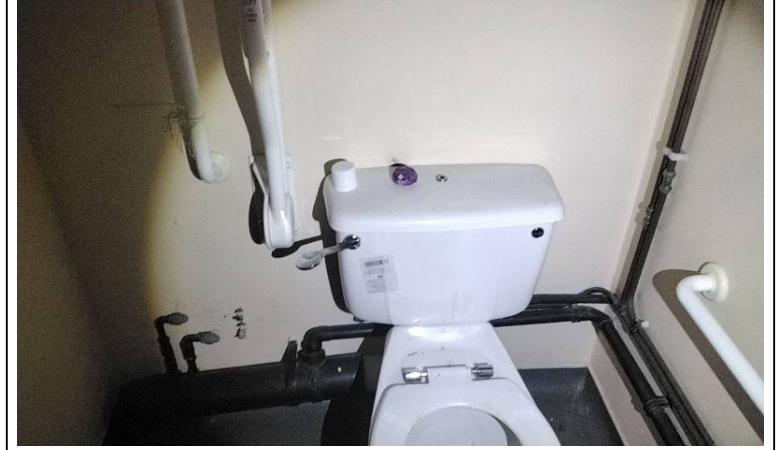
Report No	J043984	Site	Veterinary Clinic	Date	21 July 2023
Inspection No	62	Level of Identification:		No suspect materials found	
Description	Ceramic cistern				
Building	Veterinary Clinic

Floor	Ground Floor				
Room Area	WC				
Position	N/A				
Quantity	N/A				
Accessibility	N/A				
MATERIAL RISK ASSESSMENT					
Product Type	Condition	Surface Treatment	Asbestos Type	Material Risk Score	Risk Category
N/A (0)	(0)	(0)	No Asbestos Detected (0) (0)	N/A	N/A
Comments:					
General Observations:					
Room consists of a suspended ceiling tile grid with Masonry and plasterboard walls and a concrete floor with modern vinyl

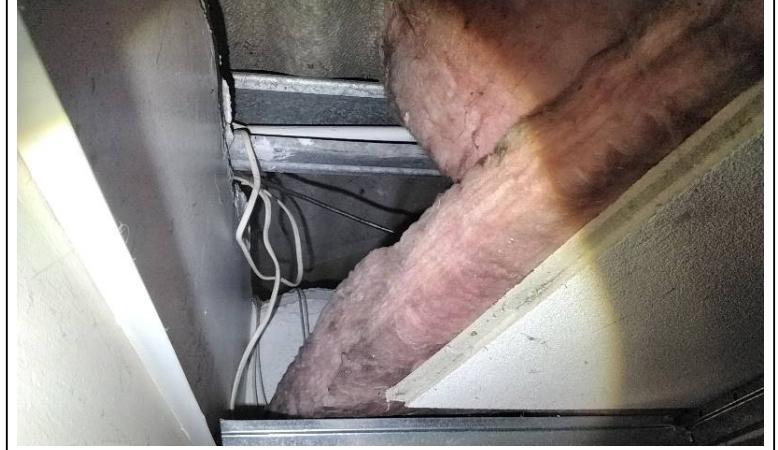
Report No	J043984	Site	Veterinary Clinic	Date	21 July 2023
Inspection No	63	Level of Identification:		No suspect materials found	
Description	Mmmf insulation above ceiling tiles.				
Building	Veterinary Clinic

Floor	Ground Floor				
Room Area	WC				
Position	N/A				
Quantity	N/A				
Accessibility	N/A				
MATERIAL RISK ASSESSMENT					
Product Type	Condition	Surface Treatment	Asbestos Type	Material Risk Score	Risk Category
N/A (0)	(0)	(0)	No Asbestos Detected (0) (0)	N/A	N/A
Comments:					
General Observations:					
Room consists of a suspended ceiling tile grid with Masonry and plasterboard walls and a concrete floor with modern vinyl

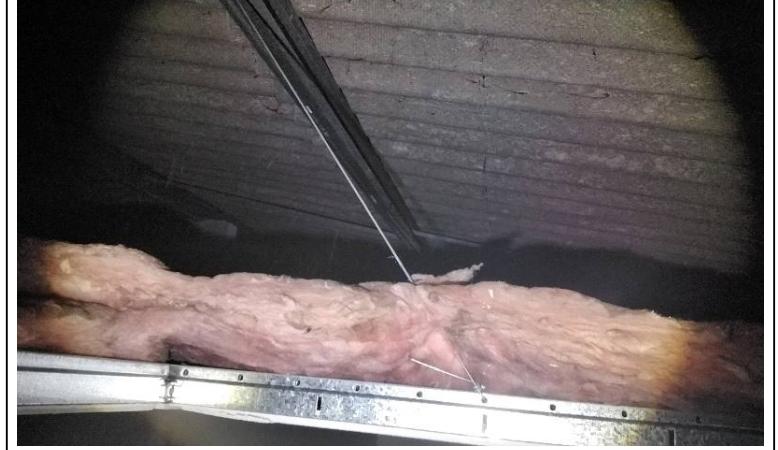
Report No	J043984	Site	Veterinary Clinic	Date	21 July 2023
Inspection No	65	Level of Identification:		No suspect materials found	
Description	Mmmf insulation above ceiling tiles.				
Building	Veterinary Clinic

Floor	Ground Floor				
Room Area	Room 1				
Position	N/A				
Quantity	N/A				
Accessibility	N/A				
MATERIAL RISK ASSESSMENT					
Product Type	Condition	Surface Treatment	Asbestos Type	Material Risk Score	Risk Category
N/A (0)	(0)	(0)	No Asbestos Detected (0) (0)	N/A	N/A
Comments:					
General Observations:					
Room consists of a suspended ceiling tile grid with Masonry and plasterboard walls and a concrete floor with modern vinyl

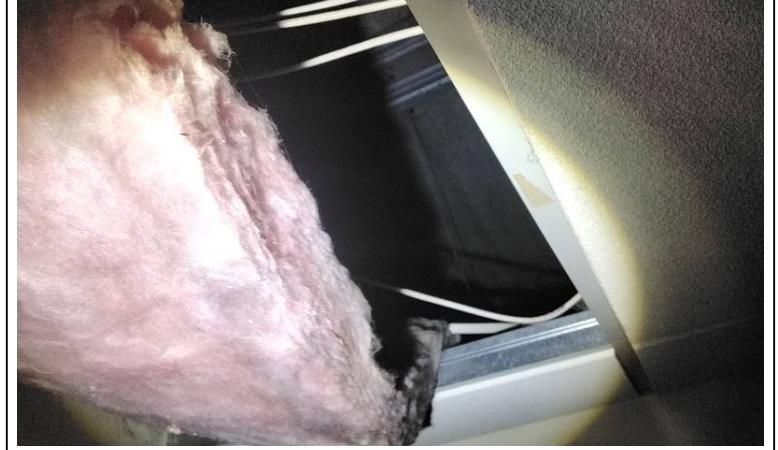
Report No	J043984	Site	Veterinary Clinic	Date	21 July 2023
Inspection No	66	Level of Identification:		No suspect materials found	
Description	Mmmf insulation above ceiling tiles.				
Building	Veterinary Clinic

Floor	Ground Floor				
Room Area	Room 2				
Position	N/A				
Quantity	N/A				
Accessibility	N/A				
MATERIAL RISK ASSESSMENT					
Product Type	Condition	Surface Treatment	Asbestos Type	Material Risk Score	Risk Category
N/A (0)	(0)	(0)	No Asbestos Detected (0) (0)	N/A	N/A
Comments:					
General Observations:					
Room consists of a suspended ceiling tile grid with Masonry and plasterboard walls and a concrete floor with modern vinyl

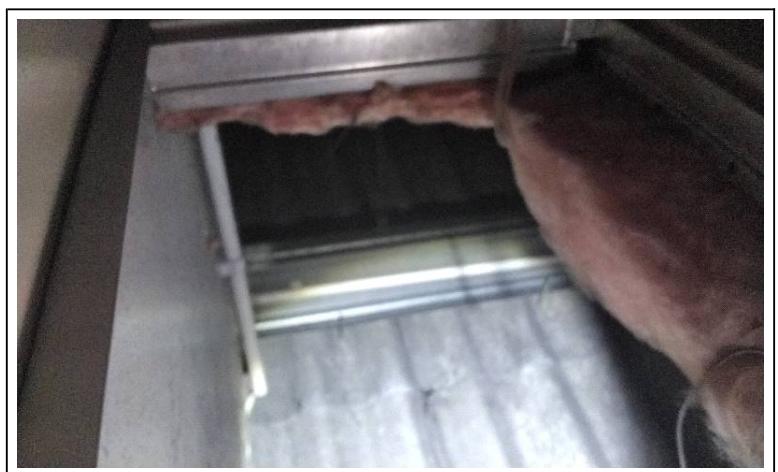
Report No	J043984	Site	Veterinary Clinic	Date	21 July 2023
Inspection No	68	Level of Identification:		No suspect materials found	
Description	Mmmf insulation above ceiling tiles.				
Building	Veterinary Clinic

Floor	Ground Floor				
Room Area	Room 4				
Position	N/A				
Quantity	N/A				
Accessibility	N/A				
MATERIAL RISK ASSESSMENT					
Product Type	Condition	Surface Treatment	Asbestos Type	Material Risk Score	Risk Category
N/A (0)	(0)	(0)	No Asbestos Detected (0) (0)	N/A	N/A
Comments:					
General Observations:					
Room consists of a suspended ceiling tile grid with Masonry and plasterboard walls and a concrete floor with modern vinyl

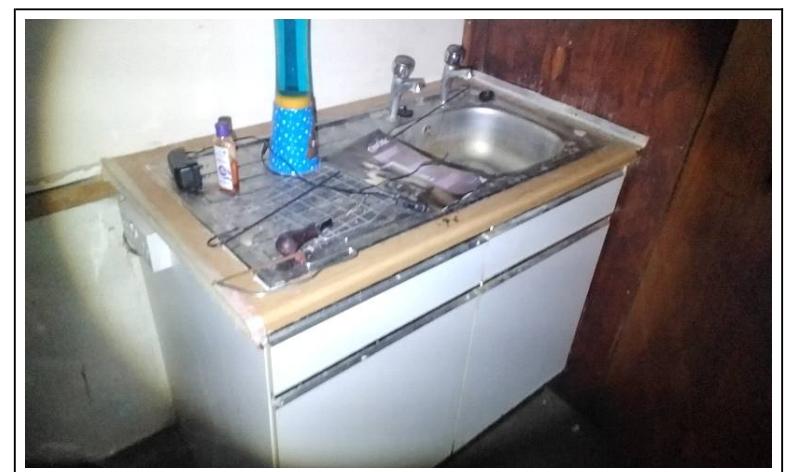
Report No	J043984	Site	Veterinary Clinic	Date	21 July 2023
Inspection No	69	Level of Identification:		No suspect materials found	
Description	Modern sink unit				
Building	Veterinary Clinic

Floor	Ground Floor				
Room Area	Room 4				
Position	N/A				
Quantity	N/A				
Accessibility	N/A				
MATERIAL RISK ASSESSMENT					
Product Type	Condition	Surface Treatment	Asbestos Type	Material Risk Score	Risk Category
N/A (0)	(0)	(0)	No Asbestos Detected (0) (0)	N/A	N/A
Comments:					
General Observations:					
Room consists of a suspended ceiling tile grid with Masonry and plasterboard walls and a concrete floor with modern vinyl

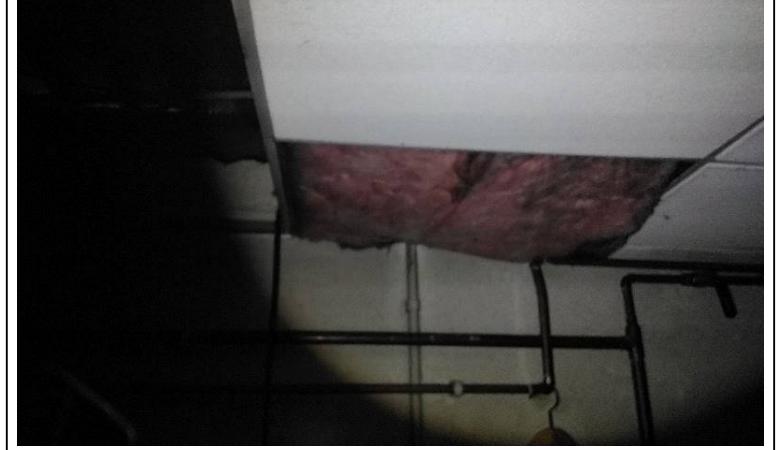
Report No	J043984	Site	Veterinary Clinic	Date	21 July 2023
Inspection No	70	Level of Identification:		No suspect materials found	
Description	Mmmf insulation above ceiling tiles.				
Building	Veterinary Clinic

Floor	Ground Floor				
Room Area	Boiler room				
Position	N/A				
Quantity	N/A				
Accessibility	N/A				
MATERIAL RISK ASSESSMENT					
Product Type	Condition	Surface Treatment	Asbestos Type	Material Risk Score	Risk Category
N/A (0)	(0)	(0)	No Asbestos Detected (0) (0)	N/A	N/A
Comments:					
General Observations:					
Room consists of a suspended ceiling tile grid with Masonry and plasterboard walls and a concrete floor with modern vinyl

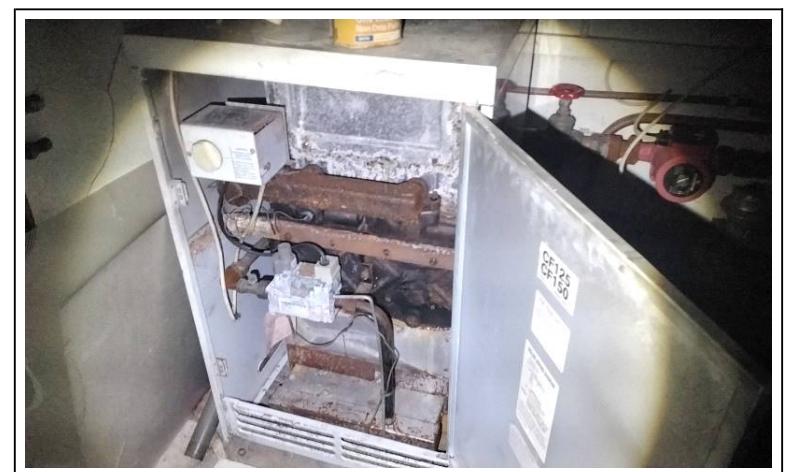
Report No	J043984	Site	Veterinary Clinic	Date	21 July 2023
Inspection No	71	Level of Identification:		No suspect materials found	
Description	Modern potterton boiler.				
Building	Veterinary Clinic

Floor	Ground Floor				
Room Area	Boiler room				
Position	N/A				
Quantity	N/A				
Accessibility	N/A				
MATERIAL RISK ASSESSMENT					
Product Type	Condition	Surface Treatment	Asbestos Type	Material Risk Score	Risk Category
N/A (0)	(0)	(0)	No Asbestos Detected (0) (0)	N/A	N/A
Comments:					
General Observations:					
Room consists of a suspended ceiling tile grid with Masonry and plasterboard walls and a concrete floor with modern vinyl

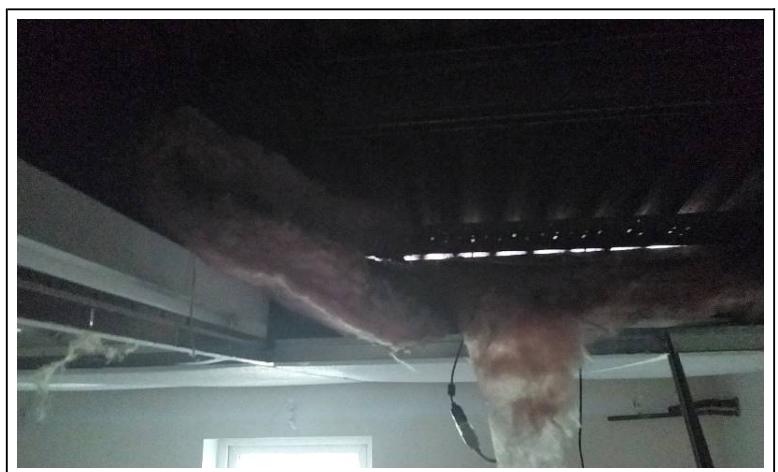
Report No	J043984	Site	Veterinary Clinic	Date	21 July 2023
Inspection No	72	Level of Identification:		No suspect materials found	
Description	Mmmf insulation above ceiling tiles.				
Building	Veterinary Clinic

Floor	Ground Floor				
Room Area	Room 5				
Position	N/A				
Quantity	N/A				
Accessibility	N/A				
MATERIAL RISK ASSESSMENT					
Product Type	Condition	Surface Treatment	Asbestos Type	Material Risk Score	Risk Category
N/A (0)	(0)	(0)	No Asbestos Detected (0) (0)	N/A	N/A
Comments:					
General Observations:					
Room consists of a suspended ceiling tile grid with Masonry and plasterboard walls and a concrete floor with modern vinyl

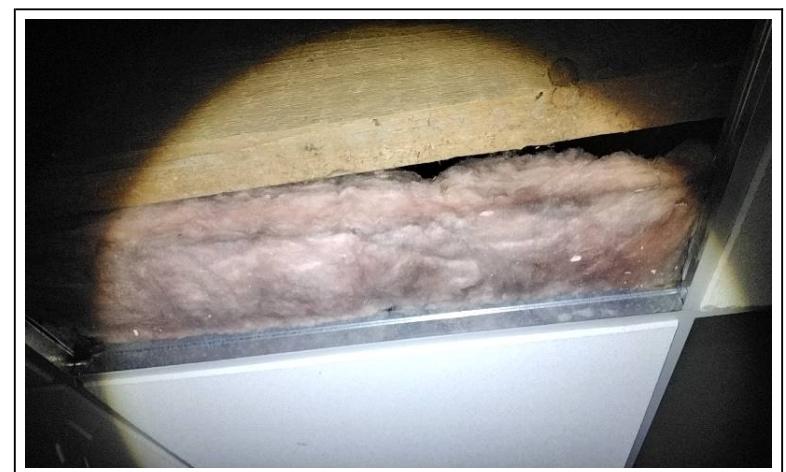
Report No	J043984	Site	Veterinary Clinic	Date	21 July 2023
Inspection No	74	Level of Identification:		No suspect materials found	
Description	Mmmf insulation above ceiling tiles.				
Building	Veterinary Clinic

Floor	Ground Floor				
Room Area	Room 7				
Position	N/A				
Quantity	N/A				
Accessibility	N/A				
MATERIAL RISK ASSESSMENT					
Product Type	Condition	Surface Treatment	Asbestos Type	Material Risk Score	Risk Category
N/A (0)	(0)	(0)	No Asbestos Detected (0) (0)	N/A	N/A
Comments:					
General Observations:					
Room consists of a suspended ceiling tile grid with Masonry and plasterboard walls and a concrete floor with modern vinyl

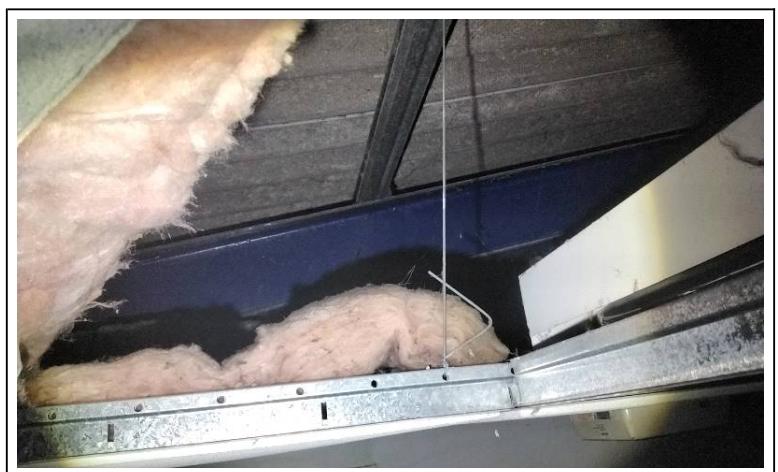
Report No	J043984	Site	Veterinary Clinic	Date	21 July 2023
Inspection No	75	Level of Identification:		No suspect materials found	
Description	Mmmf insulation above ceiling tiles.				
Building	Veterinary Clinic

Floor	Ground Floor				
Room Area	Room 8				
Position	N/A				
Quantity	N/A				
Accessibility	N/A				
MATERIAL RISK ASSESSMENT					
Product Type	Condition	Surface Treatment	Asbestos Type	Material Risk Score	Risk Category
N/A (0)	(0)	(0)	No Asbestos Detected (0) (0)	N/A	N/A
Comments:					
General Observations:					
Room consists of a suspended ceiling tile grid with Masonry and plasterboard walls and a concrete floor with modern vinyl

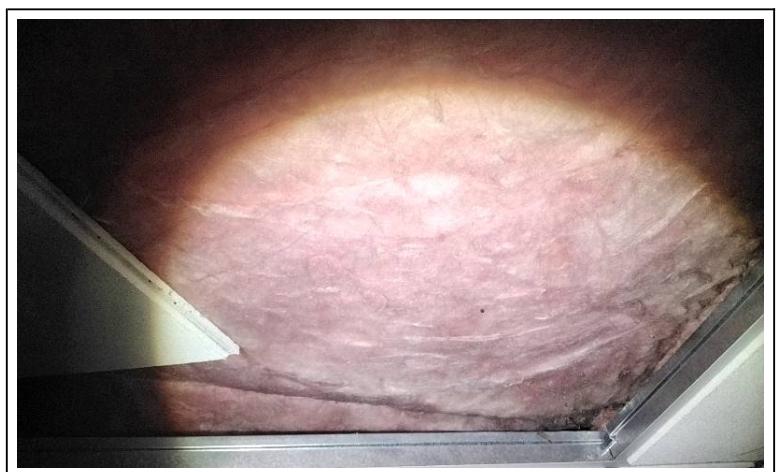
Report No	J043984	Site	Veterinary Clinic	Date	21 July 2023
Inspection No	77	Level of Identification:		No suspect materials found	
Description	Mmmf insulation above ceiling tiles.				
Building	Veterinary Clinic

Floor	Ground Floor				
Room Area	Room 10				
Position	N/A				
Quantity	N/A				
Accessibility	N/A				
MATERIAL RISK ASSESSMENT					
Product Type	Condition	Surface Treatment	Asbestos Type	Material Risk Score	Risk Category
N/A (0)	(0)	(0)	No Asbestos Detected (0) (0)	N/A	N/A
Comments:					
General Observations:					
Room consists of a suspended ceiling tile grid with Masonry and plasterboard walls and a concrete floor with modern vinyl

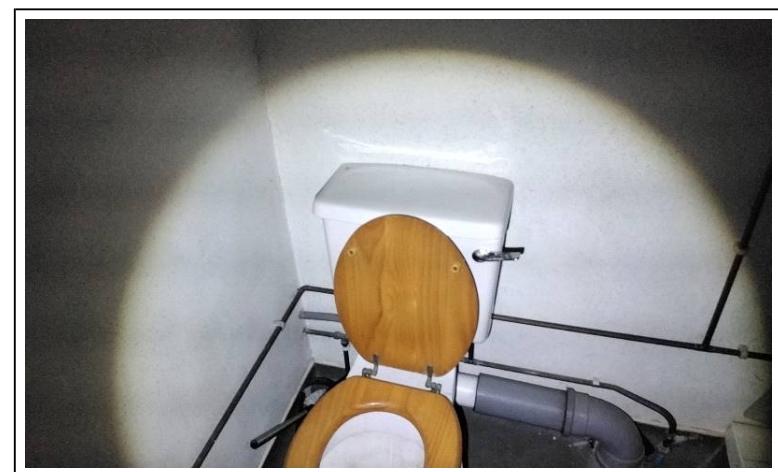
Report No	J043984	Site	Veterinary Clinic	Date	21 July 2023
Inspection No	78	Level of Identification:		No suspect materials found	
Description	Ceramic cistern				
Building	Veterinary Clinic

Floor	Ground Floor				
Room Area	WC2				
Position	N/A				
Quantity	N/A				
Accessibility	N/A				
MATERIAL RISK ASSESSMENT					
Product Type	Condition	Surface Treatment	Asbestos Type	Material Risk Score	Risk Category
N/A (0)	(0)	(0)	No Asbestos Detected (0) (0)	N/A	N/A
Comments:					
General Observations:					
Room consists of a suspended ceiling tile grid with Masonry and plasterboard walls and a concrete floor with modern vinyl

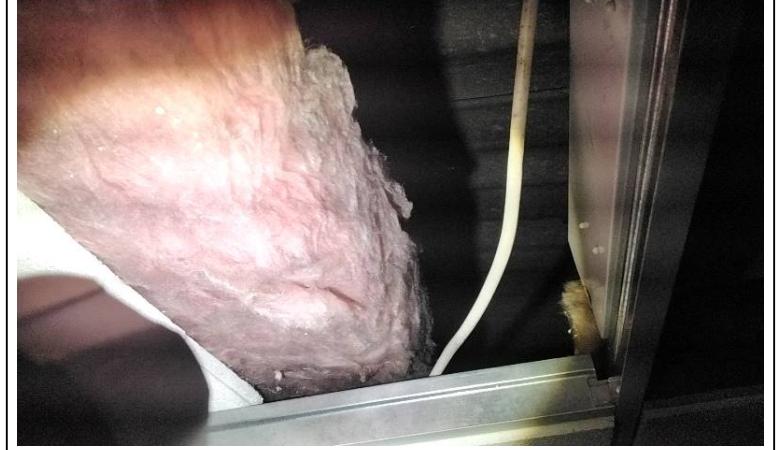
Report No	J043984	Site	Veterinary Clinic	Date	21 July 2023
Inspection No	79	Level of Identification:		No suspect materials found	
Description	Mmmf insulation above ceiling tiles.				
Building	Veterinary Clinic

Floor	Ground Floor				
Room Area	WC2				
Position	N/A				
Quantity	N/A				
Accessibility	N/A				
MATERIAL RISK ASSESSMENT					
Product Type	Condition	Surface Treatment	Asbestos Type	Material Risk Score	Risk Category
N/A (0)	(0)	(0)	No Asbestos Detected (0) (0)	N/A	N/A
Comments:					
General Observations:					
Room consists of a suspended ceiling tile grid with Masonry and plasterboard walls and a concrete floor with modern vinyl

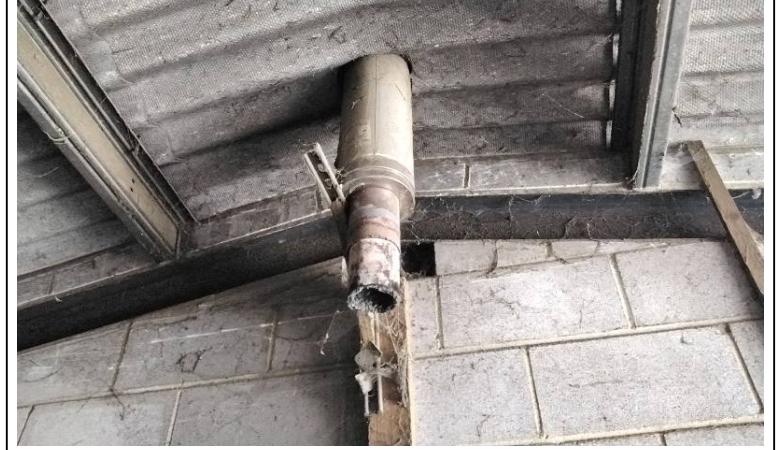
Report No	J043984	Site	Veterinary Clinic	Date	21 July 2023
Inspection No	82	Level of Identification:		No suspect materials found	
Description	Metal flue pipe				
Building	Veterinary Clinic

Floor	Ground Floor				
Room Area	Store				
Position	N/A				
Quantity	N/A				
Accessibility	N/A				
MATERIAL RISK ASSESSMENT					
Product Type	Condition	Surface Treatment	Asbestos Type	Material Risk Score	Risk Category
N/A (0)	(0)	(0)	No Asbestos Detected (0) (0)	N/A	N/A
Comments:					
General Observations:					
Area consists of a corrugated cement sheet roof with masonry walls and a concrete floor.

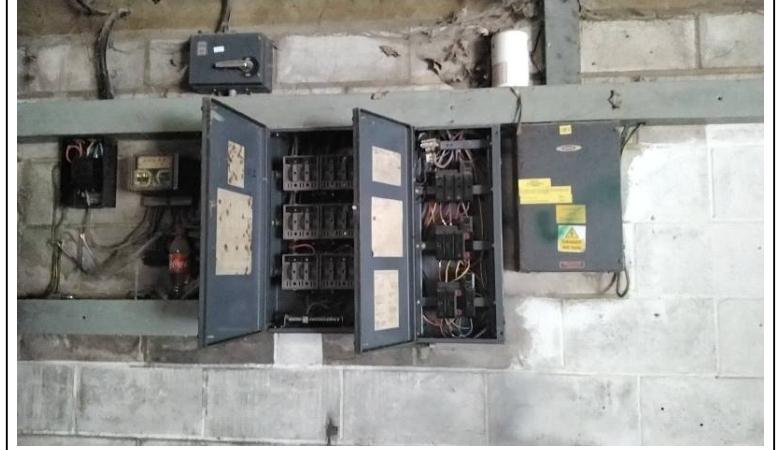
Report No	J043984	Site	Veterinary Clinic	Date	21 July 2023
Inspection No	83	Level of Identification:		No suspect materials found	
Description	Modern fuse board.				
Building	Veterinary Clinic

Floor	Ground Floor				
Room Area	Store				
Position	N/A				
Quantity	N/A				
Accessibility	N/A				
MATERIAL RISK ASSESSMENT					
Product Type	Condition	Surface Treatment	Asbestos Type	Material Risk Score	Risk Category
N/A (0)	(0)	(0)	No Asbestos Detected (0) (0)	N/A	N/A
Comments:					
General Observations:					
Area consists of a corrugated cement sheet roof with masonry walls and a concrete floor.

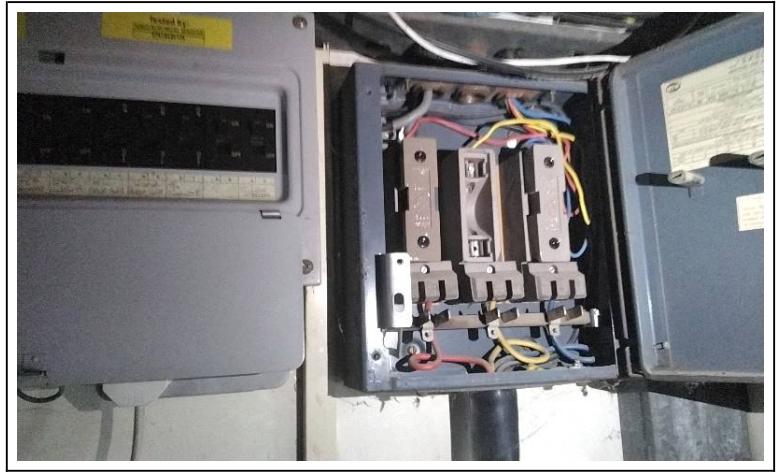
Report No	J043984	Site	Two storey storage unit	Date	21 July 2023
Inspection No	88	Level of Identification:		Sampled DJ000659	
Description	Flash guards				
Building	Two storey storage unit

Floor	Ground Floor				
Room Area	Office				
Position	Within switch box				
Quantity	3no.				
Accessibility	Usually inaccessible or unlikely to be Disturbed				
MATERIAL RISK ASSESSMENT					
Product Type	Condition	Surface Treatment	Asbestos Type	Material Risk Score	Risk Category
Asbestos Textiles/Paper (2)	(0)	(1)	Chrysotile (1)	4	Very Low
Comments:					
General Observations:					
Room consists of a high level timber ceiling with Masonry walls and a concrete floor. Timber windows and frames. Timber door and frame.
