REFURBISHMENT SURVEY

Site Name: Bungalow , London meat company , Sheds, Two storey storage unit, Veterinary Clinic

Site address: The Elms, 371A High Street, Harlington, Hayes, Greater London, UB3 5DQ

Report Ref: J043984

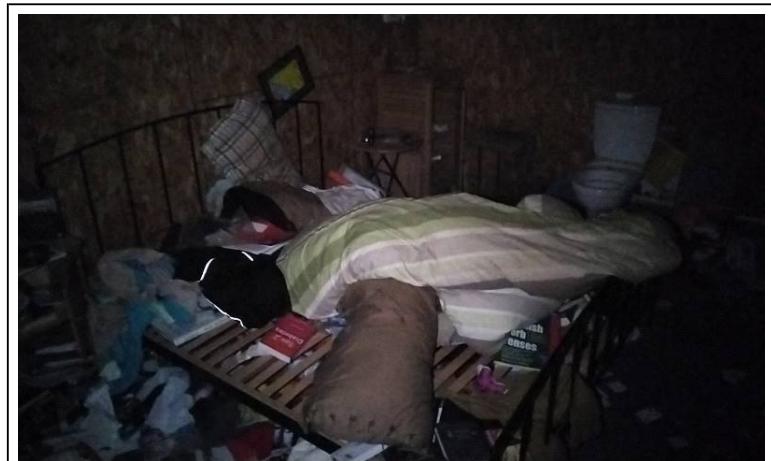
Report No	J043984	Site	Two storey storage unit	Date	21 July 2023
Inspection No	93	Level of Identification:		No suspect materials found	
Description	No suspect materials found				
Building	Two storey storage unit				
Floor	1st Floor				
Room Area	Storage 4				
Position	N/A				
Quantity	N/A				
Accessibility	N/A

Timber panelled roof, walls and floor.

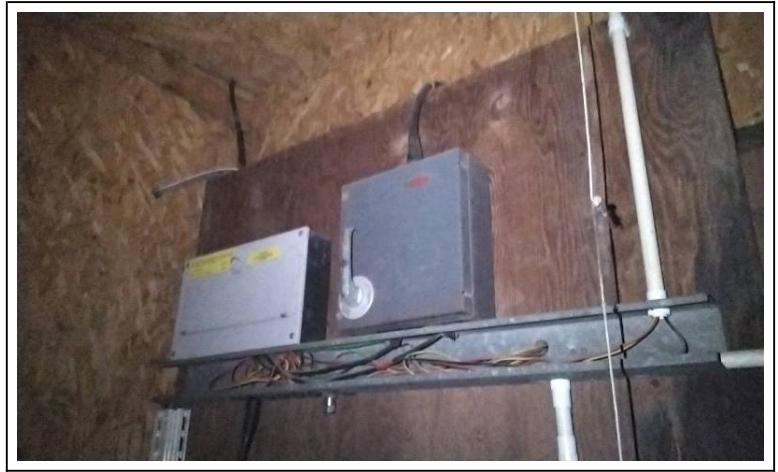
Report No	J043984	Site	Two storey storage unit	Date	21 July 2023
Inspection No	97	Level of Identification:		Strongly Presumed As DJ000659	
Description	Flash guards				
Building	Two storey storage unit

Floor	Ground Floor				
Room Area	Store 6				
Position	Within switch box				
Quantity	3no.				
Accessibility	Usually inaccessible or unlikely to be Disturbed				
MATERIAL RISK ASSESSMENT					
Product Type	Condition	Surface Treatment	Asbestos Type	Material Risk Score	Risk Category
Asbestos Textiles/Paper (2)	(0)	(1)	Chrysotile (1)	4	Very Low
Comments:					
General Observations:					
Room consists of a high level timber ceiling with Masonry walls and a concrete floor. Timber windows and frames. Timber door and frame.

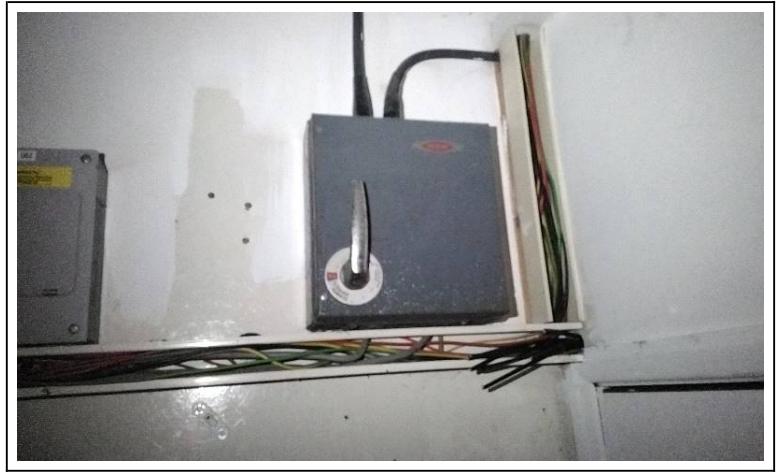
Report No	J043984	Site	Two storey storage unit	Date	21 July 2023
Inspection No	98	Level of Identification:		Strongly Presumed As DJ000659	
Description	Flash guards				
Building	Two storey storage unit

Floor	Ground Floor				
Room Area	Store 7				
Position	Within switch box				
Quantity	3no.				
Accessibility	Usually inaccessible or unlikely to be Disturbed				
MATERIAL RISK ASSESSMENT					
Product Type	Condition	Surface Treatment	Asbestos Type	Material Risk Score	Risk Category
Asbestos Textiles/Paper (2)	(0)	(1)	Chrysotile (1)	4	Very Low
Comments:					
General Observations:					
Room consists of a high level timber ceiling with Masonry walls and a concrete floor. Timber windows and frames. Timber door and frame.

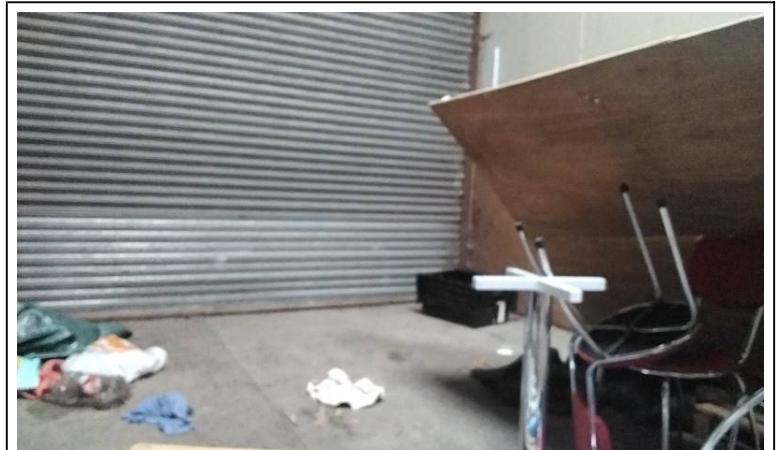
Report No	J043984	Site	Two storey storage unit	Date	21 July 2023					
Inspection No	100	Level of Identification:		No suspect materials found						
Description	No suspect materials found									
Building	Two storey storage unit

Floor	Ground Floor									
Room Area	store 8									
Position	N/A									
Quantity	N/A									
Accessibility	N/A

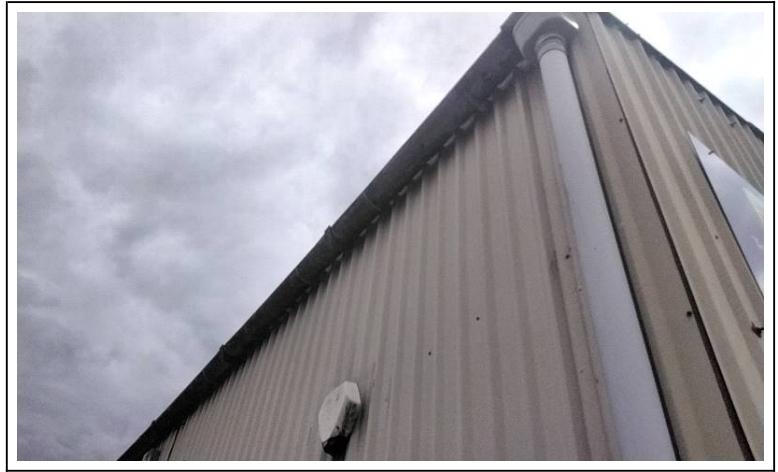
Report No	J043984	Site	Two storey storage unit	Date	21 July 2023
Inspection No	101	Level of Identification:		Sampled DJ000660	
Description	Guttering				
Building	Two storey storage unit

Floor	External				
Room Area	External				
Position	Cement				
Quantity	80lm				
Accessibility	Usually inaccessible or unlikely to be Disturbed				
MATERIAL RISK ASSESSMENT					
Product Type	Condition	Surface Treatment	Asbestos Type	Material Risk Score	Risk Category
Asbestos Cement (1)	(0)	(1)	Chrysotile (1)	3	Very Low
Comments: Present to both sides of building					
General Observations: Brick and metal cladded building. Timber windows and frames, timber doors and frames. Cement guttering,

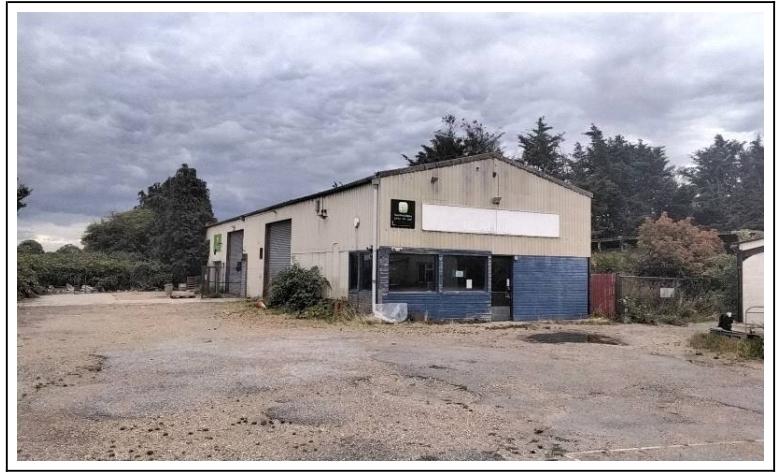
Report No	J043984	Site	Two storey storage unit	Date	21 July 2023
Inspection No	102	Level of Identification:		Strongly Presumed As DJ000656	
Description	Corrugated cement sheets				
Building	Two storey storage unit

Floor	External				
Room Area	External				
Position	Roof				
Quantity	350m ²				
Accessibility	Usually inaccessible or unlikely to be Disturbed				
MATERIAL RISK ASSESSMENT					
Product Type	Condition	Surface Treatment	Asbestos Type	Material Risk Score	Risk Category
Asbestos Cement (1)	(0)	(1)	Chrysotile (1)	3	Very Low
Comments:					
General Observations:					
Brick and metal cladded building. Timber windows and frames, timber doors and frames. Cement guttering,
