Site Investigation Report

145212.1.USI

Auger were commissioned by - to undertake a site investigation and CCTV inspection of the underground drainage within the area of concern (AOC) at the property.

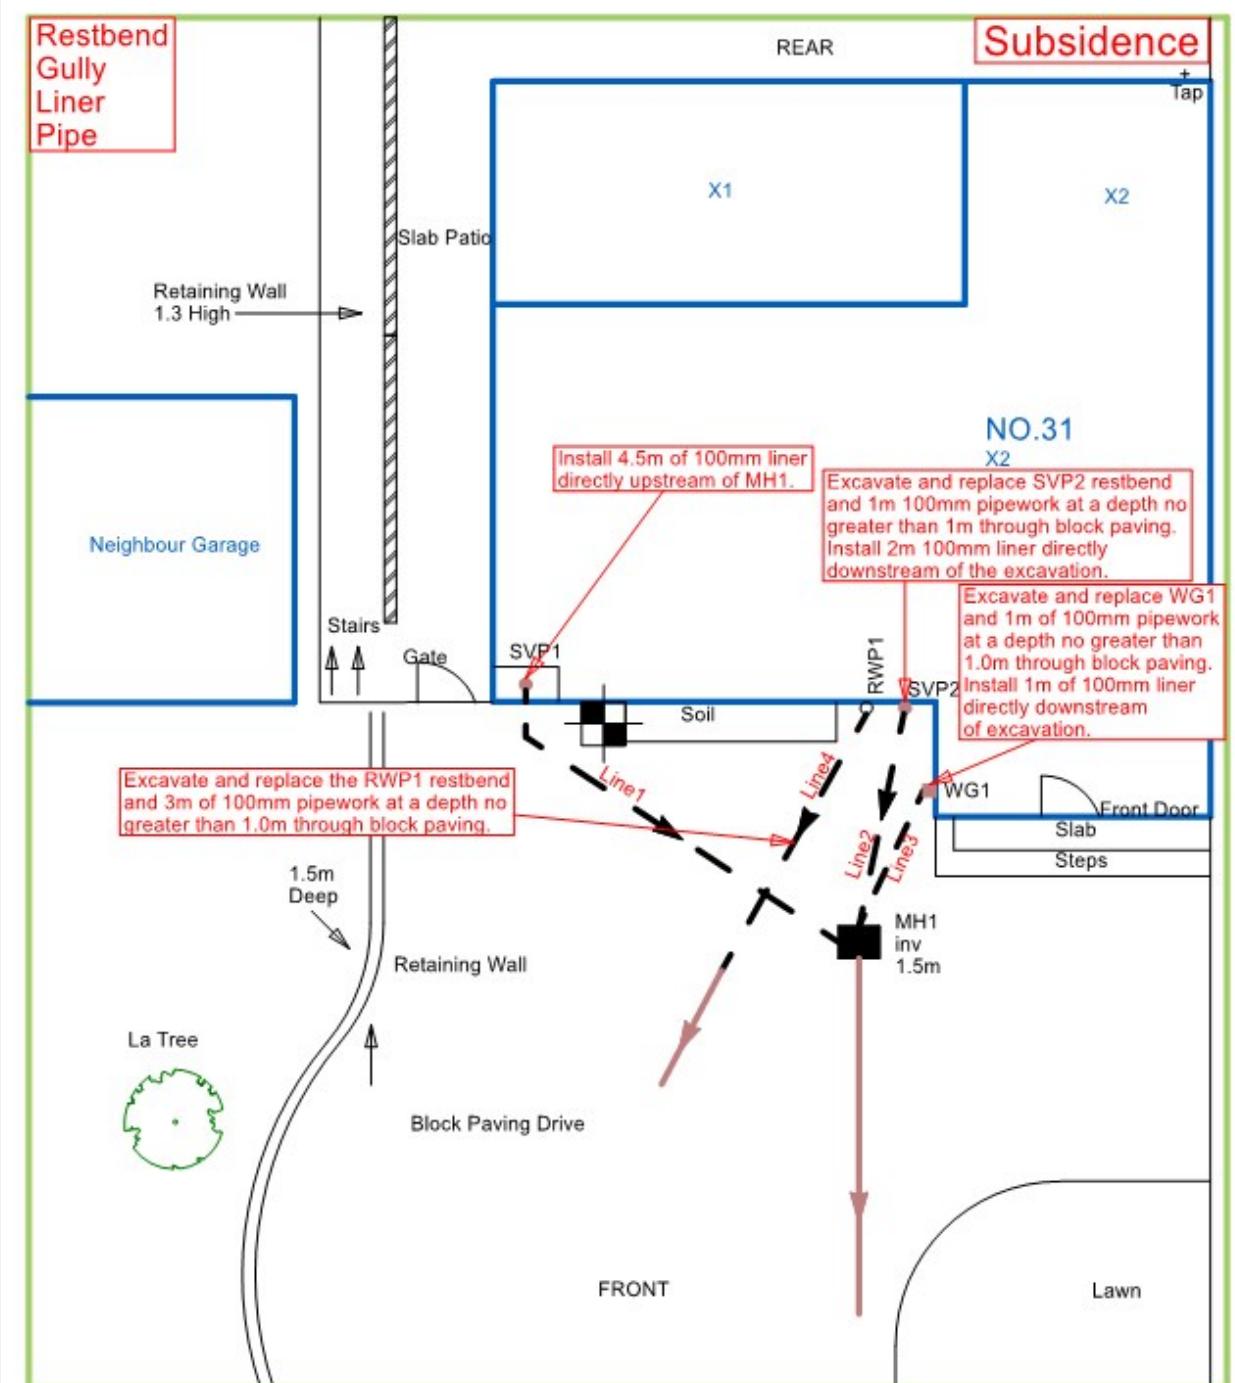
Our survey of line 1 revealed root ingress at 0.6m and cracking at 4.1m.

Our survey of line 2 revealed root ingress at 1m and 3.8m and joint displacements at 1.5m, 2m 2.5m and 3m.

Our survey of line 3 revealed joint displacements at 2m and cracking at 1m.

Our survey of line 4 revealed root ingress through the pipe.

The above mentioned defects to the below ground drainage system have been caused by ground movement.

Refer Back to Client	<p>It is recommended that the following repairs are carried out to prevent an escape of water from the system:</p> <p>Line 1 Install 4.5m of 100mm liner directly upstream of MH1.</p> <p>Line 2 Excavate and replace SVP2 restbend and 1m 100mm pipework at a depth no greater than 1m through block paving. Install 2m 100mm liner directly downstream of the excavation.</p> <p>Line 3 Excavate and replace WG1 and 1m of 100mm pipework at a depth no greater than 1.0m through block paving. Install 1m of 100mm liner directly downstream of excavation.</p> <p>Line 4 Excavate and replace the RWP1 restbend and 3m of 100mm pipework at a depth no greater than 1.0m through block paving.</p> <p>Auger have not allowed or will not be held responsible for any alteration or modification to the above ground drainage following the removal of the existing gully and reinstatement of a new gully. The customer must ensure that the above ground drainage correctly expels into the gully pot and avoids overcrowding the gully with numerous downpipes which could lead to the gully overflowing.</p> <p>During the clean-up/reinstatement process we will endeavour to leave the area we are working in clean and tidy and as close to how we found it as possible. There will always be an element of general debris/mud/waste that will build up in the area which cannot be prevented. There may however be elements of this process that are outside our remit i.e., Repainting or cleaning. If this is the case, then we will need to speak to the customer's insurer to help in this regard.</p> <p>We will now refer the claim back to the client in order to progress the claim.</p>
