Site Investigation Report

145212.1.USI

Auger were commissioned by - to undertake a site investigation and CCTV inspection of the underground drainage within the area of concern (AOC) at the property.

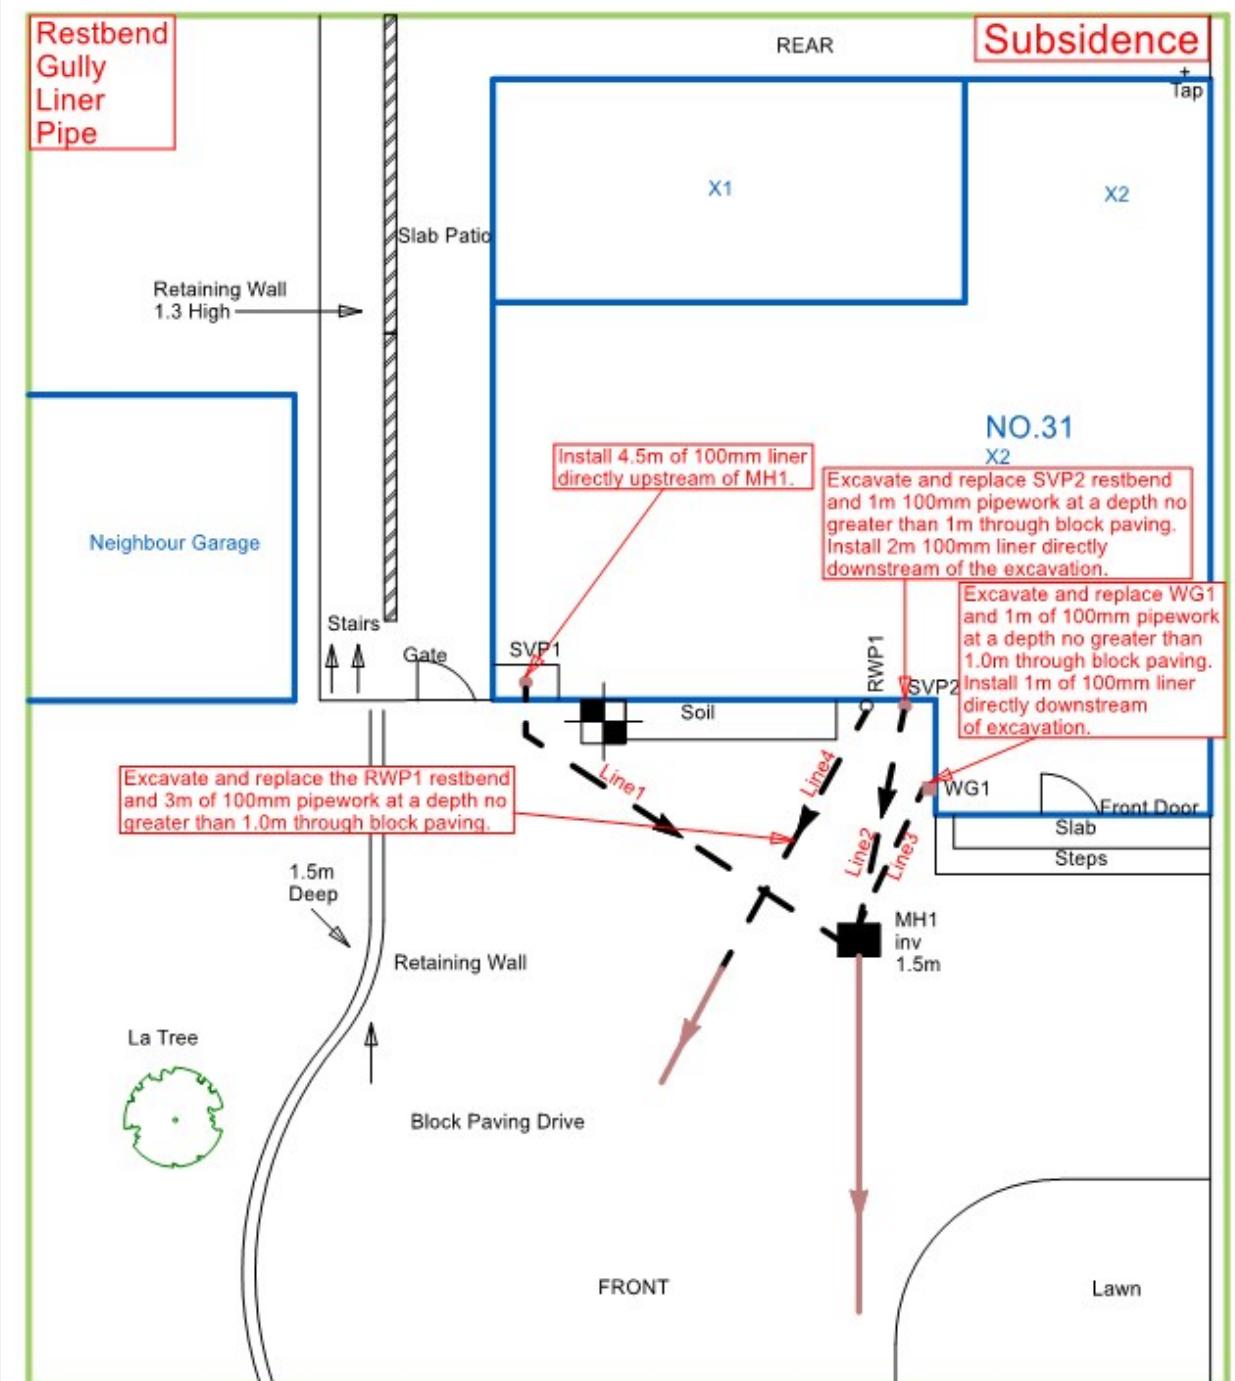
Line 1 - From MH1 upstream to SVP1

Our survey of line 1 revealed root ingress at 0.6m and cracking at 4.1m.

Line 2 - From MH1 upstream to SVP2

Our survey of line 2 revealed root ingress at 1m and 3.8m and joint displacements at 1.5m, 2m 2.5m and 3m.

Line 3 - From MH1 upstream to WG1

Our survey of line 3 revealed joint displacements at 2m and cracking at 1m.

Line 4 - From RWP1 downstream to Out of AOC

Our survey of line 4 revealed root ingress through the pipe.

The above mentioned defects to the below ground drainage system have been caused by ground movement.

Refer Back to Client	<p>It is recommended that the following repairs are carried out to prevent an escape of water from the system:</p> <p>Line 1 Install 4.5m of 100mm liner directly upstream of MH1.</p> <p>Line 2 Excavate and replace SVP2 restbend and 1m 100mm pipework at a depth no greater than 1m through block paving. Install 2m 100mm liner directly downstream of the excavation.</p> <p>Line 3 Excavate and replace WG1 and 1m of 100mm pipework at a depth no greater than 1.0m through block paving. Install 1m of 100mm liner directly downstream of excavation.</p> <p>Line 4 Excavate and replace the RWP1 restbend and 3m of 100mm pipework at a depth no greater than 1.0m through block paving.</p> <p>Auger have not allowed or will not be held responsible for any alteration or modification to the above ground drainage following the removal of the existing gully and reinstatement of a new gully. The customer must ensure that the above ground drainage correctly expels into the gully pot and avoids overcrowding the gully with numerous downpipes which could lead to the gully overflowing.</p> <p>During the clean-up/reinstatement process we will endeavour to leave the area we are working in clean and tidy and as close to how we found it as possible. There will always be an element of general debris/mud/waste that will build up in the area which cannot be prevented. There may however be elements of this process that are outside our remit i.e., Repainting or cleaning. If this is the case, then we will need to speak to the customer's insurer to help in this regard.</p> <p>We will now refer the claim back to the client in order to progress the claim.</p>
