Arboricultural Consultancy for Methodist Insurance Plc

Insured	Harrow & Hillingdon Methodist Circuit	Address	19 Mount Pleasant, ruislip, middlesex, HA4 9HG		
Client	Subsidence Management Services	Contact	Alun Dwyer	Claim No.	IFS-MET-SUB-22-0104780
ES Ref	SA-251876	Consultant	Keith Burgess	Contact No.	0330 380 1036
Report Date	27/01/2023

GEOTECHNICAL

19 Mount Pleasant, Ruislip, Middlesex, HA4 9HG

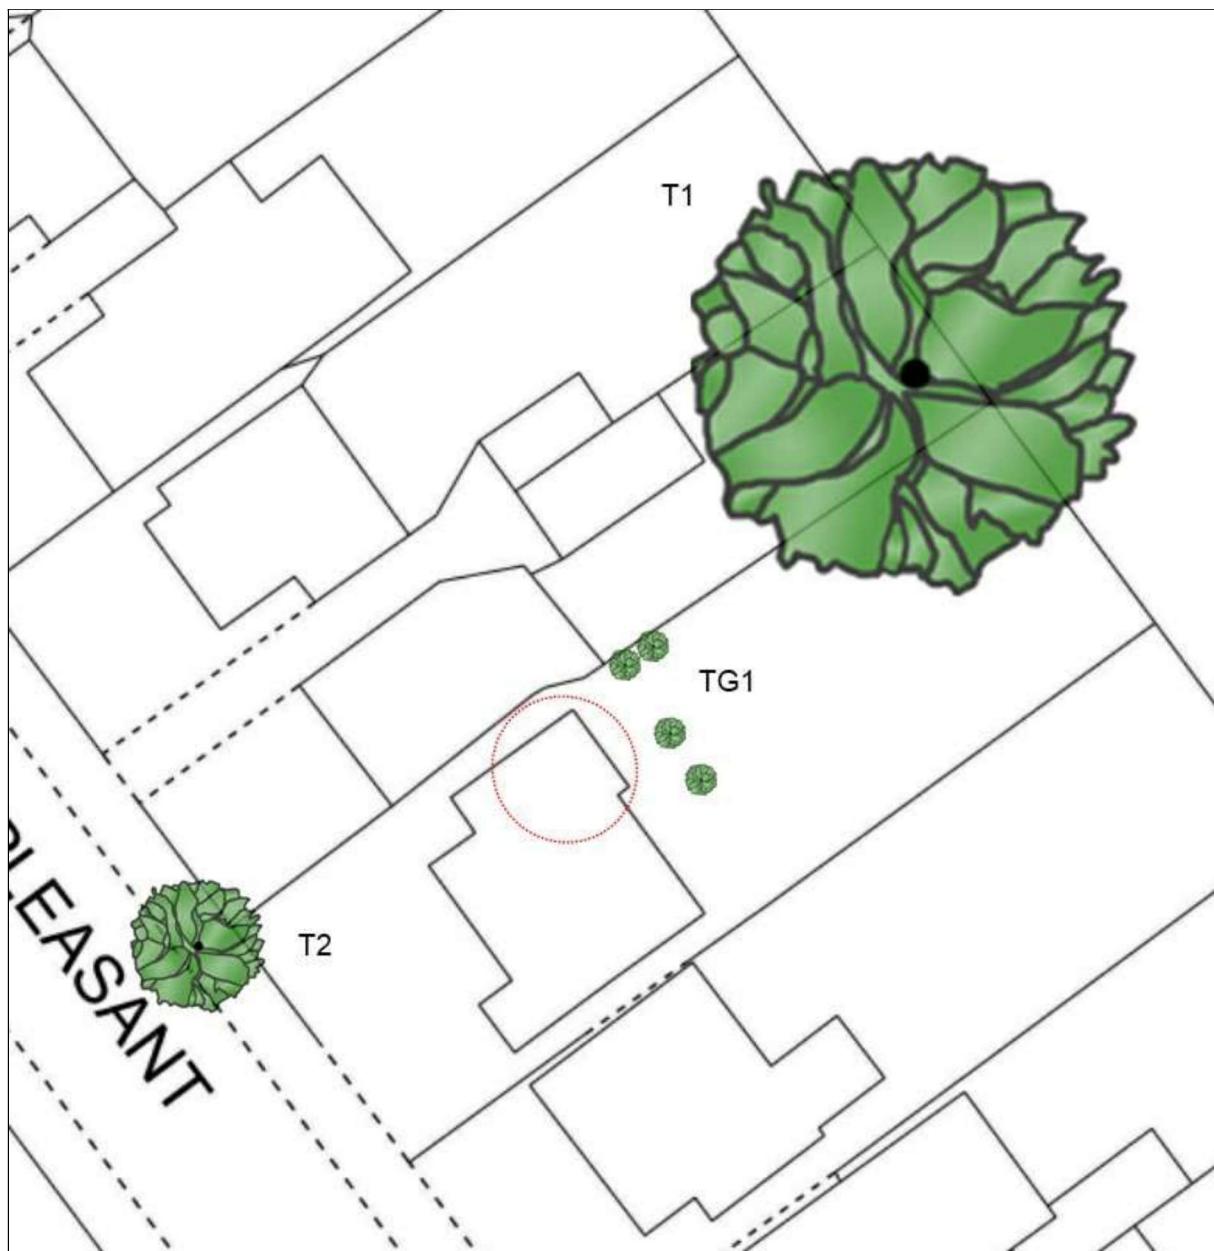
7. Site Plan

We have been advised that the current damage relates to the rear left-hand corner of the insured dwelling, where cracking indicates downwards movement.

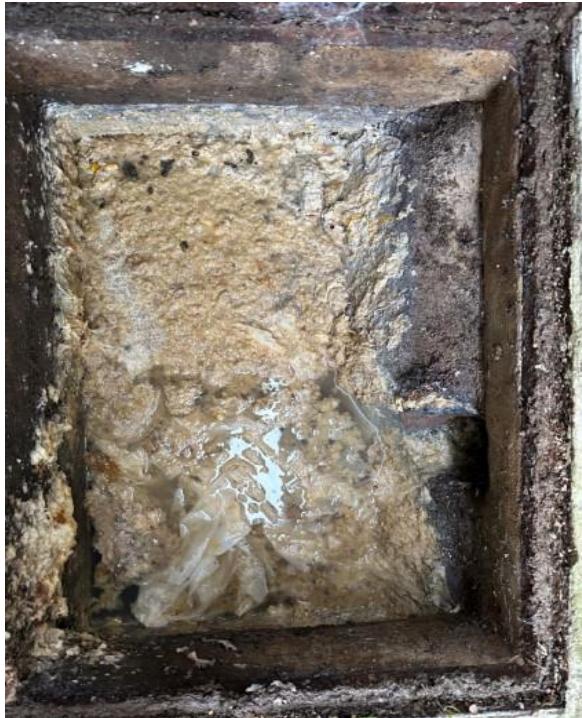
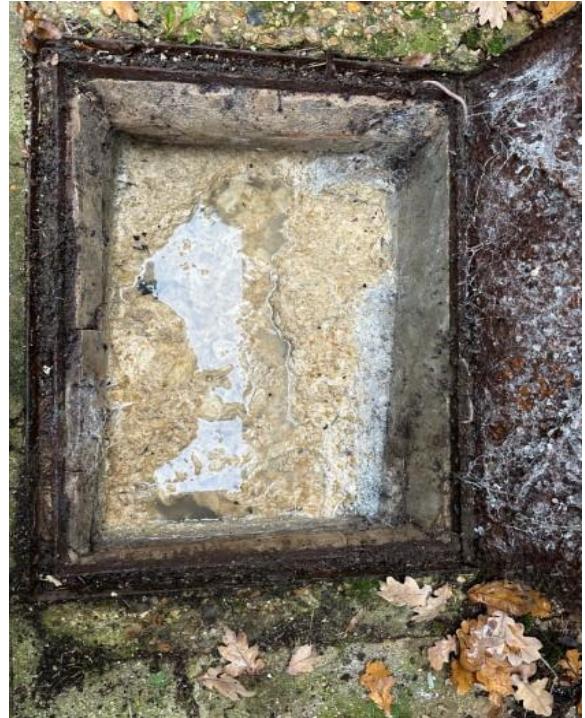
We attended site to conduct a CCTV survey of the underground drainage within the area of concern and found two manholes blocked.

We would therefore recommend that the local water authority attend and resolve the issue before re-attending to survey any private drainage within the area of concern.
