# BS5837 Arboricultural Impact Assessment & Method Statement

18 Harvil Road, Ickenham, Uxbridge, UB10 8AJ

Client: Multi Creation

July 2023

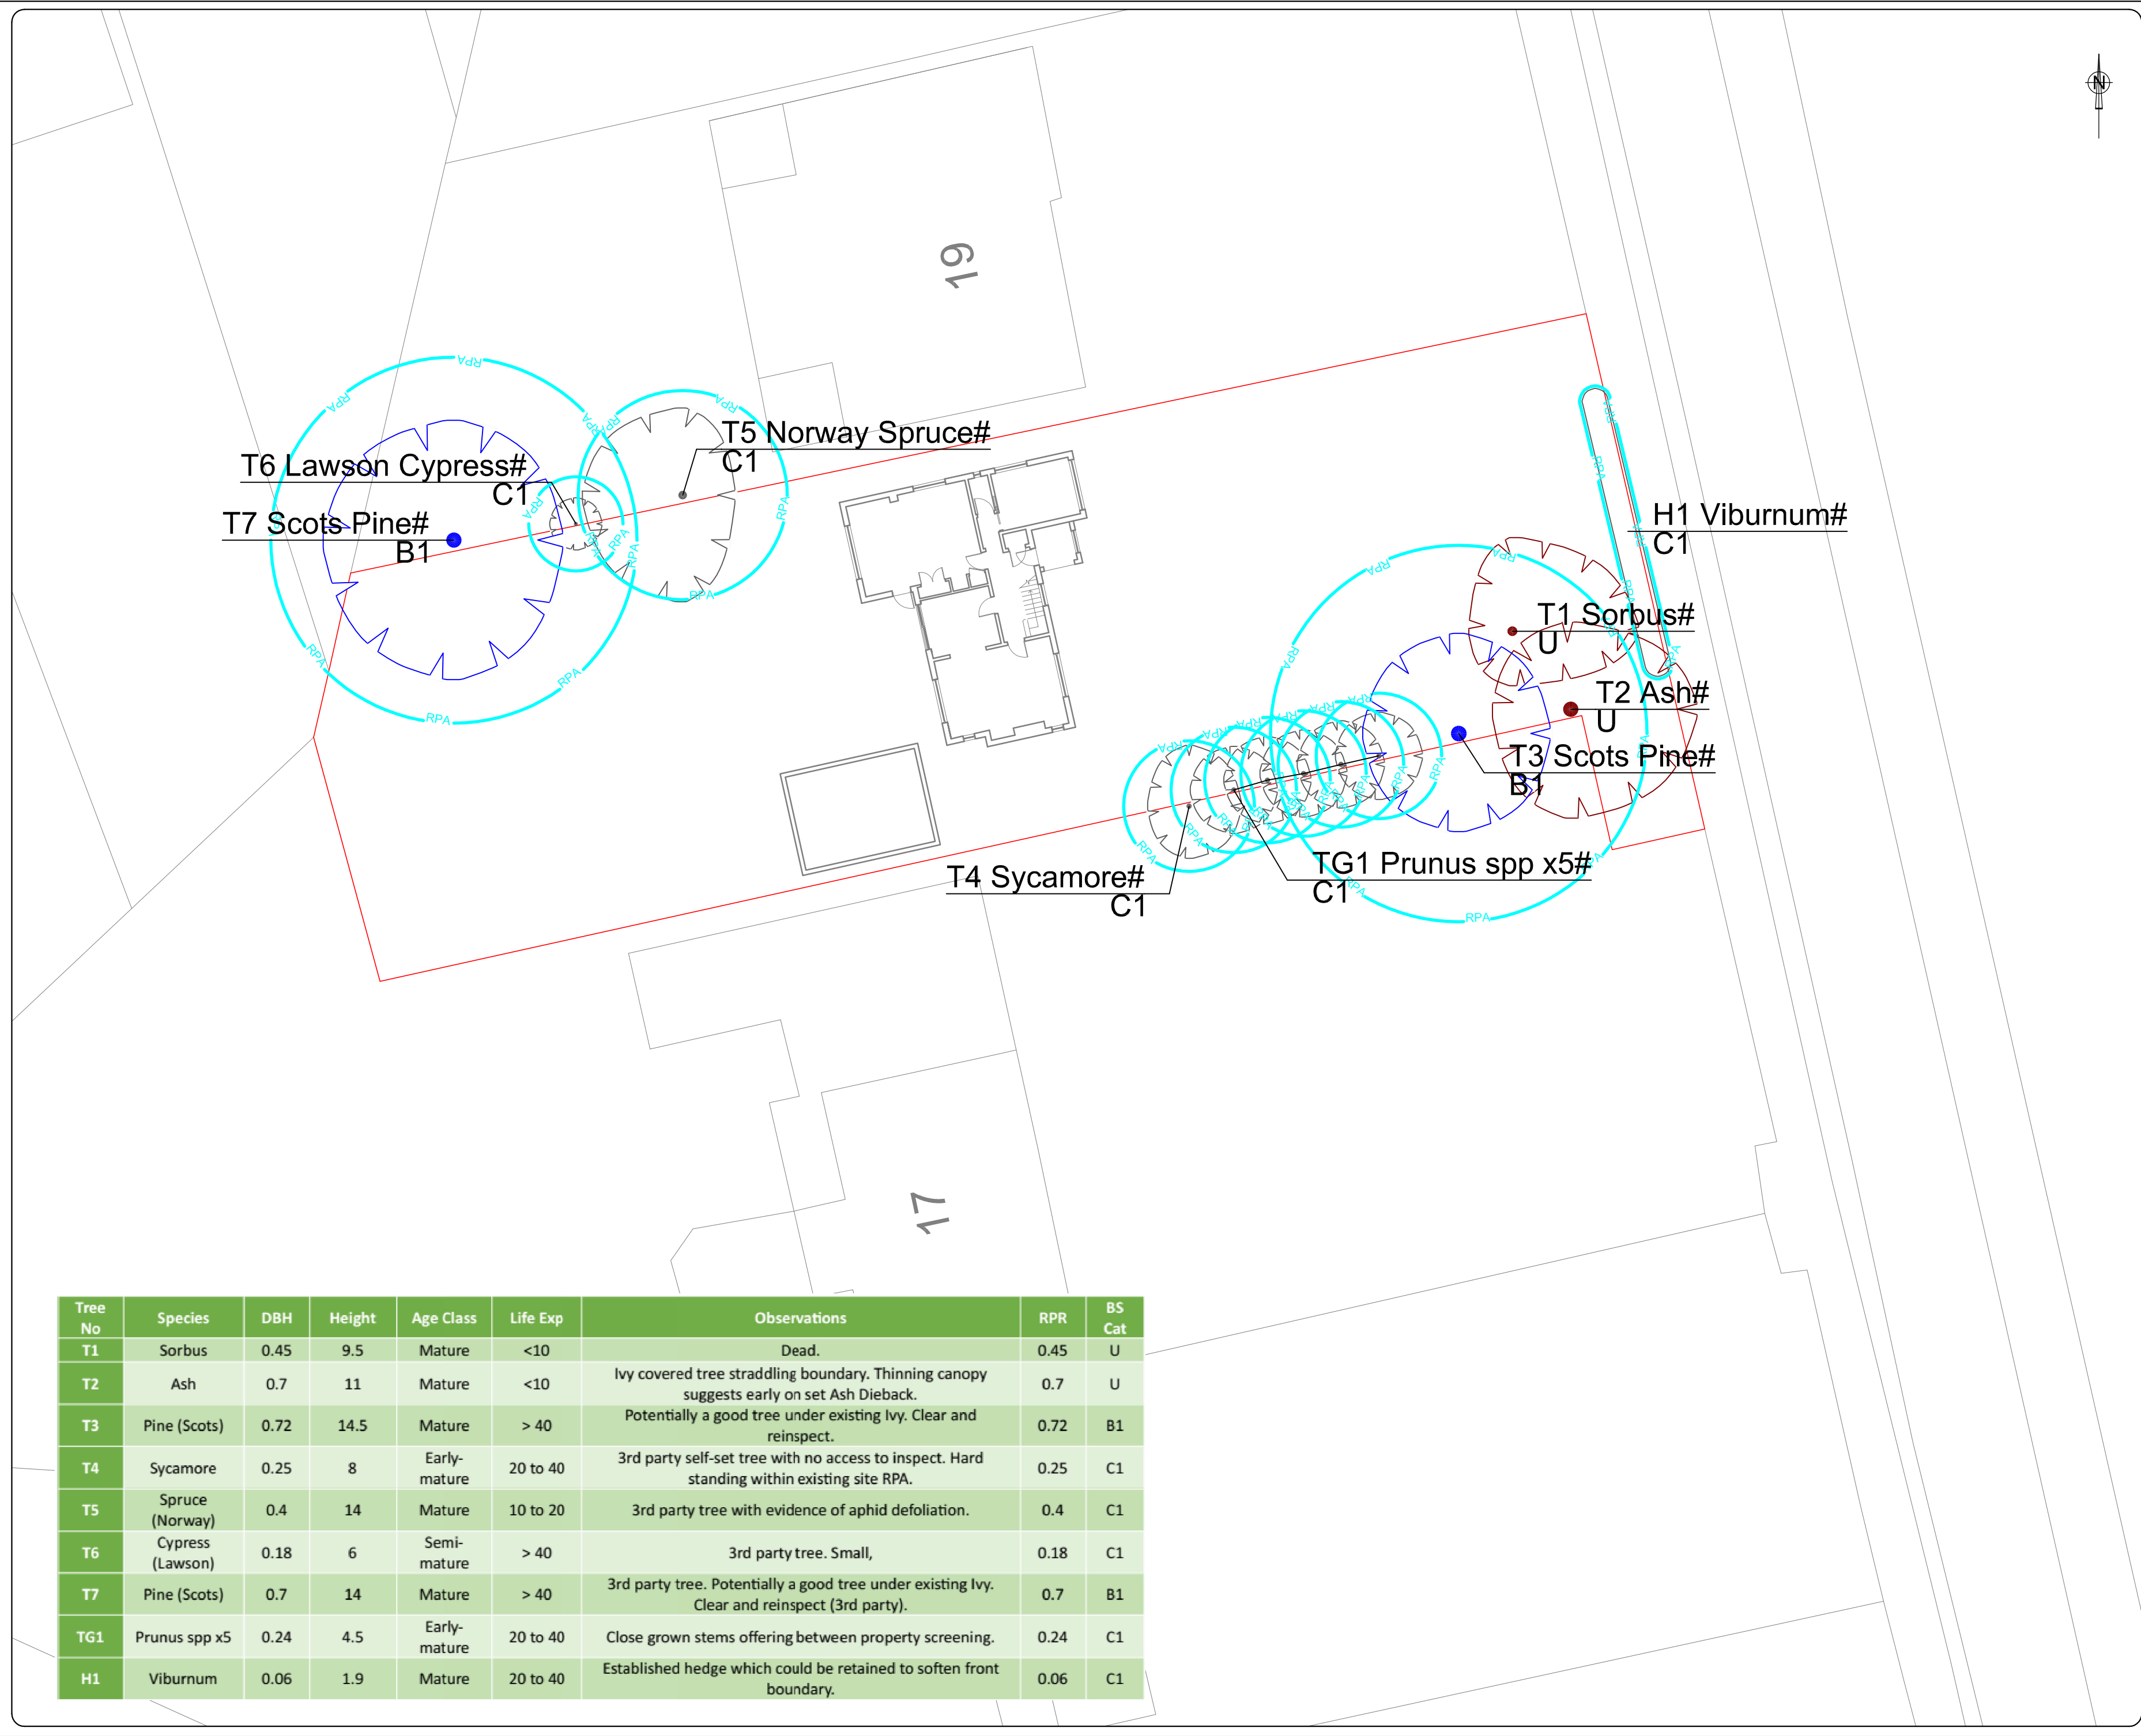
# Appendix 5 - Tree Constraints Plan

| Tree No | Species | DBH | Height | Age Class | Life Exp | Observations | RPR | BS Cat |
|---|---|---|---|---|---|---|---|---|
| T1 | Sorbus | 0.45 | 9.5 | Mature | <10 | Dead. | 0.45 | U |
