# BS5837 Arboricultural Impact Assessment

Northwood and Pinner Cottage Hospital, Pinner Road, HA6  
1DE

Job Reference: 02370Rv9

## March 2021

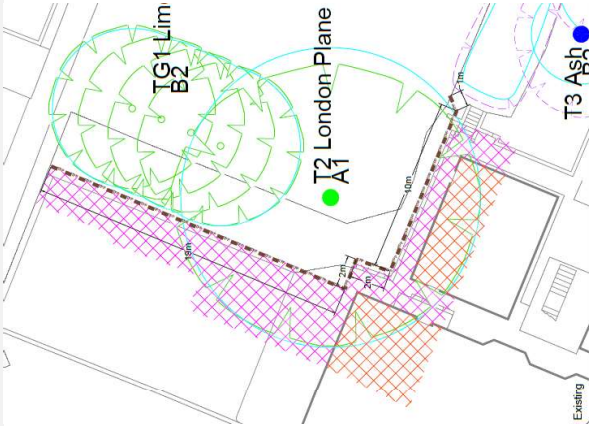
| Demolition | |
|---|---|
| | <div>Overview</div> <ul style="list-style-type: none"> <li>Tree protection indicated at Appendix 5 (example area left) will be installed prior to any on site activity.</li> <li>Buildings removed via existing established access routes over hard standing away from retained trees.</li> </ul> |
| Threat level to Retained Trees | LOW |

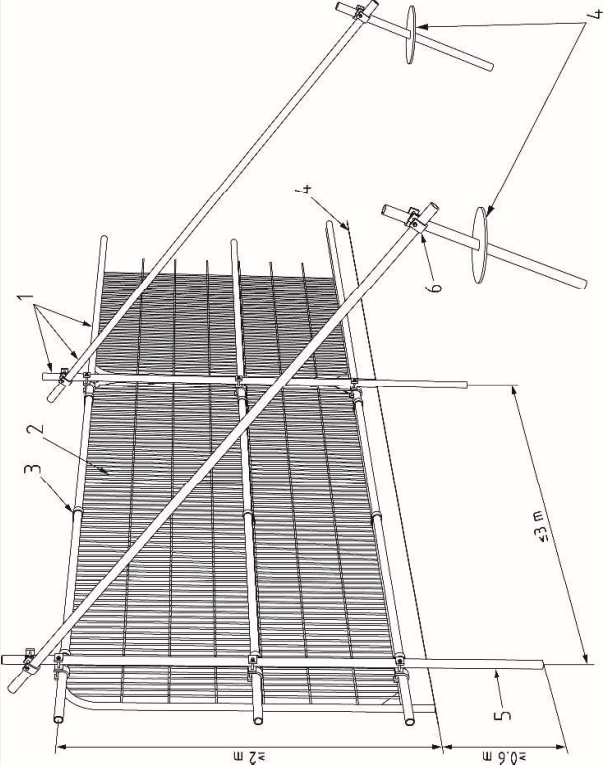
| Tree Protection | |
|---|---|
| | <div>Overview</div> <ul style="list-style-type: none"> <li>Tree protection required internally to site.</li> <li>Installed prior to any onsite works (including demolition)</li> <li>Note: To be marked with signs (inset) and purpose to be briefed to all ground workers.</li> <li>Maintained for duration of the build.</li> </ul> |
| Threat Level to Retained Trees | LOW |

5.4.4 All internal tree protection must be appropriately signed to ensure that all site operatives know its purpose.
