Optera Structural Solutions

OPT-20188 Agreement to install a root barrier for Graham High Group Ltd

CLIENT NAME:	Graham High Group Ltd
CLIENT ADDRESS:	Barclay House, 20-24 Upper Market Street, Eastleigh, Hampshire, SO50 9FD
POLICY HOLDER:	Mr Peter Sims
POLICY HOLDER ADDRESS:	Oak Tree House, Wood Lane, Ruislip. HA4 6EY
CLIENT REFERENCE:	S2516983
OUR REFERENCE:	OPT-20188
PROJECT MANAGER:	Paul Milliam
DATE	16/10/2025
ETSIMATED DURATION:	3- 4weeks

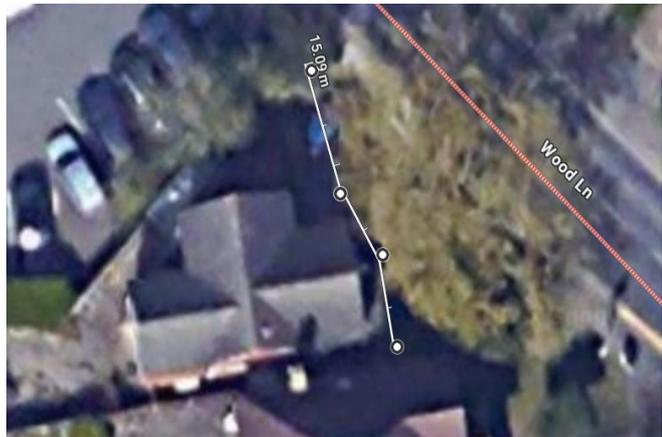
Aerial plan indicating proposed 16m length and alignment of barrier.

The investigations to the front of the porch in 2022 recorded no roots below 3m. It is therefore proposed to allow a barrier depth of 4m and for this to extend 15m across the front of the property.

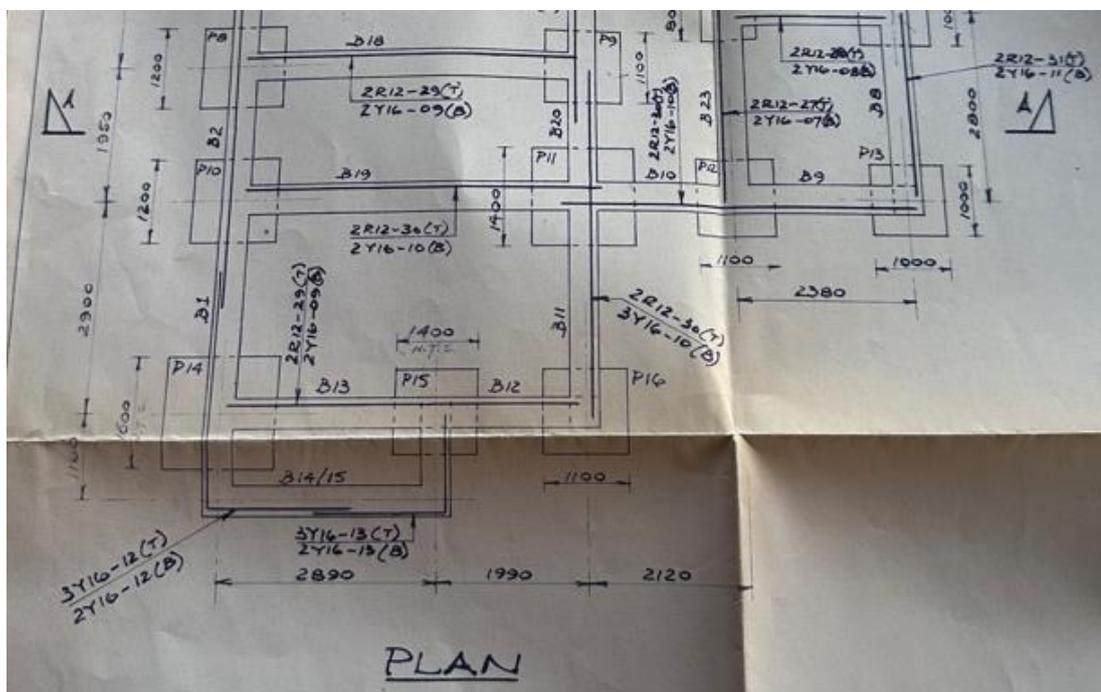
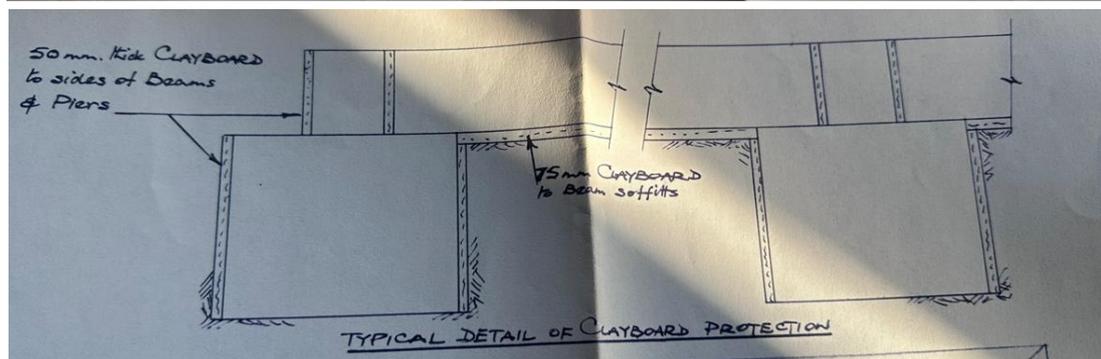
The property is a detached house built c1980 by the Insured. The Oak tree at the front was present at the time of construction and therefore it was built off of a Engineered design pad and beam foundation system where deep pads are installed at strategic positions with concrete beam connecting. The homeowner was able to show us the original drawings and whilst these do not confirm the depth of the pads they do show there positions. It is worth noting that the current movement predominantly affects the front porch that appears from the drawings to cantilever out from the front pads to the left corner. Mr Sims did confirm that anti-heave provisions were allowed for during construction and were noted on the drawings, see below.
