## ADDENDUM ARBORICULTURAL REPORT

Crawford Reference: 1786071 / SU2206150

**143 The Greenway**

29 July 2024

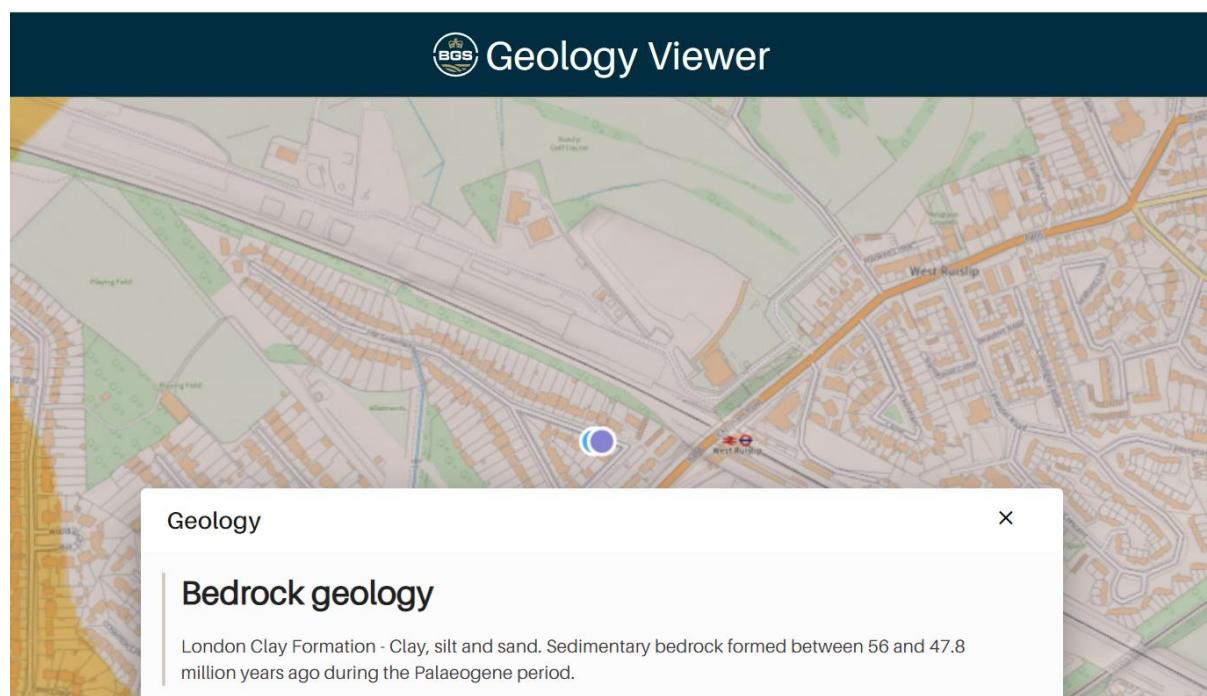
Reference to the British Geological Survey online viewer confirms that the geology comprises of London Clay.

London Clay can significantly change in volume due to seasonal variations in moisture content, particularly if influenced by tree roots extracting moisture.
