MAYFORDS
Chartered Surveyors

BUILDING SURVEY REPORT

6 Lawrence Drive, Ickenham, UB10 8RN

On: 31st October 2019

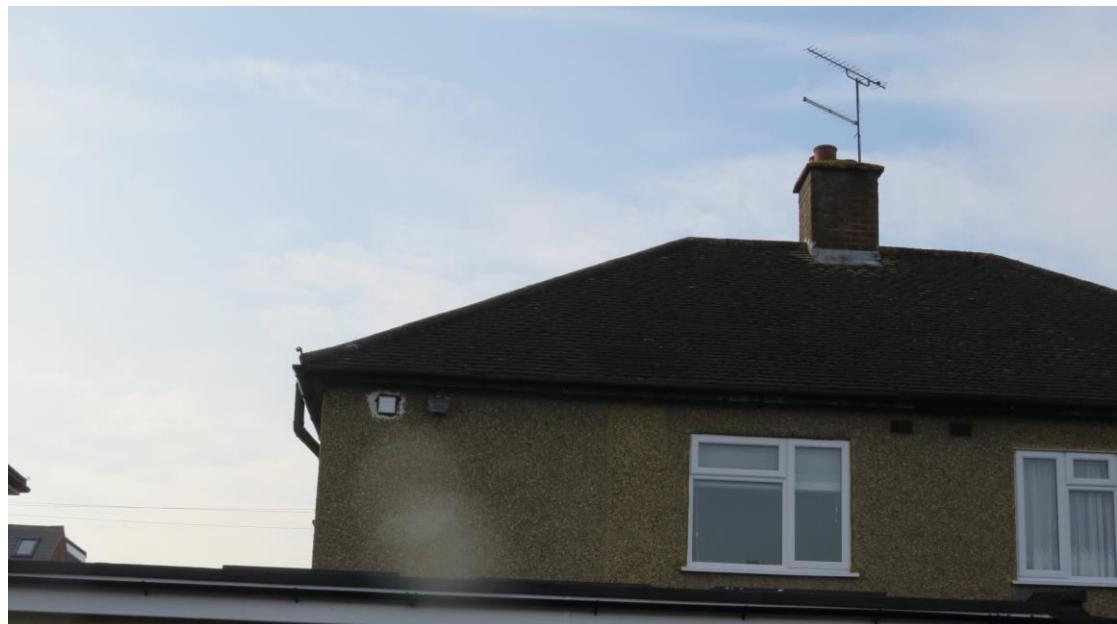
We saw no visible signs of significant cracking or leaning where possible to view.

A chimney stack built during this era would not necessarily have incorporated a damp proof course and it is therefore essential to maintain the condition of the brickwork in order to prevent such dampness occurring. In this regard, some local deterioration and weathering is noted to the surface brickwork and pointing and this requires repair. When any pointing is carried out it is essential that the joints are raked out sufficiently, usually to a depth not less than 12mm so that the new pointing is given sufficient key. Failure to do this can result in the new pointing simply cracking and falling out over a relatively short timescale. The pointing itself should not be stronger than the bricks to which it is applied. Too high a cement content can allow shrinkage cracking.

Lead flashings are featured at the base of the chimney stack where this adjoins the sloping roof surface, where visible this appears to be in a serviceable condition.

In order to slow down future deterioration of the brickwork, it is recommended that the brick surfaces be treated with a microporous transparent water-proofing solution. These solutions have the ability to prevent rain penetration while at the same time allowing trapped moisture to dry out. They are not long lasting and will require re-treatment in conjunction with future external redecoration programmes.

All chimney pots above redundant flues should be removed and the latter capped off and ventilated in order to minimise the risk of condensation from occurring within the flues. Ventilation is essential to capped off flues as weather penetration downwards, coupled with the effects of condensation within, will often result in deterioration to the materials within the structure and brown damp stains could occur on chimney breasts inside.

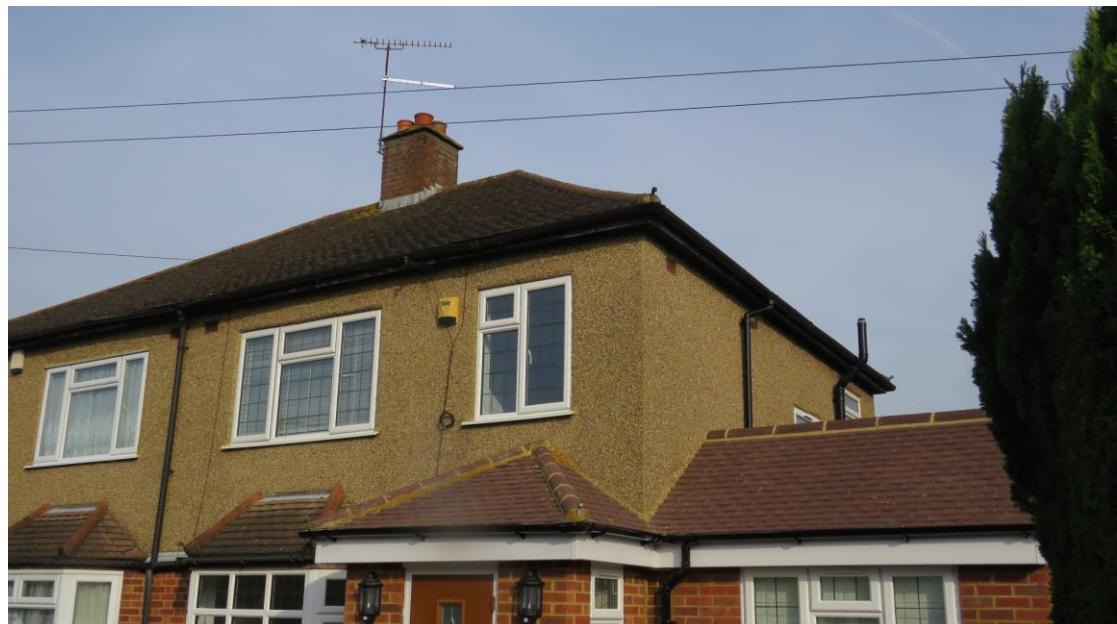
The main walls to the property appear to be of cavity brick construction with pebbledashed surfaces to the first floor front and full height to the right hand side and rear elevation.

When corrosion takes place it can cause horizontal cracks every four, five or six courses of brickwork in the mortar joint and sometimes this is accompanied by bulging in the outer leaf of the brick wall. We have found no indication of failures to suggest that there is an existing defect in the wall ties.

We note some slight deterioration evident to the pointing to the front elevation around the bay window.

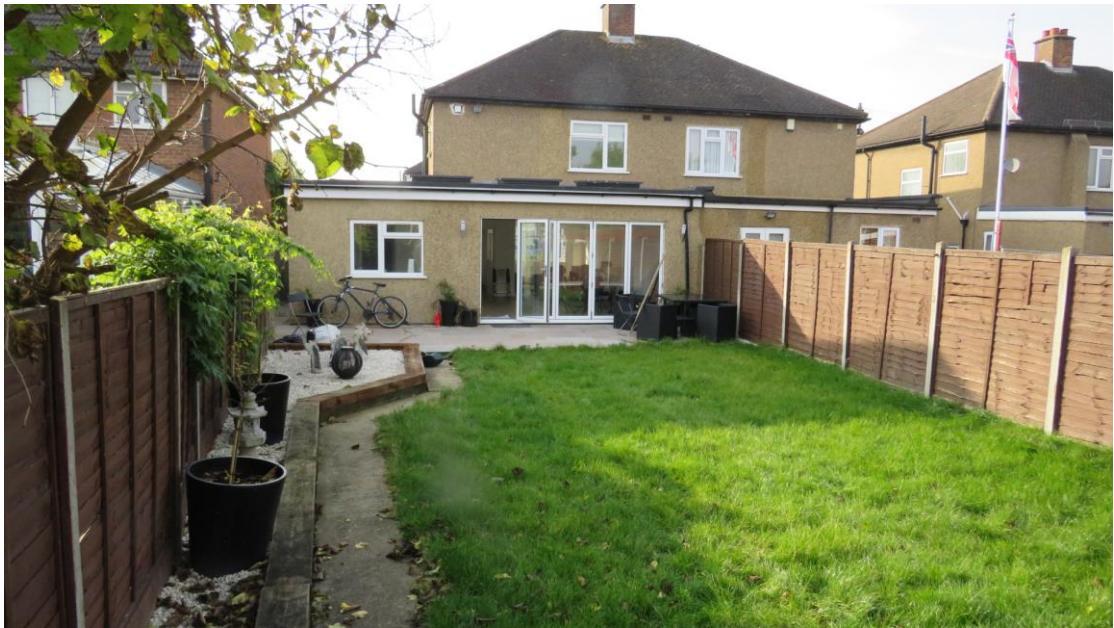
There is a new brick wall to the front and left hand corner of the front garden area with a more dated brick wall to the right hand side which has suffered some weathering and damage, and local cracking and will need repair. New fences have been installed in the rear garden, where visible these appear to be in good condition.

The gardens are in a seasonal condition, and there are some cracked, weathered and uneven paved areas.
