Arboricultural Report

In accordance with BS 5837:2012

For land adjacent to

67 Chiltern View Road

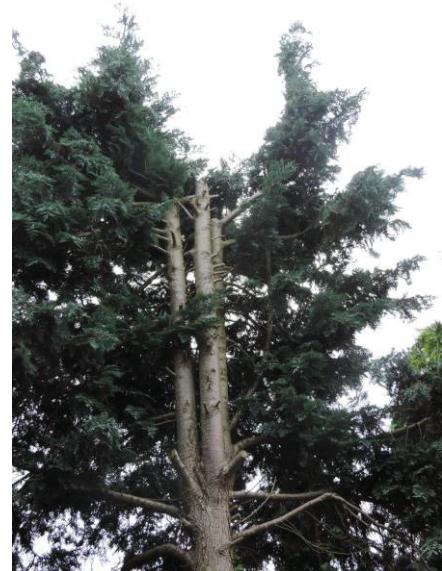
T4 Lawson's Cypress that has been unsympathetically pruned and topped. A poor quality tree with in excess of 80% of the crown encroaching over the fence to the worksite.

However, it has been previously noted that these trees are in poor condition having been unsympathetically pruned leaving the majority of the remaining leafing area encroaching over the boundary fence.

An alternative would be to liaise with the owner of 67 Chiltern View Road with a view to felling these trees prior to the development of the worksite and then replanting suitable replacements once work is completed. The Developer would bear the costs of these operations and the Tree Officers at Hillingdon consulted on suitable replacements and the necessary conditions added to the planning approval.
