TREE SURVEY - HEALTH & SAFETY

Proj. No 11132	9 Ravenscourt Close, Ruislip, Middlesex, HA4 7PP	
Client:	Daniel Sparrowhawk	
Date of Report:	21/08/2024

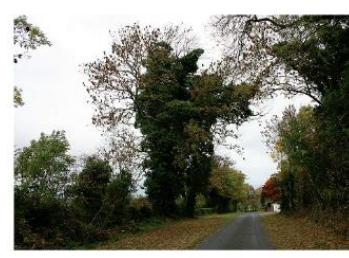
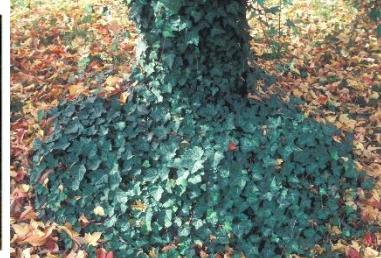
Name: <i>Hedera helix</i> (Ivy)	
Symptoms/damage type and cause:	Ivy may grow to varying degrees on all areas of a tree from the base to the upper crown. It is possible that in doing so it will out-compete the host tree for available light thereby suppressing the host.
Consequence:	This is generally only harmful to the tree on already unhealthy specimens which may be constricted by large ivy stems around the trunk or may have their top growth suppressed by a mass of flowering shoots in the crown. Ivy can also mask potentially dangerous faults on a tree.
Control:	Ivy should only be removed if necessary because it provides abundant cover to wildlife and then by severing twice close to the ground and removing a length of stem thereby causing the gradual dying away of the aerial parts of the plant providing extended benefit to wildlife whilst relieving the pressure on the tree.
Species affected:	Most trees can be affected.
