# **Willow Tree Depot, Ditchfield Road**

**Verification Report**

| ISSUE RECORD | | | | | |
|---|---|---|---|---|---|
| Report Reference: 2001015.001.01 | | | | | |

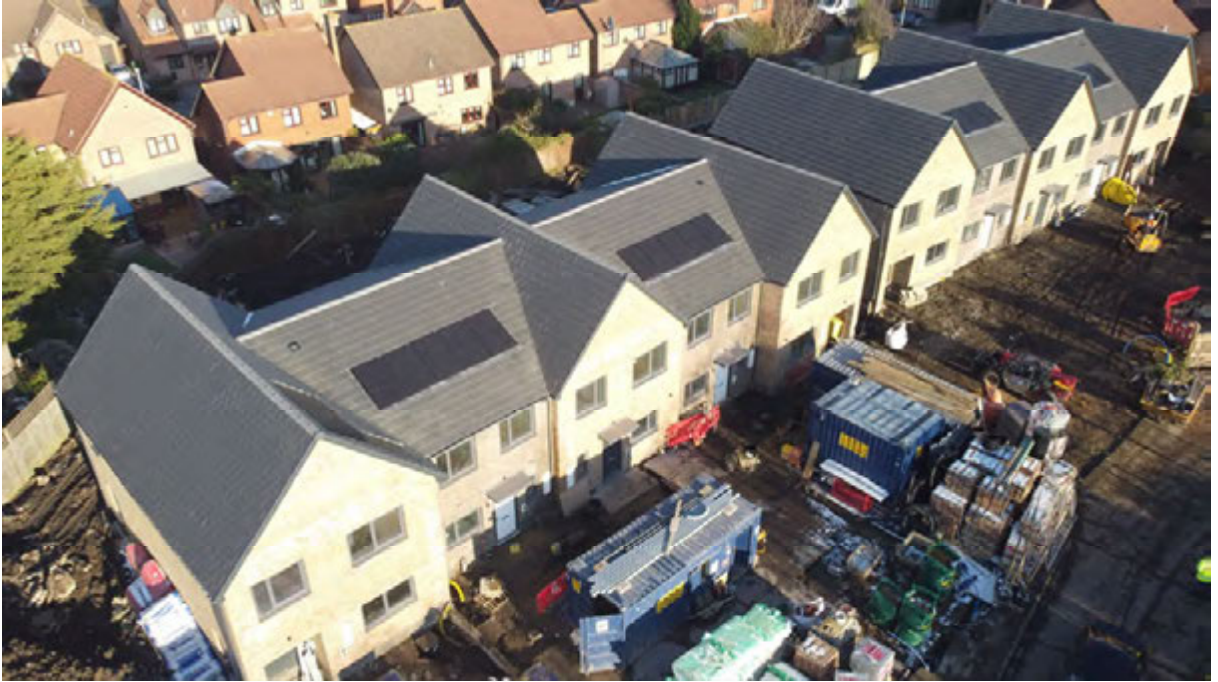
Photograph 1: General site view.

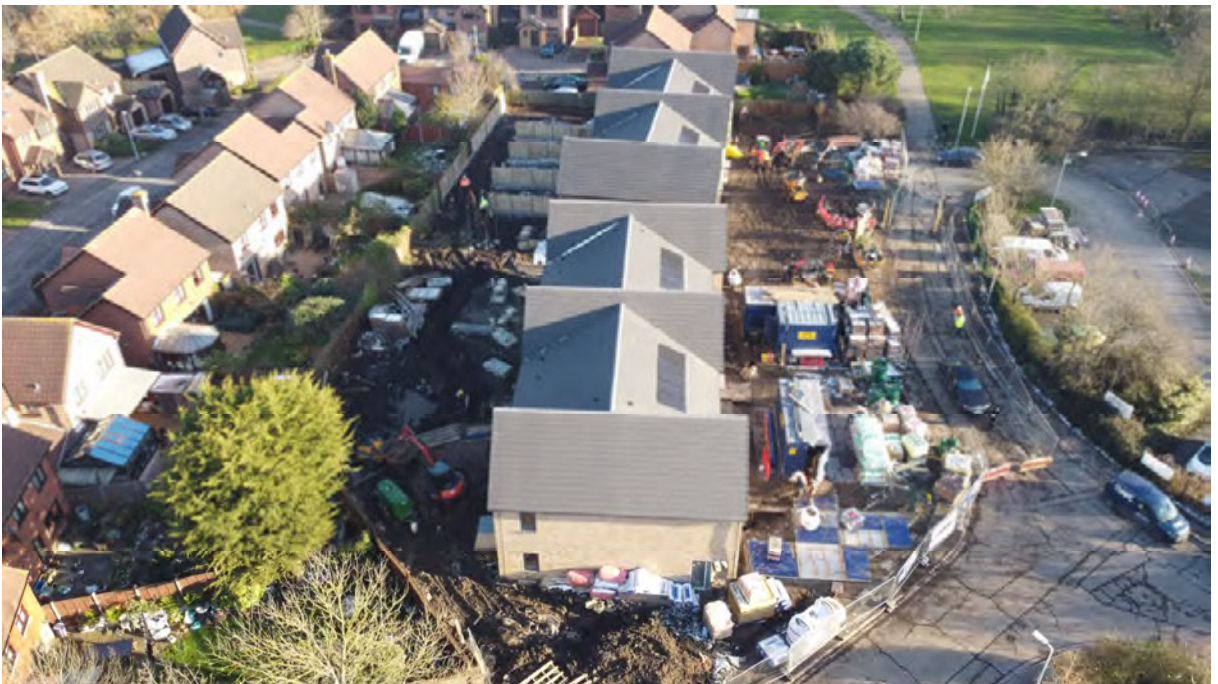
Photograph 2: General site view.

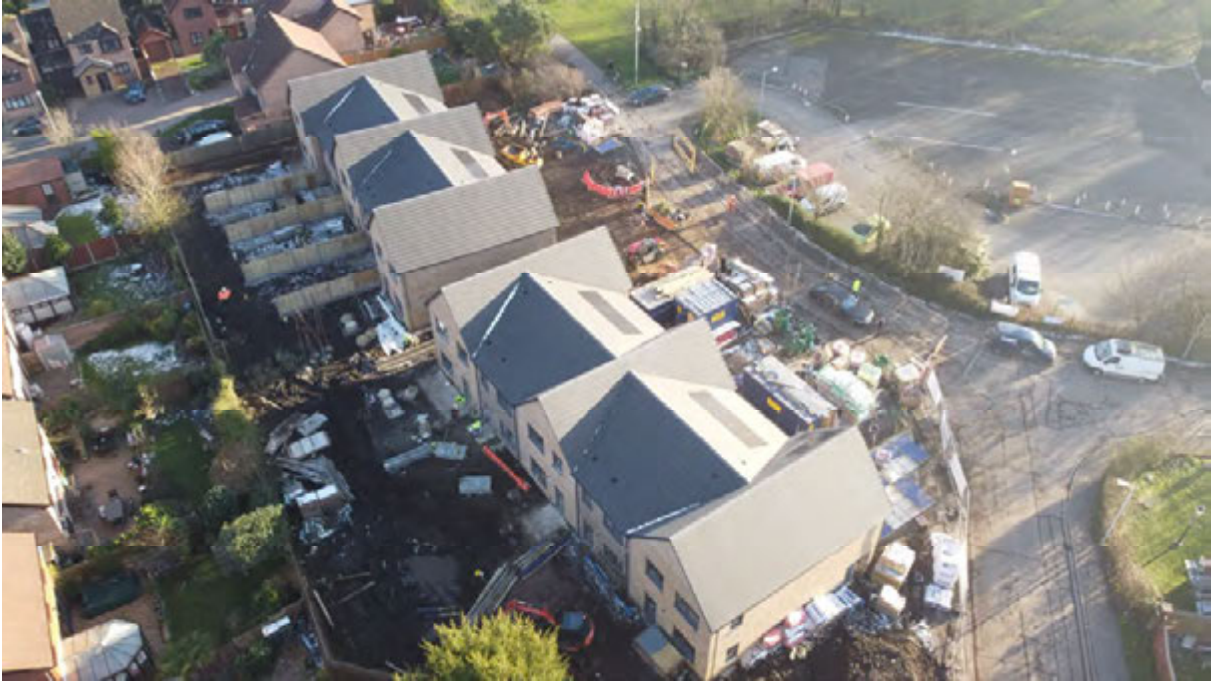
Photograph 3: General site view.

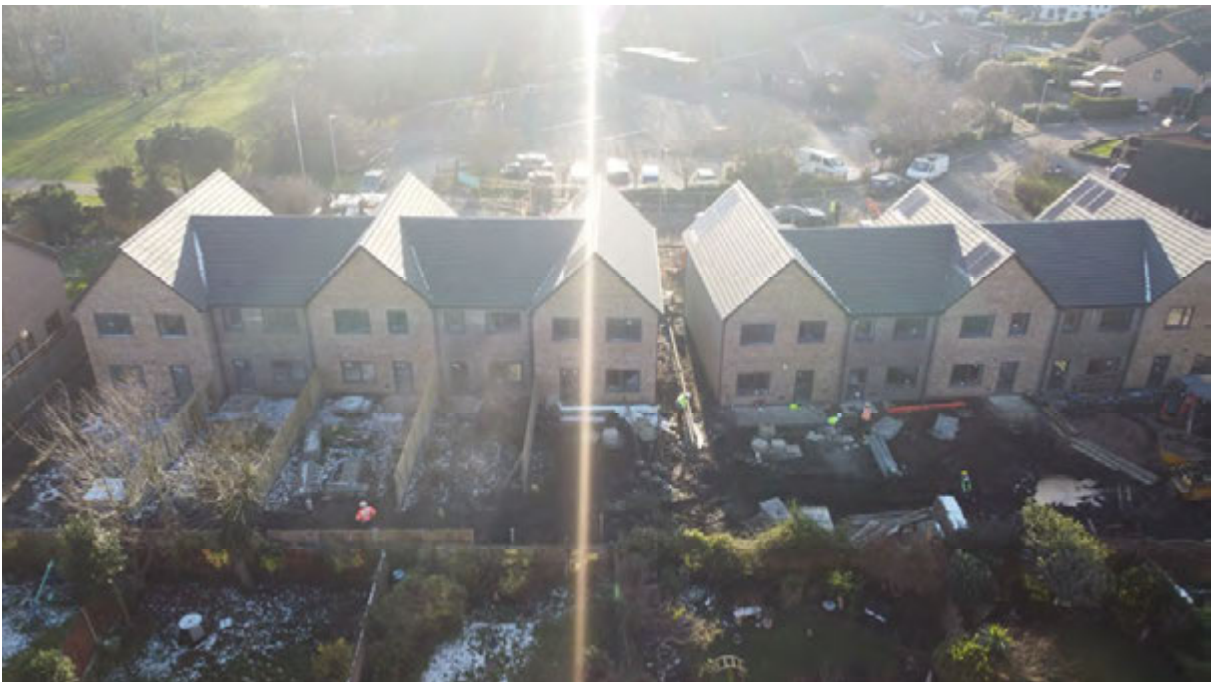
Photograph 4: General site view.

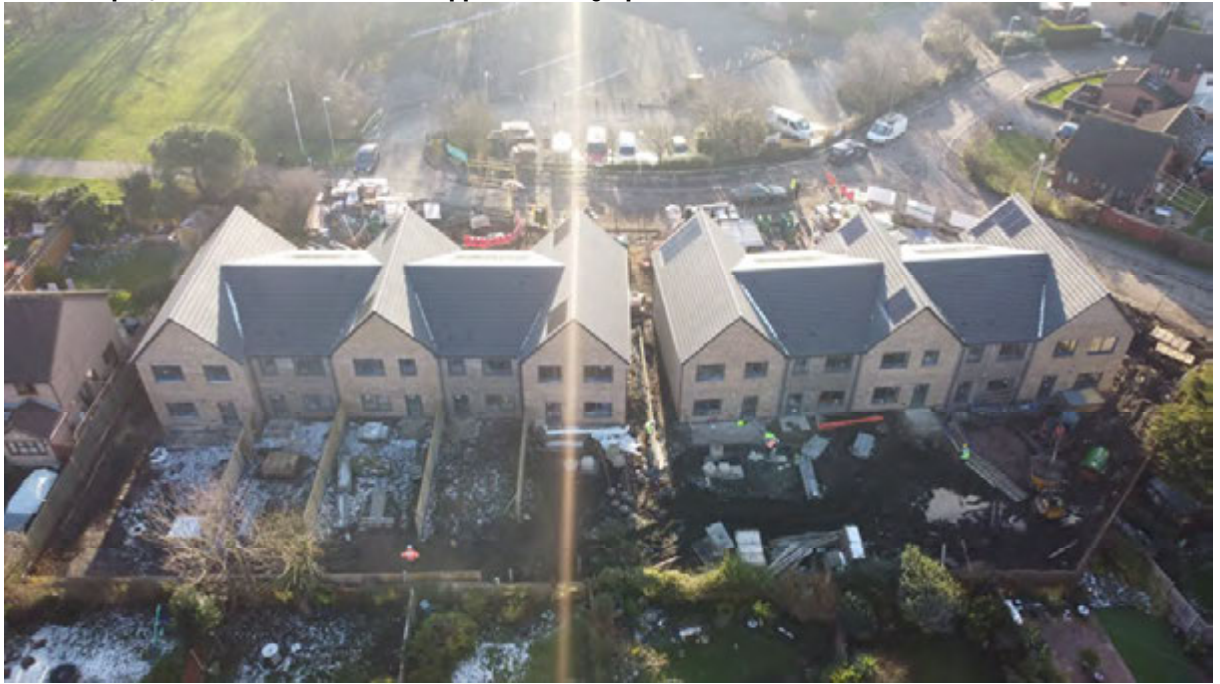
Photograph 5: General site view.

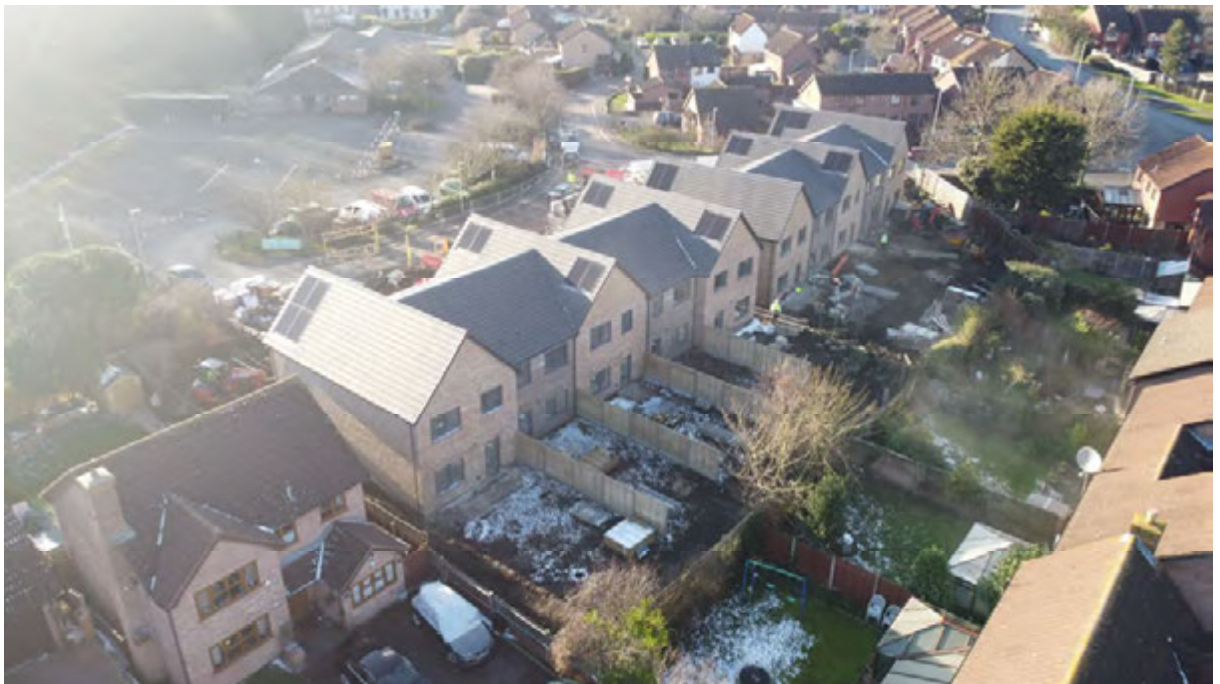
Photograph 6: General site view.

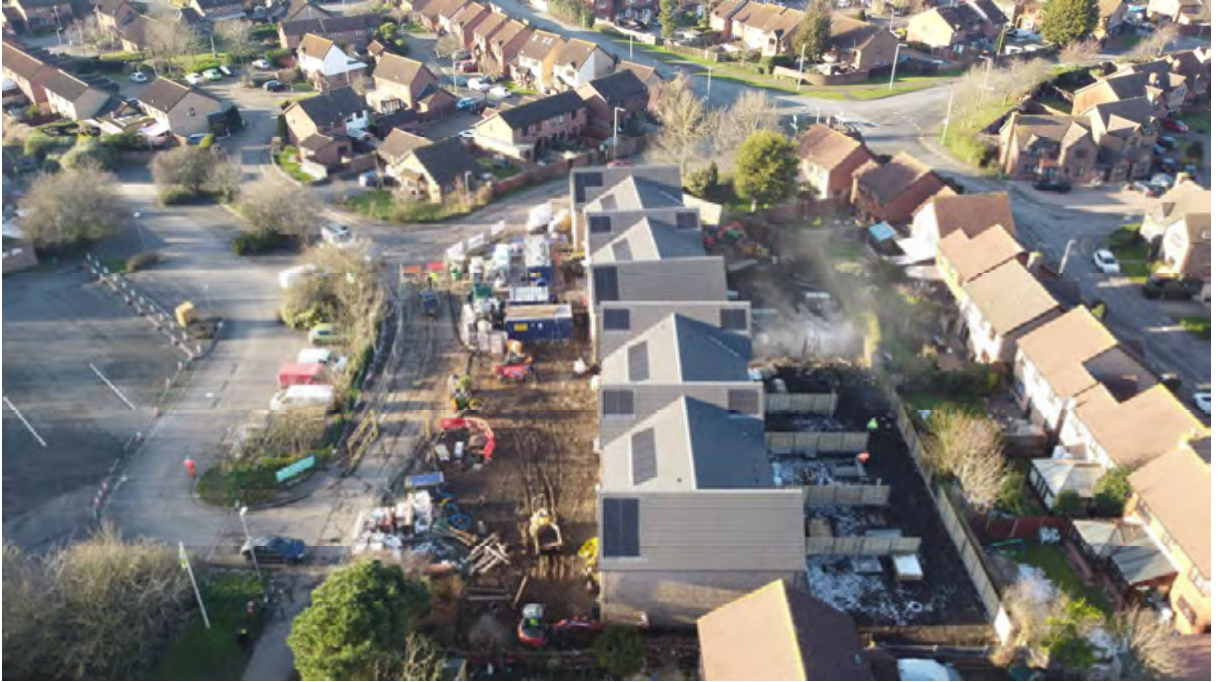
Photograph 7: General site view.

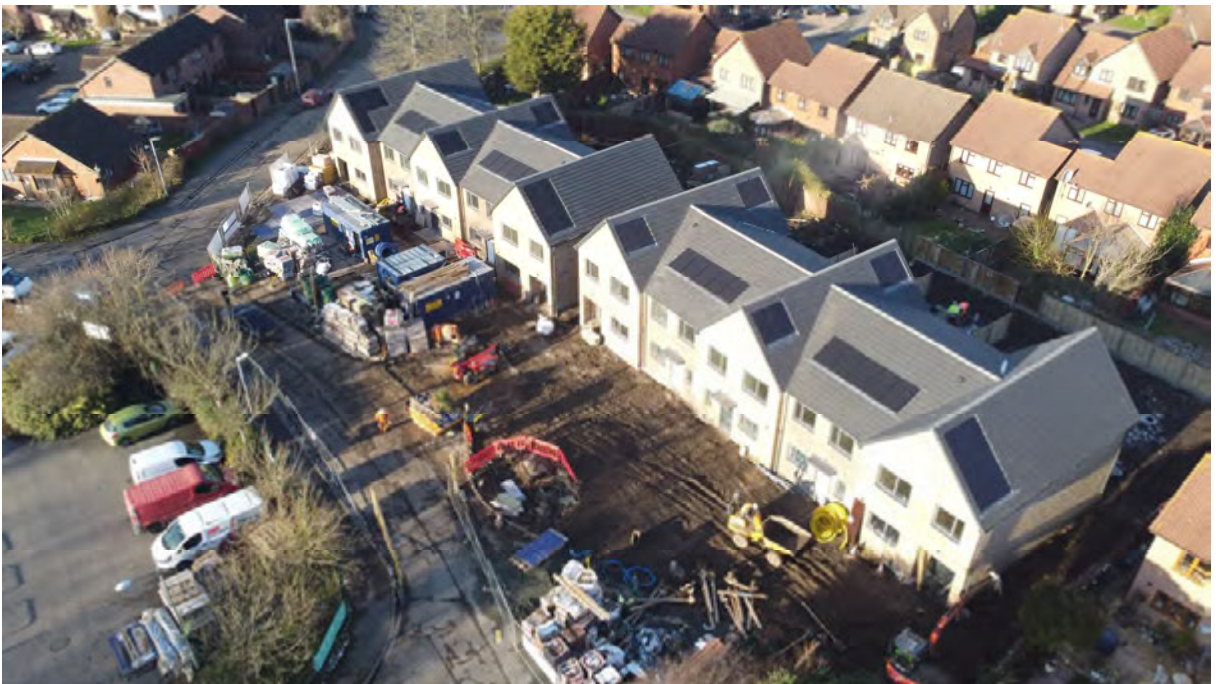
Photograph 8: General site view.
