**CCTV REPORT FOR: 7 ROGERS RUFF  
NORTHWOOD  
MIDDLESEX  
HA6 2FD**

**Insured:** Mrs B. M. Whitehead  
**Reference:** Your Ref: DLG-SN-19-001049    Ins Ref: 067361337

**Site Visit:** 14-Oct-19  
**Report Date:** 21-Nov-19

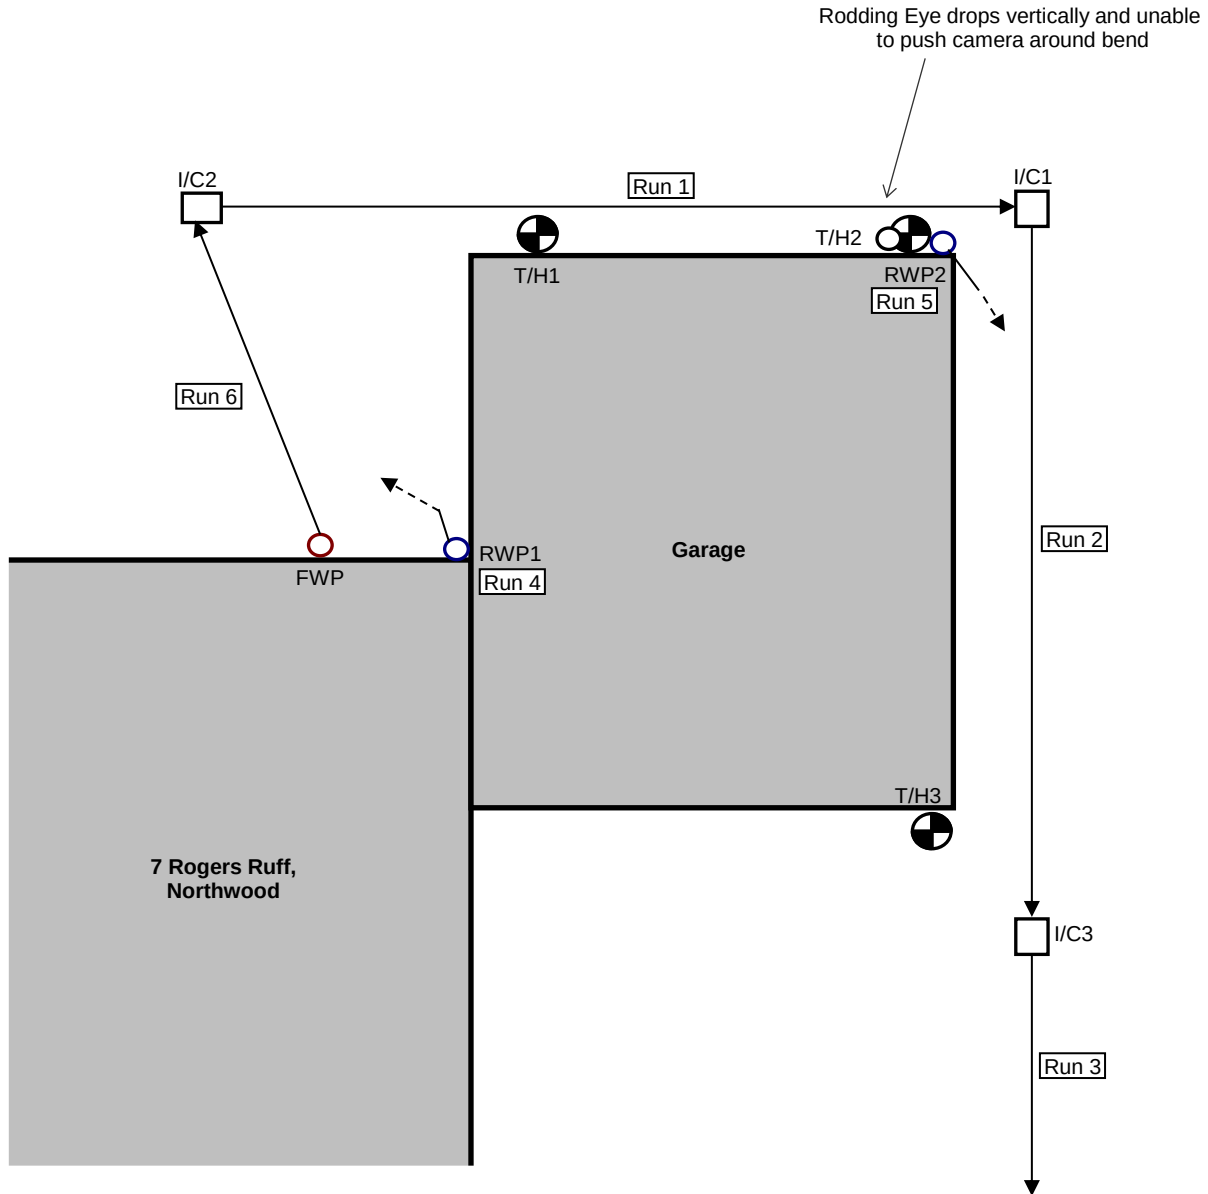
**Drainage**  
 Repair Company  
**SITE AND DRAINAGE LAYOUT**

**Note: Runs shown in red have been adopted by the local water authority.**
