# Site Investigation and Drainage Report

| <b>Site</b> | 2 Ebury Close<br>Northwood<br>Middlesex<br>HA6 2PF |
| <b>Our Ref</b> | 10877 |

**Project Name:** 2 Ebury Close HA6 2PE  
**Project Description:** WinCan Import in Miraculix WRc4 Standard  
**Project Status:** Complete  
**Project Date:** 19/07/2019

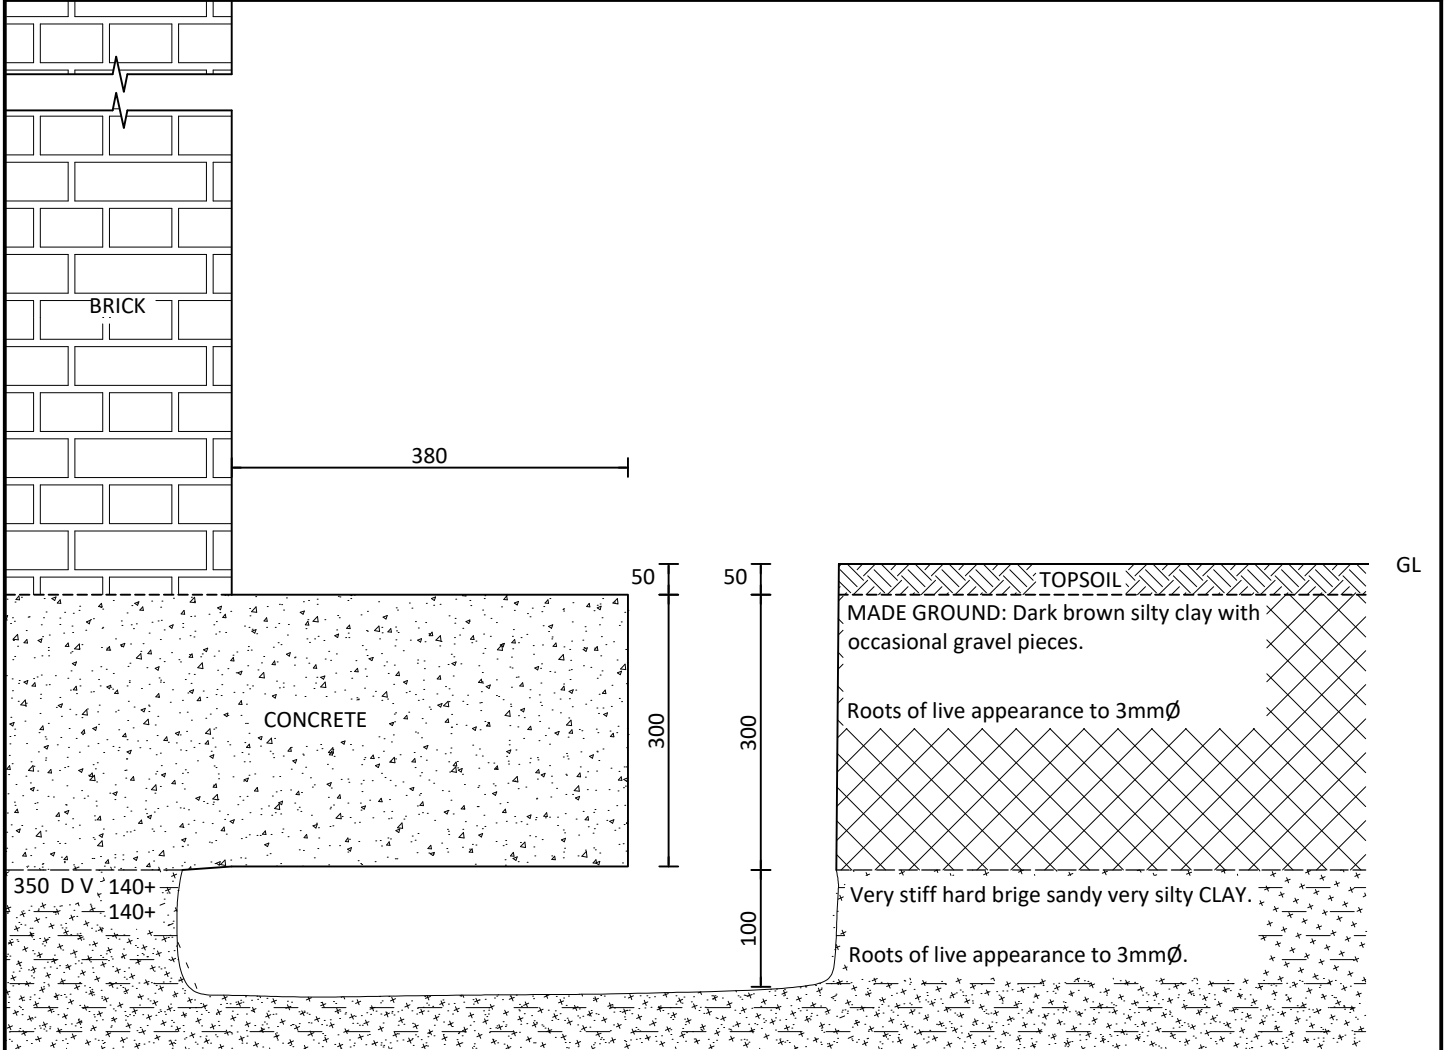
| No groundwater encountered.<br>All dimensions in millimetres. | ND No Data<br>NTS Not to Scale<br>GL Ground Level<br>D Small Disturbed Sample<br>V Pilcon Vane (kPa) |

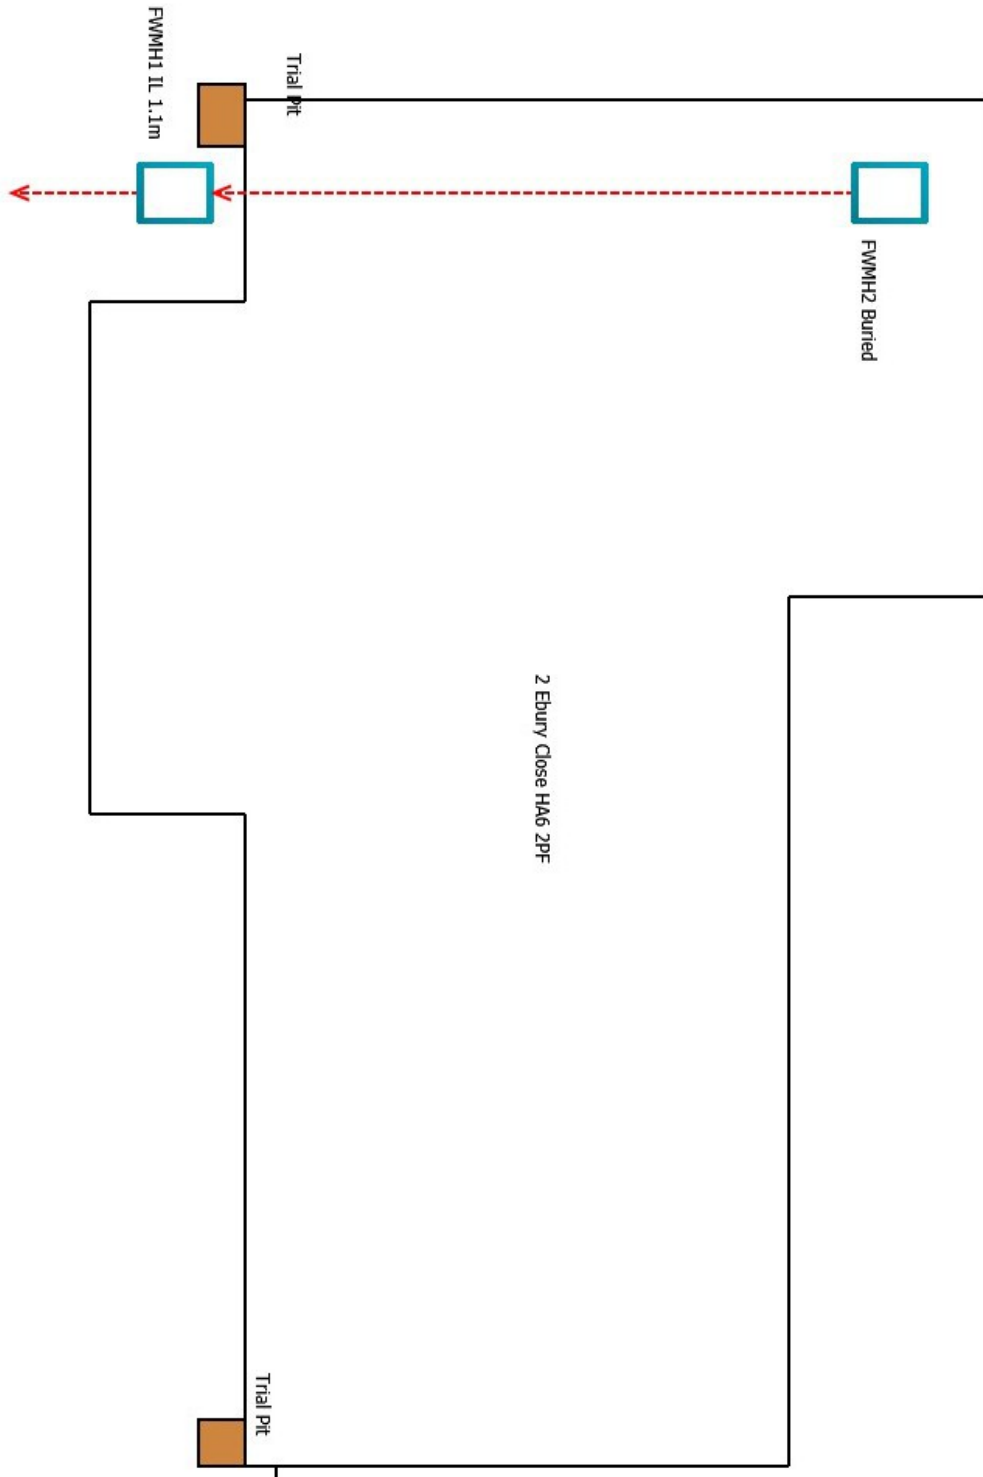
## Project Drawing

- 1) FWMH1-FWMH2: This drain is constructed from 100mm Vitrified Clay Pipe and appears to be visually in a serviceable condition and without any major structural defects. There are some attached deposits which are slightly restricting the bore and flow of the drain but it doesn't appear to have caused any blockages.

| Section | PLR | Grade | Description |
|---|---|---|---|
| All inspected pipes are in an acceptable structural condition (< grade 3). | | | |

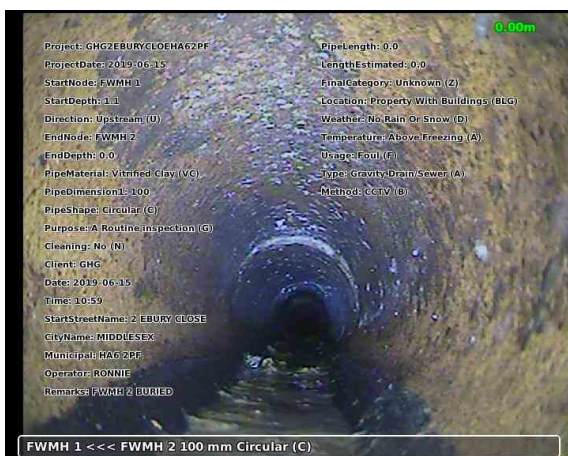
20190615-105947-snap0000.jpg, 00:00:01, 0.00 m  
Start node type, manhole, reference number: 1
