TREE SURVEY - HEALTH & SAFETY

Proj. No 9736	8 Ravenscourt Close, Ruislip, Middlesex, HA4 7PP	
Client:	Pat Taverner	
Date of Report:	23/09/2022

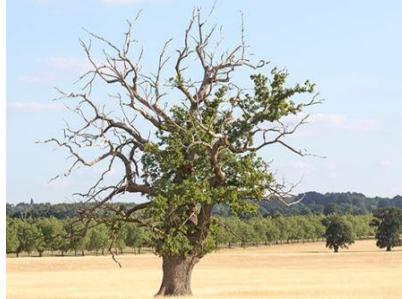
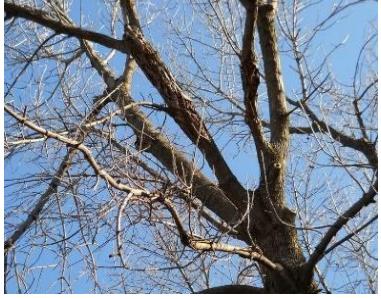
Name: Deadwood	
Symptoms/damage type and cause:	This relates to dead branches in the crown of the tree. In most cases, this is caused by the natural ageing process of the tree or shading due to its proximity to neighbouring trees. However, in some situations, it may be related to fungal, bacterial or viral infection.
Consequence:	Depending upon the location and mass of dead wood removal of the affected tissue may be necessary to prevent harm to persons or property as the wood will become unstable as it decays and in some circumstances is likely to fall from the tree with little or no warning.
Control:	Detailed monitoring should be undertaken on those trees showing signs of excessive deadwood production to identify the underlying cause.
Species affected:	Most tree species.
Images:

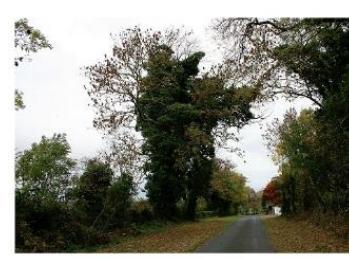
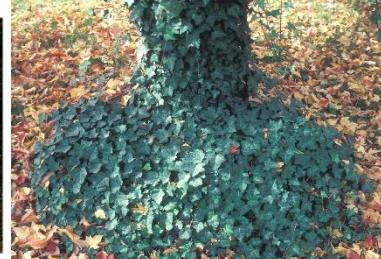
Name: <i>Hedera helix</i> (Ivy)	
Symptoms/damage type and cause:	Ivy may grow to varying degrees on all areas of a tree from the base to the upper crown. It is possible that in doing so it will out-compete the host tree for available light thereby suppressing the host.
Consequence:	This is generally only harmful to the tree on already unhealthy specimens which may be constricted by large ivy stems around the trunk or may have their top growth suppressed by a mass of flowering shoots in the crown. Ivy can also mask potentially dangerous faults on a tree.
Control:	Ivy should only be removed if necessary because it provides abundant cover to wildlife and then by severing twice close to the ground and removing a length of stem thereby causing the gradual dying away of the aerial parts of the plant providing extended benefit to wildlife whilst relieving the pressure on the tree.
Species affected:	Most trees can be affected.
