Arboricultural Appraisal

28 Moor Park Road, HA6 2DJ

Report Reference: 211770r_AA001_25-26

Date of inspection: 10/02/2026

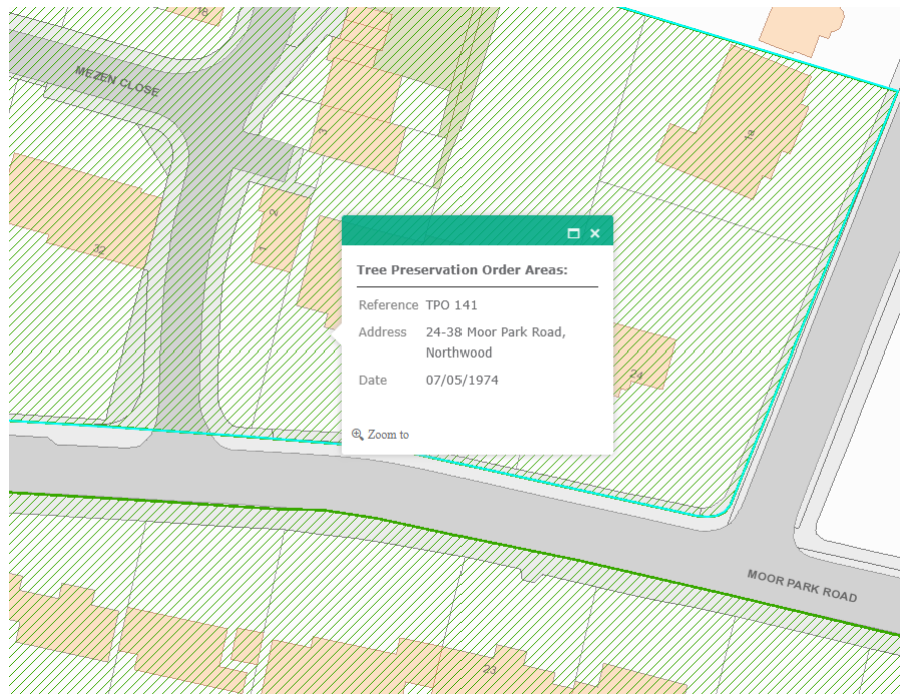
4.2 Ther site is not within a conservation area but there is an area preservation order associated with the pocket of greenery including 24, 26 and Mezen Close. This makes all tree works subject to agreement from the local planning authority. .

Fig1) [Tree preservation order pocket](#) that contains trees adjacent to the structure of 28 Moor Park Road.

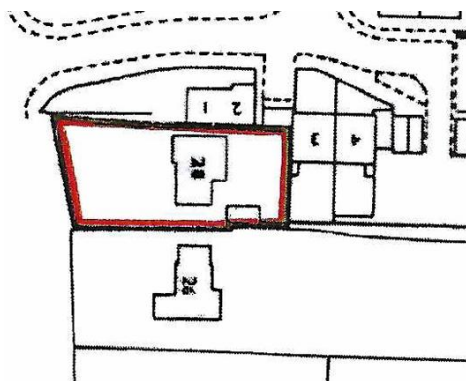
4.3 The ownership status of both trees is questionable. Both are situated on what appears to be a staggered boarder, but the property line as displayed in the title deeds is a straight line, meaning that the Oaks likely owned by one property or the other. Legal precedent states that trees can not be jointly owned; whilst maintenance agreements may be shared through common consensus, the ownership cannot be. For instance, a common law duty of care cannot be burden jointly as one may defer to the other without any responsibility being taken. The RHS and other official bodies suggest that this can be shared, but this is a misconception. Tree ownership is defined by either where it was planted and ownership being visibly obvious, or when in dispute, where the majority of the stem at base level resides.

Ownership of both T1 and T2 should be assessed by using the title deeds to position in which property the greater part of the root crown of the tree resides.
