ADDENDUM ARBORICULTURAL REPORT

SUBSIDENCE CLAIM

Crawford Reference: SU1903345

Uplands Court

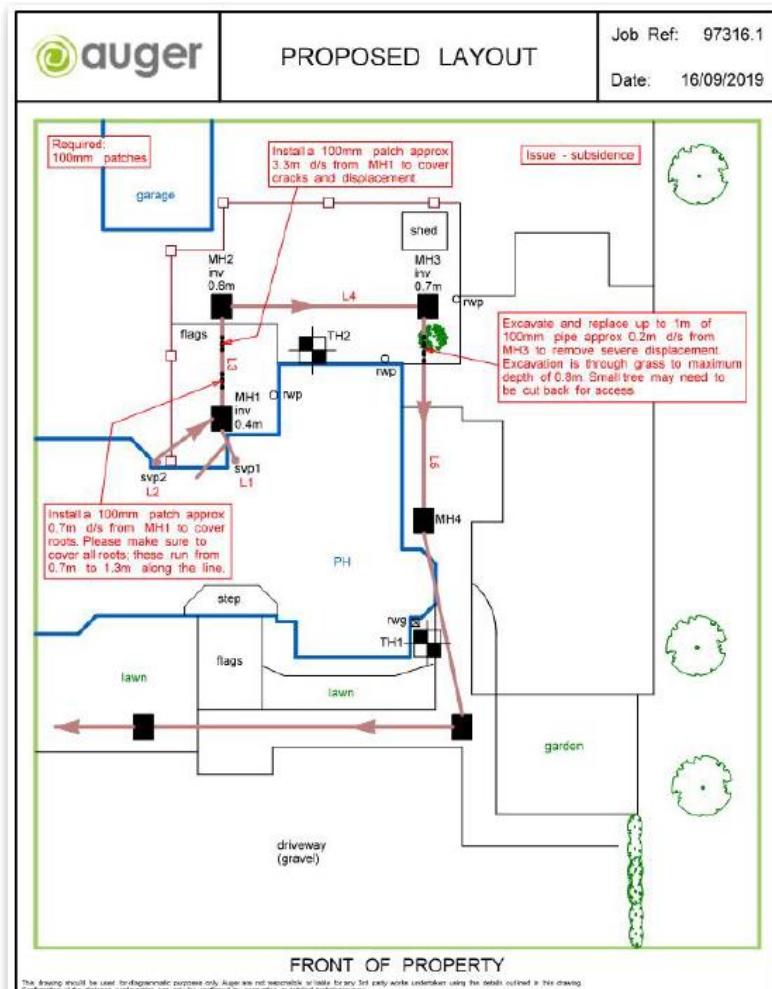
A trial hole was excavated to expose the foundations - see site plan for location and the diagram below for details.

No.	Borehole Depth	Footing (a)	Underside (b)	Thickness (c)
TH1	3.00 m.	200 mm.	1,000 mm.	700 mm.

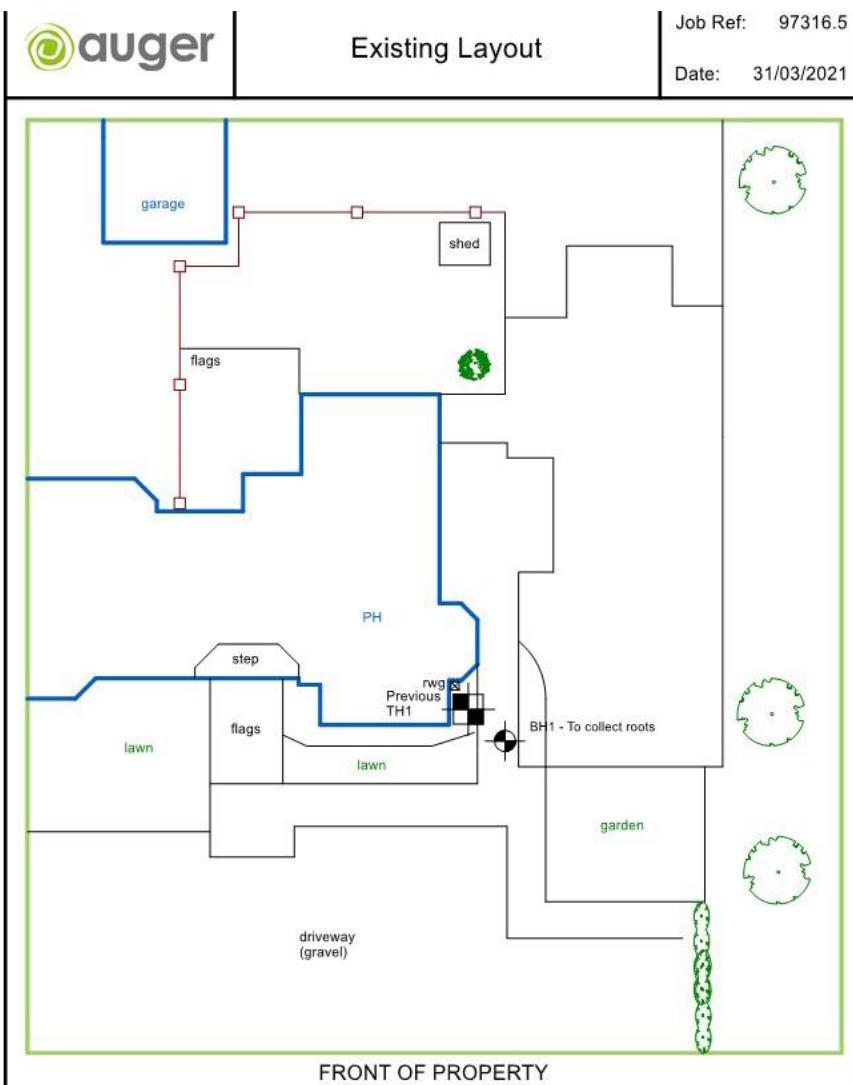
RBH, 1.0m		
2 no.	Examined root: similar in many ways to AESCULUS (Horse Chestnut and related Buckeyes). This was a very IMMATURE sample.	Alive, recently*.
RBH, 1.2m		
3 no.	Examined root: essentially too immature for identification; definitely NOT a conifer.	Dead*.
RBH, 1.5m		
1 no.	Examined root: also very THIN. We cannot rule out AESCULUS (Horse Chestnut and related Buckeyes).	Alive, recently*.
2 no.	Both pieces of BARK only - insufficient material for recognition.	
RBH, 1.8m		
2 no.	Examined sample: very unusual in structure. Could, tentatively be either GINKGO (Maidenhair Tree) - or - a fairly insignificant herbaceous (non-woody) plant. Note that this could well be a TWIG or SUCKER, rather than a root.	Dead*.
RBH, 2.1m		
1 no.	Examined root: as previously, could be AESCULUS (Horse Chestnut and related Buckeyes).	Alive, recently*.
1 no.	Examined root: QUERCUS (Oak) or the related CASTANEA (Sweet Chestnut).	Alive, recently*.

1 no.	A piece of BARK only, insufficient material for identification.

The results of the site investigations confirm that the cause of subsidence is root-induced clay shrinkage. The clay is plastic and thus will shrink and swell with changes in moisture content. Roots have extracted moisture below the depth of the footings, thus causing differential foundation movement to occur. This is supported by the following investigation results:-
