ADDENDUM TECHNICAL REPORT

Crawford Reference: SU1903345

**Uplands Residents Management Company
Flats 1 & 3
Uplands Court
19 Frithwood Avenue
Northwood
HA6 3LY**

SUBSIDENCE CLAIM

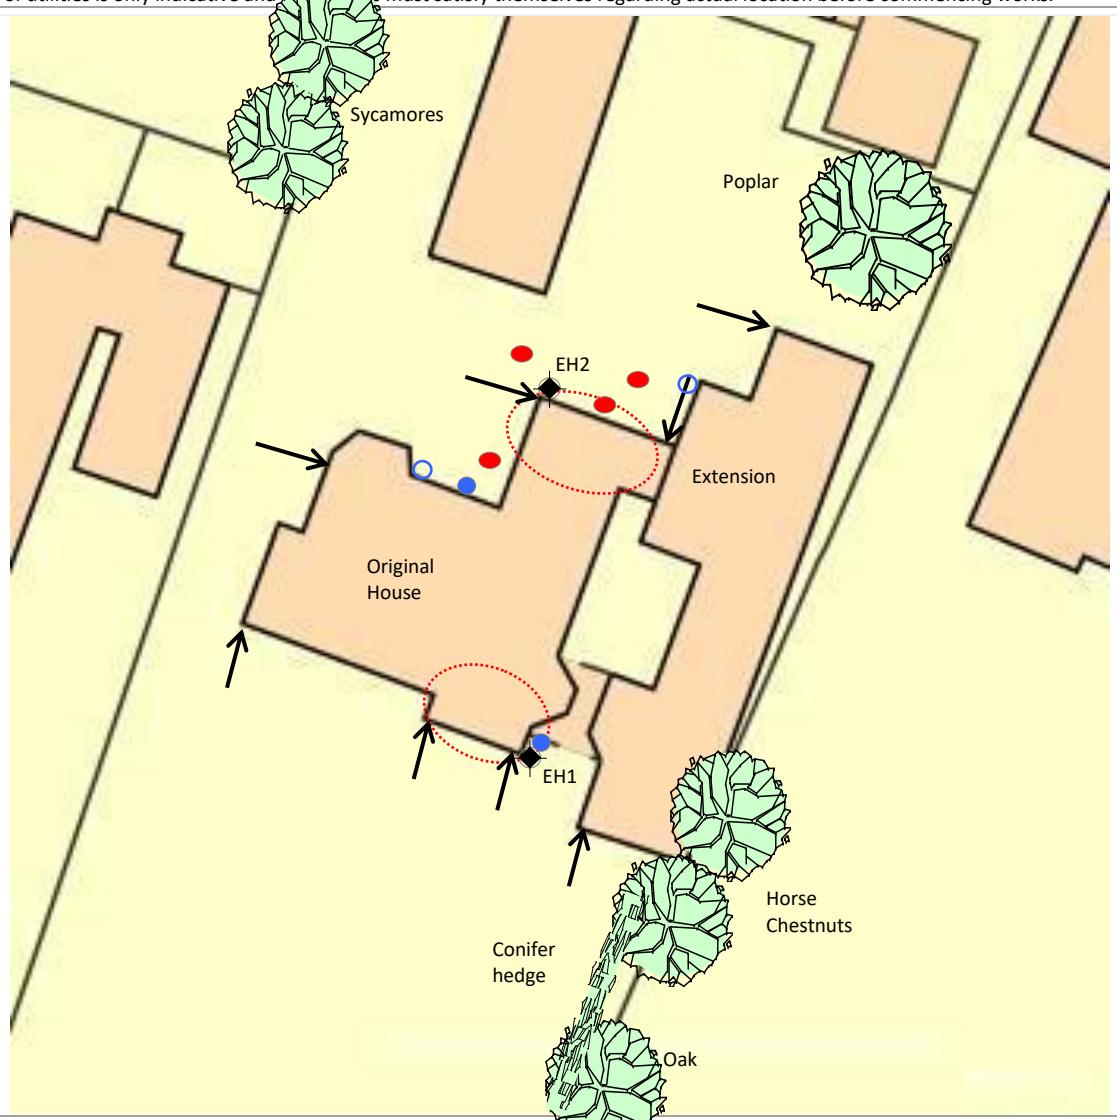
Site Plan
This plan is Not to Scale

A trial hole was excavated to expose the foundations - see site plan for location and the diagram below for details.

Trial hole 01 was completed to the front right corner of the building in September 2019. The trial hole revealed a concrete trench fill foundation bearing on to a dry very stiff brown fine to medium gravelly CLAY.
