**TECHNICAL REPORT ON A SUBSIDENCE CLAIM**

**Crawford Reference: SU1903345**

**Flats 1 & 3 Uplands Court,  
19 Frithwood Avenue  
Northwood, HA6 3LY**

23<sup>rd</sup> August 2019

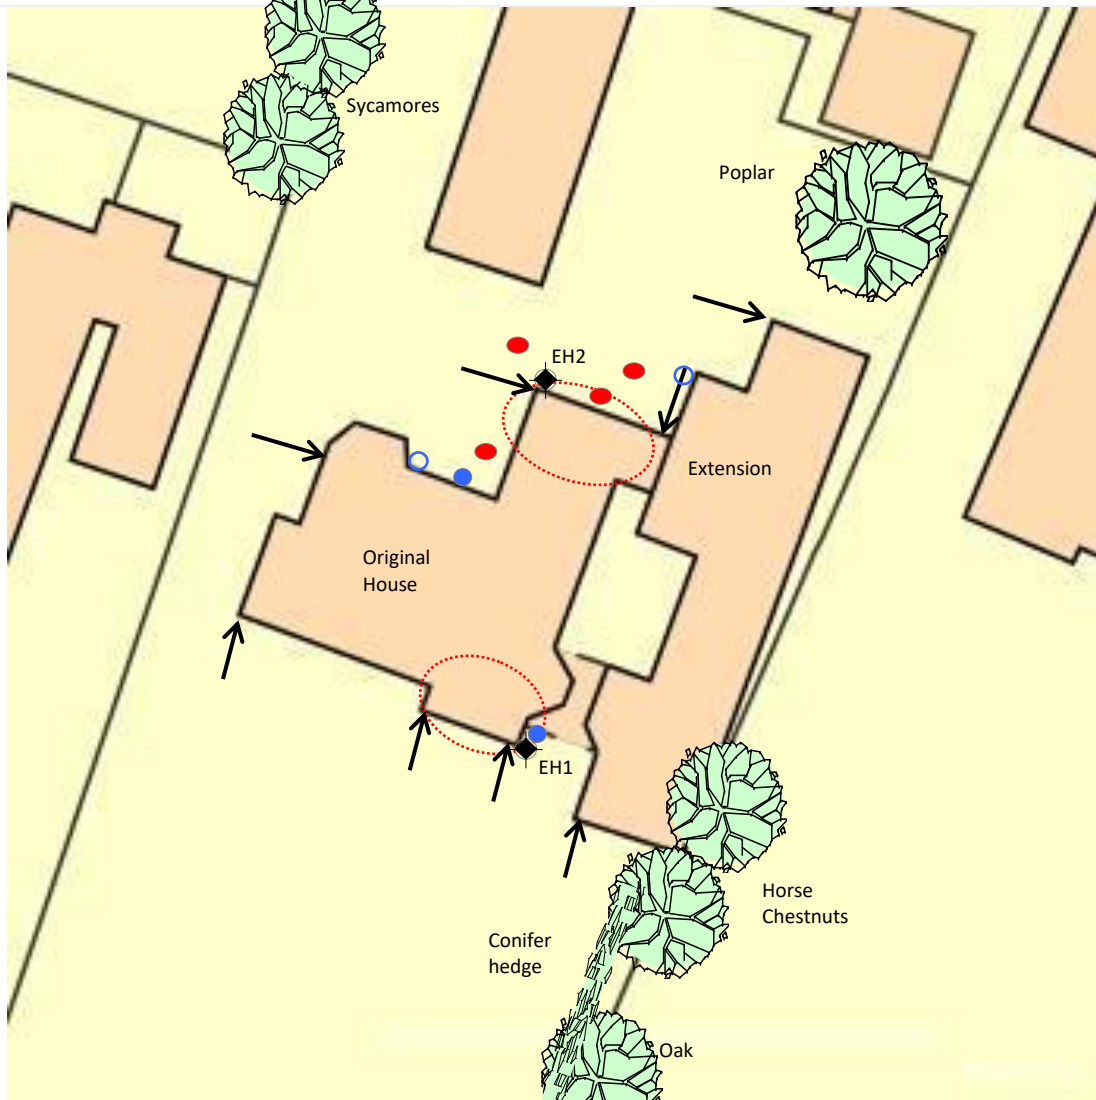
Site Plan

The areas of damage are the front right elevation and the rear elevations of Flats 1 and 3.

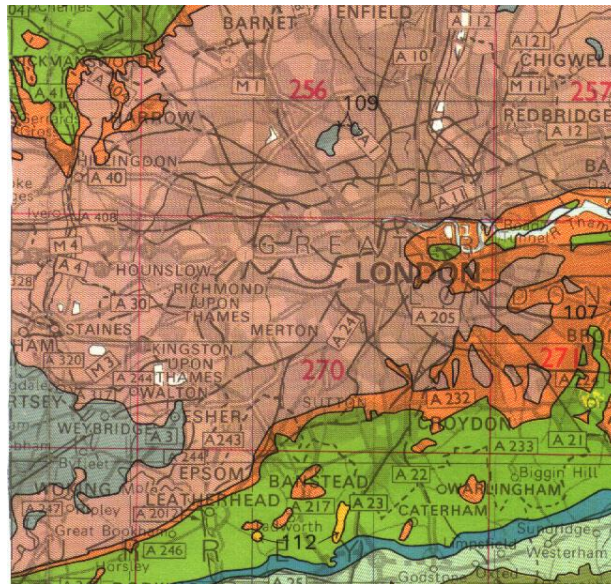
See sketch. Tree roots can be troublesome in cohesive (clay) soils because they can induce volumetric change. They are rarely troublesome in non-cohesive soils (sands and gravels etc.) other than when they enter drains, in which case blockages can ensue.
