Arboricultural Consultancy for Aviva / Barclays / Woolwich

1. Case Details

Insured	Mr Amit Karia	Address	16 Deerings Drive, Pinner, HA5 2NZ		
Client	Subsidence Management Services	Contact	Ian Domigan	Claim No.	IFS-AVI-SUB-22-0101567
ES Ref	SA-250316	Consultant	Giles Mercer	Contact No.	0330 380 1036
Report Date	26/09/2022

16 Deerings Drive, Pinner, HA5 2NZ

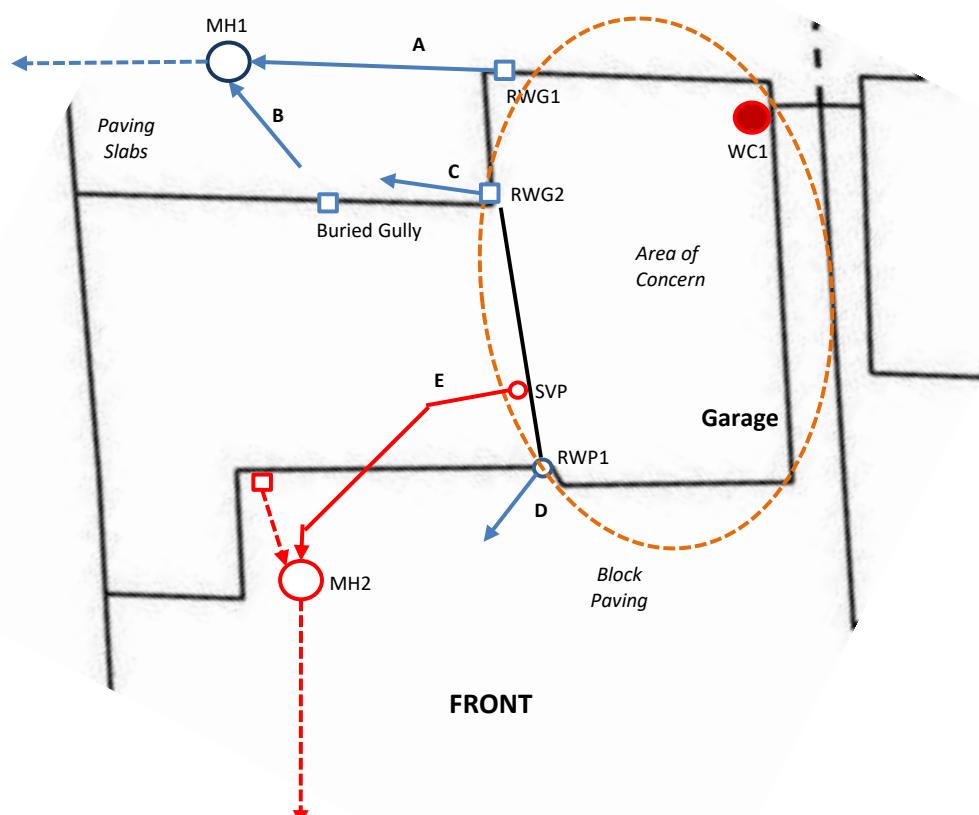
RUN	Start From :	MH1	Finish at :	RWG1	Pipe Ø:	100mm
A	Invert Level (m):	N/a	Invert Level (m):	N/a	Material:	Plastic
COMBINED	Condition grade:	B	Direction:	Upstream	Responsibility:	Home Owner
Distance	Code	Hydraulic Test - Fail

0.00	SN	Start Node from MH1				
0.00	WL	Water Level 0%				
5.08	JN	Junction at 9 o'clock to WC				
5.37	JDM	Joint Displaced (Medium)				
5.47	FN	Finish Node at RWG1				
RUN	Start From :	MH1	Finish at :	BURIED GY	Pipe Ø:	100mm
B	Invert Level (m):	N/a	Invert Level (m):	N/a	Material:	Clay
STORM	Condition grade:	B	Direction:	Upstream	Responsibility:	Home Owner
Distance	Code	Hydraulic Test - Not Tested
