Reference No: PS - 1386

# Roof Condition Report

The Furze – External

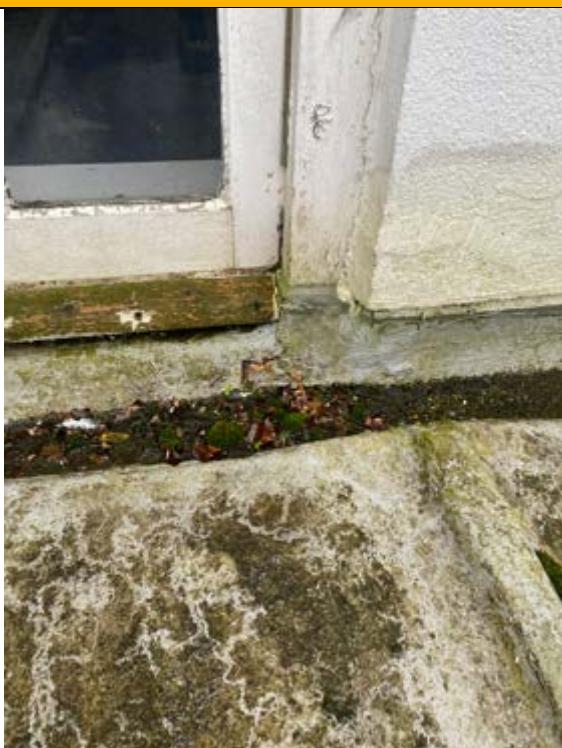
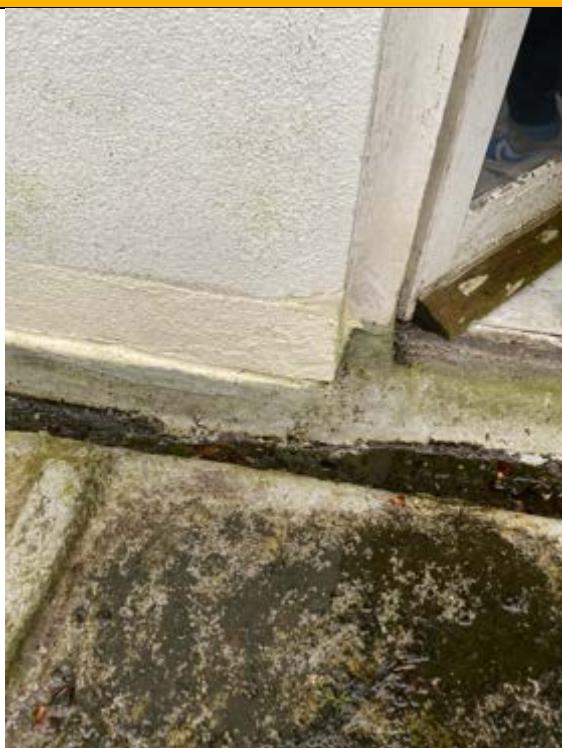
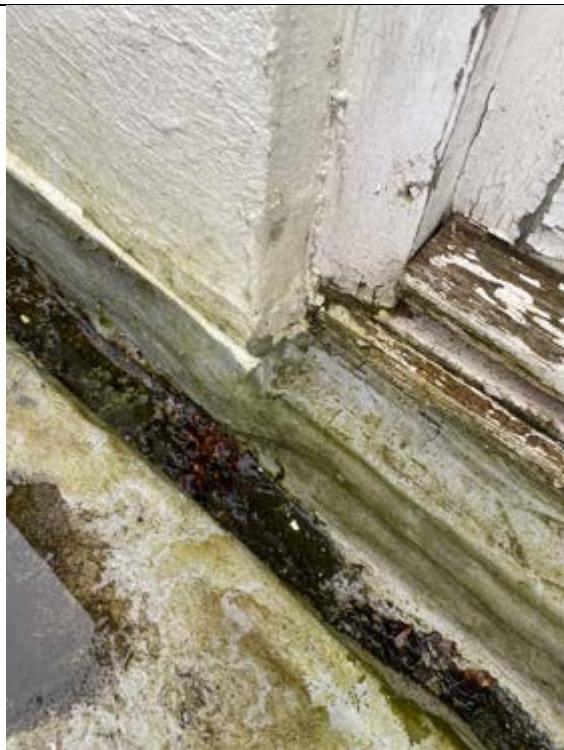
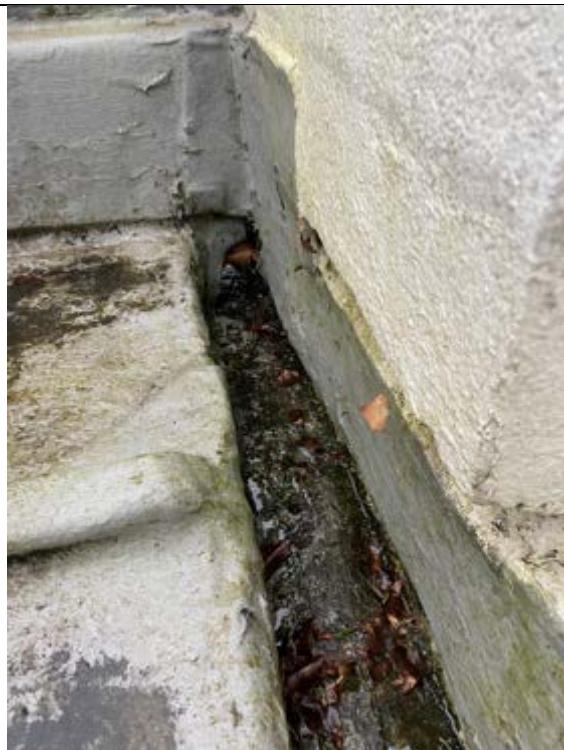
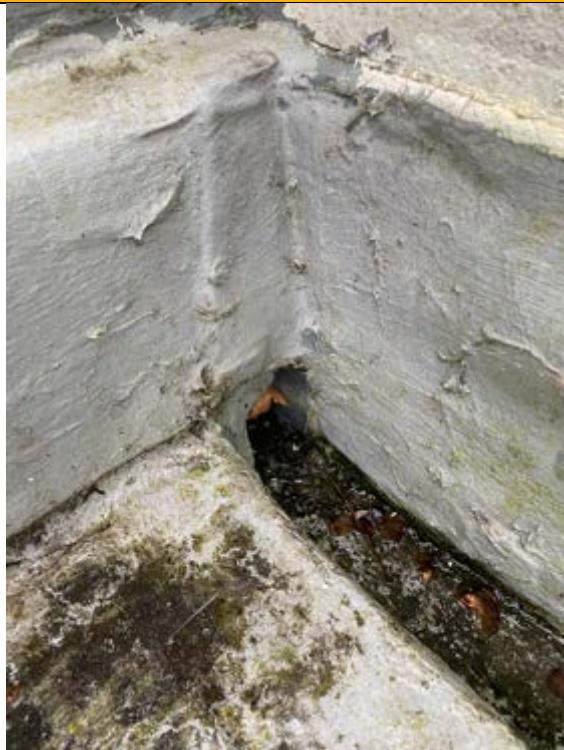
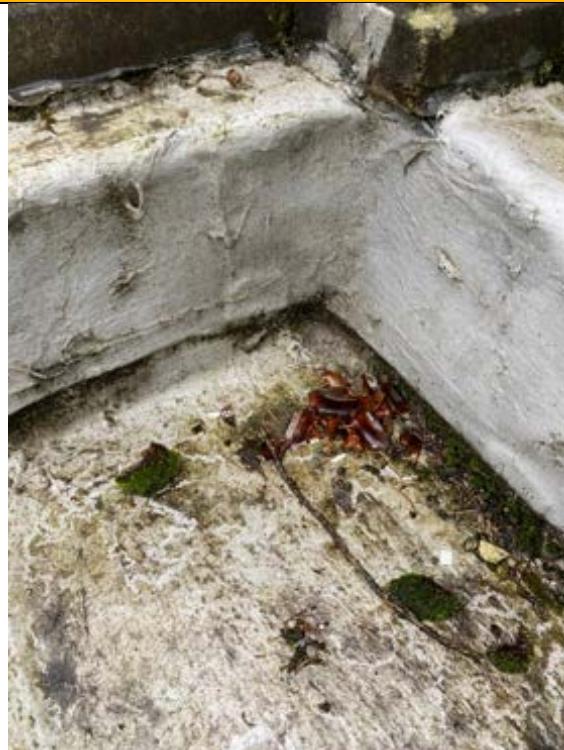
Number	Action/Cause	Appendix B
1.	<p>Painted Lead Roof Terrace 01C:</p> <p>The lead roof terrace has been subject to remedial works over time and been painted with a fibreglass reinforced liquid membrane. Cracking and splits can be viewed on the upstands/terminations and at points of the door thresholds along the terrace. This would lead to water travelling behind the liquid membrane and this product is incompatible with lead due to the thermal expansion and contraction which occurs with lead at different temperatures. The terrace falls back towards the building and the rain water gully appears to be flat with one outlet leading on to Flat Roof 01A. The gully could not be fully inspected due to debris however assumption would be significant rainfall would result in the gully overflowing and the thresholds would be compromised and appear to show historic signs of this.</p>	1 - 12

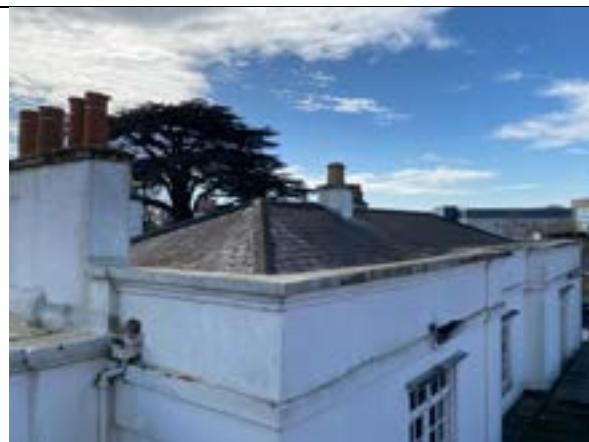
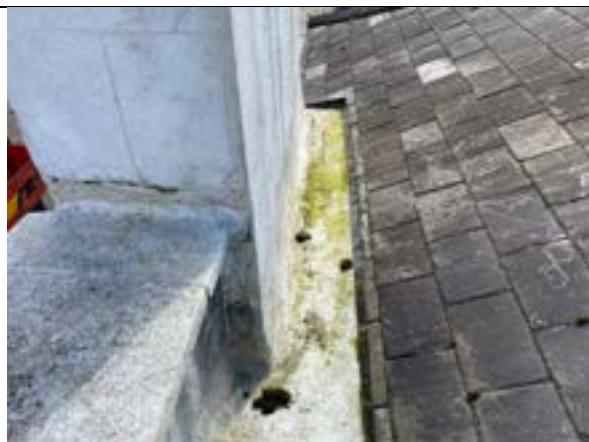
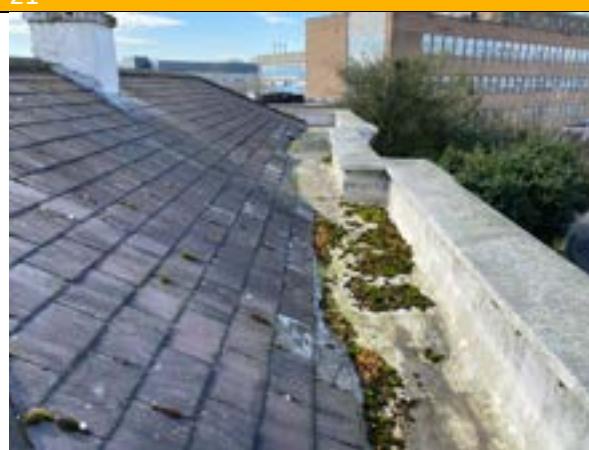
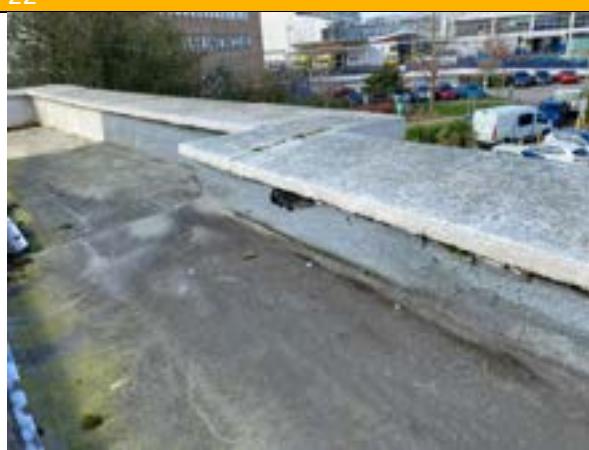
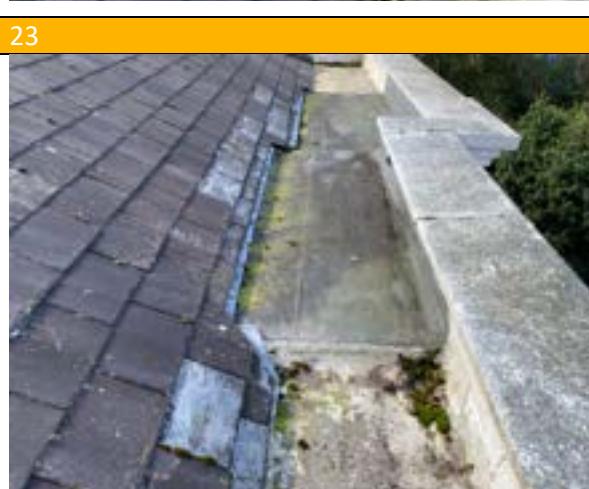
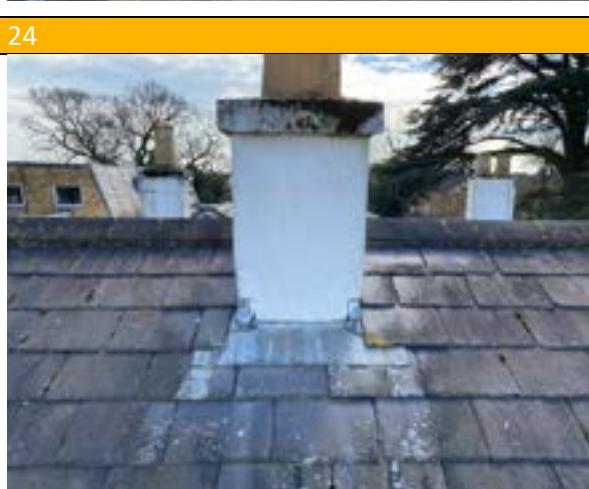
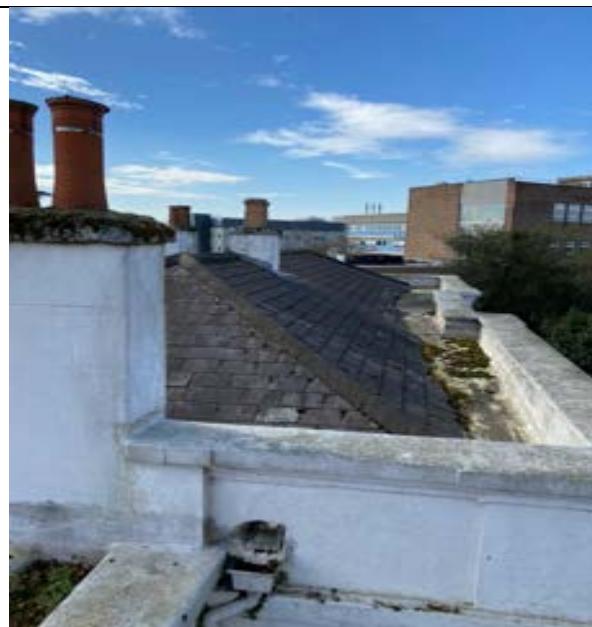
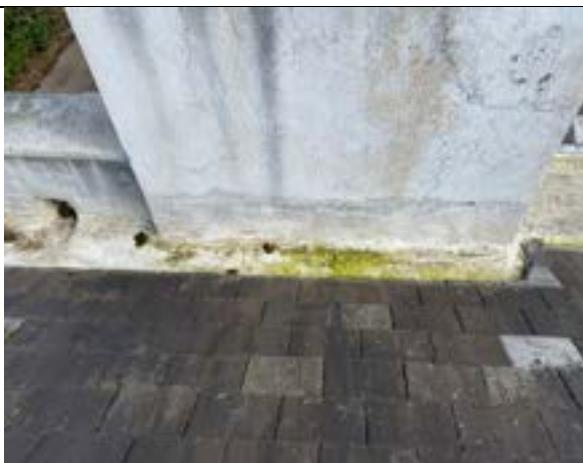
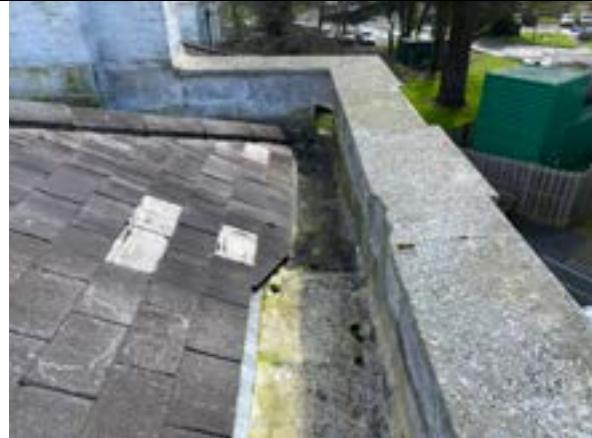
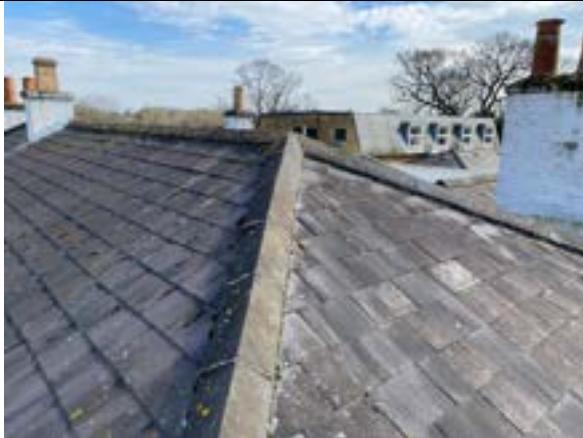
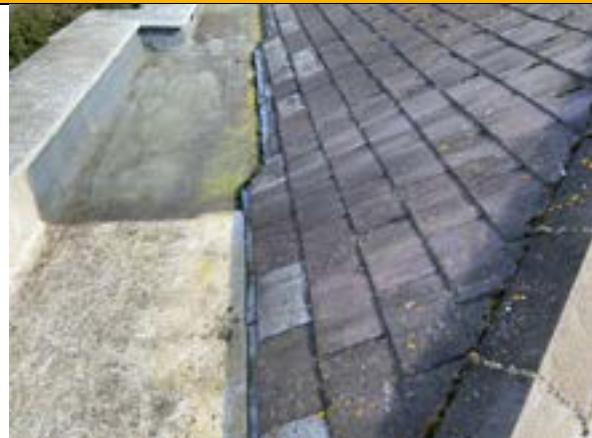
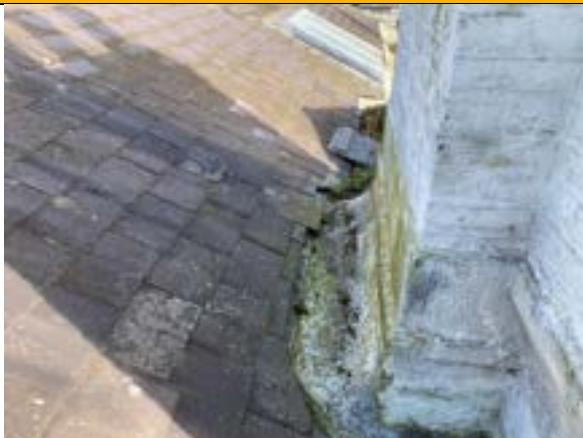
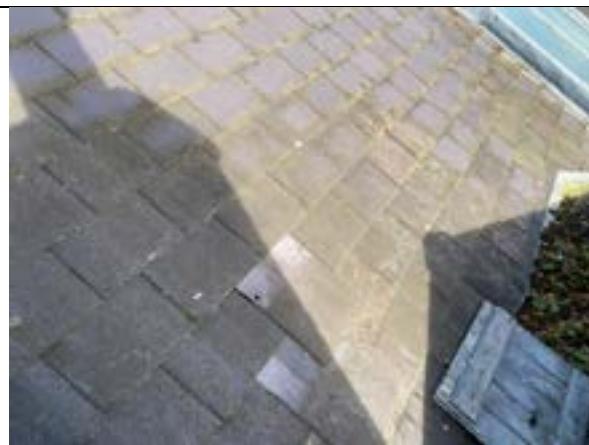
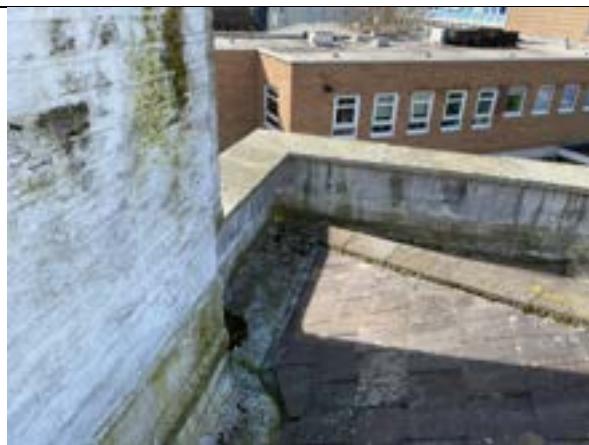
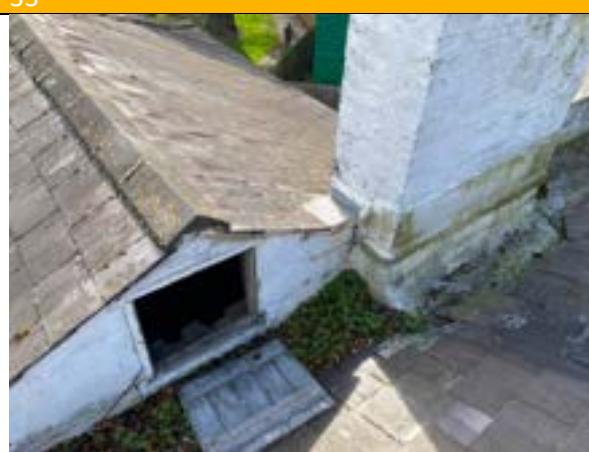
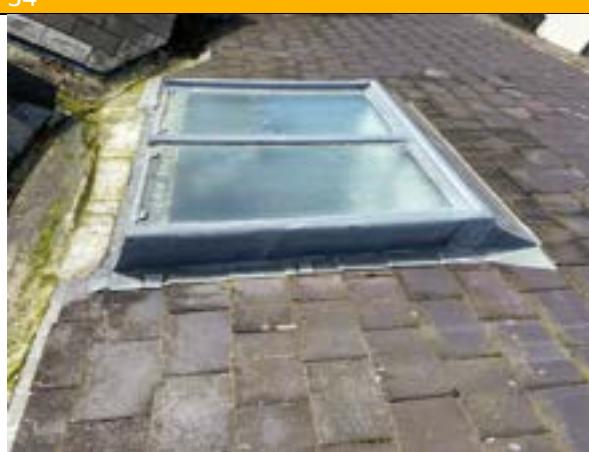
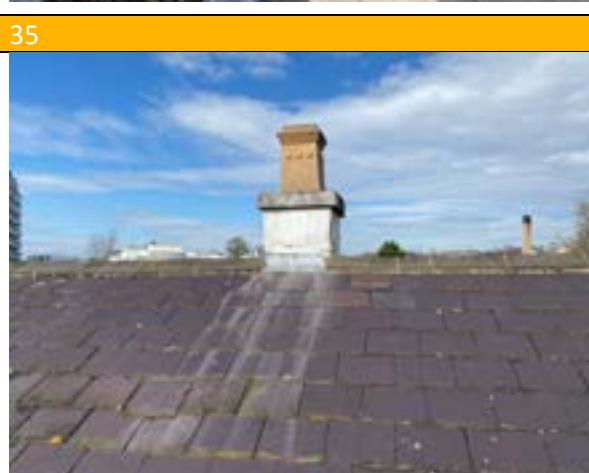
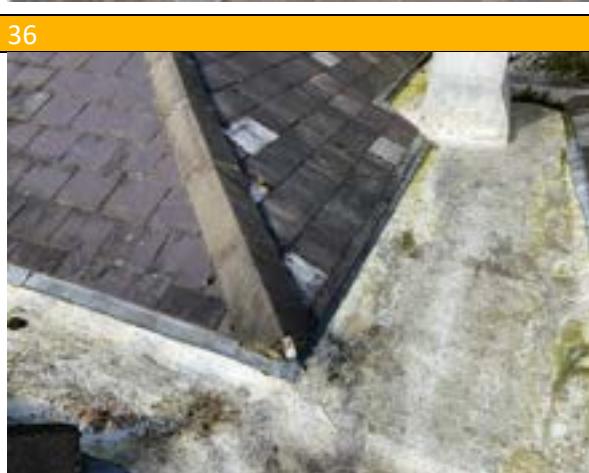
3.	<p>Slate Roof 01:</p> <p>This is the main roof above the front entrance so must be assumed it forms part of the oldest section of the building, this appears to be in keeping with visuals from the internal survey of the same area. There have been repairs over time to the slates, the upstands onto the parapet, the parapet themselves and also the perimeter which frames the slate roof down onto the parapet.</p> <p>Repairs are also evident to the chimney stacks, there is one to the rear right one to the front left and a central chimney.</p> <p>Historically there was severe ingress resulting in internal damage to room 40.0, this appears to have been repaired at some point using new slates, lead flashings under the slates and it has been heavily coated in a liquid membrane and onto the parapet upstands. That liquid repair has failed over time and it is assumed that it is the cause of continuing ingress to that area</p>	21 - 38

<p>The lead flashing around the central chimney stack appears to be in reasonable condition and there is no signs of ingress internally in this area.</p> <p>The upstands on the other two chimneys present on the roof have been heavily treated with a liquid membrane preventing adequate inspection of the masonry however it is assumed these have been historic issues due to the presence of the liquid treatment.</p> <p>The rear chimney stack terminates on the junction between this roof and Slate roof 09 and there is heavy build up of vegetation, lichen and moss. There is also a wooden access hatch to the roof space and this has become detached leaving it open to the elements.</p> <p>The lead flashings of the rear double skylight appears to be in good condition however there is heavy algae and lichen build up in the gully directly beneath onto slate roof 09 suggesting the rainwater doesn't drain adequately from that area.</p> <p>The ridge and hip slates appear to be in reasonable condition however there are a number of slates that require replacing or repositioning and when this is undertaken further inspection should be given to the ridge and hips whilst on the roof.</p>

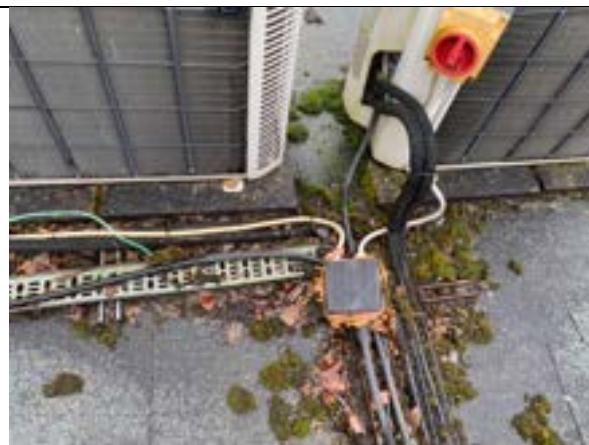
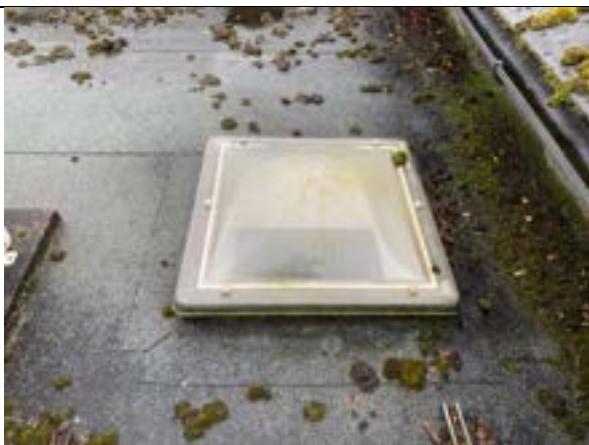
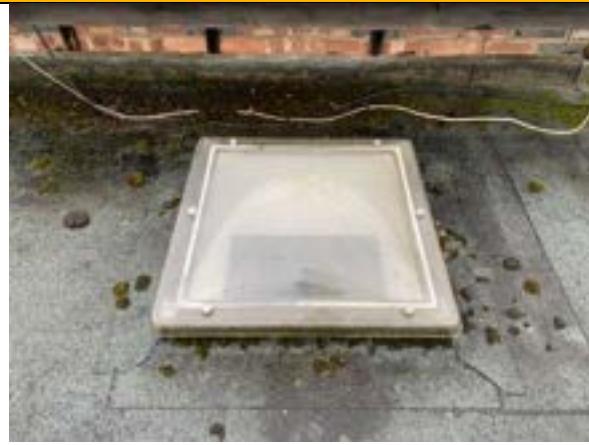
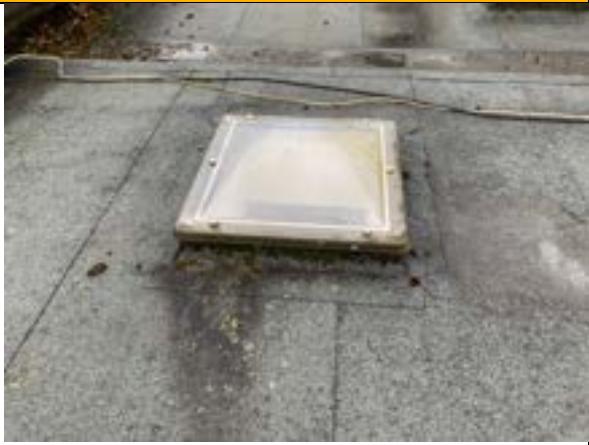
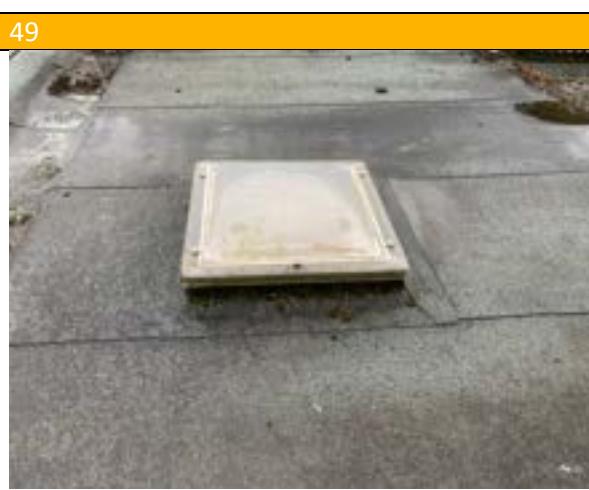
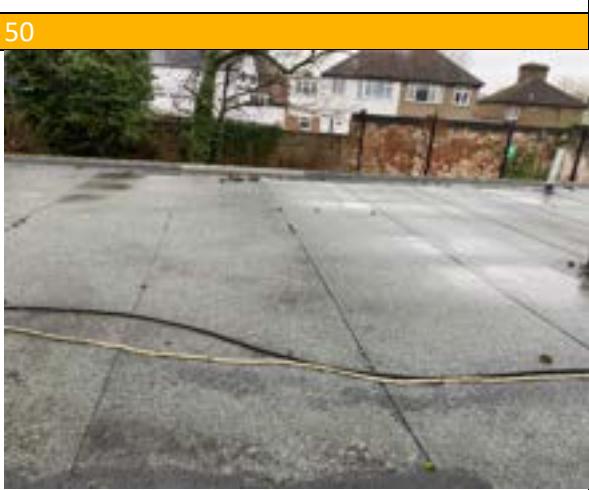
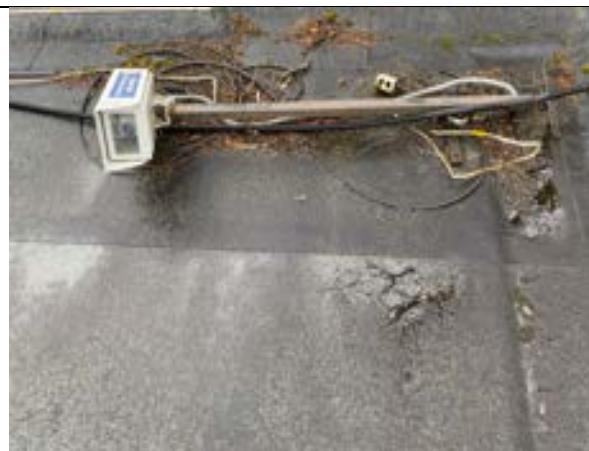
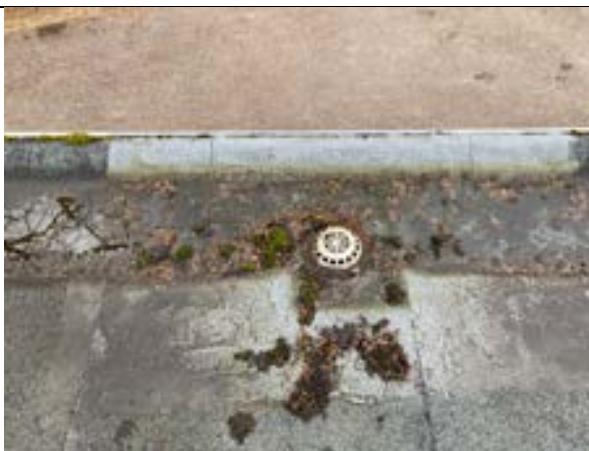
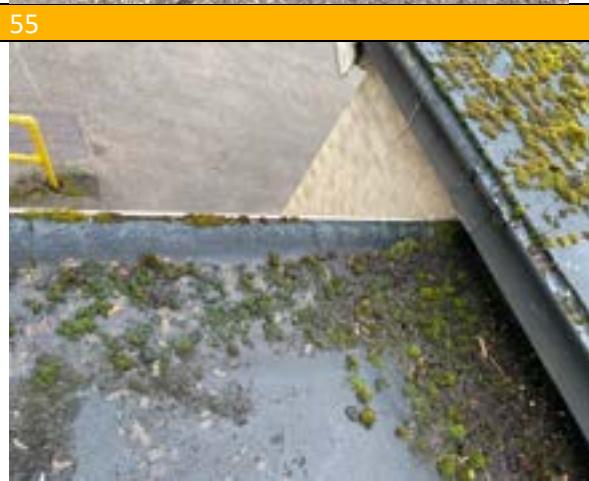
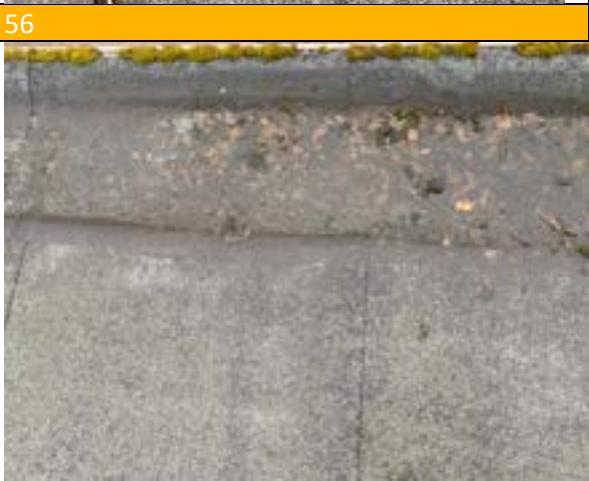
5.	<p>Flat Roof 02A:</p> <p>The roof is constructed of a bituminous membrane assumed on a timber deck. It is at the end of its normal lifespan and severe cracks and defects are visible throughout. The roof appears to have some damage to the substrate due to undulations and it is assumed at some point water have penetrated the system resulted in damage to the substrate beneath. There are defective laps on the upstands of the sides of the valley gutters in</p>	47 - 82

<p>the centre of the roof and these defects will also allow rainwater to penetrate beneath the membrane.</p> <p>The roof is heavily soiled with moss, debris, redundant plant and the rainwater goods appear blocked as a result.</p> <p>The cappings and upstand are split and cracked in various places also allowing ingress.</p> <p>Numerous repairs appear to have been undertaken over time to lead flashings on upstands and liquid repairs to the flat areas around the outlets. Repairs have been carried out to a vent pipe which the rubber has degraded and cracked and will be a point of ingress.</p> <p>The grp rooflight covering the void below has been replaced in time however has been cracked in various places and requires replacement.</p>
