Reference No: PS - 1381

Roof Condition Report

The Furze – Internal

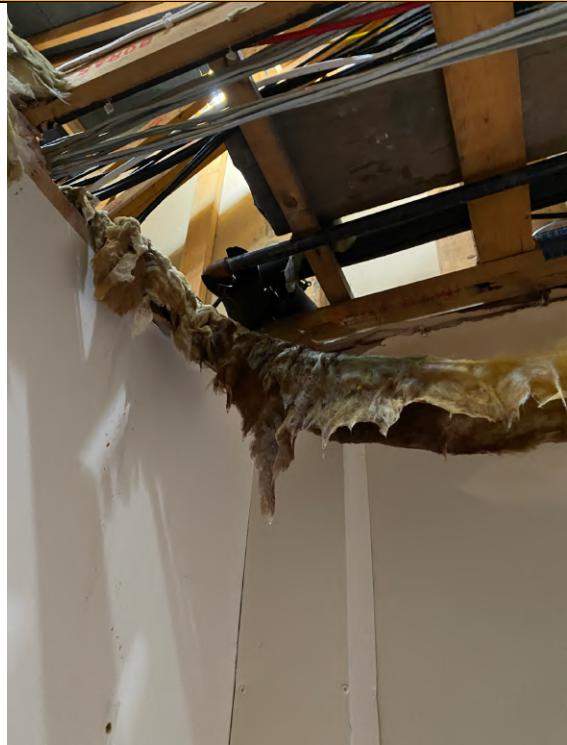
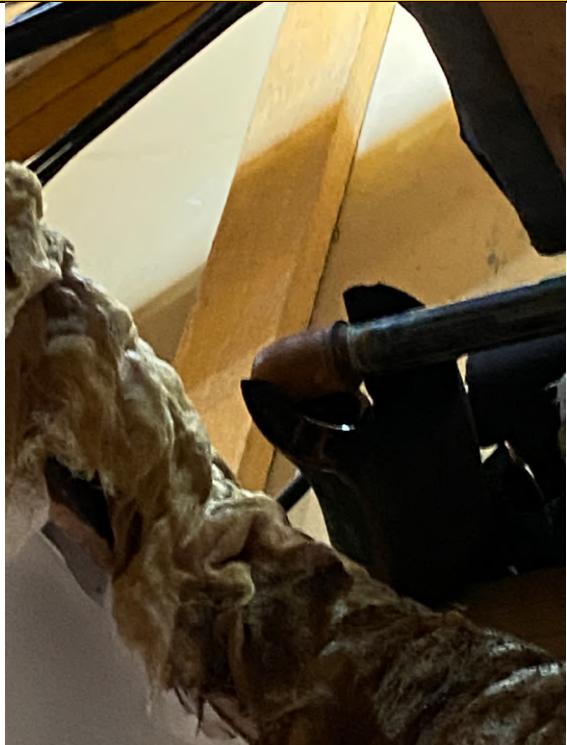
2 – Slate Roof 07 Room 10.5

Number	Action/Cause	Appendix B
1.	<p><u>Ground Floor Level:</u></p> <p>Slate Roof 07 –</p> <p>Damage above Room 10.5 caused by damaged valve on water pipe above as shown.</p> <p>Higher levels of light penetration than one would expect links in with external images showing dilapidated timber fascia's surrounding Slate roof 07. Roof is otherwise dry.</p> <p>Slate Roof 03 –</p> <p>Roof above Audiology suite difficult access to reach eaves however exploratory hatch shows pitched slate roof installed straight onto existing flat roof build up, no visible sign of ingress from hatch joists appear in fair condition.</p> <p>Courtyard –</p> <p>Poor detailing on fascia boards and damp visible on lintel above window of 19.3 due to detailing. Loose slates and poor allowance for pipework to enter adjacent roof will all contribute to ingress in adverse weather conditions.</p>	1 – 6 7 – 14 15 – 21 22 – 24

The defect found above room 10.5 from the internal pipework failure is indicative of other services viewed and it is advisable to undertake a full mechanical and electrical survey of existing services to include all internal plumbing.

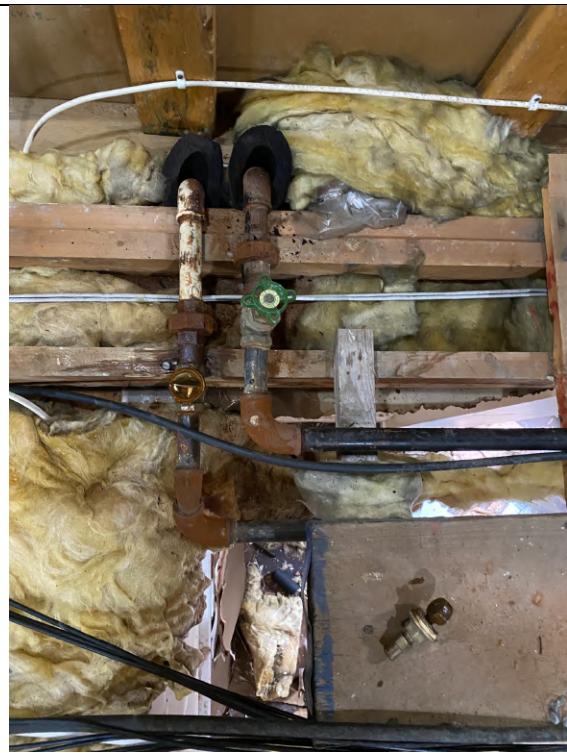
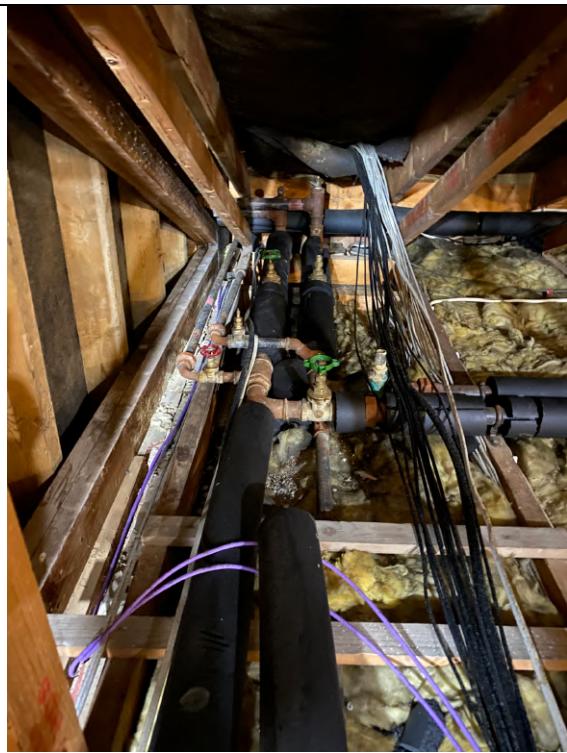
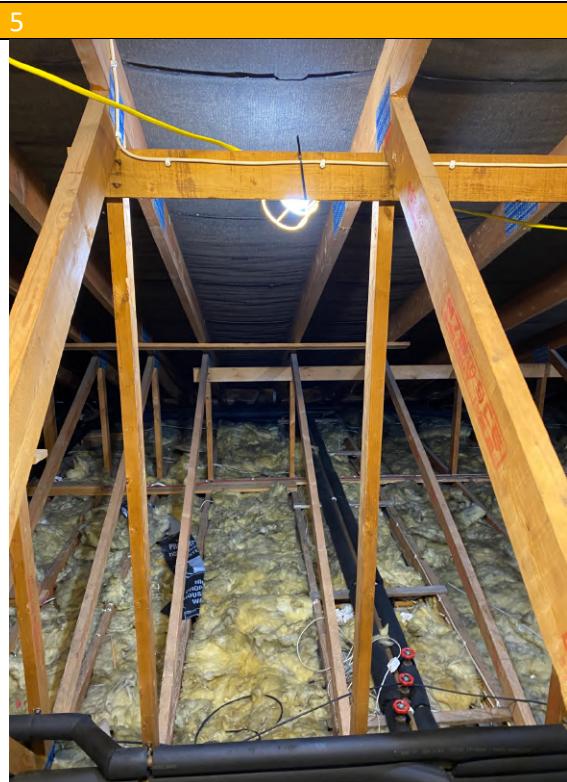
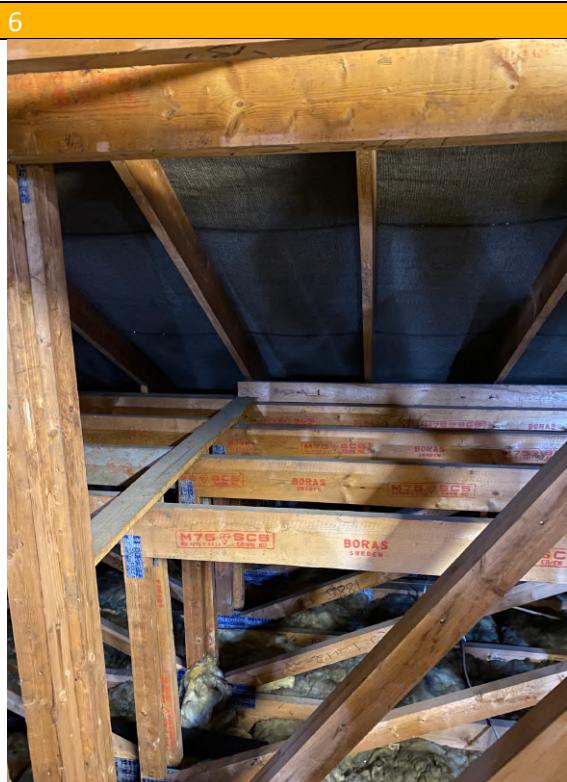
The visible section under slate roof 07 is in fair condition but for the eaves exposure to the elements, this will be addressed and closed in line with external works to the soffits/fascias and any damaged or slipped slates.

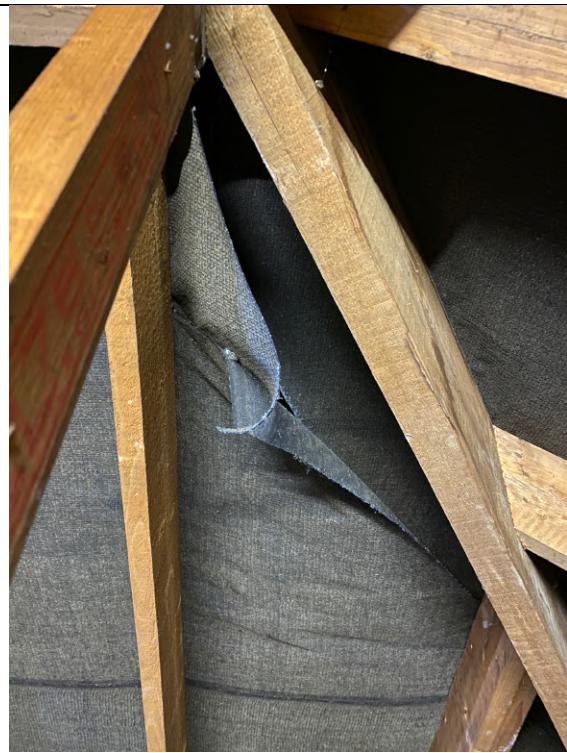
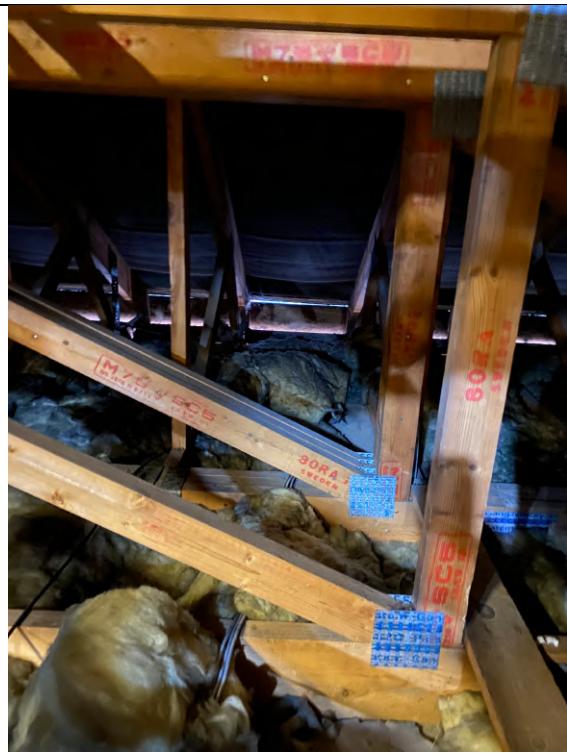
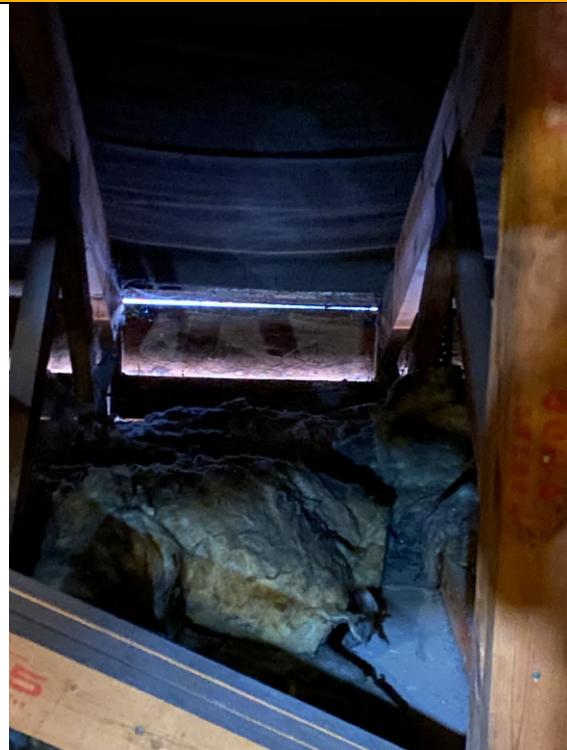
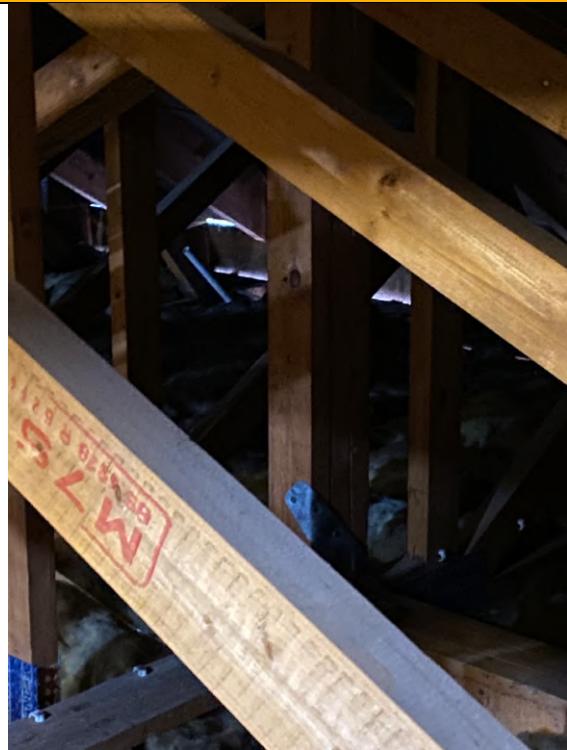
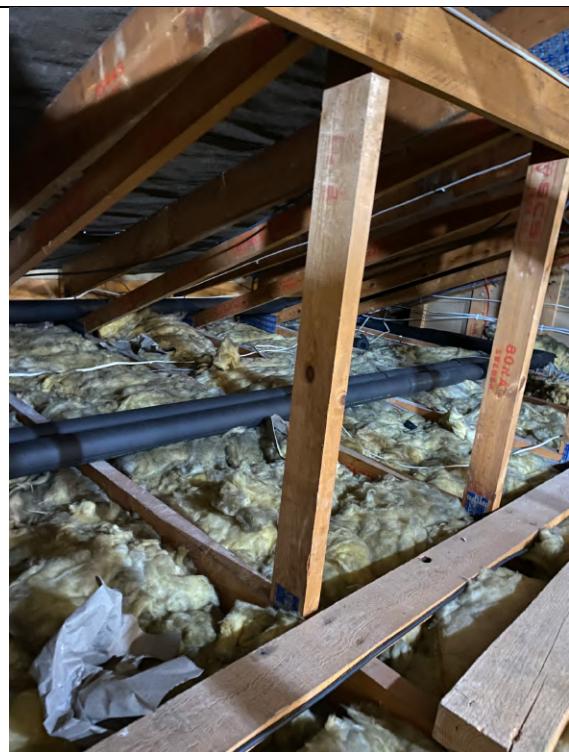
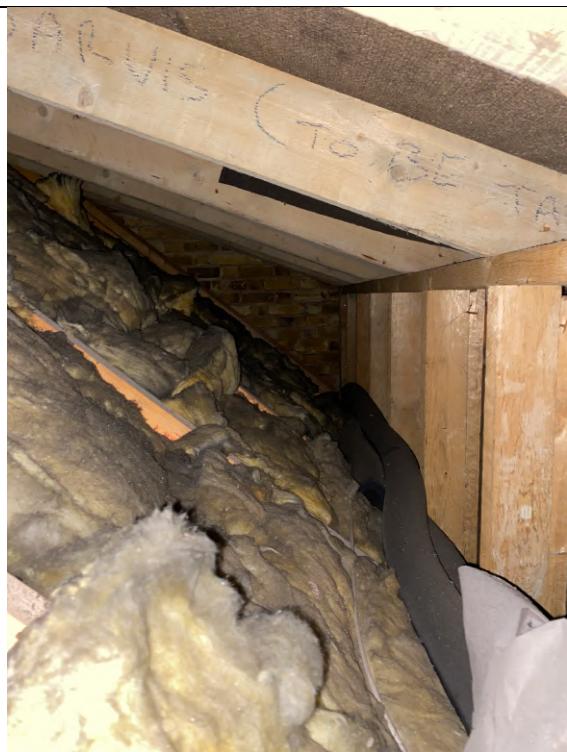
The ventilation in the roof space appears to be sufficient in the areas viewed, however there are defects shown in the images where the fascias/soffits have failed therefore failures have occurred and extensive daylight can be viewed from the roof space. Despite this it does not appear that nesting birds have taken advantage of these defects and there was no sign of guano or nests in any areas viewed.

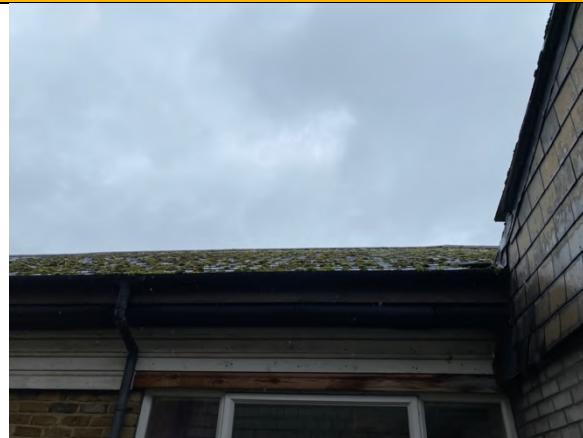
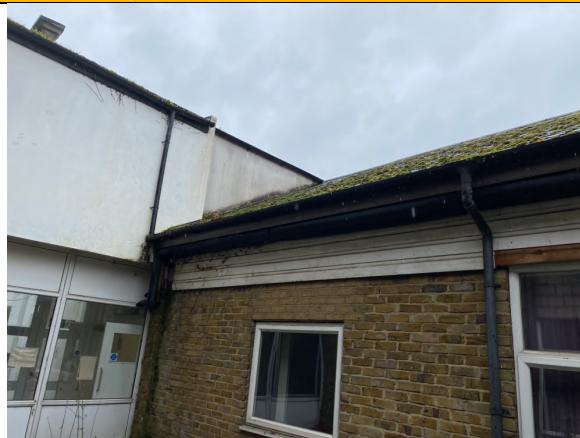
The Courtyard defects will be addressed within the external roofing works, however if future consideration is given to replacing the windows in room 19.3 the lintel should be inspected to determine if any damage has been caused by the poor external detailing.

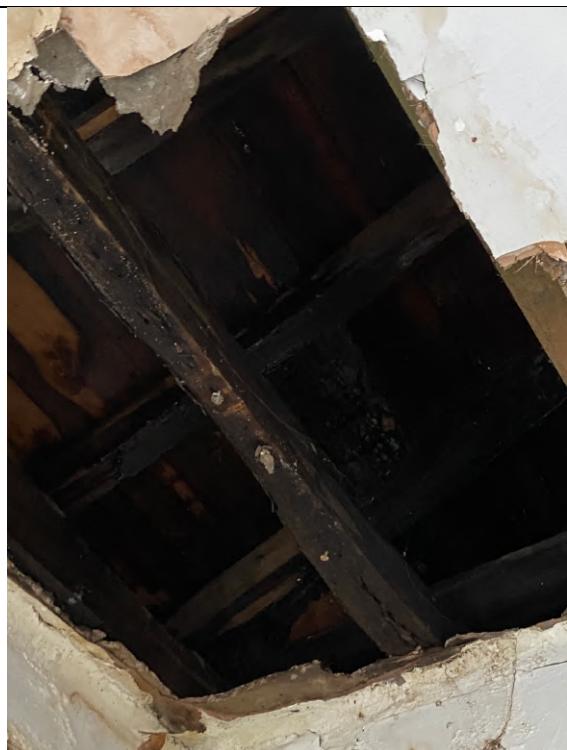
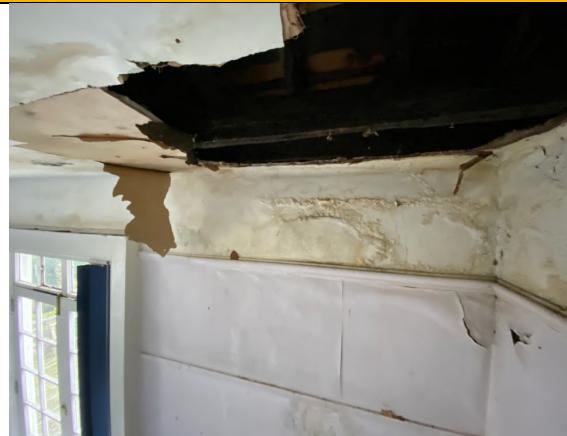
2.	<p><u>First Floor Level:</u></p> <p>Room 40.0 –</p> <p>Historic ingress from Slate Roof 01 present in room 40.0, exposed panel shows damage to beams and substrate of this section. Consistent with images from Slate Roof 01 of patch repair. Ingress damage extends to corner of roof above room 11.5.</p> <p>Room 29.5 –</p> <p>Hatch shows chimney stack above to centre of Slate Roof 01, appears to be in reasonable condition and the ceiling above room 29.5 has been completed replaced, no information has been given for this.</p> <p>Office 9.4 –</p> <p>Extensive water damage to ceiling consistent with upstand detailing on Flat roof 01A, no panel exposure available to view substrate.</p>	25 – 38 39 – 41 42 – 43

The historic ingress caused by the defects on Slate Roof 01 has resulted in extensive internal damage to the ceiling and substrate above room 40.0. As this appears to have been poorly repaired externally there is evidence that it remains an ongoing point of ingress which has resulted in damage over a significant period of time to the substrate of the Slate Roof, the beams underneath the ingress and the ceiling below. Assumption of damage to the floor of room 40 under the ingress point is assumed due to the time elapsed however due to a lack of intrusive works this cannot be confirmed.
