Schedule of condition

**The Furze, Hillingdon
Hospital, Pield Heath
Road, Hillingdon UB8 3NN**

Prepared for: Northmores
Prepared by: Chris Baker BSc (Hons) MRICS
Date: 18 September 2023
Reference: 120937-100/MET/CBk

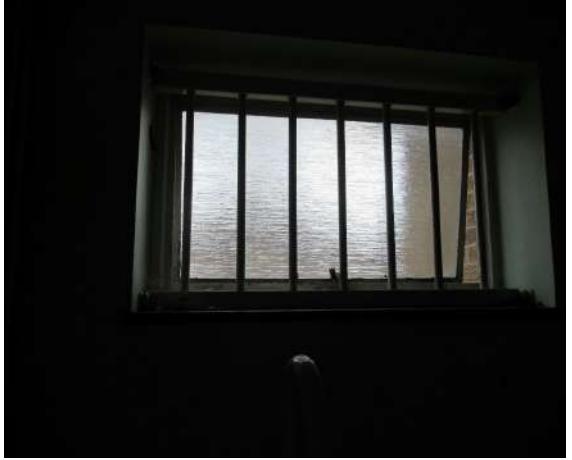
1.	<p>Location: Ground Floor – East elevation</p> <p>Description: Steel frame Crittall window with single glazing and paint finish.</p> <p>Condition: Fair. Operational. Poor paint finish</p>	<p>Element: Internal window 00-01</p>

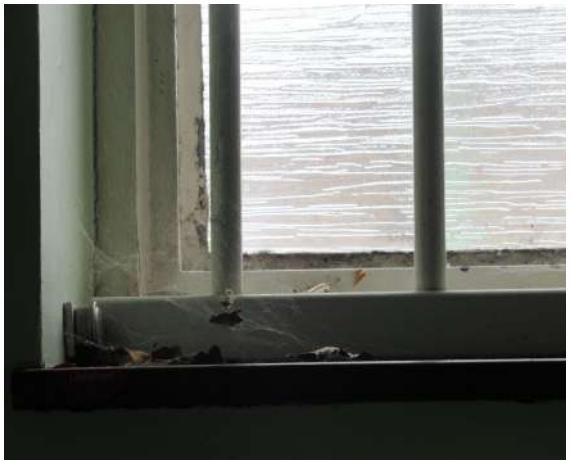
2.	<p>Location: Ground Floor – East elevation</p> <p>Description: Steel frame Crittall window with single glazing and paint finish.</p> <p>Condition: As above. As above.</p>	<p>Element: Internal window 00-01</p>

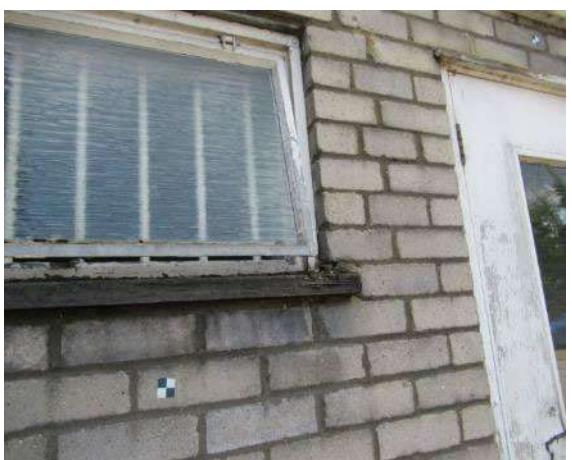
3.	<p>Location: Ground Floor – East elevation</p> <p>Description: Steel frame Crittall window with single glazing and paint finish.</p> <p>Condition: Poor. Decay to the entire timber sill. Defective sealant. Poor paint finish.</p>	<p>Element: External window 00-01</p>

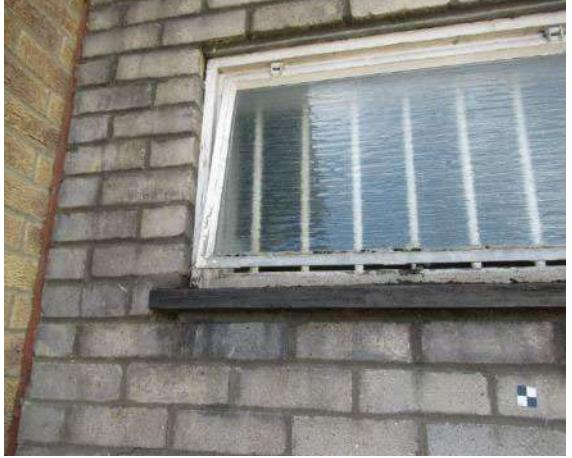
4.	<p>Location: Ground Floor – East elevation</p> <p>Description: Steel frame Crittall window with single glazing and paint finish.</p> <p>Condition: As above.</p>	<p>Element: External window 00-01</p>

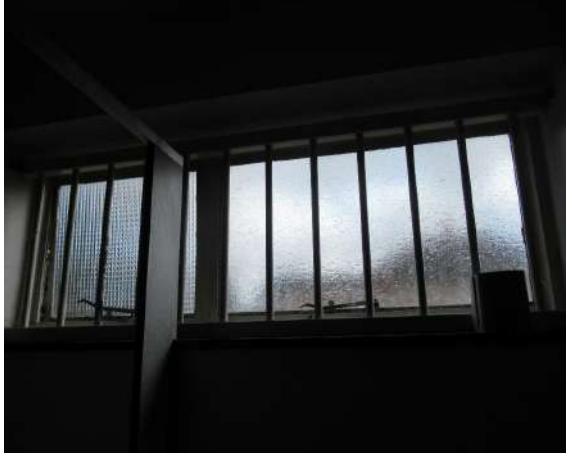
5.	<p>Location: Ground Floor – East elevation</p> <p>Description: Steel frame Crittall window with single glazing and paint finish.</p> <p>Condition: Fair. Operational. Poor paint finish.</p>	<p>Element: Internal window 00-02</p>

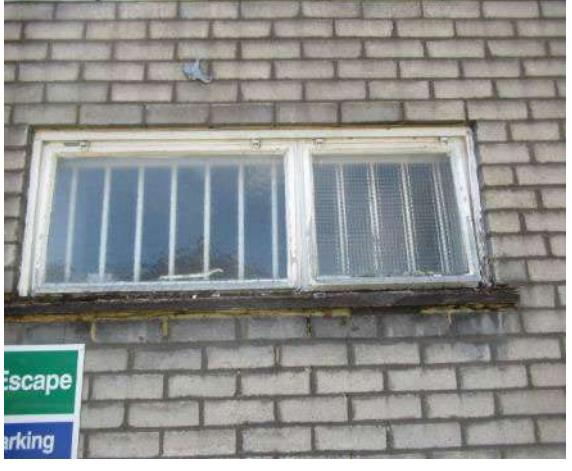
7.	Location: Ground Floor – East elevation Description: Steel frame Crittall window with single glazing and paint finish.	Element: External window 00-02
	Condition: Poor. Decay to the entire timber sill. Defective sealant. Poor paint finish.

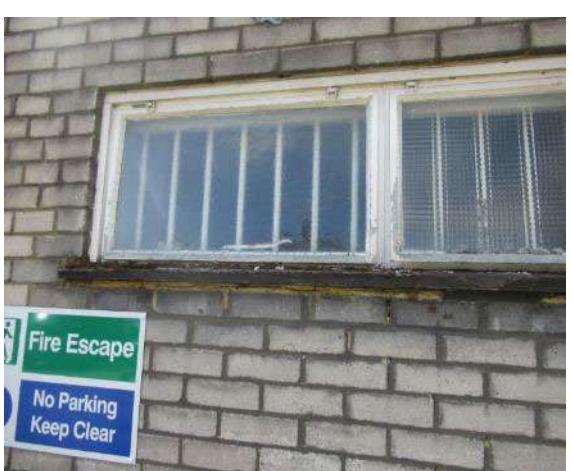
8.	Location: Ground Floor – East elevation	Element: External window 00-02
	Description: Steel frame Crittall window with single glazing and paint finish.

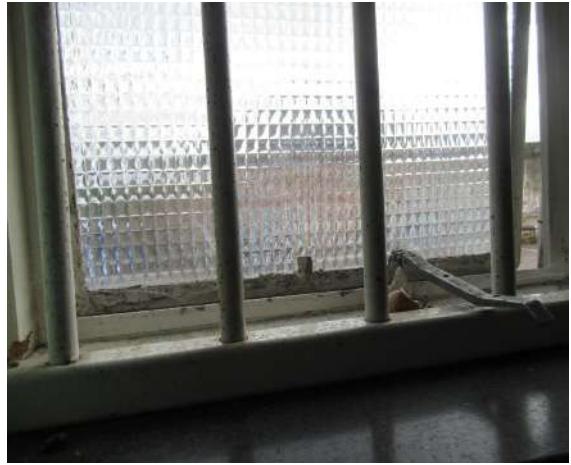
10.	<p>Location: Ground Floor – East elevation</p> <p>Description: Steel frame Crittall window with single glazing and paint finish.</p> <p>Condition: Fair. As above.</p>	<p>Element: Internal window 00-03</p>

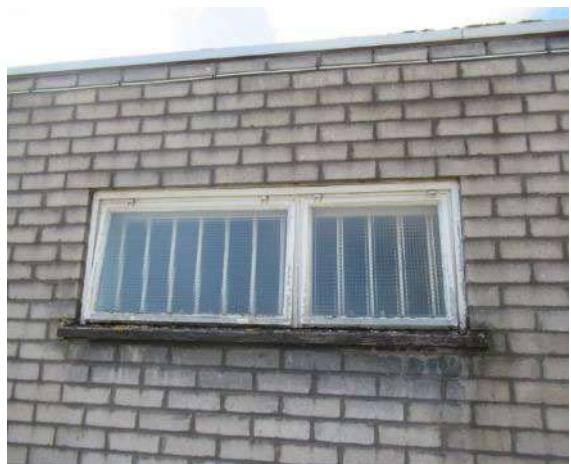
11.	<p>Location: Ground Floor – East elevation</p> <p>Description: Steel frame Crittall window with single glazing and paint finish.</p> <p>Condition: Poor. Decay to the entire timber sill. Defective sealant. Poor paint finish.</p>	<p>Element: External window 00-03</p>

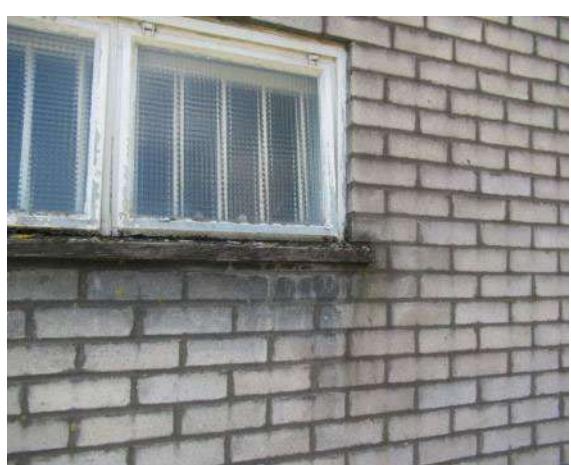
12.	<p>Location: Ground Floor – East elevation</p> <p>Description: Steel frame Crittall window with single glazing and paint finish.</p> <p>Condition: Poor. As above.</p>	<p>Element: External window 00-03</p>

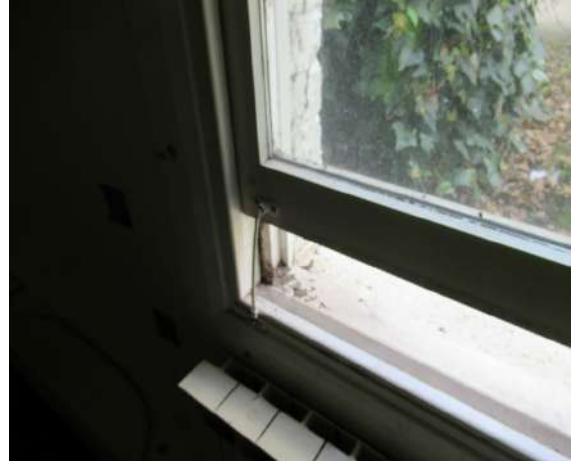
14.	<p>Location: Ground Floor – North elevation</p> <p>Description: Timber frame vertical sliding sash window with single glazing and paint finish.</p> <p>Condition: Fair. As above.</p>	<p>Element: Internal window 00-04</p>

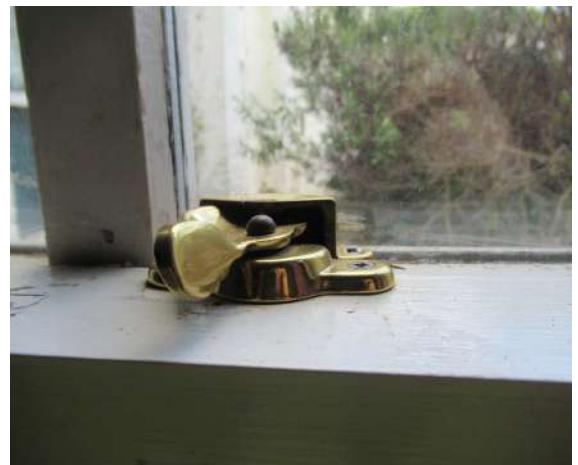
Condition: Fair. Locked shut.	
17.	Location: Ground Floor – North elevation	Element: Internal window 00-05
	Description: Timber frame vertical sliding sash window with single glazing and paint finish.

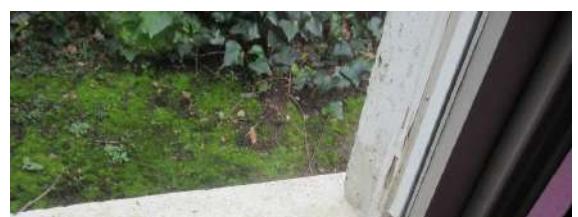
Condition: Fair. As above.	
18.	Location: Ground Floor – North elevation	Element: Internal window 00-05
	Description: Timber frame vertical sliding sash window with single glazing and paint finish.

Condition: Fair. As above.

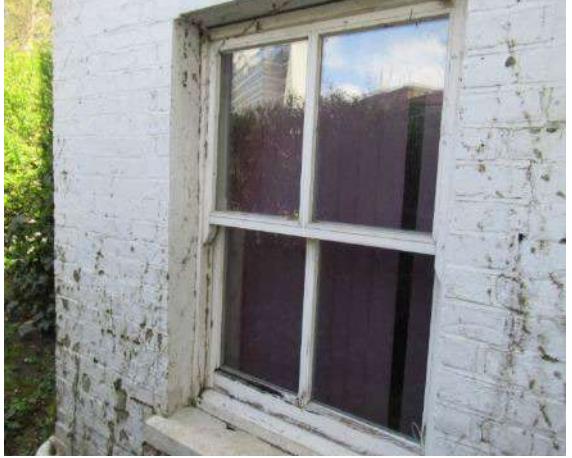
19.	<p>Location: Ground Floor – North elevation</p> <p>Description: Timber frame vertical sliding sash window with single glazing and paint finish.</p> <p>Condition: Poor. Decay to the timber sill and bottom rail. Poor paint finish.</p>	<p>Element: External window 00-05</p>

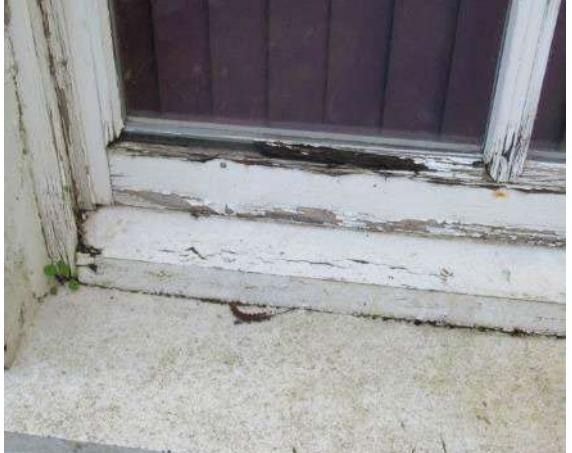
20.	<p>Location: Ground Floor – North elevation</p> <p>Description: Timber frame vertical sliding sash window with single glazing and paint finish.</p> <p>Condition: As above.</p>	<p>Element: External window 00-05</p>

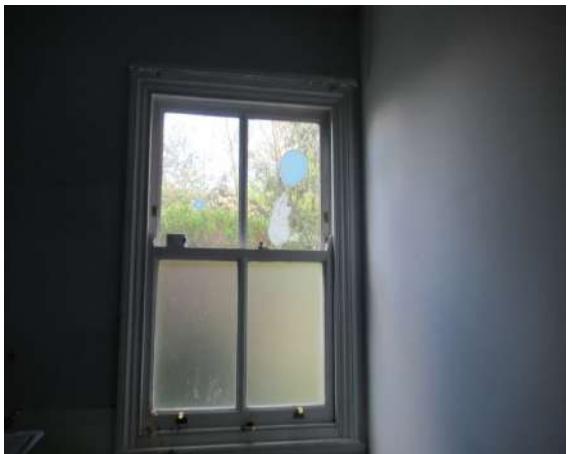
21.	<p>Location: Ground Floor – North elevation</p> <p>Description: Timber frame vertical sliding sash window with double glazing and paint finish.</p> <p>Condition: Fair. Unable to test window secured shut.</p>	<p>Element: Internal window 00-06</p>

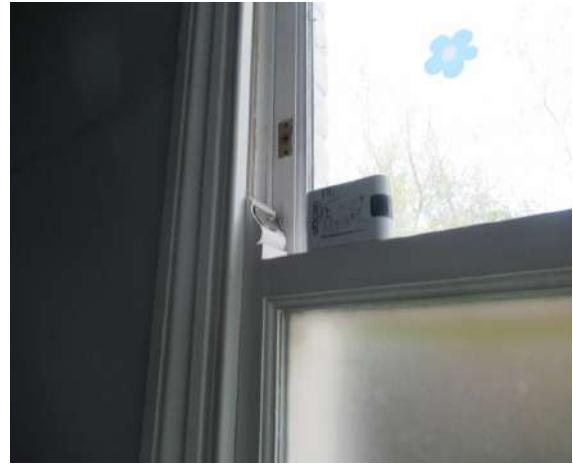
22.	Location: Ground Floor – North elevation	Element: Internal window 00-06
	Description: Timber frame vertical sliding sash window with double glazing and paint finish.

Condition: As above. As above.	
23.	Location: Ground Floor – North elevation	Element: External window 00-06
	Description: Timber frame vertical sliding sash window with double glazing and paint finish.

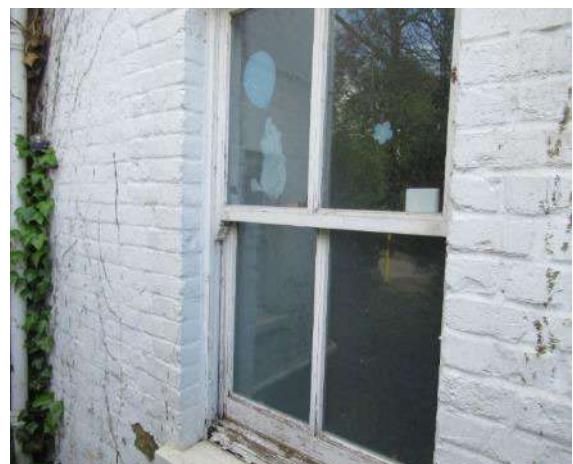
Condition: Poor. Decay to timber sill. Poor paint finish.	
24.	Location: Ground Floor – North elevation	Element: External window 00-06
	Description: Timber frame vertical sliding sash window with double glazing and paint finish.

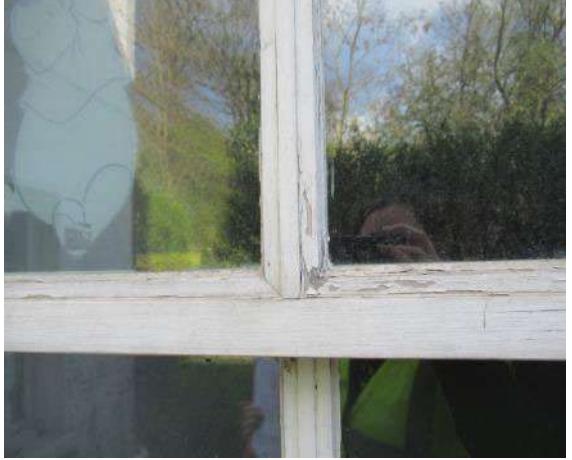
25.	<p>Location: Ground Floor – North elevation</p> <p>Description: Timber frame vertical sliding sash window with double glazing and paint finish.</p> <p>Condition: Poor. As above.</p>	<p>Element: External window 00-06</p>

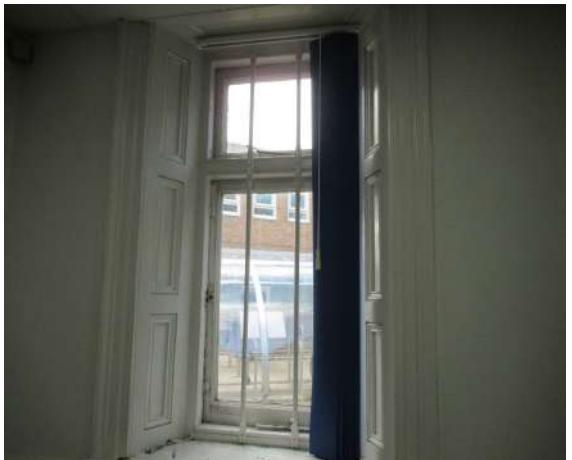
26.	<p>Location: Ground Floor – West elevation</p> <p>Description: Timber frame side hung casement window with single glazing and paint finish.</p> <p>Condition: Poor. Does not operate correctly. Difficult to open and close. Missing catch on lock. Timber shrinkage causing splitting to frame. Poor paint finish.</p>	<p>Element: Internal window 00-07</p>

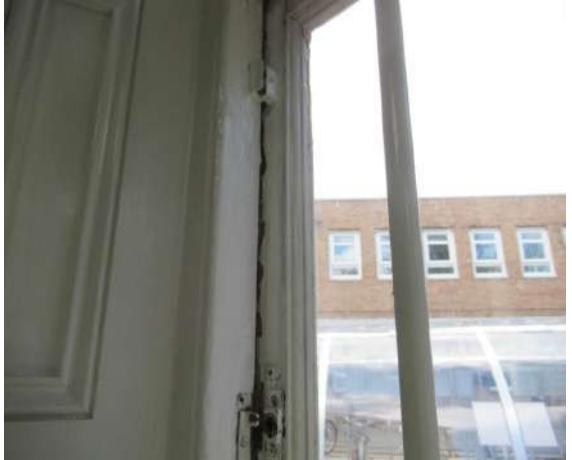
27.	<p>Location: Ground Floor – West elevation</p> <p>Description: Timber frame side hung casement window with single glazing and paint finish.</p> <p>Condition: Poor. As above.</p>	<p>Element: Internal window 00-07</p>

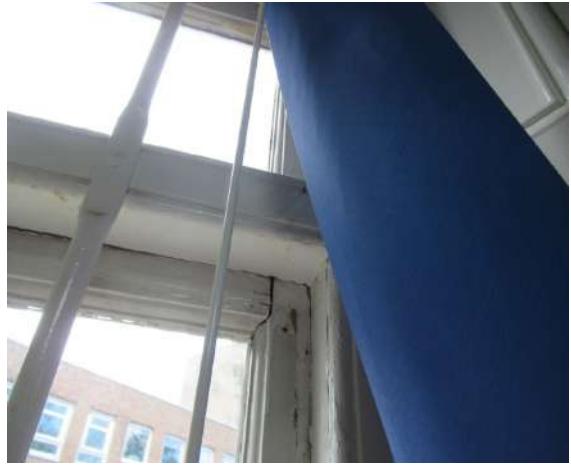
28.	Location: Ground Floor – West elevation	Element: Internal window 00-07
	Description: Timber frame side hung casement window with single glazing and paint finish.

Condition: Poor. As above.	
29.	Location: Ground Floor – West elevation	Element: External window 00-07
	Description: Timber frame side hung casement window with single glazing and paint finish.

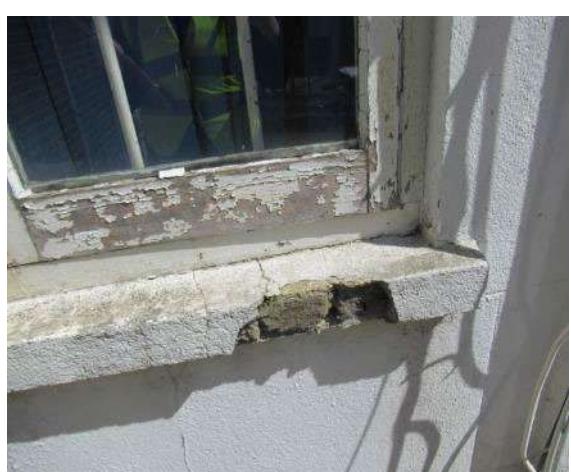
Condition: Poor. Poor paint finish.	
30.	Location: Ground Floor – West elevation	Element: External window 00-07
	Description: Timber frame side hung casement window with single glazing and paint finish.

Condition: Poor. As above.

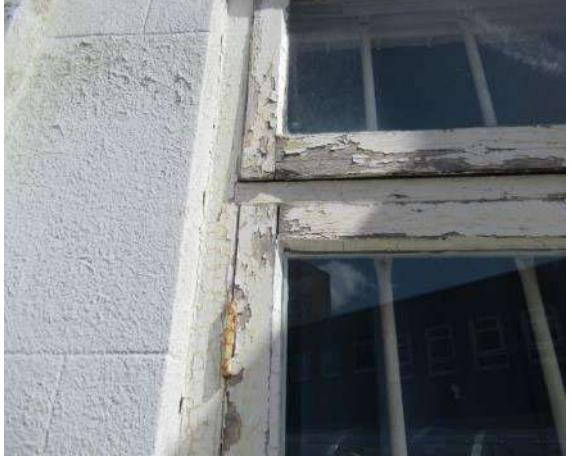
31.	Location: Ground Floor – West elevation	Element: External window 00-07
	Description: Timber frame side hung casement window with single glazing and paint finish.

Condition: As above.	
32.	Location: Ground Floor – West elevation	Element: Internal window 00-08
	Description: Timber frame side hung casement window with single glazing and paint finish.

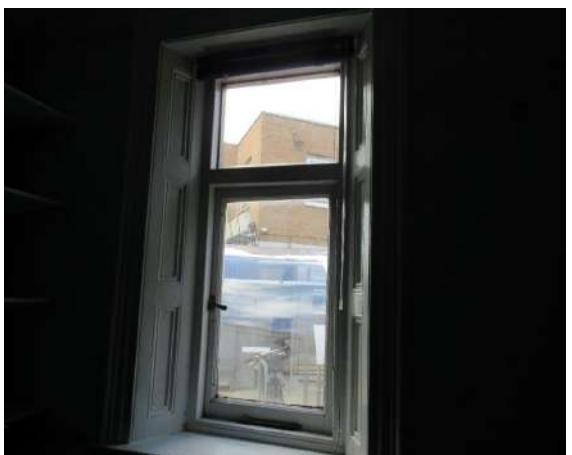
Condition: Fair. Operates poorly. Window sticks. Handle loose. Poor paint finish.	
33.	Location: Ground Floor – West elevation	Element: Internal window 00-08
	Description: Timber frame side hung casement window with single glazing and paint finish.

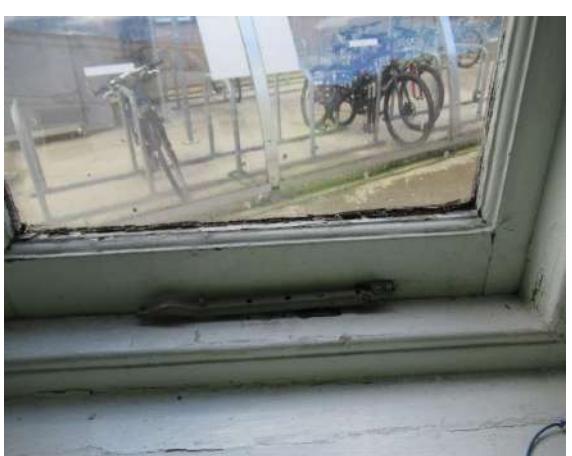
Condition: Fair. As above.

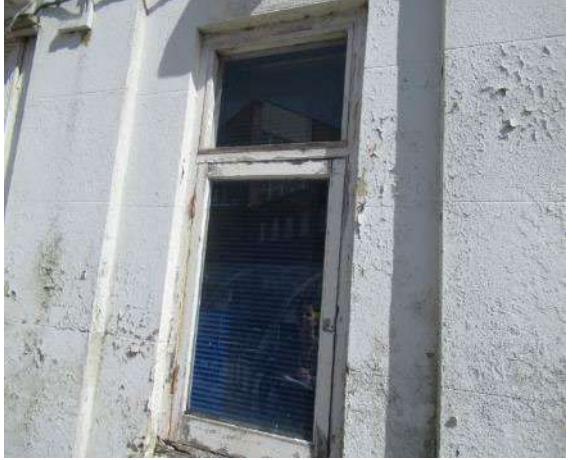
34.	Location: Ground Floor – West elevation	Element: External window 00-08
	Description: Timber frame side hung casement window with single glazing and paint finish.

Condition: Poor. Decay to the entire timber sill, bottom rail and mid rail. Defective sealant. Poor paint finish.	
35.	Location: Ground Floor – West elevation	Element: External window 00-08
	Description: Timber frame side hung casement window with single glazing and paint finish.

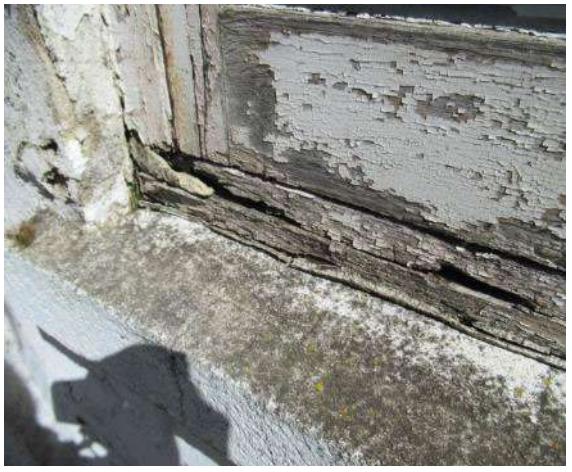
Condition: Poor. As above.	
36.	Location: Ground Floor – West elevation	Element: External window 00-08
	Description: Timber frame side hung casement window with single glazing and paint finish.

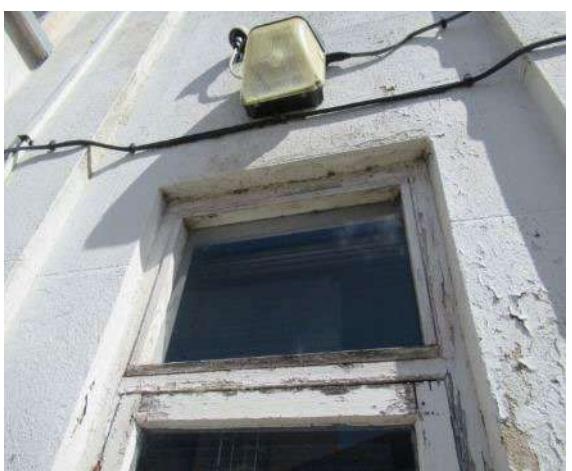
Condition: Poor. As above.

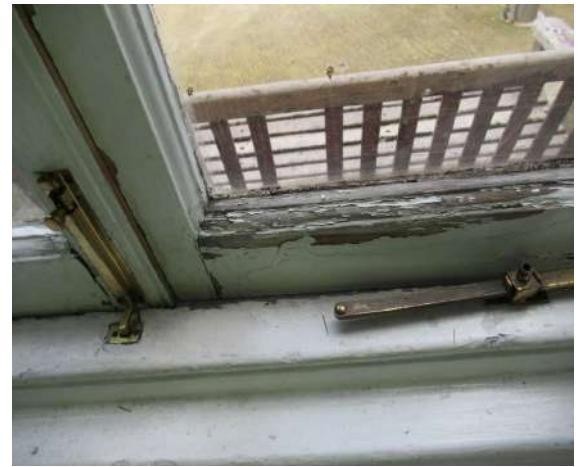
Condition: Poor. Operational. Fixings to top level restrictor missing. Decay to entire timber bottom rail. Poor paint finish	
38.	Location: Ground Floor – West elevation	Element: Internal window 00-09
	Description: Timber frame side hung casement window with single glazing and paint finish.

Condition: Poor. As above.	
39.	Location: Ground Floor – West elevation	Element: Internal window 00-09
	Description: Timber frame side hung casement window with single glazing and paint finish.

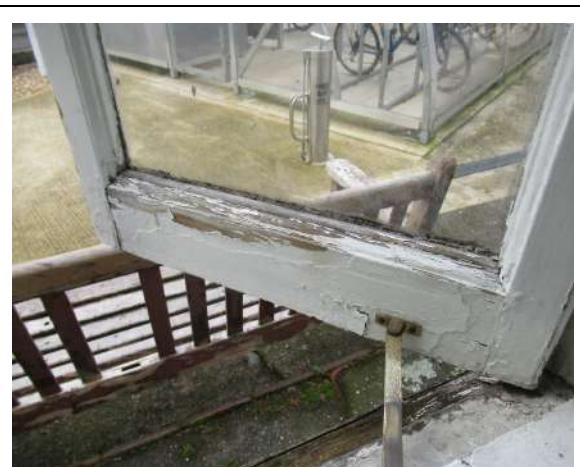
Condition: Poor. As above.

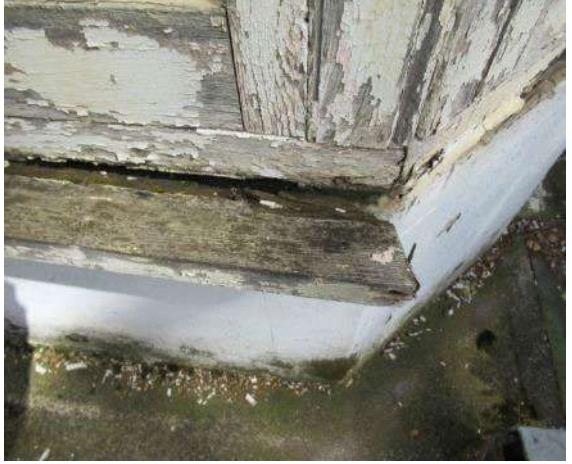
Condition: Poor. Missing and defective timber sill. Decay to sill. Defective and missing sealant. Poor paint finish.	
41.	Location: Ground Floor – West elevation	Element: External window 00-09
	Description: Timber frame side hung casement window with single glazing and paint finish.

Condition: Poor. As above.	
42.	Location: Ground Floor – West elevation	Element: External window 00-09
	Description: Timber frame side hung casement window with single glazing and paint finish.

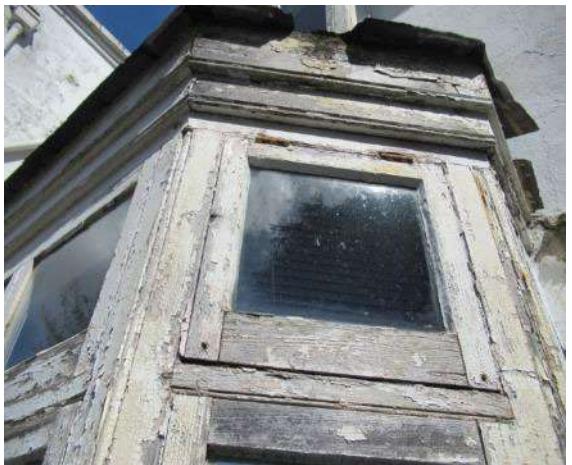
Condition: Poor. As above.

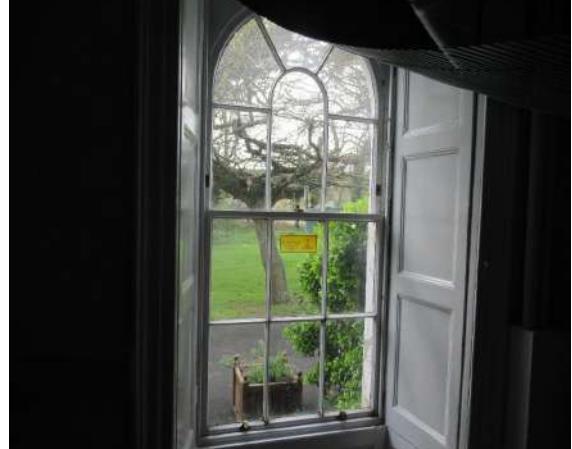
43.	Location: Ground Floor – West elevation	Element: Internal window 00-10
	Description: Timber frame vertical sliding sash window with single glazing and paint finish.

Condition: Poor. Does not operate correctly. Screwed shut. Two glazing panels cracked. Decay to timber bottom rail. Poor paint finish.	
44.	Location: Ground Floor – West elevation	Element: Internal window 00-10
	Description: Timber frame vertical sliding sash window with single glazing and paint finish.

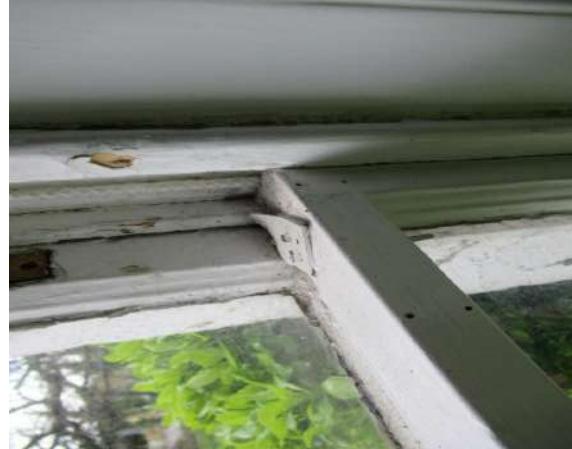
Condition: Poor. As above.	
45.	Location: Ground Floor – West elevation	Element: Internal window 00-10
	Description: Timber frame vertical sliding sash window with single glazing and paint finish.

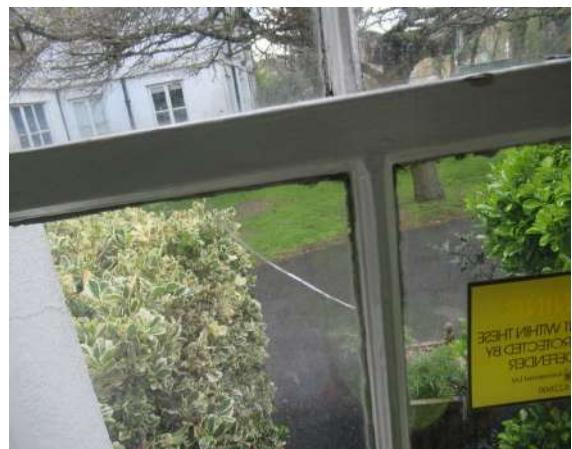
Condition: Poor. As above.

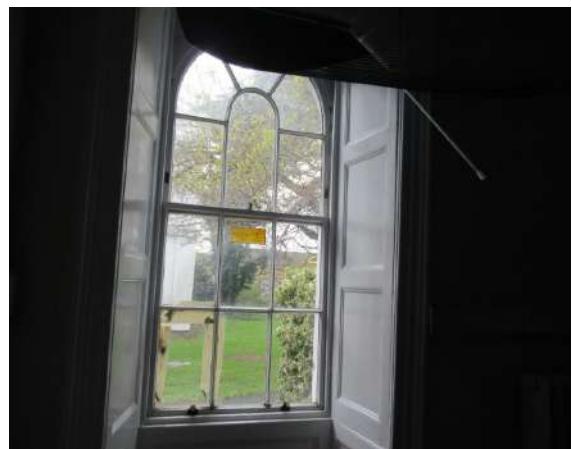
48.	Location: Ground Floor – West elevation	Element: Internal window 00-11
	Description: Timber frame vertical sliding sash window with single glazing and paint finish.

Condition: Poor. Does not operate correctly. Screwed shut. One loose glazing panel. Decay to timber bottom rail extending up the sash bars. Poor paint finish.

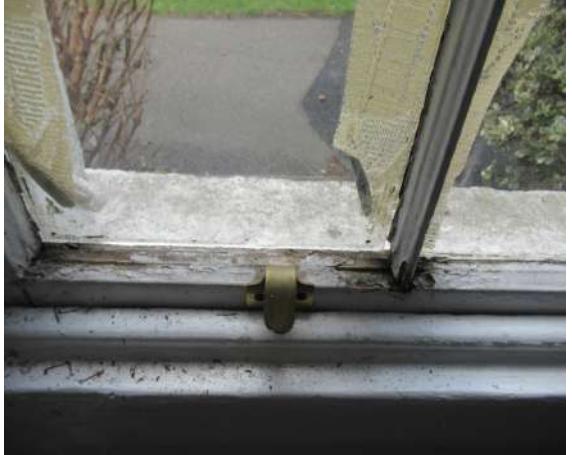
49.	Location: Ground Floor – West elevation	Element: Internal window 00-11
	Description: Timber frame vertical sliding sash window with single glazing and paint finish.

Condition: Poor. As above.	
50.	Location: Ground Floor – West elevation	Element: Internal window 00-11
	Description: Timber frame vertical sliding sash window with single glazing and paint finish.

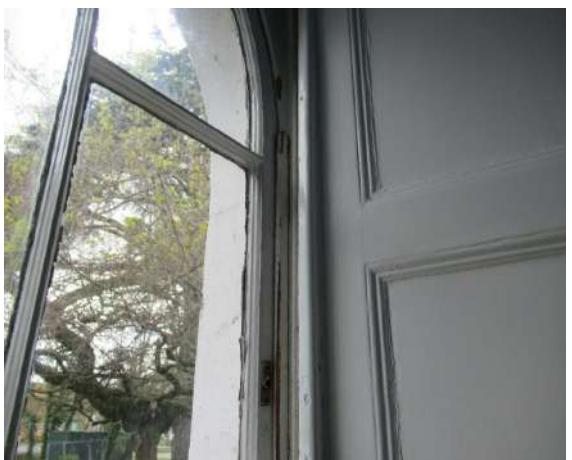
Condition: Poor. As above.	
51.	Location: Ground Floor – West elevation	Element: External window 00-11
	Description: Timber frame vertical sliding sash window with single glazing and paint finish.

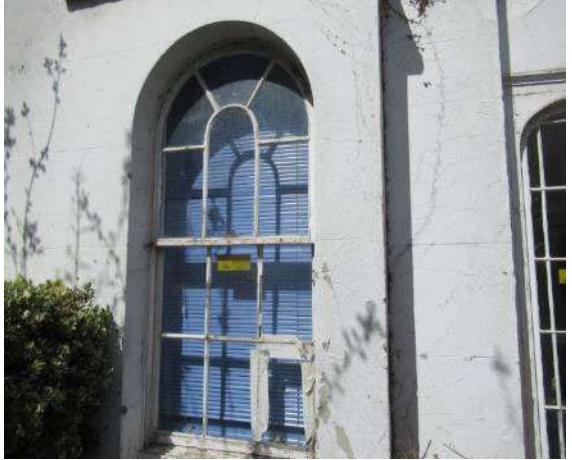
Condition: Poor. Decay to entire timber sill and bottom rail. One loose glazing panel. Poor paint finish.

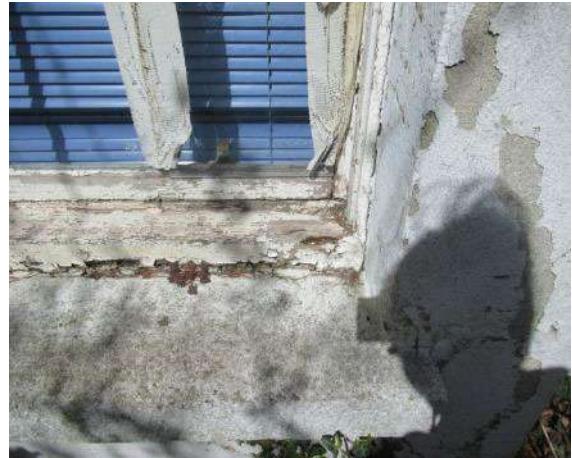
52.	Location: Ground Floor – West elevation	Element: External window 00-11
	Description: Timber frame vertical sliding sash window with single glazing and paint finish.

Condition: Poor. As above	
53.	Location: Ground Floor – West elevation	Element: External window 00-11
	Description: Timber frame vertical sliding sash window with single glazing and paint finish.

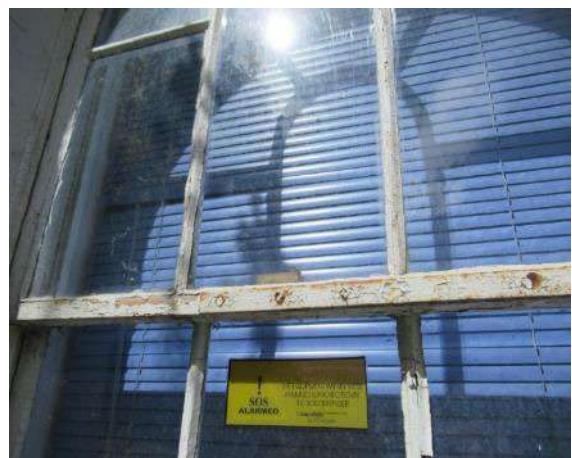
Condition: Poor. As above.	
54.	Location: Ground Floor – West elevation	Element: Internal window 00-12
	Description: Timber frame vertical sliding sash window with single glazing and paint finish.

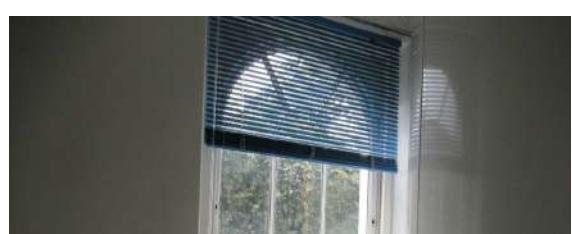
Condition: Poor. Does not operate correctly. Screwed shut. Sash cords snapped. Decay to bottom rail. Poor paint finish.

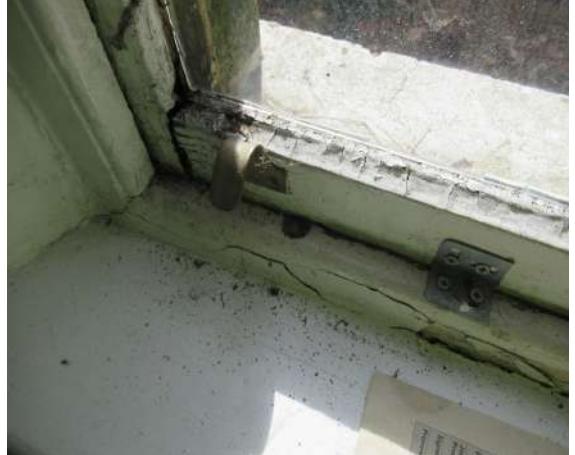
61.	Location: Ground Floor – West elevation	Element: Internal window 00-13
	Description: Timber frame vertical sliding sash window with single glazing and paint finish.

Condition: Poor. As above.	
62.	Location: Ground Floor – West elevation	Element: External window 00-13
	Description: Timber frame vertical sliding sash window with single glazing and paint finish.

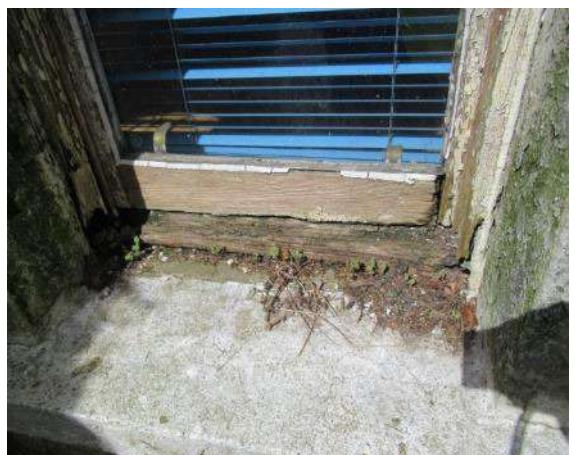
Condition: Poor. As above.	
63.	Location: Ground Floor – West elevation	Element: Internal window 00-14
	Description: Timber frame vertical sliding sash window with single glazing and paint finish.

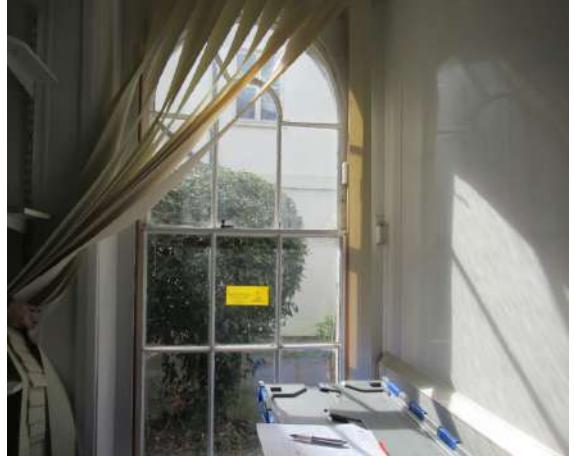
Condition: Poor. Operates poorly. Does not stay open. Decay to entire timber bottom rail. Poor paint finish.

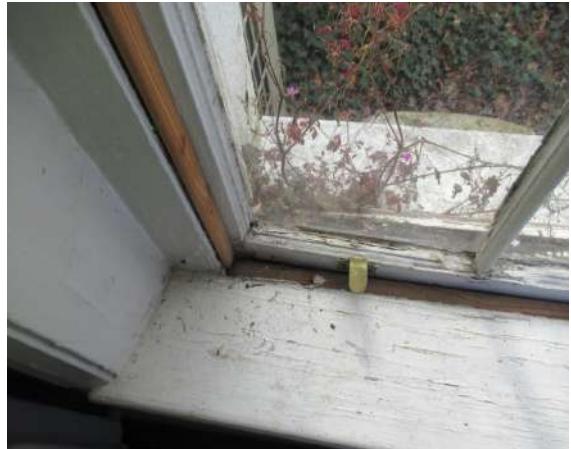
64.	Location: Ground Floor – West elevation	Element: Internal window 00-14
	Description: Timber frame vertical sliding sash window with single glazing and paint finish.

Condition: Fair. As above.	
65.	Location: Ground Floor – West elevation	Element: Internal window 00-14
	Description: Timber frame vertical sliding sash window with single glazing and paint finish.

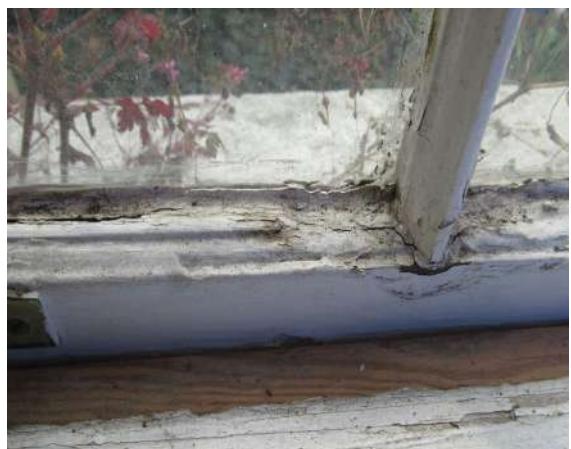
Condition: Poor. As above.	
66.	Location: Ground Floor – West elevation	Element: External window 00-14
	Description: Timber frame vertical sliding sash window with single glazing and paint finish.

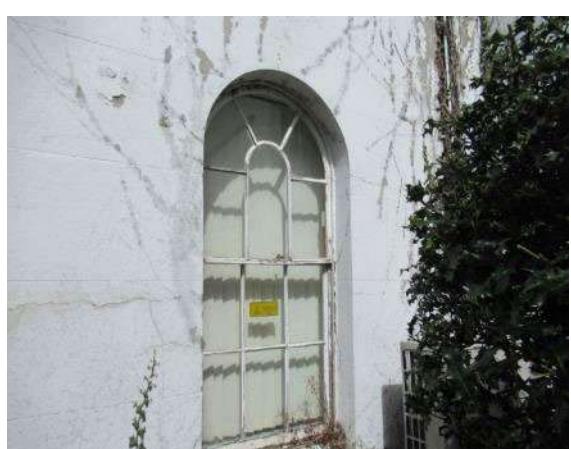
Condition: Poor. Decay to the entire timber sill. Poor sealant. Poor paint finish.

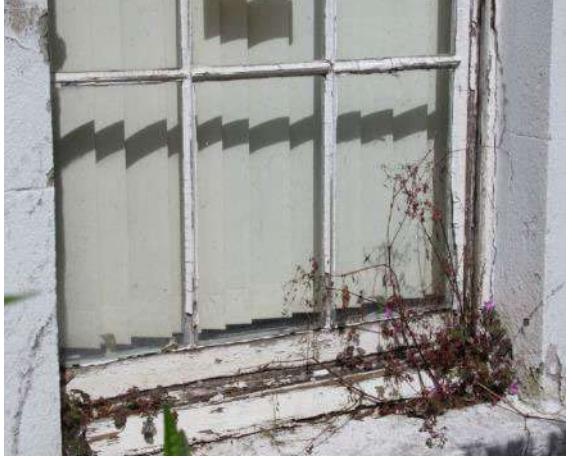
67.	Location: Ground Floor – West elevation	Element: External window 00-14
	Description: Timber frame vertical sliding sash window with single glazing and paint finish.

Condition: Poor. As above.	
68.	Location: Ground Floor – West elevation	Element: Internal window 00-15
	Description: Timber frame vertical sliding sash window with single glazing and paint finish.

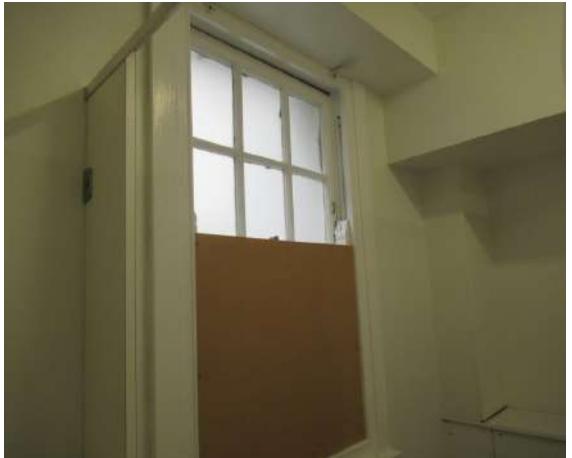
Condition: Poor. Does not operate. Screwed shut. Lock broken. Poor paint finish.	
69.	Location: Ground Floor – West elevation	Element: Internal window 00-15
	Description: Timber frame vertical sliding sash window with single glazing and paint finish.

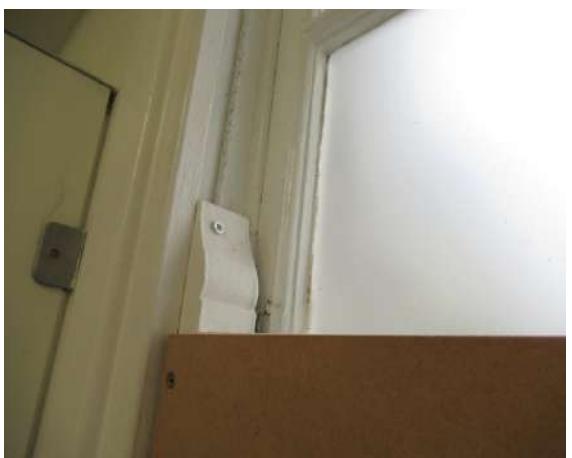
Condition: Poor. As above.

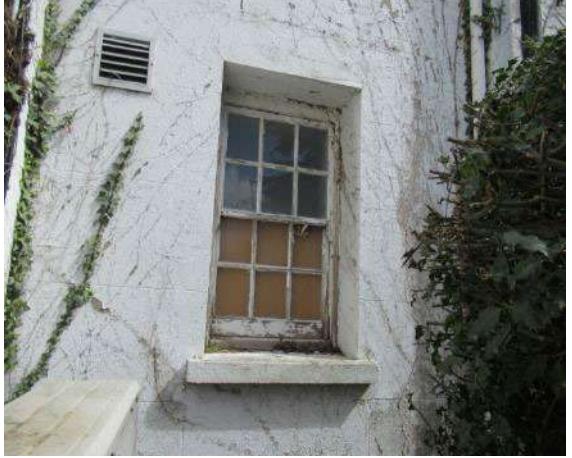
70.	Location: Ground Floor – West elevation	Element: External window 00-15
	Description: Timber frame vertical sliding sash window with single glazing and paint finish.

Condition: Poor. Decay to the entire timber jambs, rails and bars. Loose sealant. Poor paint finish	
71.	Location: Ground Floor – West elevation	Element: External window 00-15
	Description: Timber frame vertical sliding sash window with single glazing and paint finish.

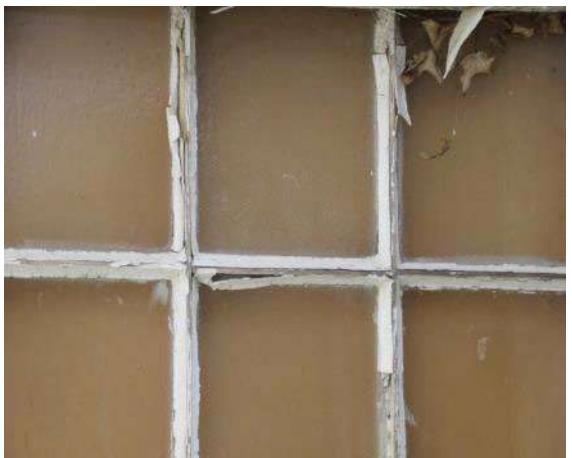
Condition: Poor. As above.	
72.	Location: Ground Floor – West elevation	Element: Internal window 00-16
	Description: Timber frame vertical sliding sash window with single glazing and paint finish.

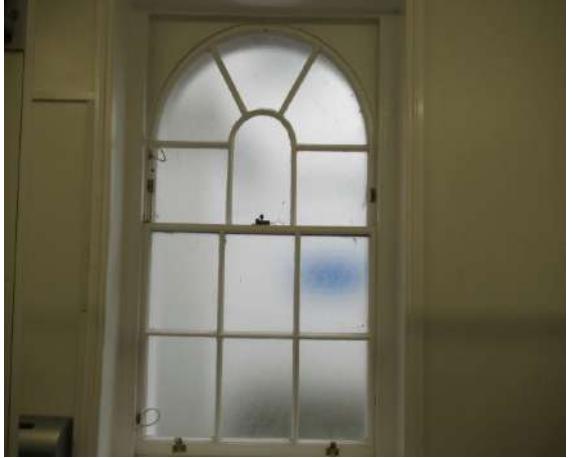
Condition: Poor. Does not operate. Sash cords snapped. Poor paint finish. Two cracked glazing panel.

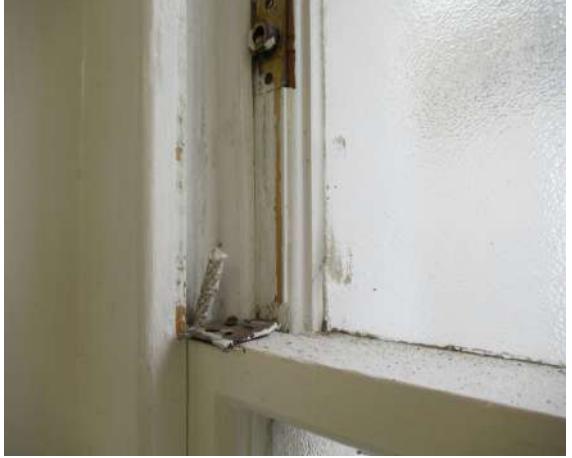
73.	Location: Ground Floor – West elevation	Element: Internal window 00-16
	Description: Timber frame vertical sliding sash window with single glazing and paint finish.

Condition: Poor. As above.	
74.	Location: Ground Floor – West elevation	Element: Internal window 00-16
	Description: Timber frame vertical sliding sash window with single glazing and paint finish.

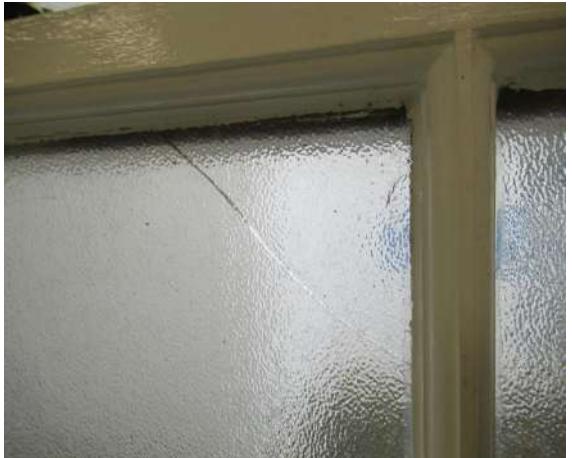
Condition: Poor. As above.	
75.	Location: Ground Floor – West elevation	Element: External window 00-16
	Description: Timber frame vertical sliding sash window with single glazing and paint finish.

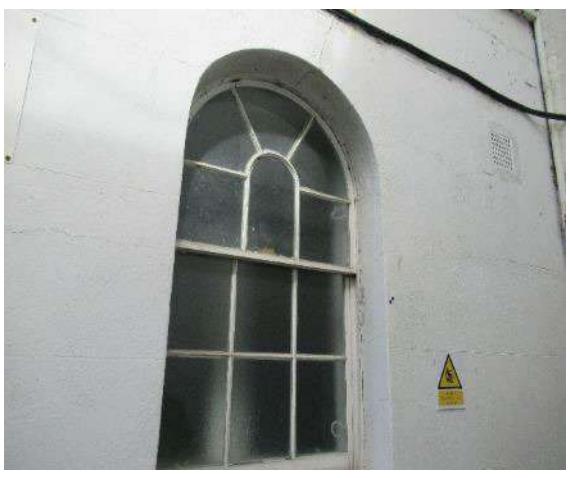
Condition: Poor. Missing and defective sealant. Poor paint finish.

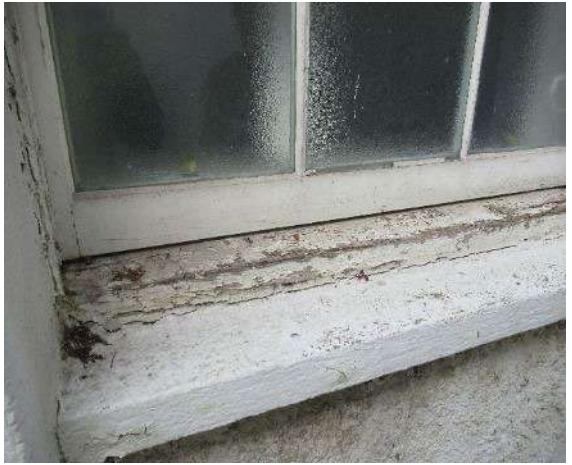
76.	Location: Ground Floor – West elevation	Element: External window 00-16
	Description: Timber frame vertical sliding sash window with single glazing and paint finish.

Condition: Poor. As above.	
77.	Location: Ground Floor – West elevation	Element: External window 00-16
	Description: Timber frame vertical sliding sash window with single glazing and paint finish.

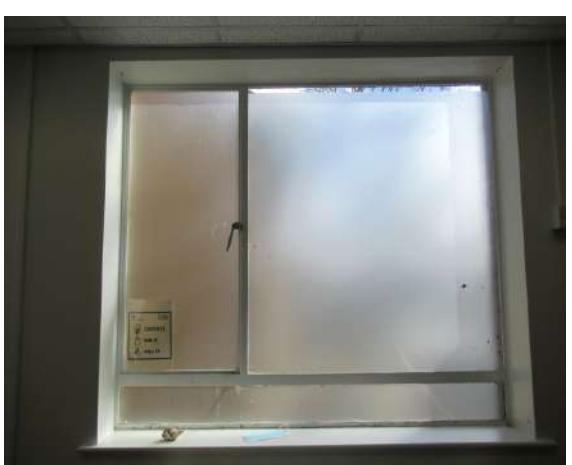
Condition: Poor. As above.	
78.	Location: Ground Floor – South elevation	Element: Internal window 00-17
	Description: Steel frame side hung Crittall window with single glazing and paint finish.

Condition: Fair. Operational. Opening restricted by window restrictor. Poor paint finish throughout.

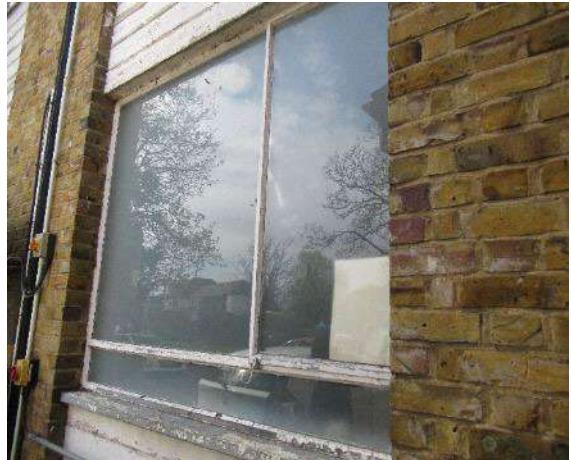
79.	Location: Ground Floor – South elevation	Element: External window 00-17
	Description: Steel frame side hung Crittall window with single glazing and paint finish.

Condition: Fair. As above.	
80.	Location: Ground Floor – South elevation	Element: Internal window 00-18
	Description: Steel frame side hung Crittall window with single glazing and paint finish.

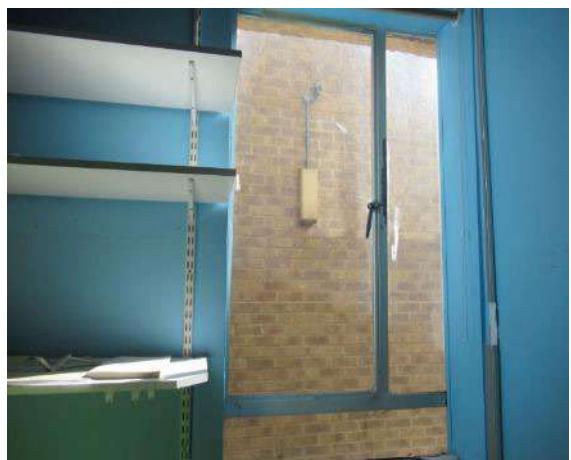
Condition: Fair. Operational. Opening restricted by window restrictor. Poor paint finish throughout.	
81.	Location: Ground Floor – South elevation	Element: Internal window 00-18
	Description: Steel frame side hung Crittall window with single glazing and paint finish.

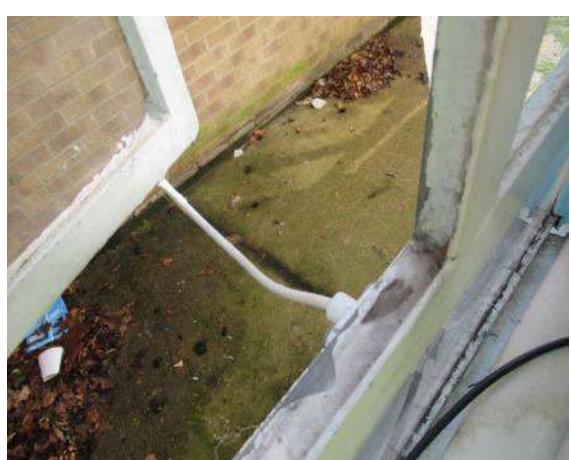
Condition: Fair. As above.

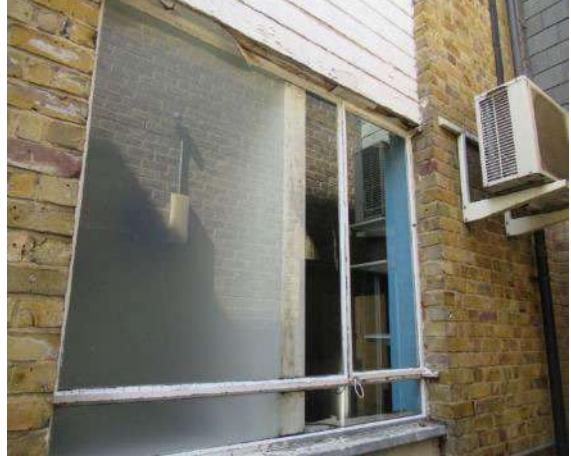
82.	Location: Ground Floor – South elevation	Element: External window 00-18
	Description: Steel frame side hung Crittall window with single glazing and paint finish.

Condition: Poor. Poor paint finish throughout.	
83.	Location: Ground Floor –North elevation	Element: Internal window 00-19
	Description: Timber frame vertical sliding sash window with single glazing and paint finish.

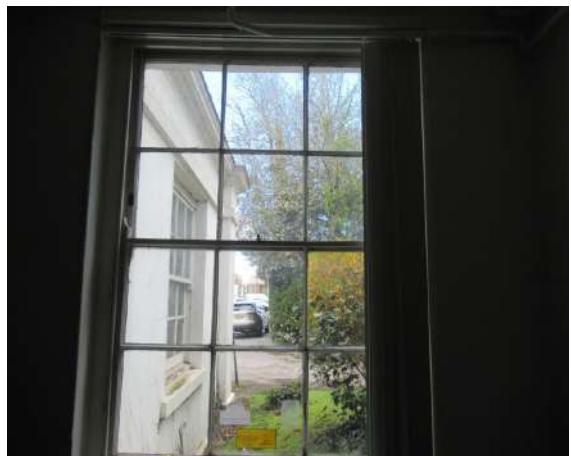
Condition: Poor. Operational. Decay to mid rail and bottom rail. Poor paint finish.	
84.	Location: Ground Floor –North elevation	Element: Internal window 00-19
	Description: Timber frame vertical sliding sash window with single glazing and paint finish.

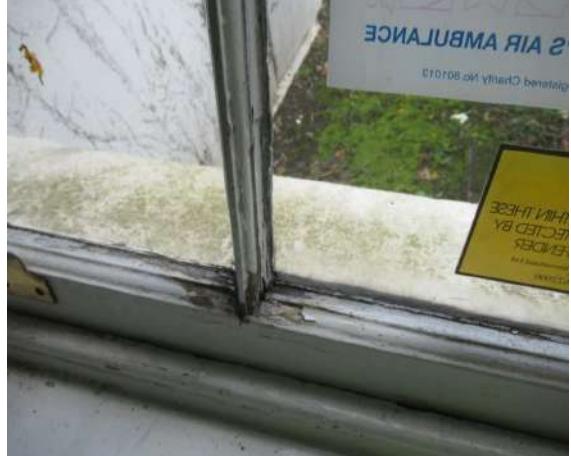
Condition: As above.

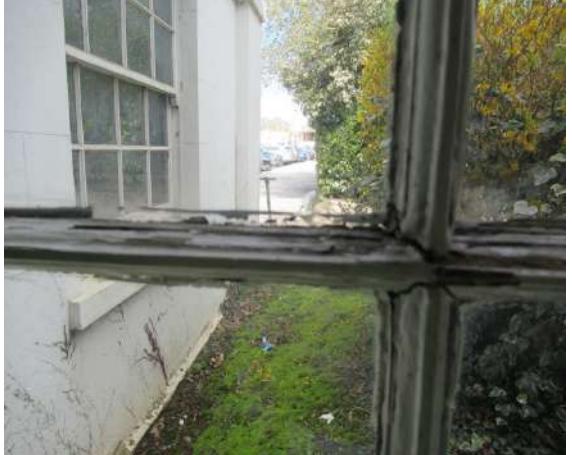
85.	Location: Ground Floor –North elevation	Element: Internal window 00-19
	Description: Timber frame vertical sliding sash window with single glazing and paint finish.

Condition: Poor. As above.	
86.	Location: Ground Floor –North elevation	Element: External window 00-19
	Description: Timber frame vertical sliding sash window with single glazing and paint finish.

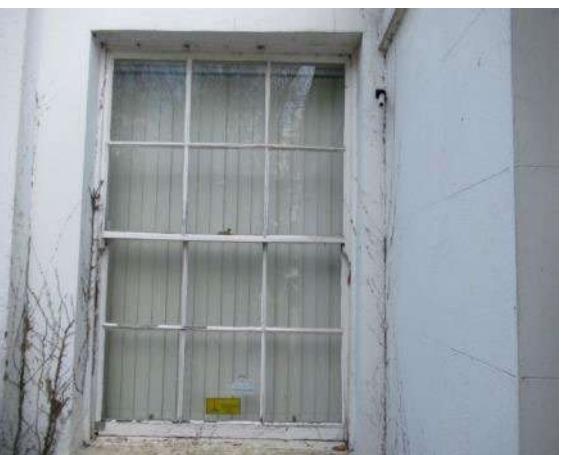
Condition: Poor. Decay to timber sill and bottom rail. Cracked stone sill.	
87.	Location: Ground Floor –North elevation	Element: Internal window 00-20
	Description: Timber frame vertical sliding sash window with single glazing and paint finish.

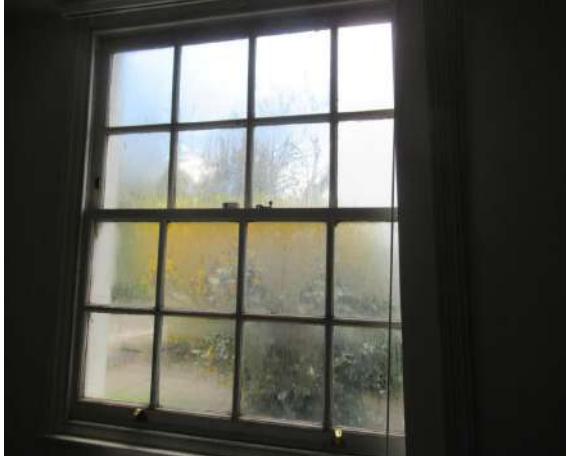
Condition: Poor. Does not operate correctly. Locked shut. One cracked panel. Mould to timber throughout. Poor paint finish.

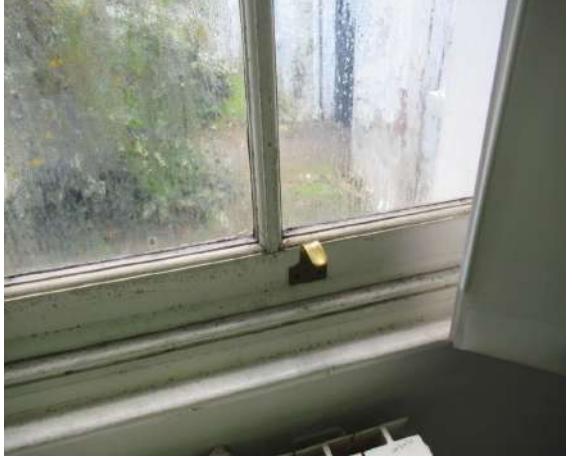
88.	Location: Ground Floor –North elevation	Element: Internal window 00-20
	Description: Timber frame vertical sliding sash window with single glazing and paint finish.

Condition: Poor. As above.	
89.	Location: Ground Floor –North elevation	Element: Internal window 00-20
	Description: Timber frame vertical sliding sash window with single glazing and paint finish.
