Schedule of condition

**The Furze, Hillingdon
Hospital, Pield Heath
Road, Hillingdon UB8 3NN**

Prepared for: Northmores
Prepared by: Chris Baker BSc (Hons) MRICS
Date: 18 September 2023
Reference: 120937-100/MET/CBk

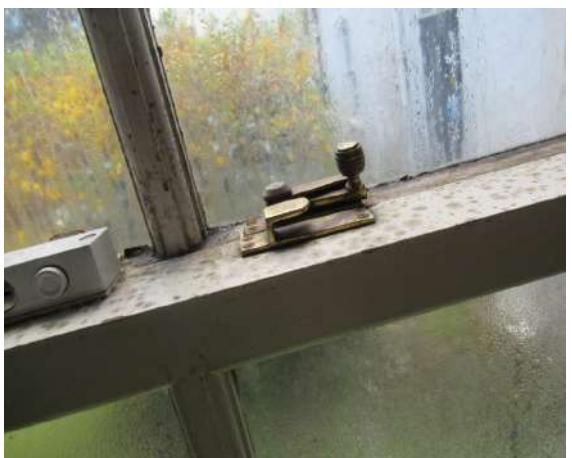
Condition: Poor. As above.	
89.	Location: Ground Floor –North elevation	Element: Internal window 00-20
	Description: Timber frame vertical sliding sash window with single glazing and paint finish.

Condition: Poor. As above.	
90.	Location: Ground Floor –North elevation	Element: External window 00-20
	Description: Timber frame vertical sliding sash window with single glazing and paint finish.

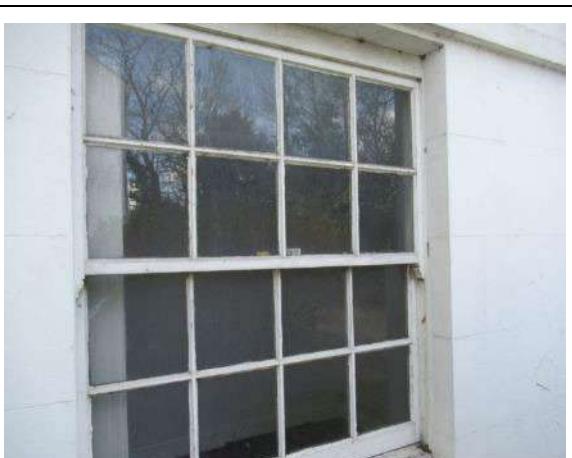
Condition: Poor. Decay to entire timber sill. Poor paint finish

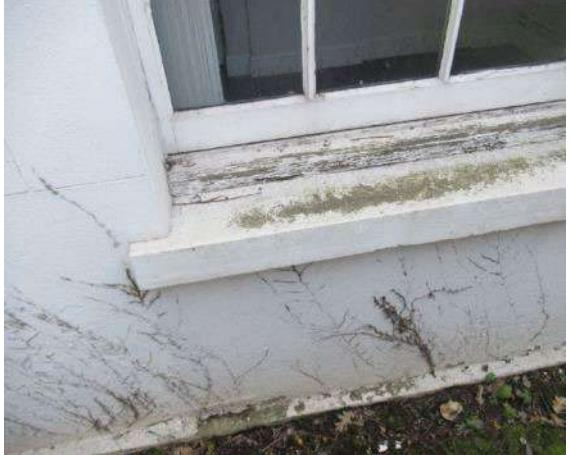
91.	Location: Ground Floor –North elevation	Element: External window 00-20
	Description: Timber frame vertical sliding sash window with single glazing and paint finish.

Condition: Poor. As above.	
92.	Location: Ground Floor – West elevation	Element: Internal window 00-21
	Description: Timber side hung casement window with double glazing and a paint finish

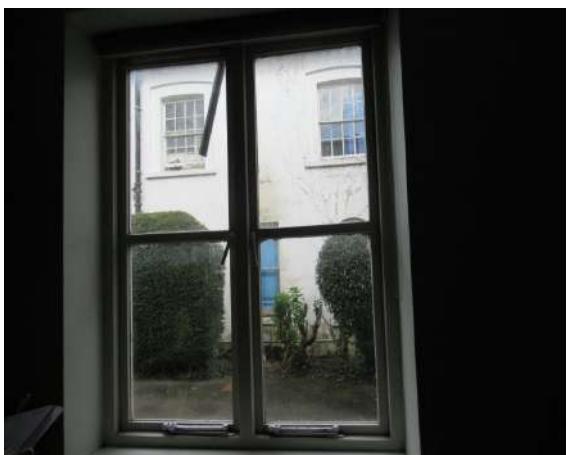
Condition: Fair. Operational. Timber shrinkage causing splitting in the frame. Poor paint finish.	
93.	Location: Ground Floor – West elevation	Element: Internal window 00-21
	Description: Timber side hung casement window with double glazing and a paint finish

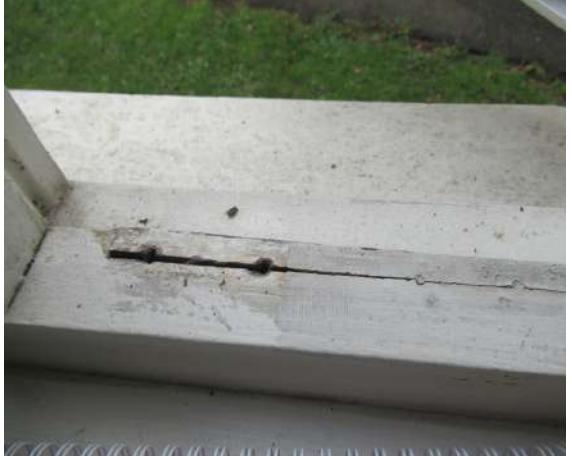
Condition: Fair. As above.

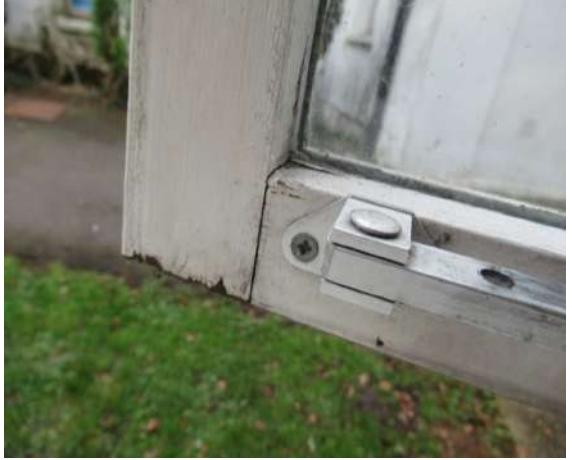
94.	Location: Ground Floor – West elevation	Element: Internal window 00-21
	Description: Timber frame vertical sliding sash window with single glazing and paint finish.

Condition: Fair. As above.	
95.	Location: Ground Floor – West elevation	Element: External window 00-21
	Description: Timber side hung casement window with double glazing and a paint finish.

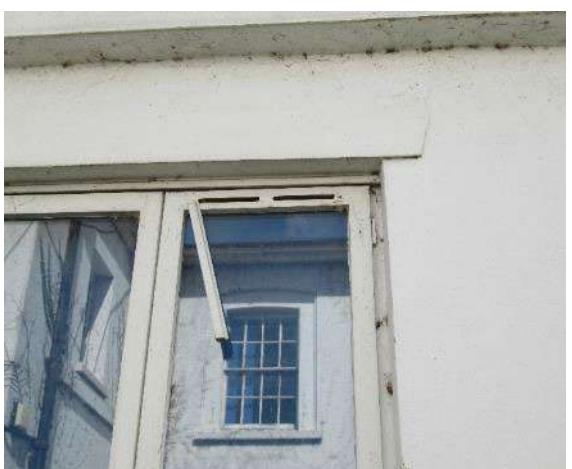
Condition: Poor. Broken vent cover to top rail. Poor paint finish.	
96.	Location: Ground Floor – West elevation	Element: External window 00-21
	Description: Timber side hung casement window with double glazing and a paint finish.

Condition: Poor. As above.

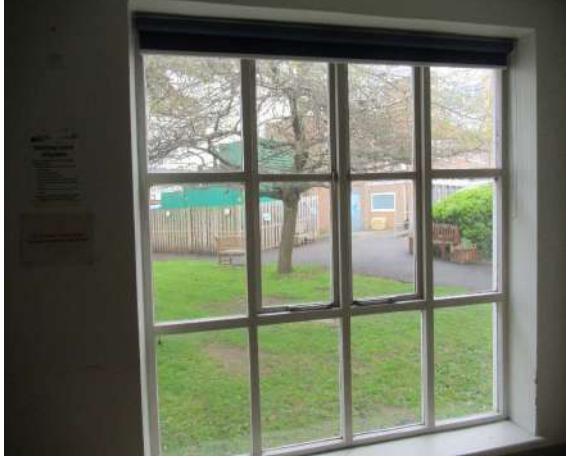
97.	Location: Ground Floor – West elevation	Element: Internal window 00-22
	Description: Side hung timber casement window with double glazing and a paint finish.

Condition: Fair. Operational. 2no. screws missing to the restrictor. Slight splitting in the timber frame due to shrinkage. Poor paint finish.	
98.	Location: Ground Floor – West elevation	Element: External window 00-22
	Description: Side hung timber casement window with double glazing and a paint finish.

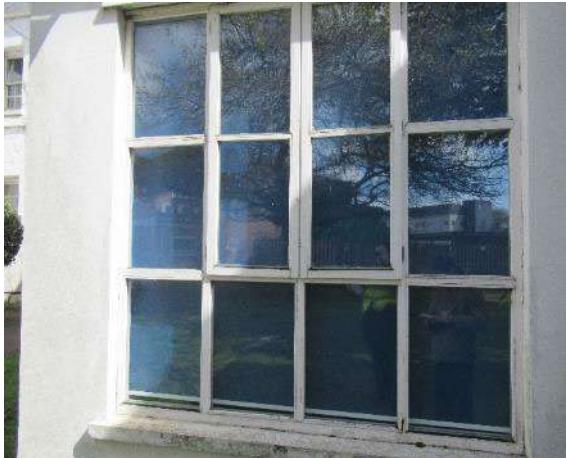
Condition: Poor. Missing timber to the bottom rail. Decay to the timber bars throughout. Poor paint finish.	
99.	Location: Ground Floor – West elevation	Element: External window 00-22
	Description: Side hung timber casement window with double glazing and a paint finish.

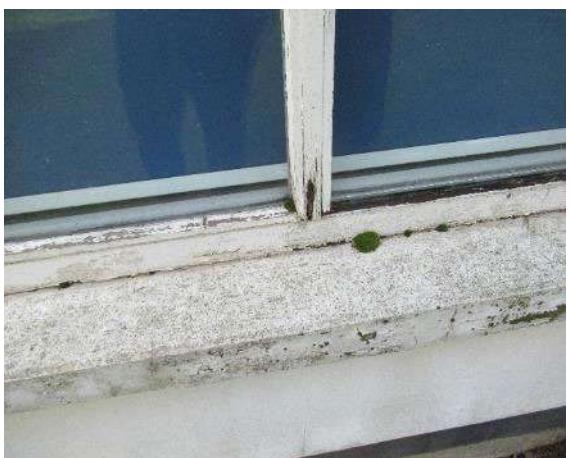
Condition: Poor. As above.

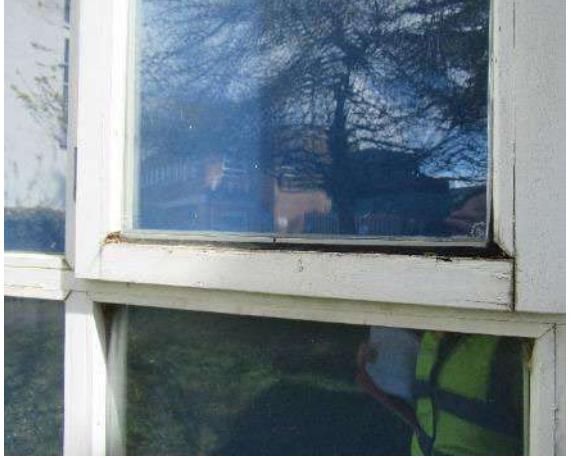
100.	<p>Location: Ground Floor – West elevation</p> <p>Description: Side hung timber casement window with double glazing and a paint finish..</p> <p>Condition: Poor. As above.</p>	<p>Element: External window 00-22</p>

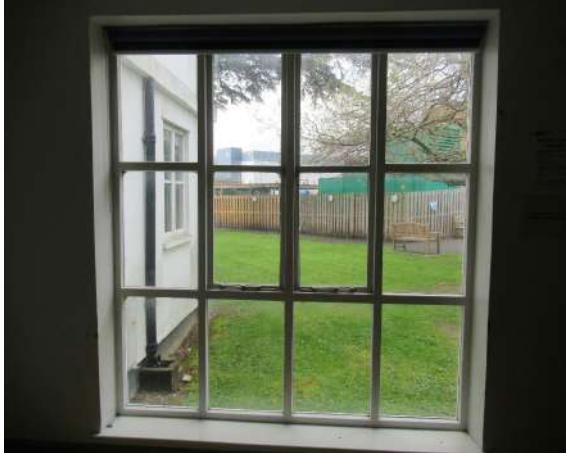
101.	<p>Location: Ground Floor – West elevation</p> <p>Description: Side hung timber casement window with double glazing and a paint finish..</p> <p>Condition: Fair. Operational. 2no. screws missing to the restrictor. Slight splitting of the timber frame due to shrinkage.</p>	<p>Element: Internal window 00-23</p>

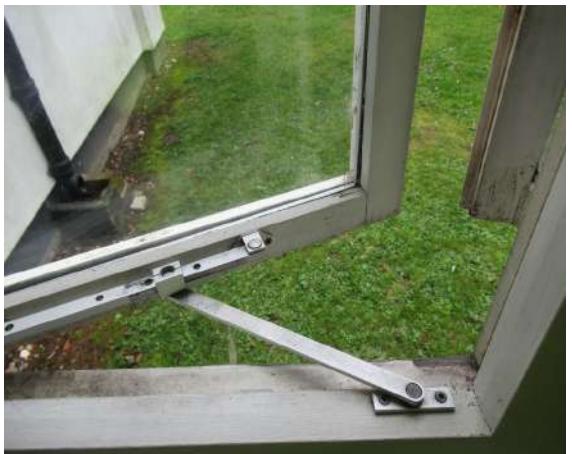
102.	<p>Location: Ground Floor – West elevation</p> <p>Description: Side hung timber casement window with double glazing and a paint finish..</p> <p>Condition: Fair. As above.</p>	<p>Element: Internal window 00-23</p>

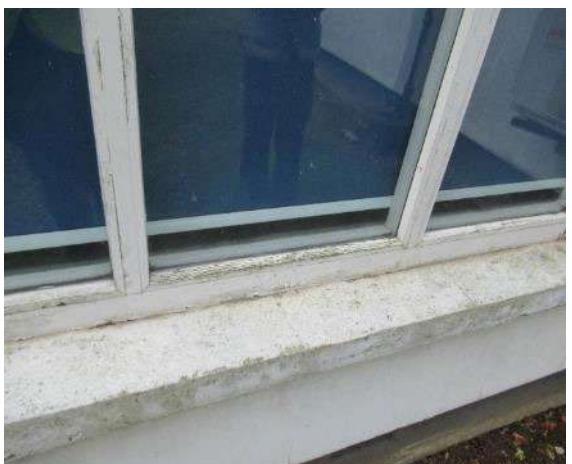
Condition: Poor. Missing timber to the sash bar. Decay to the timber bars throughout. Poor paint finish.	
104.	Location: Ground Floor – West elevation	Element: External window 00-23
	Description: Side hung timber casement window with double glazing and a paint finish.

Condition: Poor. As above.	
105.	Location: Ground Floor – West elevation	Element: Internal window 00-24
	Description: Timber side hung casement window with double glazing and a paint finish.

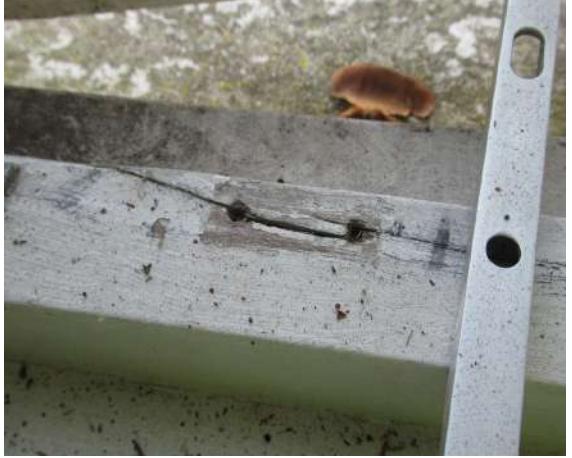
106.	<p>Location: Ground Floor – West elevation</p> <p>Description: Timber side hung casement window with double glazing and a paint finish.</p> <p>Condition: Fair. As above.</p>	<p>Element: Internal window 00-24</p>

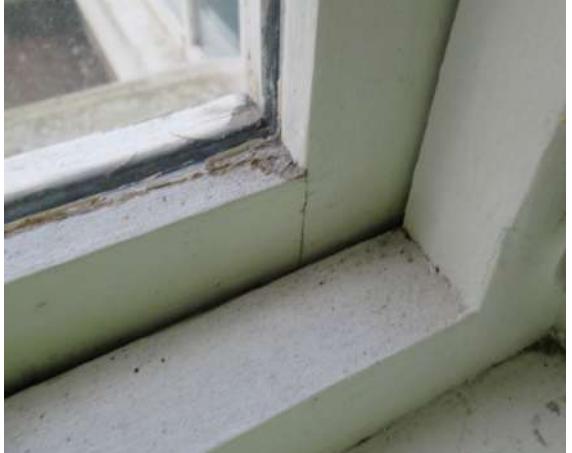
107.	<p>Location: Ground Floor – West elevation</p> <p>Description: Timber side hung casement window with double glazing and a paint finish.</p> <p>Condition: Fair. As above.</p>	<p>Element: Internal window 00-24</p>

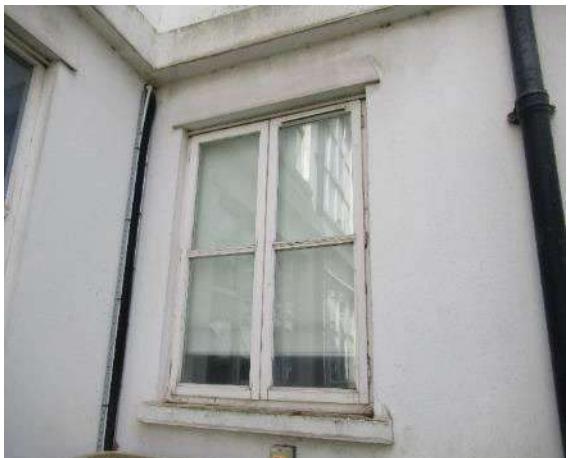
108.	<p>Location: Ground Floor – West elevation</p> <p>Description: Timber side hung casement window with double glazing and a paint finish.</p> <p>Condition: Fair. Poor paint finish.</p>	<p>Element: External window 00-24</p>

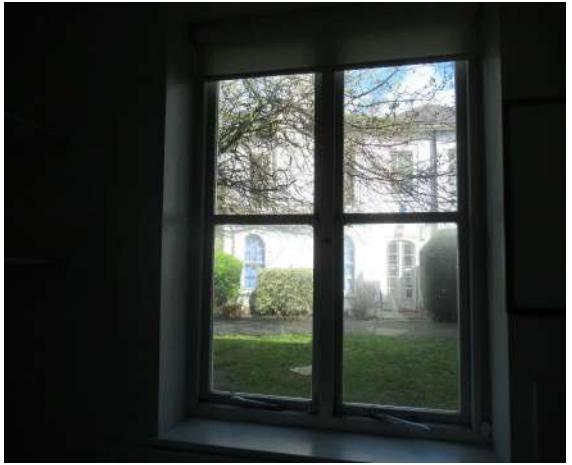
109.	<p>Location: Ground Floor – West elevation</p> <p>Description: Timber side hung casement window with double glazing and a paint finish</p> <p>Condition: Poor. Operational. Timber shrinkage causing splitting in the frame. Poor paint finish.</p>	<p>Element: Internal window 00-25</p>

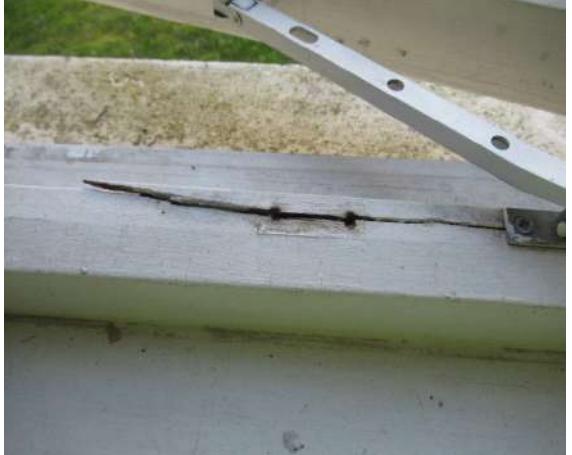
110.	<p>Location: Ground Floor – West elevation</p> <p>Description: Timber side hung casement window with double glazing and a paint finish</p> <p>Condition: Poor. As above.</p>	<p>Element: Internal window 00-25</p>

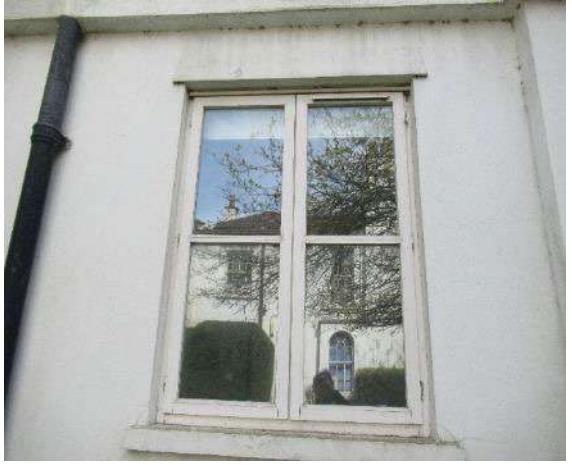
111.	<p>Location: Ground Floor – West elevation</p> <p>Description: Timber side hung casement window with double glazing and a paint finish</p> <p>Condition: Fair. Poor paint finish.</p>	<p>Element: External window 00-25</p>

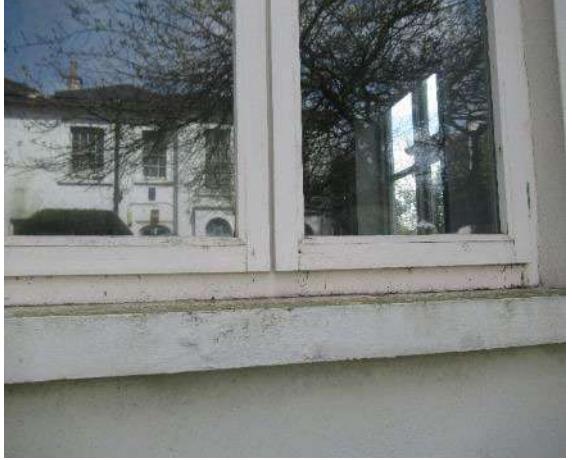
112.	Location: Ground Floor – West elevation	Element: External window 00-25
	Description: Timber side hung casement window with double glazing and a paint finish

Condition: Fair. As above.	
113.	Location: Ground Floor – West elevation	Element: Internal window 00-26
	Description: Timber side hung casement window with double glazing and a paint finish.

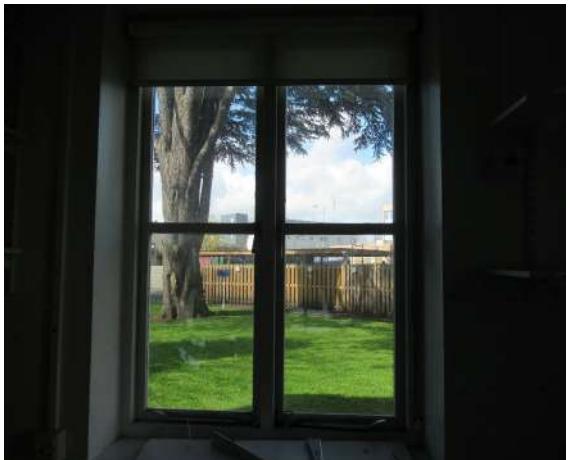
Condition: Fair. Operates moderately. Sticking of the windows. Poor paint finish.	
114.	Location: Ground Floor – West elevation	Element: External window 00-26
	Description: Timber side hung casement window with double glazing and a paint finish.

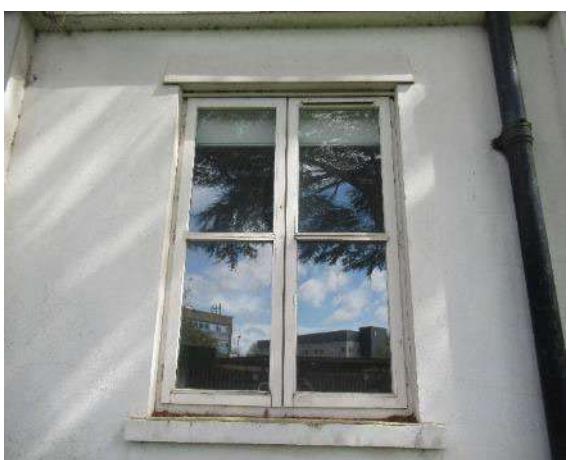
Condition: Fair. Loose timber to mid rail. Decay to entire timber bottom rail extending along the rail and up the stiles. Poor paint finish

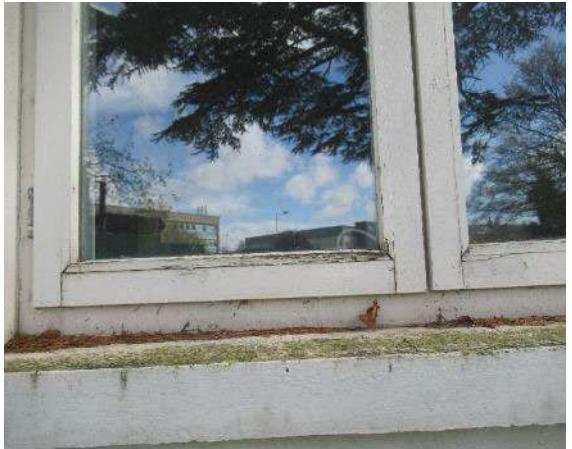
115.	Location: Ground Floor – West elevation	Element: External window 00-26
	Description: Timber side hung casement window with double glazing and a paint finish.

Condition: Good. As above.	
116.	Location: Ground Floor – West elevation	Element: Internal window 00-27
	Description: Timber side hung casement window with double glazing and a paint finish.

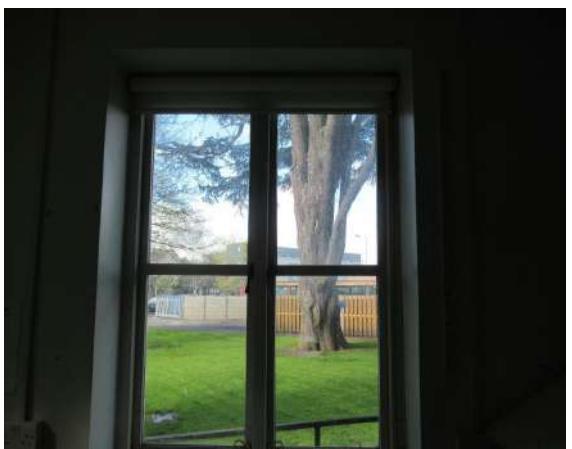
Condition: Poor. Operational. Loose handles and locks. Timber shrinkage causing splitting in the frame.	
117.	Location: Ground Floor – West elevation	Element: Internal window 00-27
	Description: Timber side hung casement window with double glazing and a paint finish.

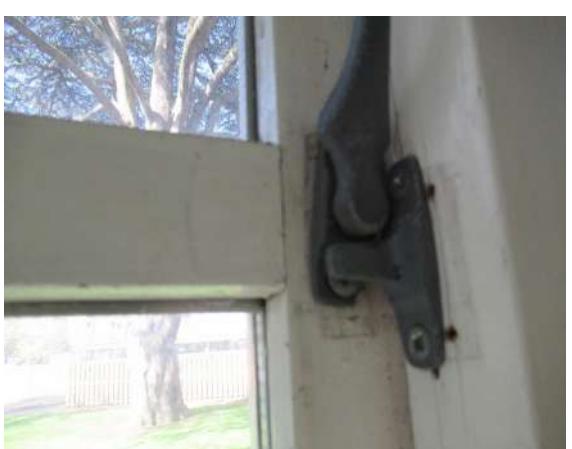
Condition: Poor. As above.

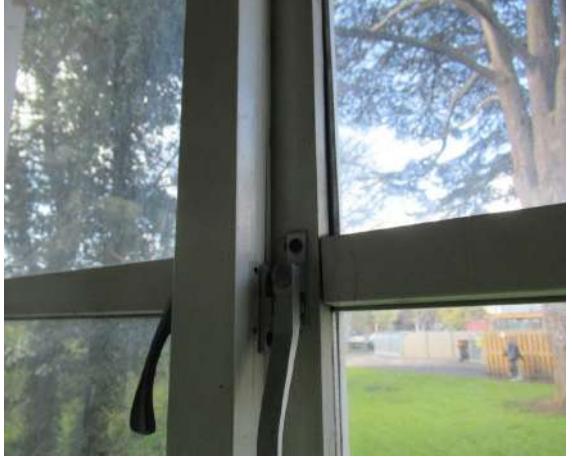
118.	<p>Location: Ground Floor – West elevation</p> <p>Description: Timber side hung casement window with double glazing and a paint finish.</p> <p>Condition: Poor. As above.</p>	<p>Element: Internal window 00-27</p>

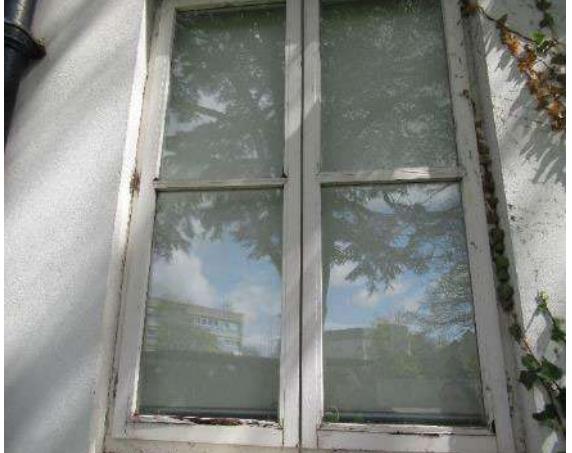
119.	<p>Location: Ground Floor – West elevation</p> <p>Description: Timber side hung casement window with double glazing and a paint finish.</p> <p>Condition: Poor. Missing timber on left side mid rail. Decay to the full timber bottom rail extending along the rail and up the stiles. Poor paint finish. Ivy growth.</p>	<p>Element: External window 00-27</p>

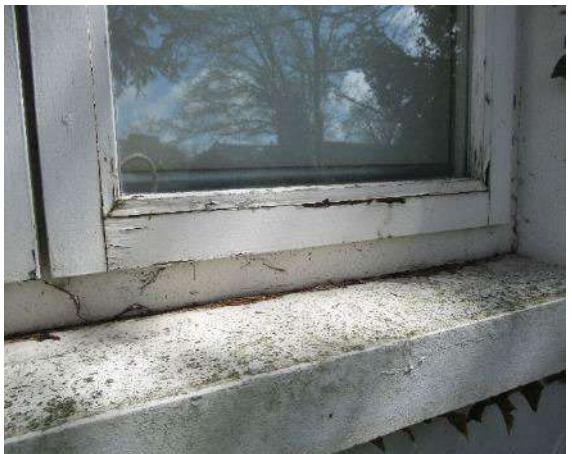
120.	<p>Location: Ground Floor – West elevation</p> <p>Description: Timber side hung casement window with double glazing and a paint finish.</p> <p>Condition: Poor. As above.</p>	<p>Element: External window 00-27</p>

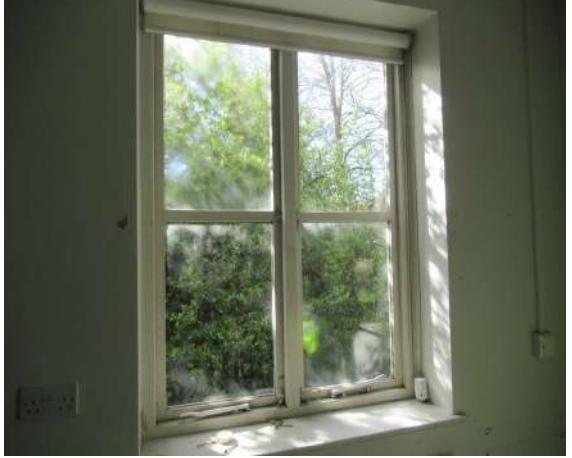
121.	<p>Location: Ground Floor – South elevation</p> <p>Description: Timber side hung casement window with double glazing and a paint finish</p> <p>Condition: Poor. Operational. Missing handle and lock to the left side. Right side handle loose. Double glazing blown with condensation. Poor paint finish.</p>	<p>Element: Internal window 00-28</p>

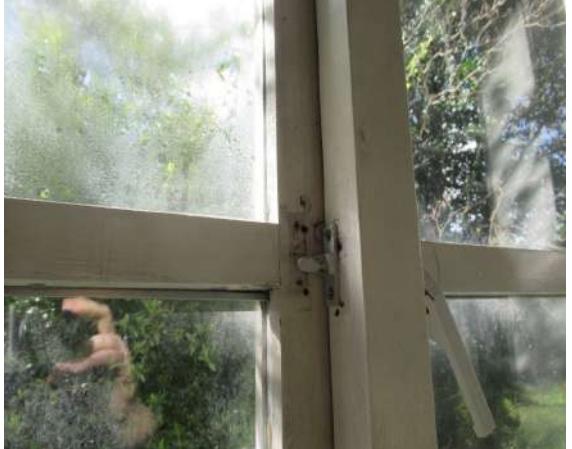
122.	<p>Location: Ground Floor – South elevation</p> <p>Description: Timber side hung casement window with double glazing and a paint finish</p> <p>Condition: Poor. As above.</p>	<p>Element: Internal window 00-28</p>

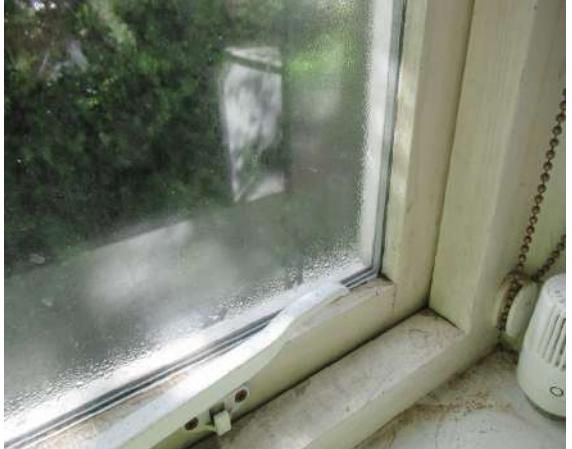
123.	<p>Location: Ground Floor – South elevation</p> <p>Description: Timber side hung casement window with double glazing and a paint finish</p> <p>Condition: Poor. As above.</p>	<p>Element: Internal window 00-28</p>

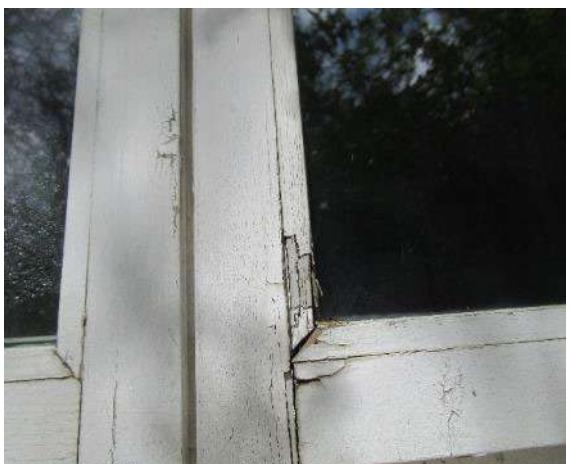
Condition: Poor. Missing timber to the left side mid rail. Decay to sill and bottom rail extending upwards along the stiles. Poor paint finish.	
125.	Location: Ground Floor – South elevation	Element: External window 00-28
	Description: Timber side hung casement window with double glazing and a paint finish

Condition: Poor. As above.	
126.	Location: Ground Floor – South elevation	Element: External window 00-28
	Description: Timber side hung casement window with double glazing and a paint finish

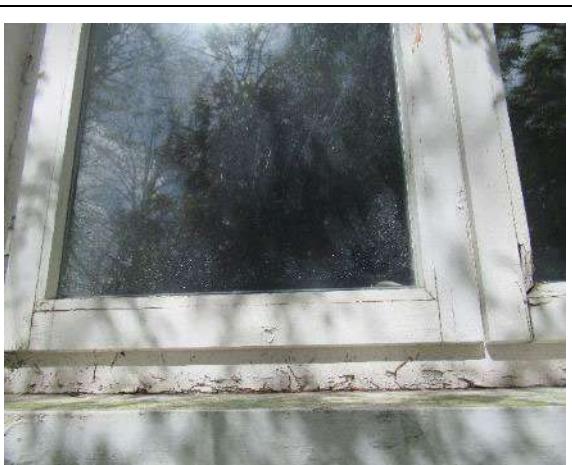
Condition: Poor. As above.

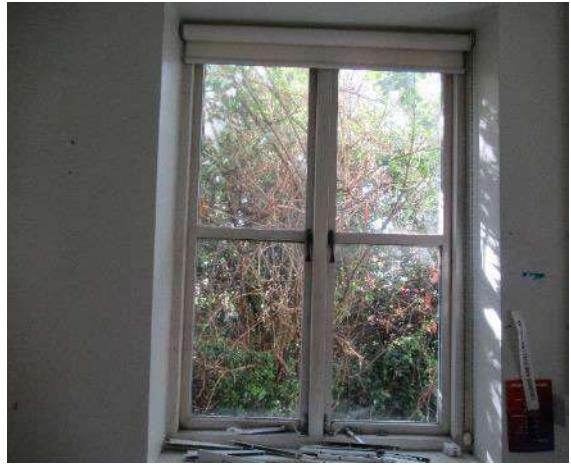
127.	Location: Ground Floor – South elevation	Element: Internal window 00-29
	Description: Timber side hung casement window with double glazing and a paint finish.

Condition: Poor. Operational. Left hand side latch loose. Shrinkage of the timber causing splitting in the frame. Poor paint finish.	
128.	Location: Ground Floor – South elevation	Element: Internal window 00-29
	Description: Timber side hung casement window with double glazing and a paint finish.

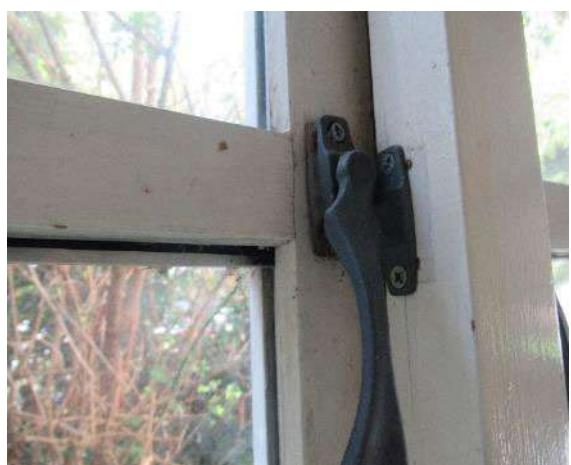
Condition: Poor. As above.	
129.	Location: Ground Floor – South elevation	Element: Internal window 00-29
	Description: Timber side hung casement window with double glazing and a paint finish.

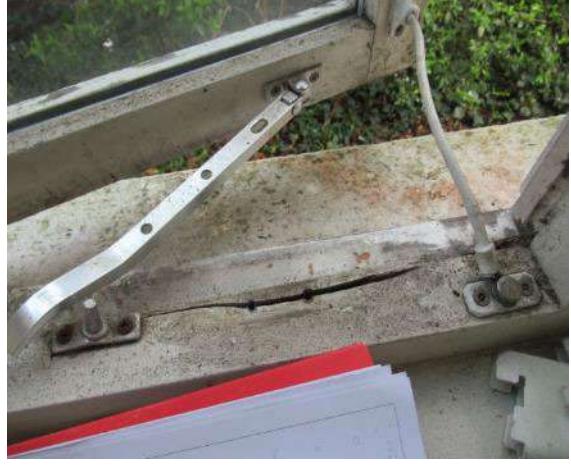
Condition: Poor. As above.

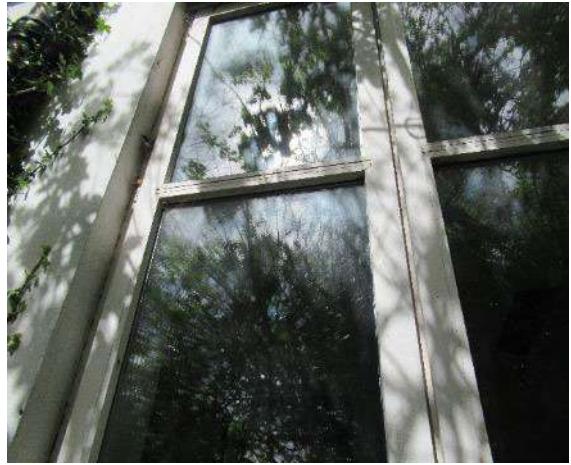
130.	Location: Ground Floor – South elevation	Element: External window 00-29
	Description: Timber side hung casement window with double glazing and a paint finish.

Condition: Poor. Decay to the timber bottom rail. Poor paint finish throughout.	
131.	Location: Ground Floor – South elevation	Element: External window 00-29
	Description: Timber side hung casement window with double glazing and a paint finish.

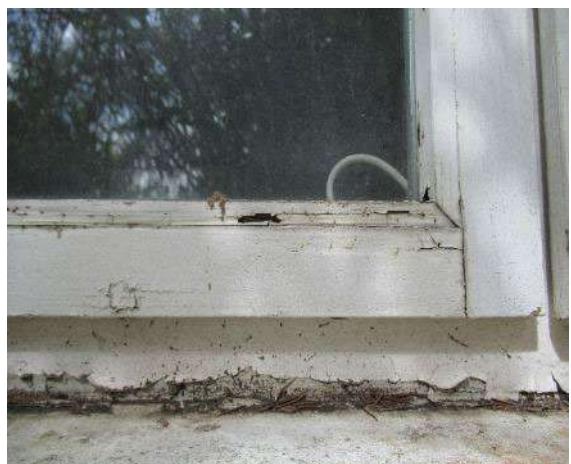
Condition: Poor. As above.	
132.	Location: Ground Floor – South elevation	Element: External window 00-29
	Description: Timber side hung casement window with double glazing and a paint finish.

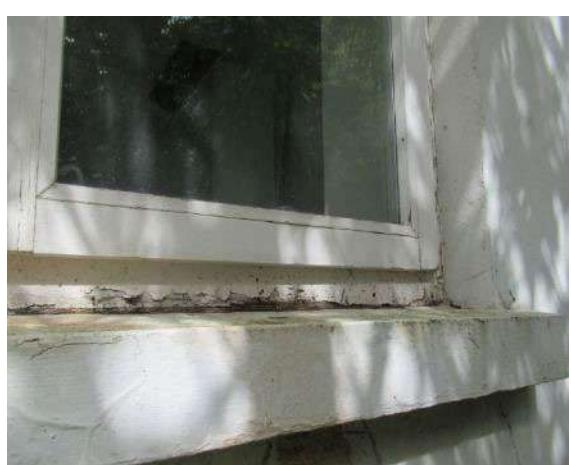
Condition: Poor. As above.

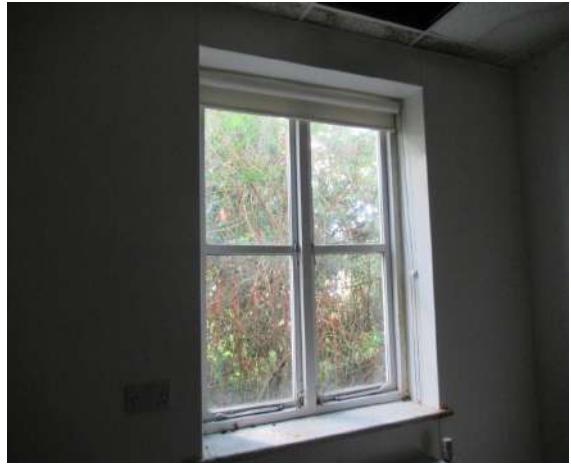
133.	Location: Ground Floor – South elevation	Element: Internal window 00-30
	Description: Timber side hung casement window with double glazing and a paint finish.

Condition: Fair. Operational. Poor paint finish throughout. Loose metal restrictor.	
134.	Location: Ground Floor – South elevation	Element: Internal window 00-30
	Description: Timber side hung casement window with double glazing and a paint finish.

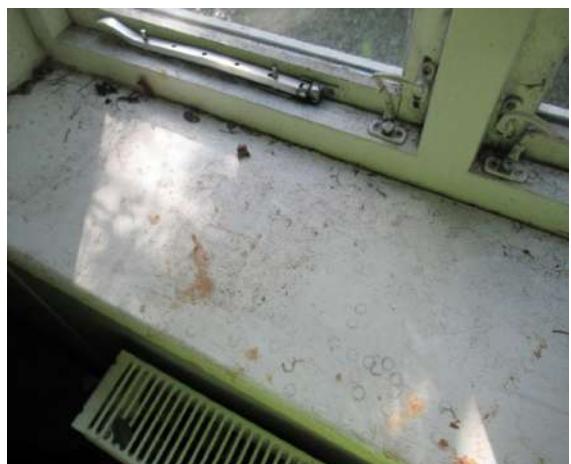
Condition: As above.	
135.	Location: Ground Floor – South elevation	Element: Internal window 00-30
	Description: Timber side hung casement window with double glazing and a paint finish.

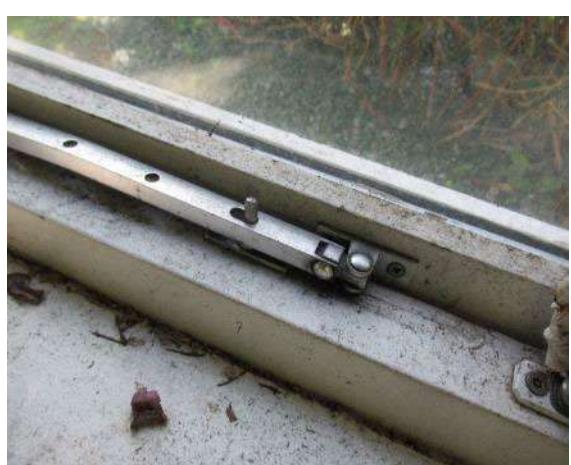
Condition: As above.

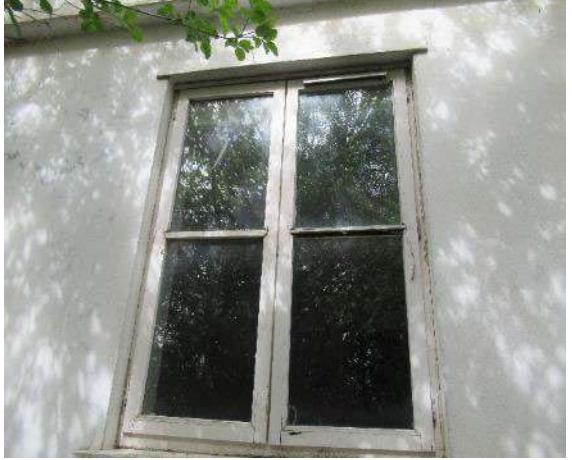
136.	Location: Ground Floor – South elevation	Element: External window 00-30
	Description: Timber side hung casement window with double glazing and a paint finish.

137.	Condition: Poor. Missing timber to the right-side mid rail. Decay to the timber bottom rail. Poor paint finish throughout.	
	Description: Timber side hung casement window with double glazing and a paint finish.	Element: External window 00-30
137.	Condition: Poor. As above.

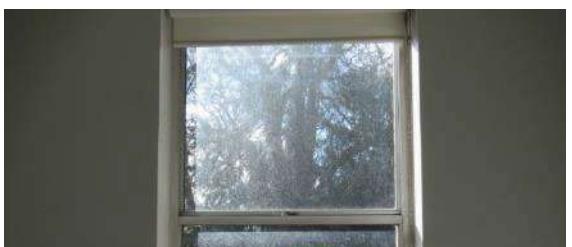
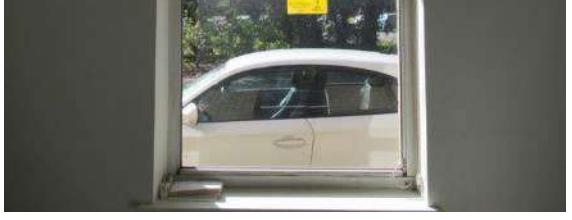
138.	Location: Ground Floor – South elevation	Element: Internal window 00-31
	Description: Aluminium frame vertical sliding sash window with single glazing.

Condition: Fair. Operational. Unable to stay open. Defective catch. Paint finish to jambs and sill scratched. Defective and aged seal.

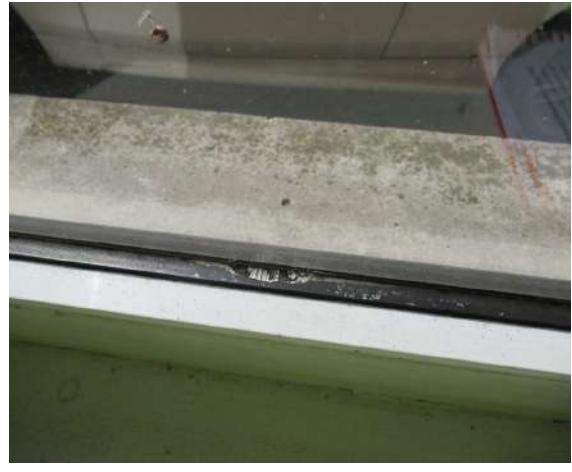
139.	Location: Ground Floor – South elevation	Element: Internal window 00-31
	Description: Aluminium frame vertical sliding sash window with single glazing.

Condition: Fair. As above.	
140.	Location: Ground Floor – South elevation	Element: External window 00-31
	Description: Aluminium frame vertical sliding sash window with single glazing.

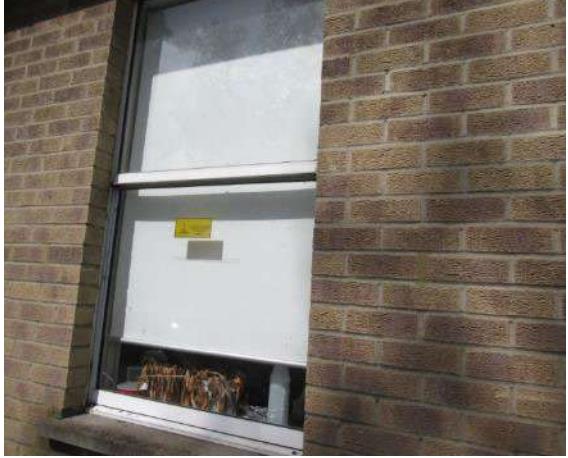
142.	<p>Location: Ground Floor – South elevation</p> <p>Description: Aluminium frame vertical sliding sash window with single glazing.</p> <p>Condition: Fair. Defective sealant.</p>	<p>Element: External window 00-32</p>

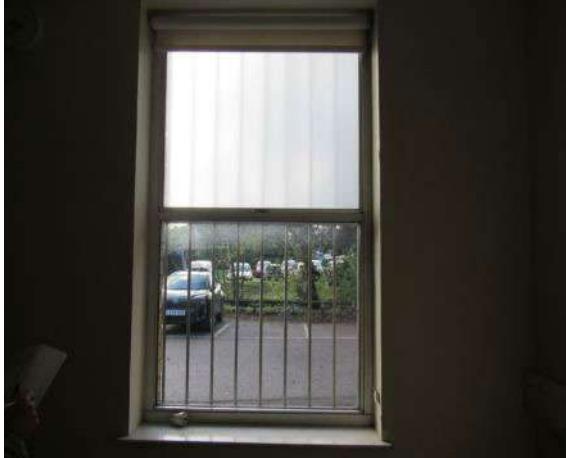
143.	<p>Location: Ground Floor – South elevation</p> <p>Description: Aluminium frame vertical sliding sash window with single glazing.</p> <p>Condition: Fair. Operational. Paint finish to jambs and sill scratched. Seals beginning to age.</p>	<p>Element: Internal window 00-33</p>

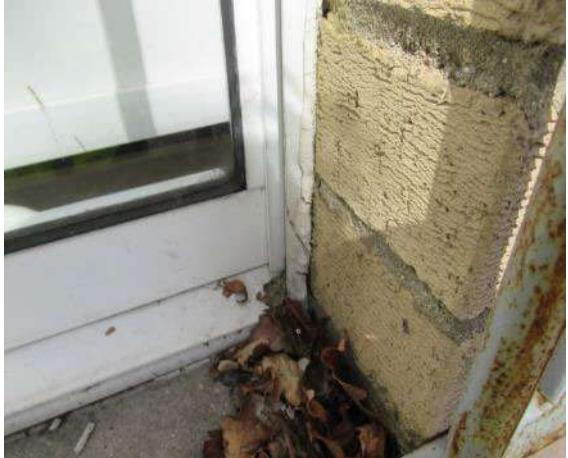
144.	<p>Location: Ground Floor – South elevation</p> <p>Description: Aluminium frame vertical sliding sash window with single glazing.</p> <p>Condition: Fair. Defective and cracked sealant. Poor paint finish to security bars.</p>	<p>Element: External window 00-33</p>

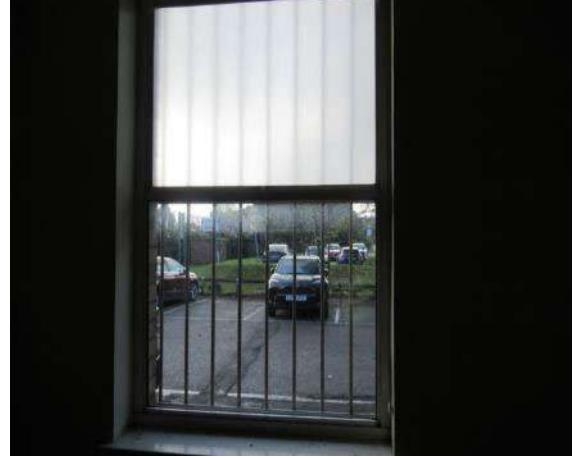
145.	Location: Ground Floor – South elevation	Element: Internal window 00-34
	Description: Aluminium frame vertical sliding sash window with single glazing.

Condition: Fair. Operational. Catch defective. Poor paint finish to jambs, sill and window board. Seals aged and defective.	
146.	Location: Ground Floor – South elevation	Element: Internal window 00-34
	Description: Aluminium frame vertical sliding sash window with single glazing.

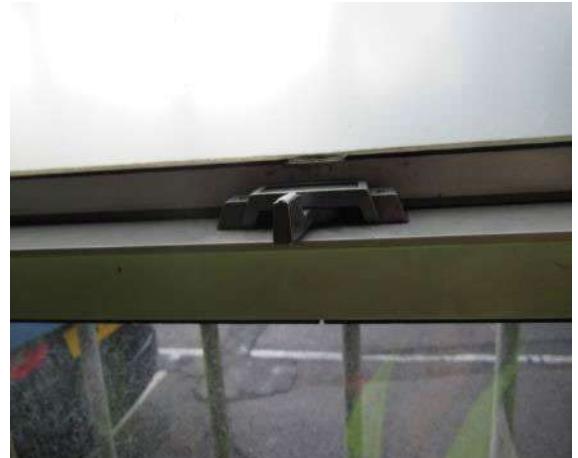
Condition: Fair. As above	
147.	Location: Ground Floor – South elevation	Element: Internal window 00-34
	Description: Aluminium frame vertical sliding sash window with single glazing.

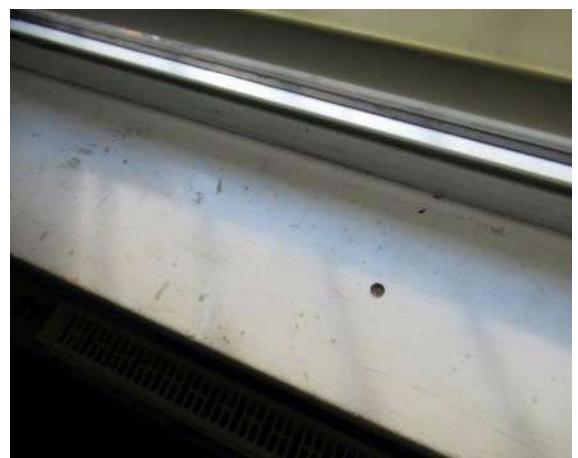
Condition: Fair. As above.

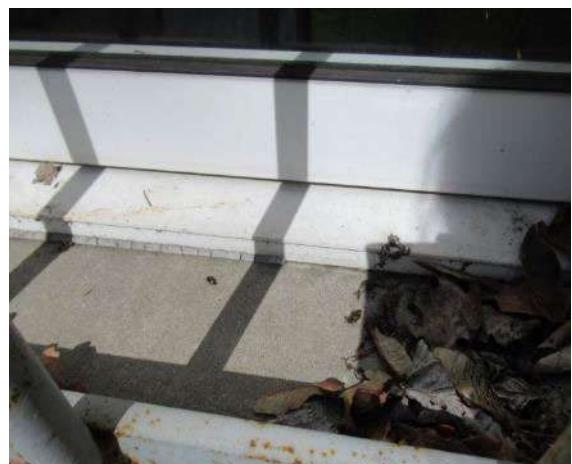
Condition: Fair. Defective and cracked sealant. Poor paint finish to security bars.	
149.	Location: Ground Floor – South elevation	Element: External window 00-34
	Description: Aluminium frame vertical sliding sash window with single glazing.

Condition: Fair. As above.	
150.	Location: Ground Floor – South elevation	Element: Internal window 00-35
	Description: Aluminium frame vertical sliding sash window with single glazing.

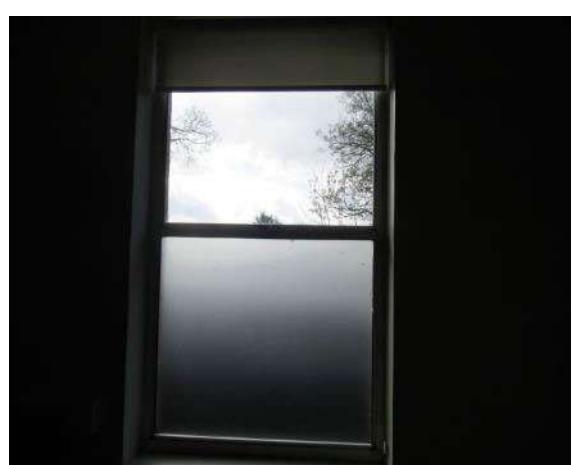
Condition: Good. Operational. Poor paint finish to jambs and sill.

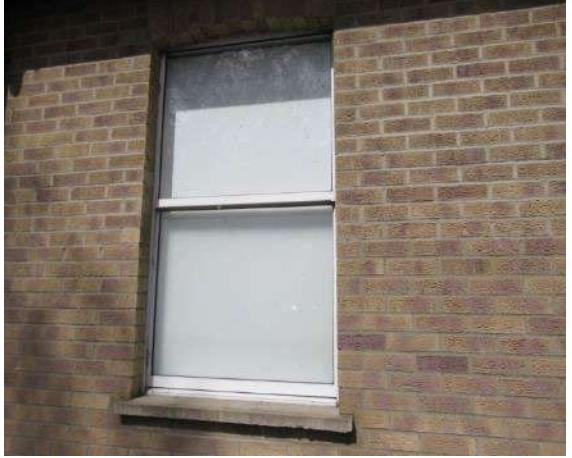
151.	Location: Ground Floor – South elevation	Element: External window 00-35
	Description: Aluminium frame vertical sliding sash window with single glazing.

Condition: Good. Defective and cracking sealant.	
152.	Location: Ground Floor – South elevation	Element: Internal window 00-36
	Description: Aluminium frame vertical sliding sash window with single glazing.

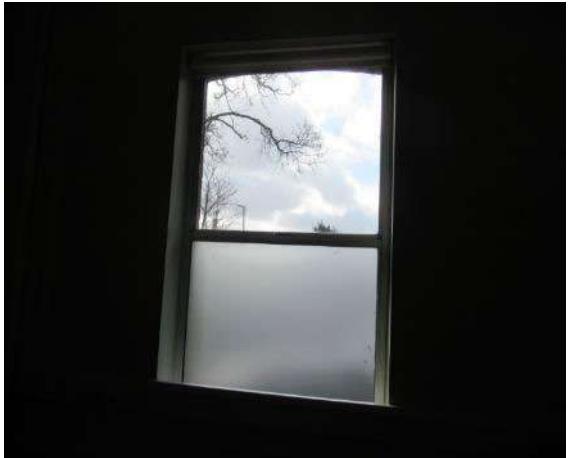
Condition: Good. Operational. Paint finish to jambs and sill scratched. Seals beginning to age.	
153.	Location: Ground Floor – South elevation	Element: Internal window 00-36
	Description: Aluminium frame vertical sliding sash window with single glazing.

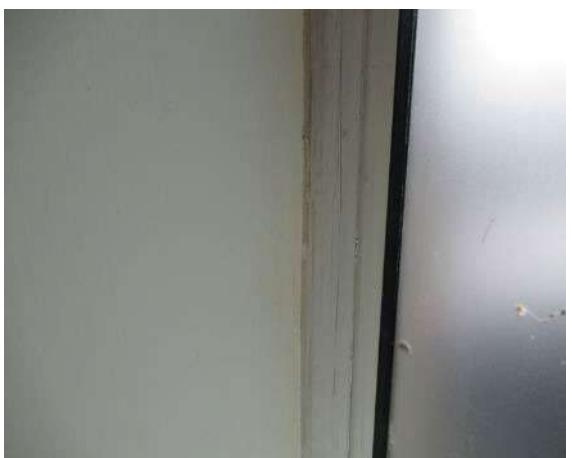
Condition: Good. As above.

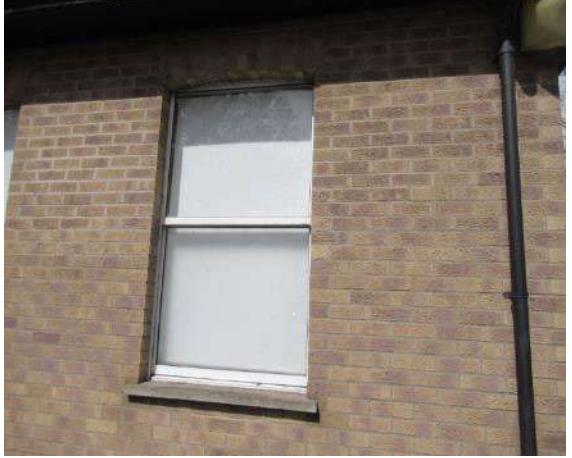
154.	<p>Location: Ground Floor – South elevation</p> <p>Description: Aluminium frame vertical sliding sash window with single glazing.</p> <p>Condition: Good. Crazing to the sealant.</p>	<p>Element: External window 00-36</p>

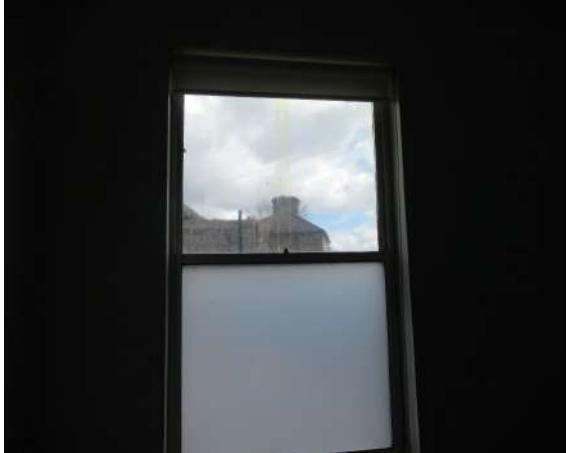
155.	<p>Location: Ground Floor – East elevation</p> <p>Description: Aluminium frame vertical sliding sash window with single glazing.</p> <p>Condition: Fair. Operates okay with some stiffness. Missing lock. Scratching to the frame finish.</p>	<p>Element: Internal window 00-37</p>

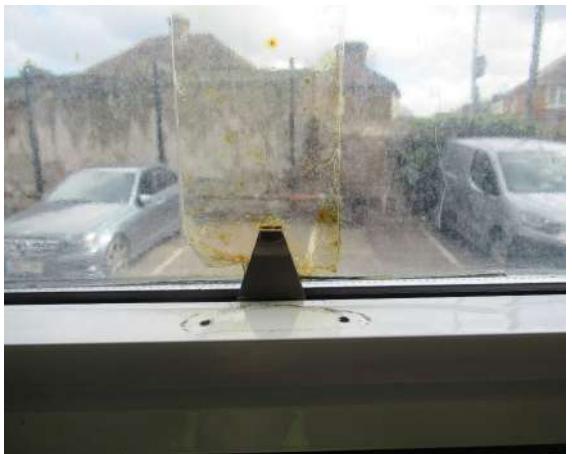
156.	<p>Location: Ground Floor – East elevation</p> <p>Description: Aluminium frame vertical sliding sash window with single glazing.</p> <p>Condition: Fair. As above.</p>	<p>Element: Internal window 00-37</p>

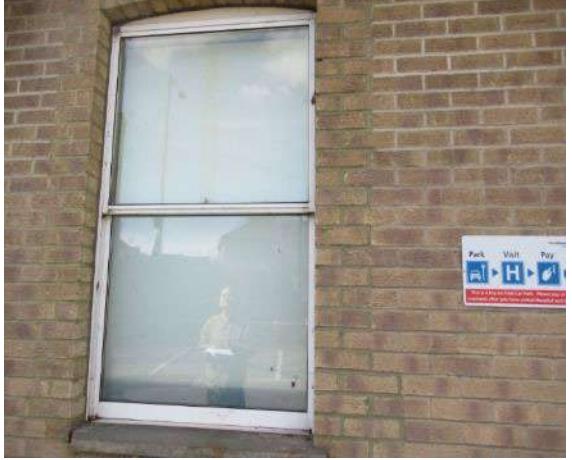
157.	<p>Location: Ground Floor – East elevation</p> <p>Description: Aluminium frame vertical sliding sash window with single glazing.</p> <p>Condition: Fair. Begrimed and soiled.</p>	<p>Element: External window 00-37</p>

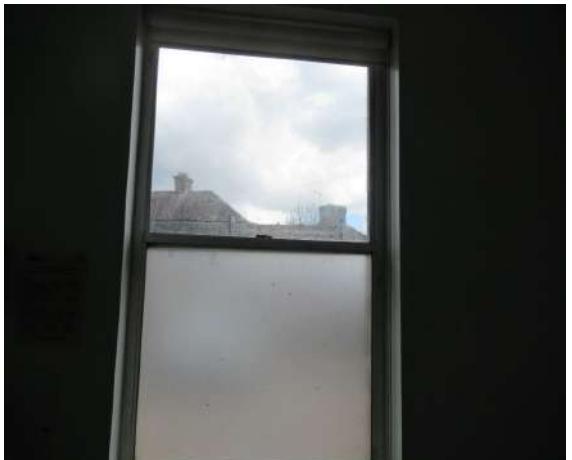
158.	<p>Location: Ground Floor – East elevation</p> <p>Description: Aluminium frame vertical sliding sash window with single glazing.</p> <p>Condition: Fair. Operational. Scratches to the frame finish.</p>	<p>Element: Internal window 00-38</p>

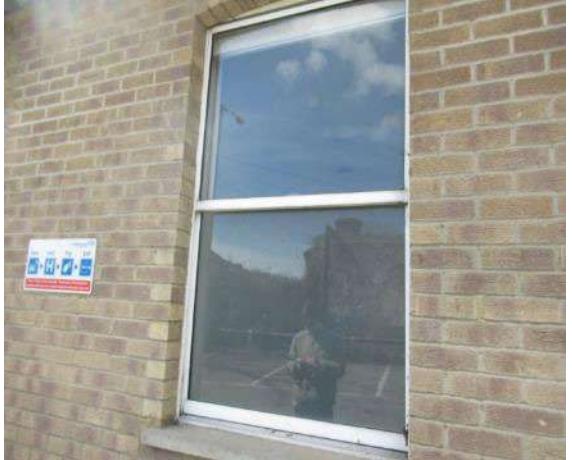
159.	<p>Location: Ground Floor – East elevation</p> <p>Description: Aluminium frame vertical sliding sash window with single glazing.</p> <p>Condition: Fair. Poor mastic. Dirt soiled.</p>	<p>Element: External window 00-38</p>

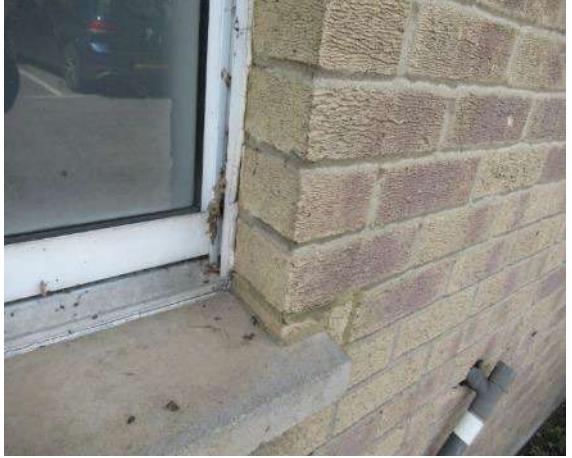
160.	<p>Location: Ground Floor – East elevation</p> <p>Description: Aluminium frame vertical sliding sash window with single glazing.</p> <p>Condition: Fair. As above.</p>	<p>Element: External window 00-38</p>

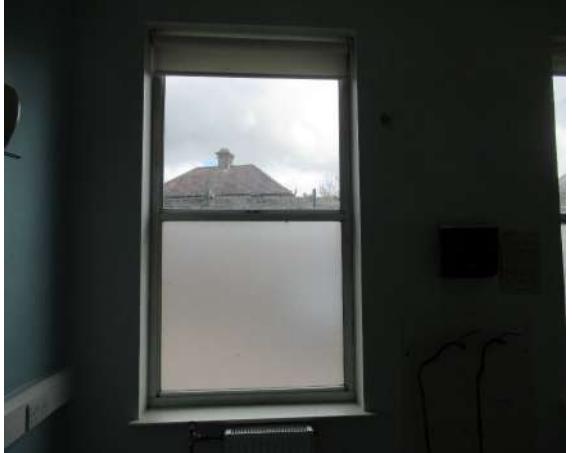
161.	<p>Location: Ground Floor – East elevation</p> <p>Description: Aluminium frame vertical sliding sash window with single glazing.</p> <p>Condition: Fair. Operational. Scratches to the frame finish.</p>	<p>Element: Internal window 00-39</p>

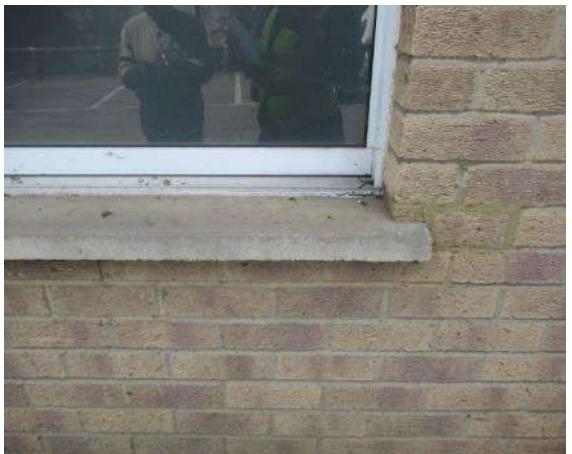
162.	<p>Location: Ground Floor – East elevation</p> <p>Description: Aluminium frame vertical sliding sash window with single glazing.</p> <p>Condition: Fair. Poor mastic. Dirt soiled.</p>	<p>Element: External window 00-39</p>

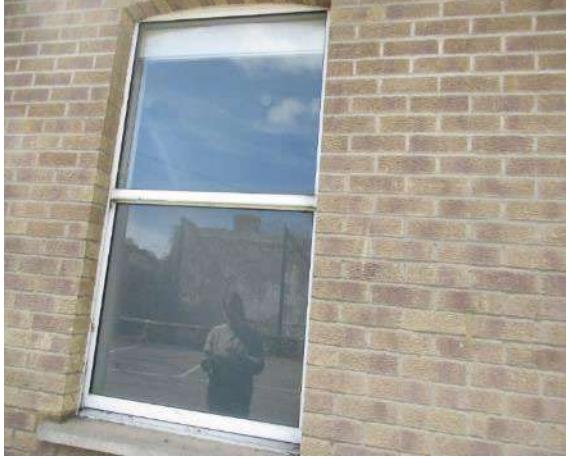
163.	<p>Location: Ground Floor – East elevation</p> <p>Description: Aluminium frame vertical sliding sash window with single glazing.</p> <p>Condition: Fair. As above.</p>	<p>Element: External window 00-39</p>

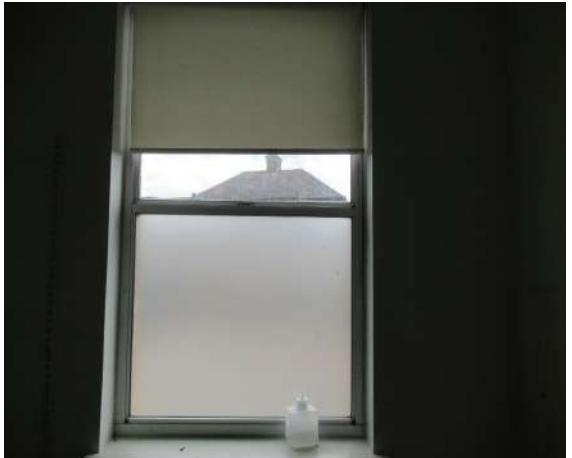
164.	<p>Location: Ground Floor – East elevation</p> <p>Description: Aluminium frame vertical sliding sash window with single glazing.</p> <p>Condition: Fair. Operational. Scratches to the frame finish.</p>	<p>Element: Internal window 00-40</p>
