Schedule of condition

**The Furze, Hillingdon
Hospital, Pield Heath
Road, Hillingdon UB8 3NN**

Prepared for: Northmores
Prepared by: Chris Baker BSc (Hons) MRICS
Date: 18 September 2023
Reference: 120937-100/MET/CBk

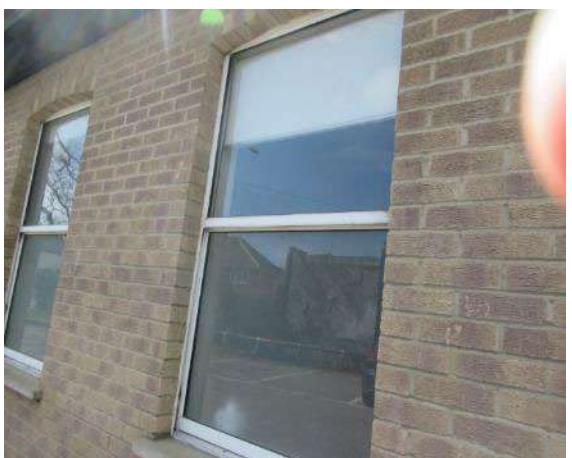
165.	<p>Location: Ground Floor – East elevation</p> <p>Description: Aluminium frame vertical sliding sash window with single glazing.</p> <p>Condition: Fair. Poor mastic. Dirt soiled</p>	<p>Element: External window 00-40</p>

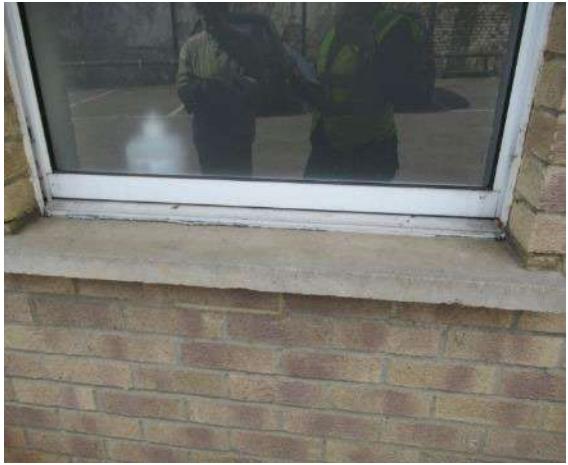
166.	<p>Location: Ground Floor – East elevation</p> <p>Description: Aluminium frame vertical sliding sash window with single glazing.</p> <p>Condition: Fair. As above.</p>	<p>Element: External window 00-40</p>

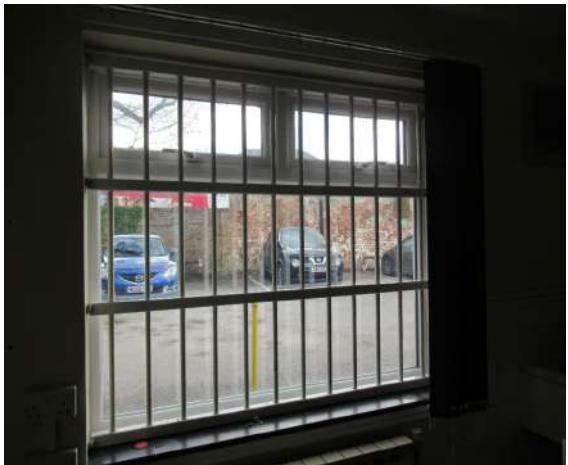
167.	<p>Location: Ground Floor – East elevation</p> <p>Description: PVCu window with double glazing.</p> <p>Condition: Good. Operational.</p>	<p>Element: Internal window 00-41</p>

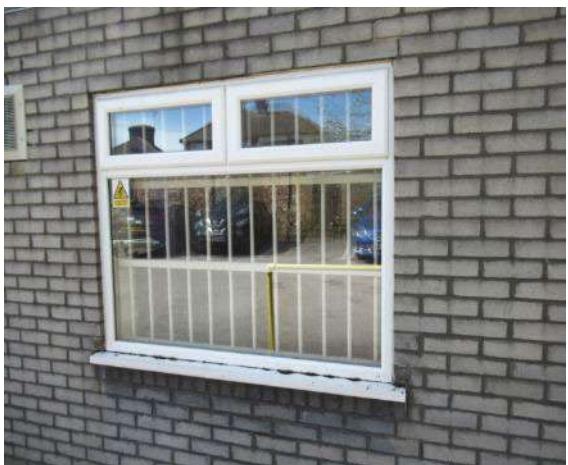
168.	<p>Location: Ground Floor – East elevation</p> <p>Description: PVCu window with double glazing.</p> <p>Condition: Good. Dirt soiled only.</p>	<p>Element: External window 00-41</p>

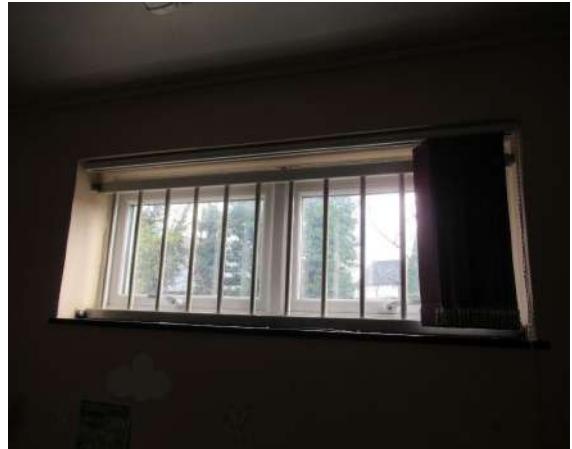
169.	Location: Ground Floor – East elevation	Element: Internal window 00-42
	Description: PVCu window with double glazing.

Condition: Fair.	
170.	Location: Ground Floor – East elevation	Element: External window 00-42
	Description: PVCu window with double glazing.

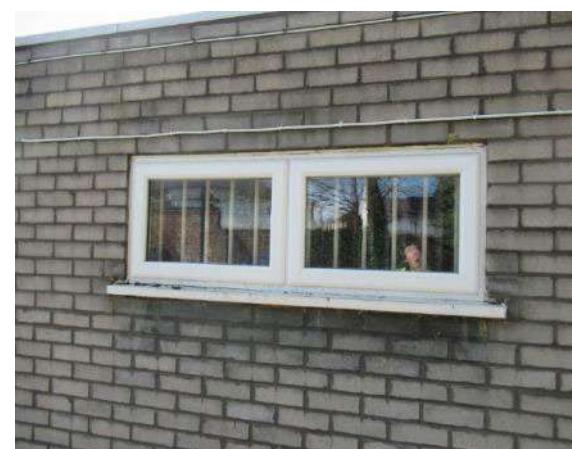
Condition: Fair. Dirt soiled.	
171.	Location: Ground Floor – North elevation	Element: Internal window 00-43
	Description: PVCu window with double glazing.

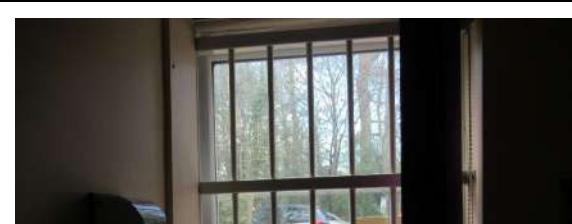
Condition: Fair. Operational.

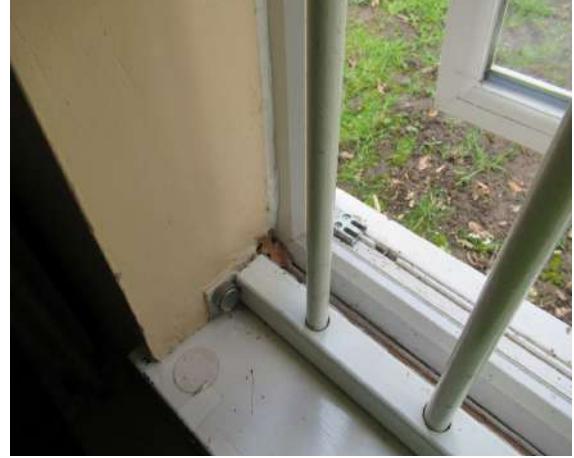
172.	<p>Location: Ground Floor – North elevation</p> <p>Description: PVCu window with double glazing.</p> <p>Condition: Fair. As above.</p>	<p>Element: Internal window 00-43</p>

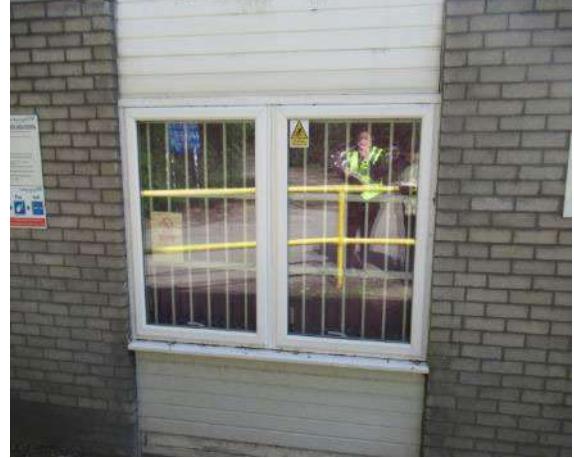
173.	<p>Location: Ground Floor – North elevation</p> <p>Description: PVCu window with double glazing</p> <p>Condition: Good. Dirt soiled.</p>	<p>Element: External window 00-43</p>

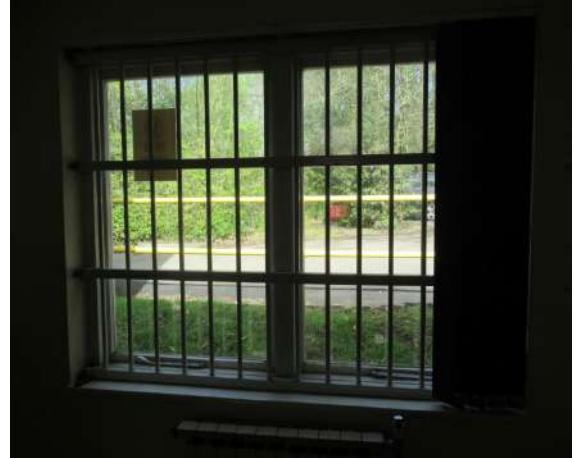
174.	<p>Location: Ground Floor – North elevation</p> <p>Description: Side hung timber casement window with double glazing and paint finish.</p> <p>Condition: Good. Operational.</p>	<p>Element: Internal window 00-44</p>

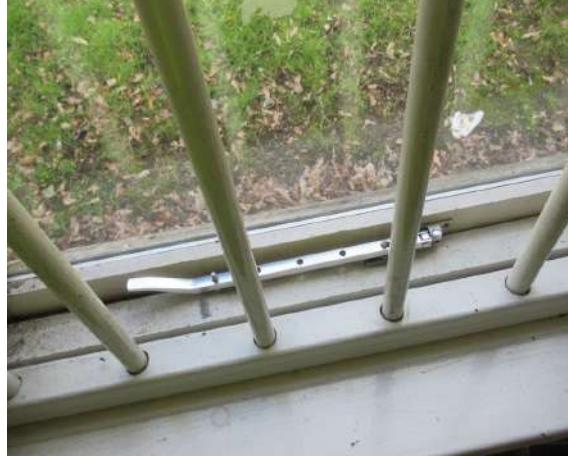
175.	<p>Location: Ground Floor – North elevation</p> <p>Description: Side hung timber casement window with double glazing and paint finish.</p> <p>Condition: Good. As above.</p>	<p>Element: Internal window 00-44</p>

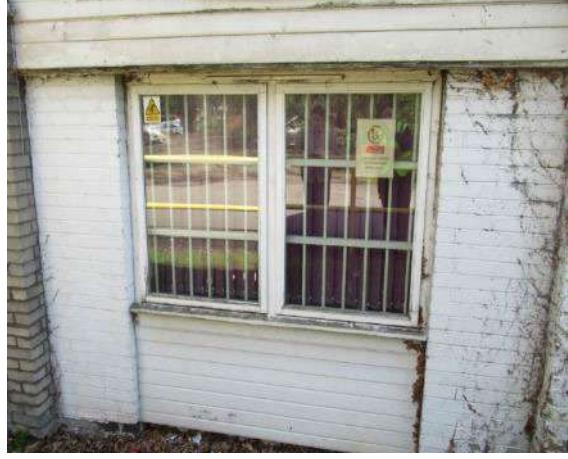
176.	<p>Location: Ground Floor – North elevation</p> <p>Description: Side hung timber casement window with double glazing and paint finish.</p> <p>Condition: Poor. Decay to the entire timber sill and bottom rail. Poor paint finish.</p>	<p>Element: External window 00-44</p>

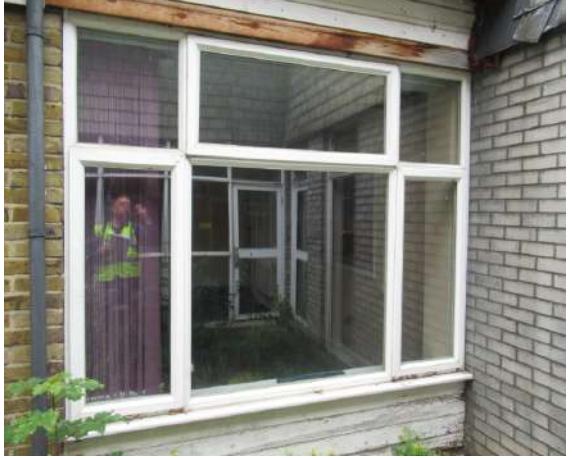
178.	<p>Location: Ground floor – courtyard</p> <p>Description: PVCu framed double glazed windows with side hung and top hung casements.</p> <p>Condition: Fair. Missing handle to one casement.</p>	<p>Element: External window 00-45</p>

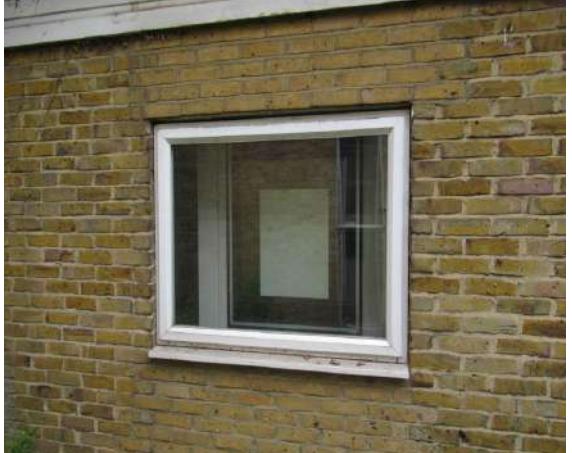
179.	<p>Location: Ground floor – courtyard</p> <p>Description: PVCu framed double glazed windows with side hung and top hung casements.</p> <p>Condition: Fair. Poor pointing to perimeter of window frame</p>	<p>Element: External window 00-46</p>

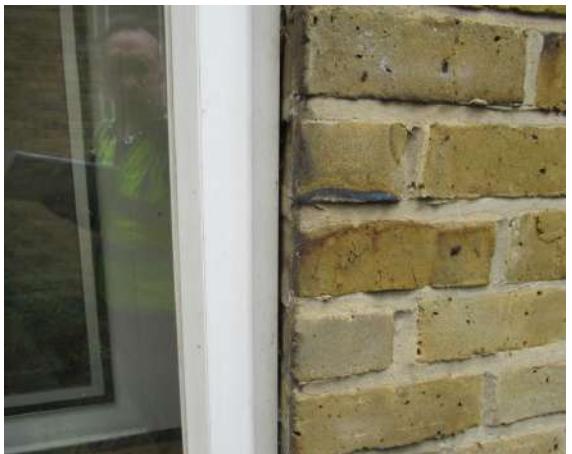
180.	<p>Location: Ground floor – courtyard</p> <p>Description: As above.</p> <p>Condition: As above.</p>	<p>Element: External window 00-46</p>

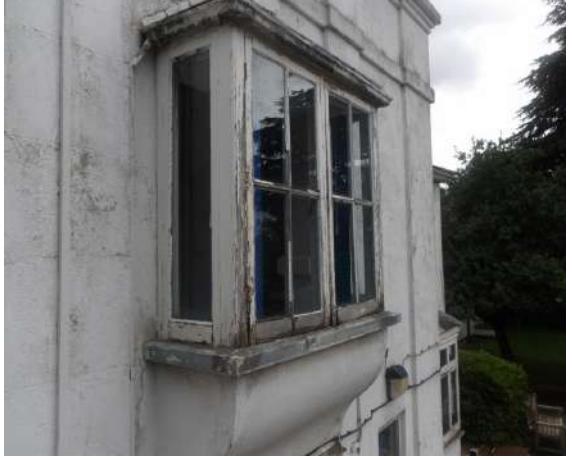
184.	<p>Location: First Floor – West elevation</p> <p>Description: Timber frame side hung casement window with single glazing and paint finish.</p> <p>Condition: As above. As above</p>	<p>Element: External window 01-01</p>

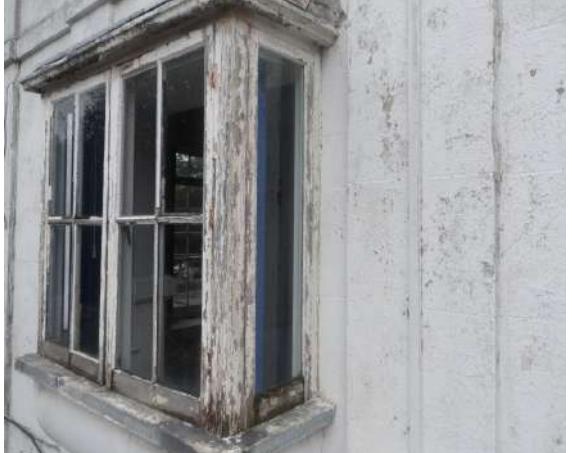
185.	<p>Location: First Floor – West elevation</p> <p>Description: Timber frame side hung casement window with single glazing and paint finish.</p> <p>Condition: As above. As above.</p>	<p>Element: External window 01-01</p>

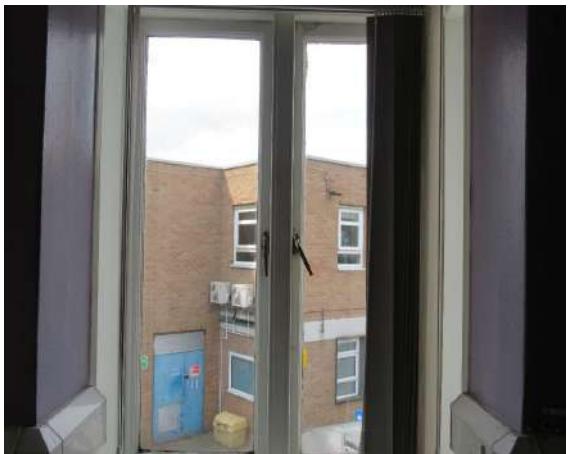
186.	<p>Location: First Floor – West elevation</p> <p>Description: Timber frame side hung casement window with single glazing and paint finish.</p> <p>Condition: Poor. Decay to entire bottom rail and sill. Poor paint finish.</p>	<p>Element: Internal window 01-02</p>

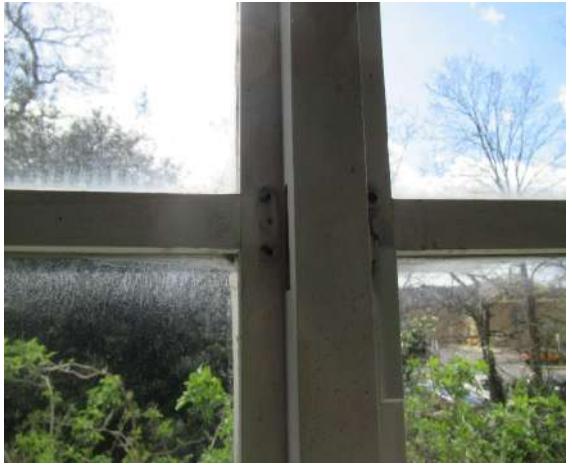
190.	<p>Location: First Floor – South elevation</p> <p>Description: Timber frame side hung casement window with double glazing and paint finish.</p> <p>Condition: Poor. As above.</p>	<p>Element: Internal window 01-03</p>

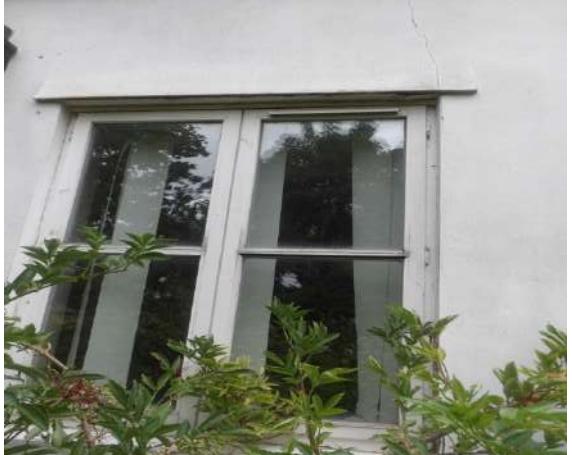
191.	<p>Location: First Floor – South elevation</p> <p>Description: Timber frame side hung casement window with double glazing and paint finish.</p> <p>Condition: As above. Poor paint finish externally.</p>	<p>Element: External window 01-03</p>

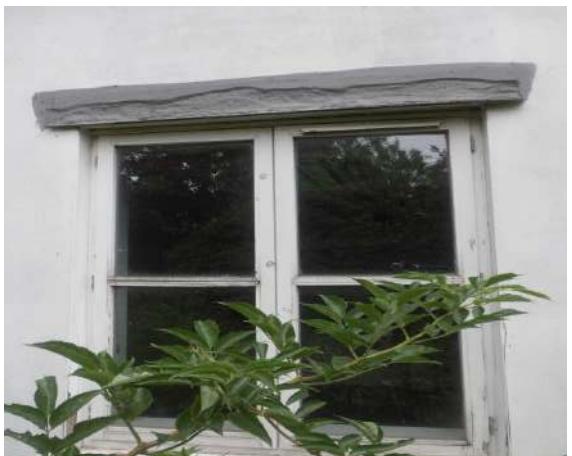
192.	<p>Location: First Floor – South elevation</p> <p>Description: Timber frame side hung casement window with double glazing and paint finish.</p> <p>Condition: Poor. Poor paint finish externally.</p>	<p>Element: External window 01-04</p>

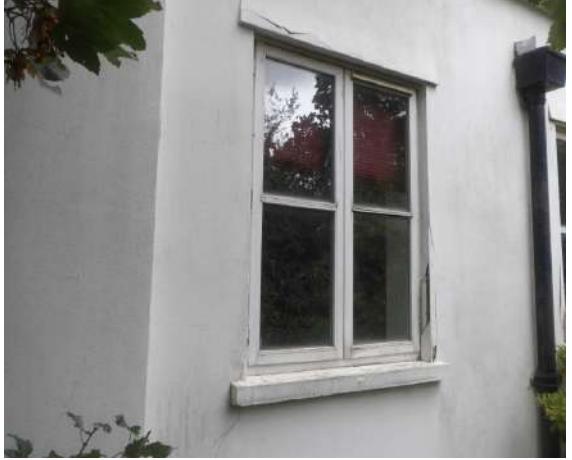
193.	<p>Location: First Floor – South elevation</p> <p>Description: Timber frame side hung casement window with double glazing and paint finish.</p> <p>Condition: Poor. Poor paint finish externally.</p>	<p>Element: External window 01-04</p>

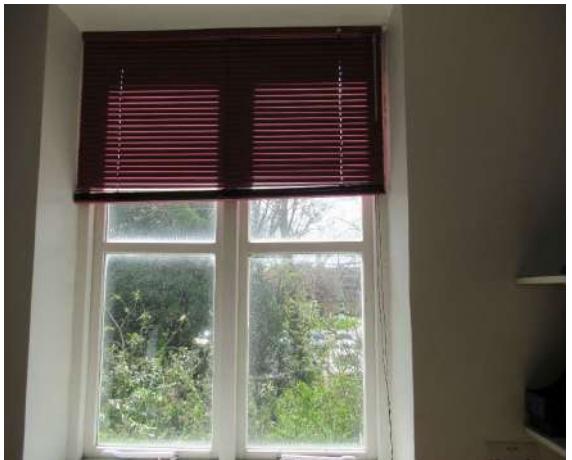
194.	<p>Location: First Floor – South elevation</p> <p>Description: Timber frame side hung casement window with double glazing and paint finish.</p> <p>Condition: Fair. Operational. Poor paint finish.</p>	<p>Element: Internal window 01-05</p>

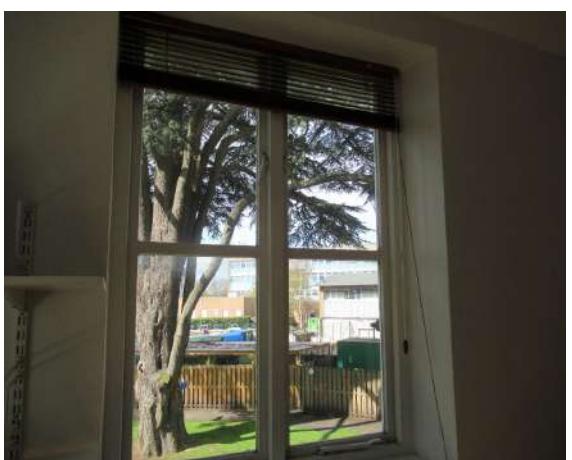
195.	<p>Location: First Floor – West elevation</p> <p>Description: Timber frame side hung casement window with double glazing and paint finish.</p> <p>Condition: Fair. Operational. Poor paint finish.</p>	<p>Element: Internal window 01-06</p>

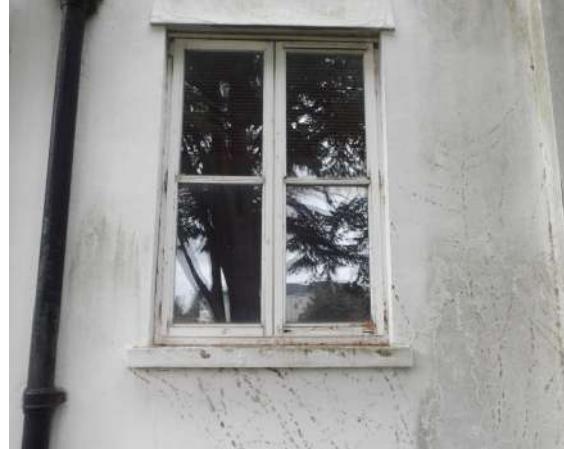
197.	<p>Location: First Floor – West elevation</p> <p>Description: Timber frame side hung casement window with double glazing and paint finish.</p> <p>Condition: Fair. Missing timber beading to mid rail. Poor paint finish.</p>	<p>Element: External window 01-06</p>

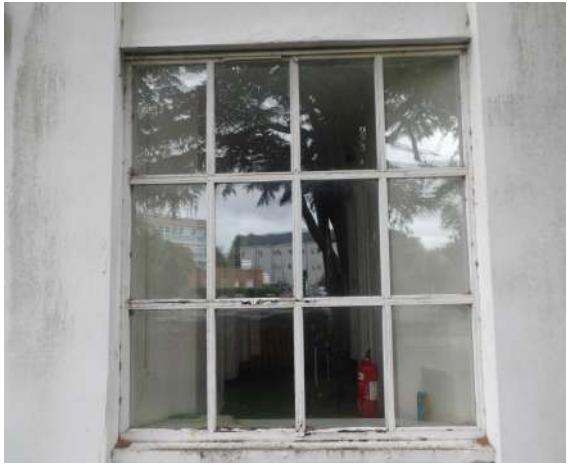
199.	<p>Location: First Floor – West elevation</p> <p>Description: Timber frame casement with double glazing and paint finish.</p> <p>Condition: Poor. Decay to timber sill. Splitting to timber frame. Poor paint finish.</p>	<p>Element: External window 01-07</p>

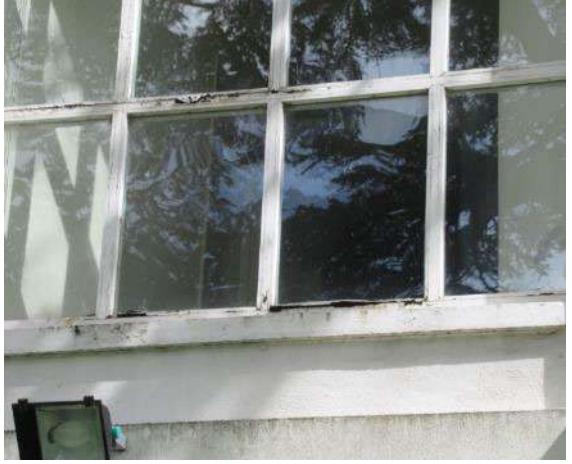
200.	<p>Location: First Floor – West elevation</p> <p>Description: Timber frame casement with double glazing and paint finish.</p> <p>Condition: Poor. As above.</p>	<p>Element: External window 01-07</p>

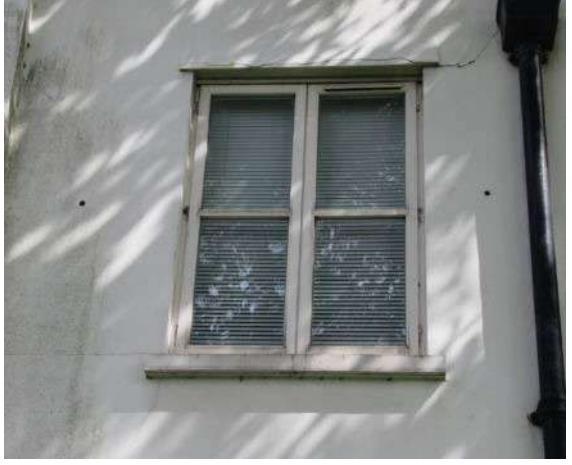
201.	<p>Location: First Floor – West elevation</p> <p>Description: Timber frame side hung casement window with double glazing and paint finish.</p> <p>Condition: Fair. Poor paint finish. Unable to access room to assess internal condition.</p>	<p>Element: External window 01-08</p>

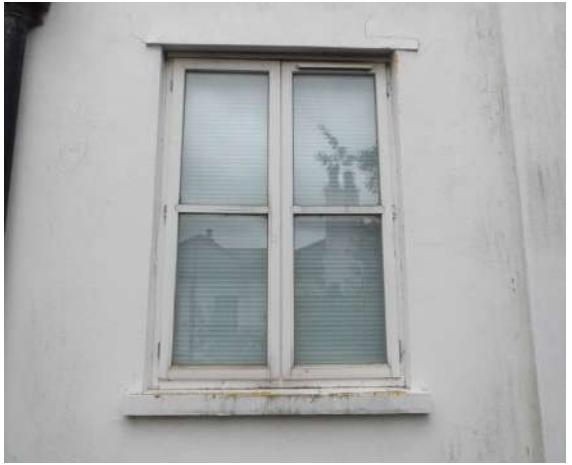
202.	<p>Location: First Floor – West elevation</p> <p>Description: Timber frame side hung casement window with double glazing and paint finish.</p> <p>Condition: Fair. Poor paint finish. Unable to access room to assess internal condition.</p>	<p>Element: External window 01-09</p>

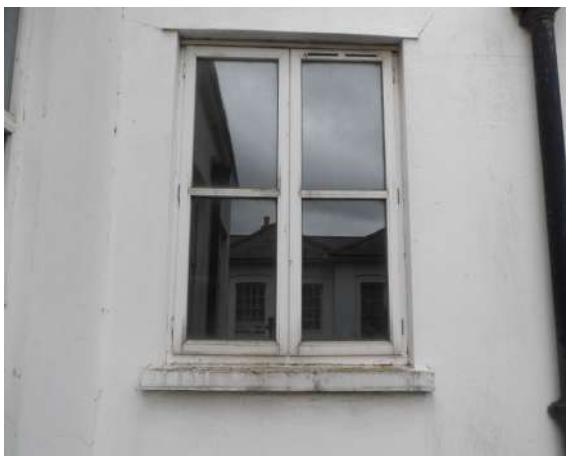
204.	<p>Location: First Floor – West elevation</p> <p>Description: Timber frame side hung casement window with double glazing and paint finish.</p> <p>Condition: Fair. Poor paint finish. Missing vent cover.</p>	<p>Element: External window 01-10</p>

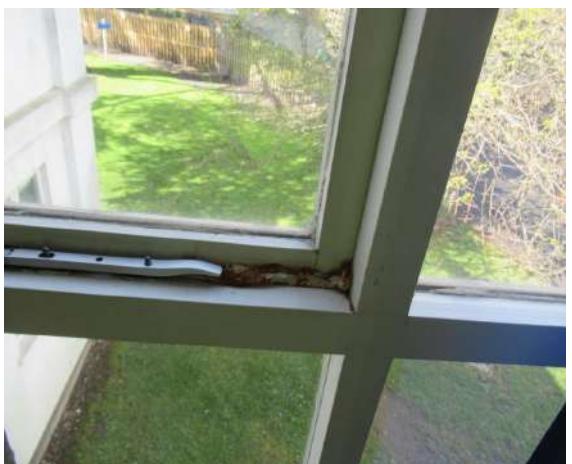
Condition: Fair. Handles lose. Gaps in the window frame.	
206.	Location: First Floor – West elevation	Element: Internal window 01-11
	Description: Timber frame side hung casement window with double glazing and paint finish.

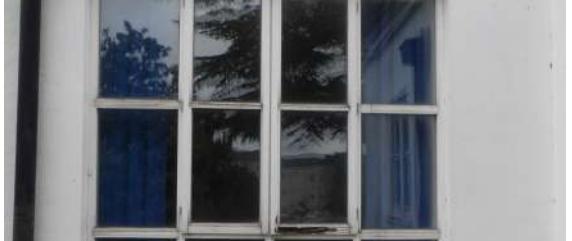
Condition: Poor. Decay to the bottom rail and window bars. Poor paint finish.

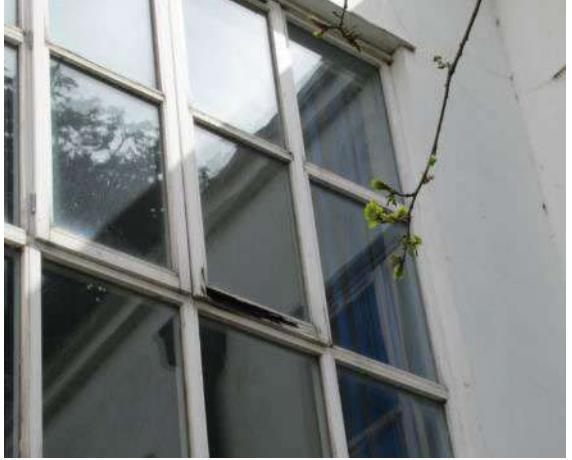
207.	<p>Location: First Floor – West elevation</p> <p>Description: Timber frame side hung casement window with double glazing and paint finish.</p> <p>Condition: Poor. As above.</p>	<p>Element: External window 01-11</p>

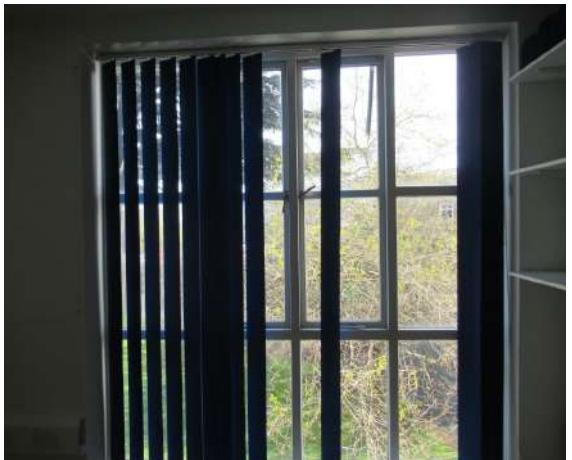
208.	<p>Location: First Floor – West elevation</p> <p>Description: Timber frame side hung casement window with double glazing and paint finish.</p> <p>Condition: Poor. Handles loose. One loose blown DGU with condensation.</p>	<p>Element: Internal window 01-12</p>

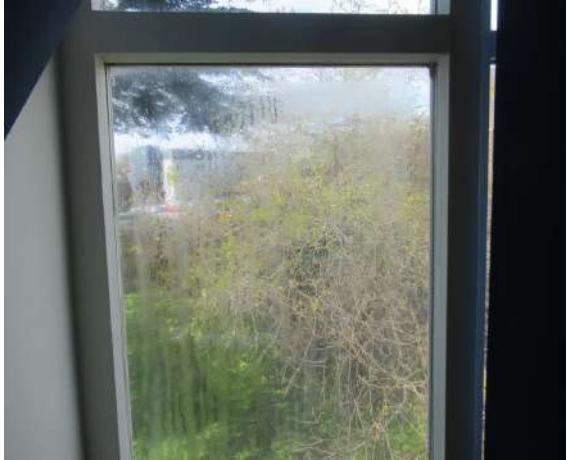
209.	<p>Location: First Floor – West elevation</p> <p>Description: Timber frame side hung casement window with double glazing and paint finish.</p> <p>Condition: Poor. Blown double glazed unit.</p>	<p>Element: Internal window 01-12</p>

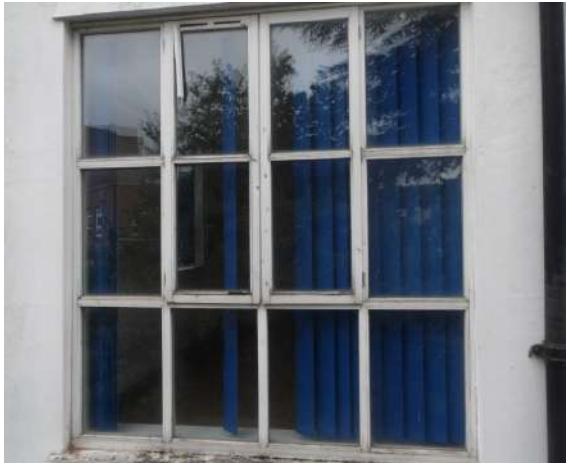
210.	<p>Location: First Floor – West elevation</p> <p>Description: Timber frame side hung casement window with double glazing and paint finish.</p> <p>Condition: Poor. Vent cover to top rail loose. Decay to bottom rail. Poor paint finish.</p>	<p>Element: External window 01-12</p>

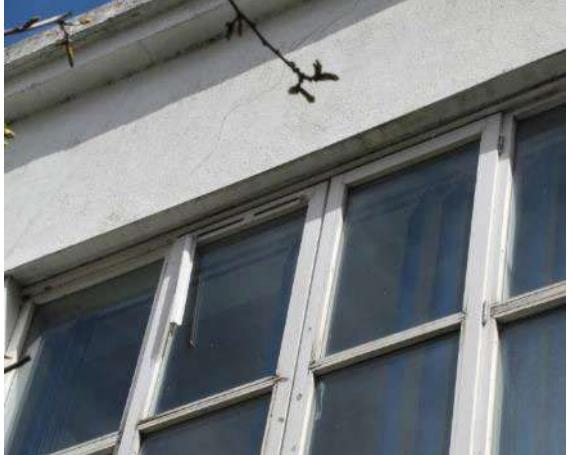
211.	<p>Location: First Floor – West elevation</p> <p>Description: Timber frame side hung casement window with double glazing and paint finish.</p> <p>Condition: Poor. As above.</p>	<p>Element: External window 01-12</p>

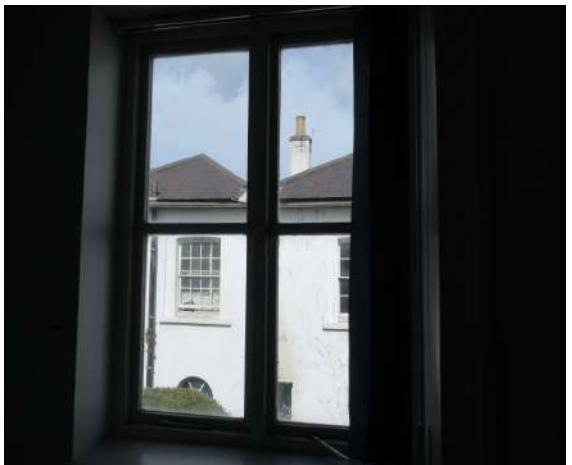
212.	<p>Location: First Floor – West elevation</p> <p>Description: Timber frame side hung casement window with double glazing and paint finish.</p> <p>Condition: Fair. Handles loose.</p>	<p>Element: Internal window 01-13</p>

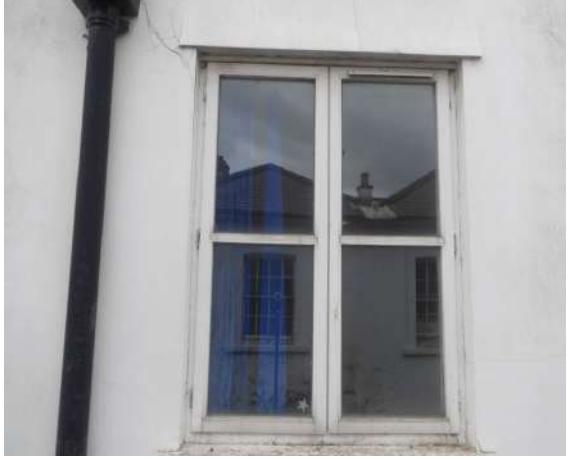
213.	<p>Location: First Floor – West elevation</p> <p>Description: Timber frame side hung casement window with double glazing and paint finish.</p> <p>Condition: Fair. Poor paint finish.</p>	<p>Element: External window 01-13</p>

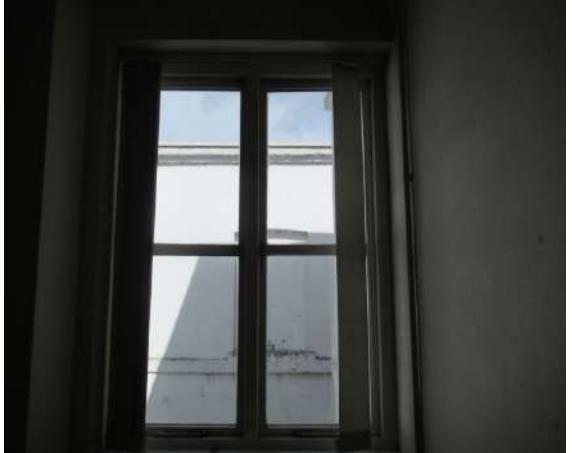
214.	<p>Location: First Floor – West elevation</p> <p>Description: Timber frame side hung casement window with double glazing and paint finish.</p> <p>Condition: Fair. Missing latch to left side. Timber shrinkage causing splitting in the frame.</p>	<p>Element: Internal window 01-14</p>

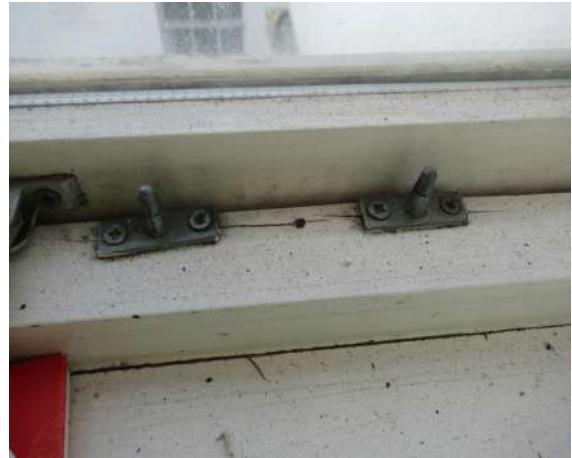
216.	Location: First Floor – West elevation	Element: Internal window 01-14
	Description: Timber frame side hung casement window with double glazing and paint finish.

Condition: As above.	
217.	Location: First Floor – West elevation	Element: External window 01-14
	Description: Timber frame side hung casement window with double glazing and paint finish.

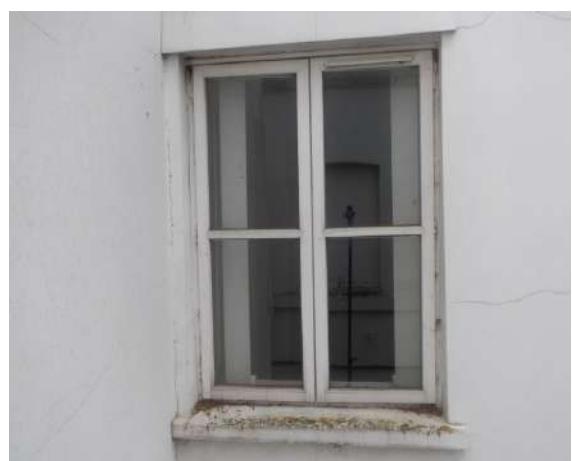
Condition: Fair. Poor paint finish.	
218.	Location: First Floor – West elevation	Element: Internal window 01-15
	Description: Timber frame casement window with double glazing and paint finish.

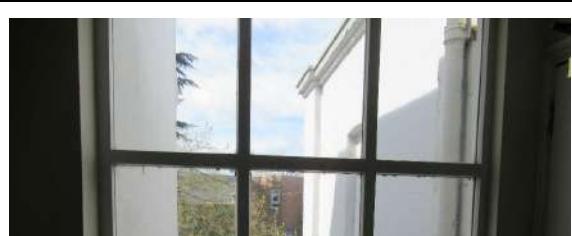
Condition: Good. Operational.

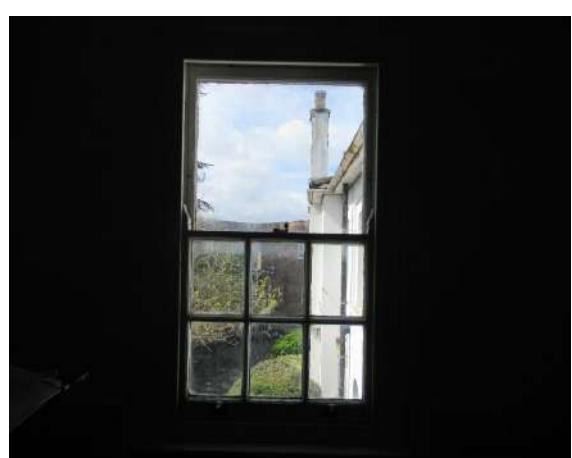
221.	Location: First Floor – West elevation	Element: Internal window 01-16
	Description: Timber frame vertical sliding sash window with double glazing and paint finish.

Condition: Poor. Defective latch. Stiffness in opening. Poor paint finish.

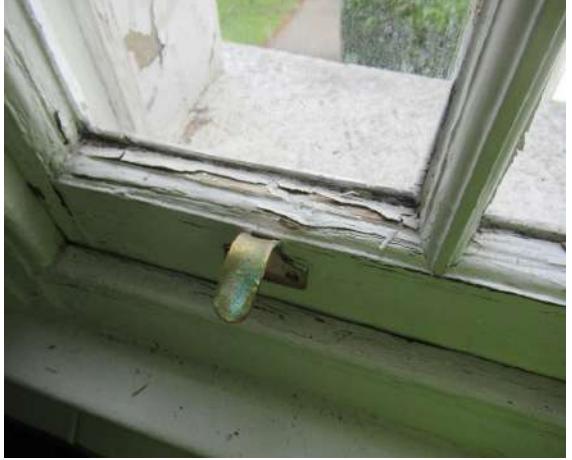
222.	<p>Location: First Floor – West elevation</p> <p>Description: Timber frame vertical sliding sash window with double glazing and paint finish.</p> <p>Condition: Poor. Defective latch. Stiffness in opening. Poor paint finish.</p>	<p>Element: Internal window 01-16</p>

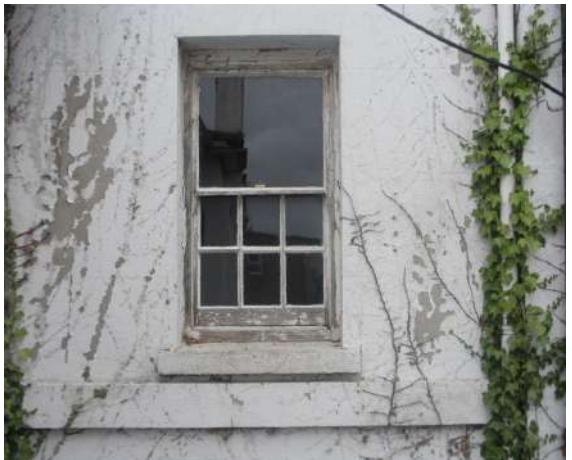
223.	<p>Location: First Floor – West elevation</p> <p>Description: Timber frame vertical sliding sash window with double glazing and paint finish.</p> <p>Condition: Poor. Decay to timber mid rail and sill. Poor paint finish.</p>	<p>Element: External window 01-16</p>

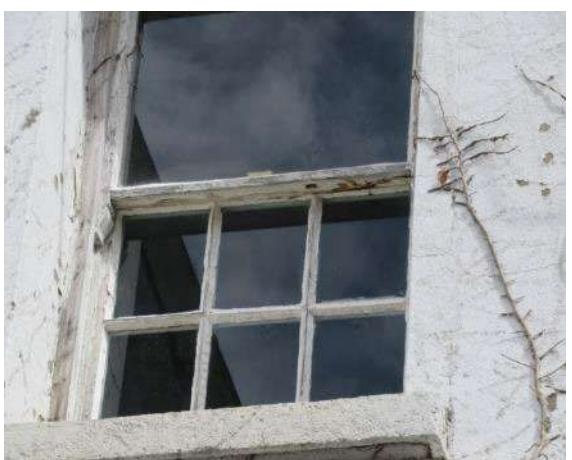
224.	<p>Location: First Floor – West elevation</p> <p>Description: Timber frame vertical sliding sash window with double glazing and paint finish.</p> <p>Condition: As above.</p>	<p>Element: External window 01-16</p>

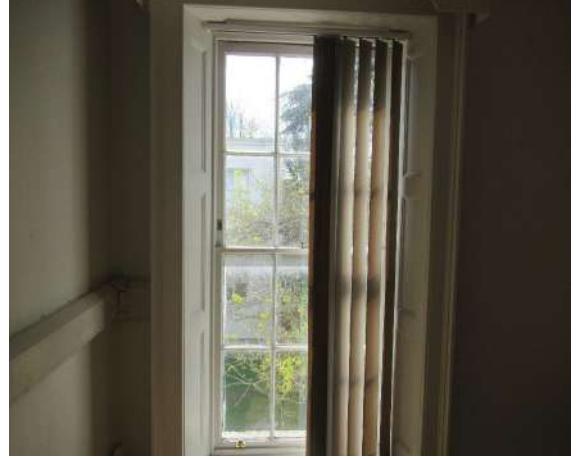
234.	Location: First Floor – West elevation	Element: Internal window 01-20
	Description: Timber frame vertical sliding sash window with single glazing and paint finish.

Condition: Fair. Poor paint finish.	
235.	Location: First Floor – West elevation	Element: Internal window 01-20
	Description: Timber frame vertical sliding sash window with single glazing and paint finish.

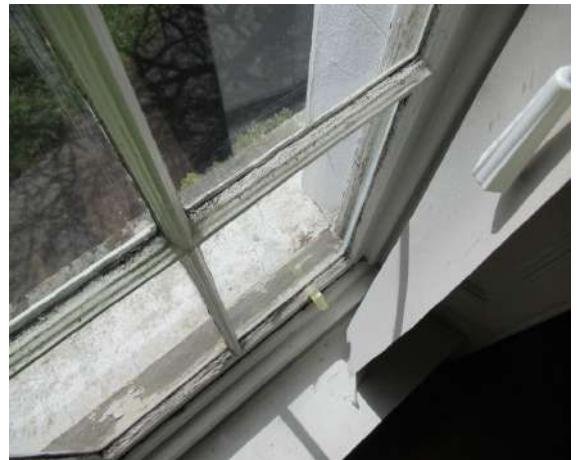
Condition: Fair. Poor paint finish.	
236.	Location: First Floor – West elevation	Element: External window 01-20
	Description: Timber frame vertical sliding sash window with single glazing and paint finish.

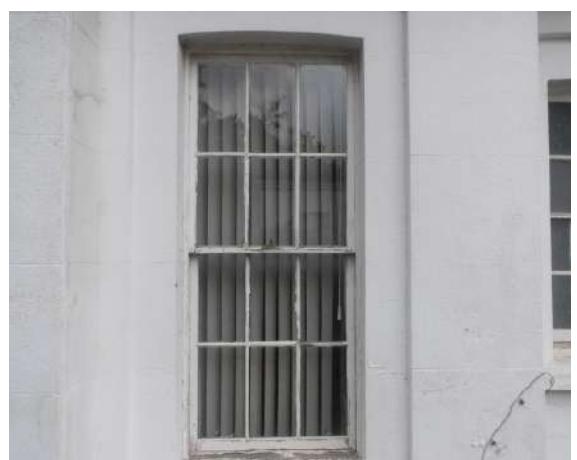
Condition: Poor. Poor paint finish.

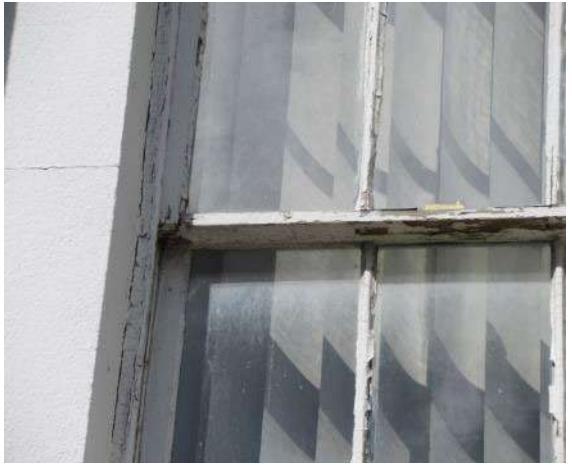
237.	<p>Location: First Floor – West elevation</p> <p>Description: Timber frame vertical sliding sash window with single glazing and paint finish.</p> <p>Condition: Poor. Poor paint finish.</p>	<p>Element: External window 01-20</p>

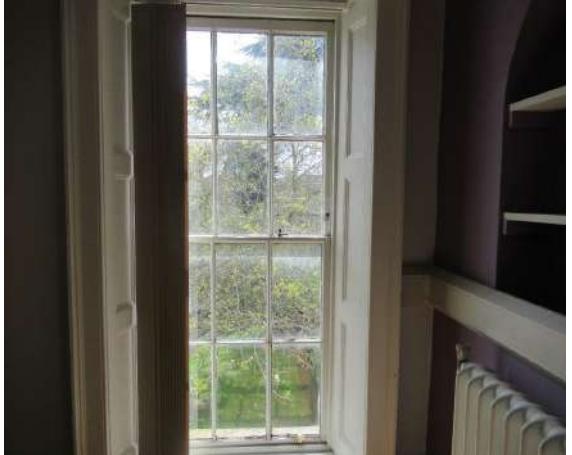
238.	<p>Location: First Floor – West elevation</p> <p>Description: Timber frame vertical sliding sash window with single glazing and paint finish.</p> <p>Condition: Poor. Unable to open. Poor paint finish.</p>	<p>Element: Internal window 01-21</p>

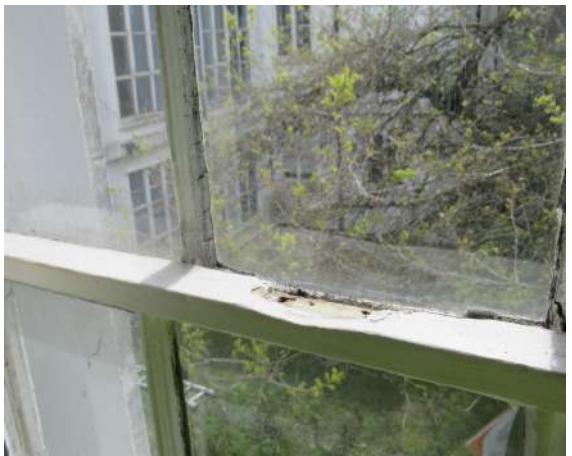
239.	<p>Location: First Floor – West elevation</p> <p>Description: Timber frame vertical sliding sash window with single glazing and paint finish.</p> <p>Condition: Poor. Unable to open. Poor paint finish.</p>	<p>Element: Internal window 01-21</p>

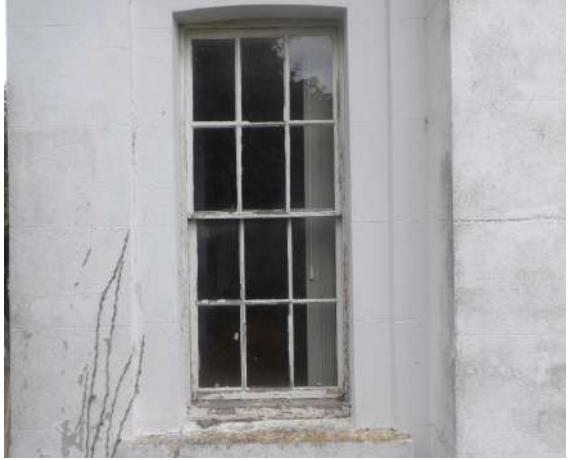
240.	<p>Location: First Floor – West elevation</p> <p>Description: Timber frame vertical sliding sash window with single glazing and paint finish.</p> <p>Condition: Poor. Decay to mid rail and sill. Poor paint finish.</p>	<p>Element: External window 01-21</p>

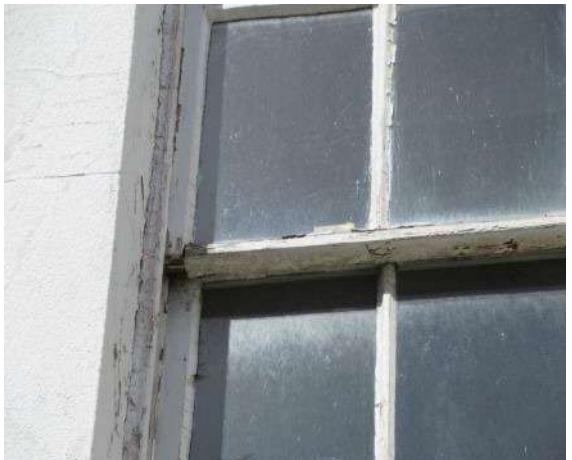
241.	<p>Location: First Floor – West elevation</p> <p>Description: Timber frame vertical sliding sash window with single glazing and paint finish.</p> <p>Condition: As above.</p>	<p>Element: External window 01-21</p>

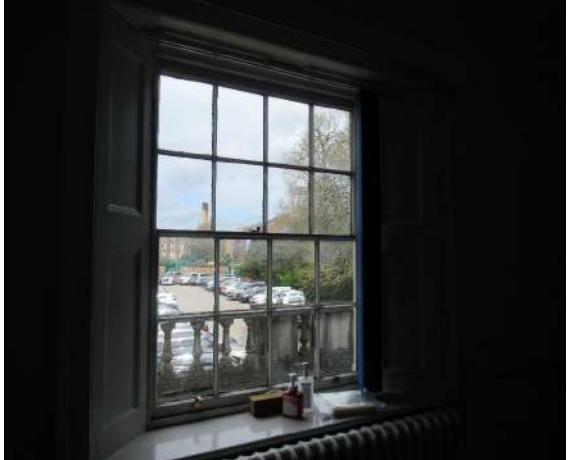
242.	<p>Location: First Floor – North elevation</p> <p>Description: Timber frame vertical sliding sash window with single glazing and paint finish.</p> <p>Condition: Poor. Operates poorly. Does not stay open. Poor paint finish.</p>	<p>Element: Internal window 01-22</p>

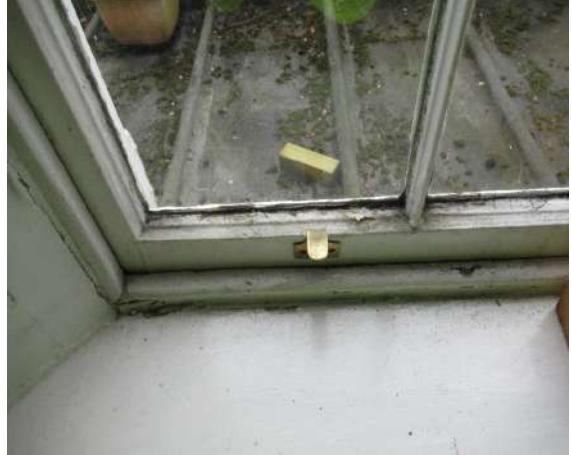
243.	Location: First Floor – North elevation	Element: Internal window 01-22
	Description: Timber frame vertical sliding sash window with single glazing and paint finish.

Condition: Poor. Operates poorly. Does not stay open. Poor paint finish.	
244.	Location: First Floor – North elevation	Element: External window 01-22
	Description: Timber frame vertical sliding sash window with single glazing and paint finish.

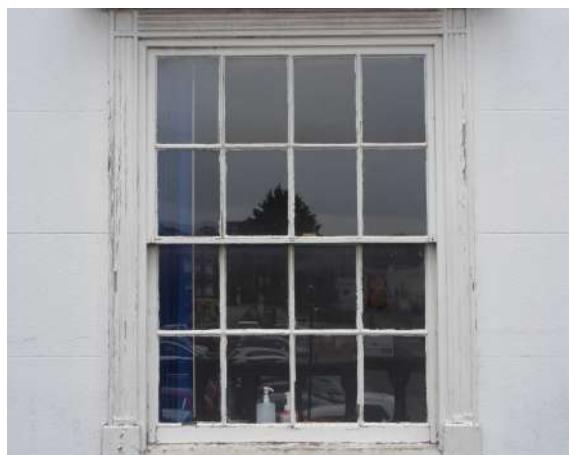
Condition: Poor. Poor paint finish. Decay to the timber.	
245.	Location: First Floor – North elevation	Element: Internal window 01-23
	Description: Timber frame vertical sliding sash window with single glazing and paint finish.

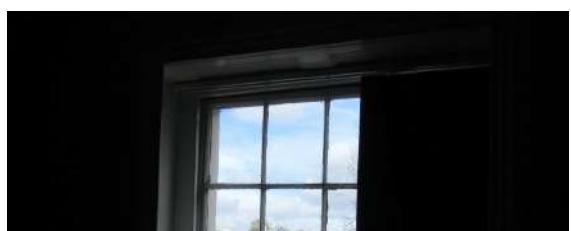
Condition: Poor. Non – operational. Stuck shut and out of frame. Poor paint finish.

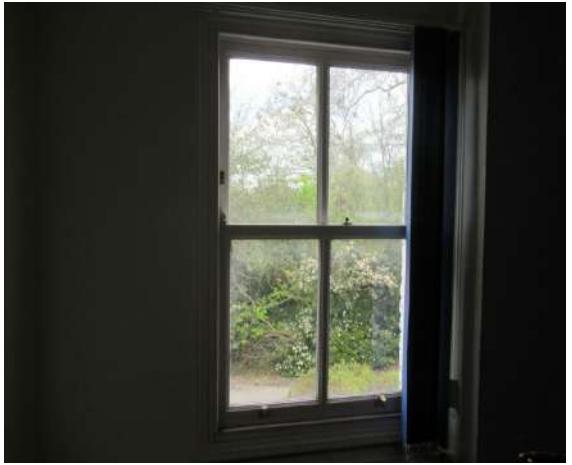
249.	<p>Location: First Floor – North elevation</p> <p>Description: Timber frame vertical sliding sash window with double glazing and paint finish.</p> <p>Condition: Poor. Operates poorly. Does not hold open. Poor paint finish.</p>	<p>Element: Internal window 01-24</p>

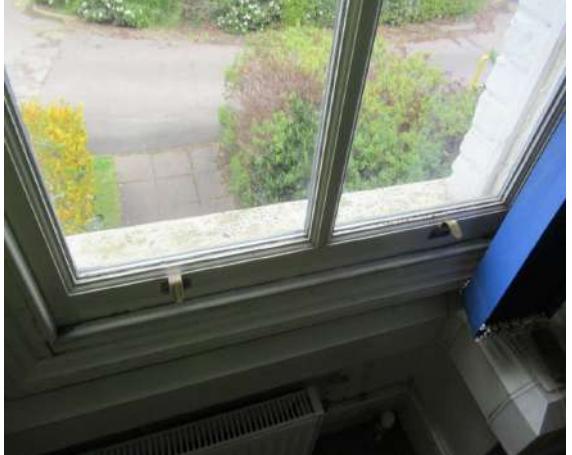
250.	<p>Location: First Floor – North elevation</p> <p>Description: Timber frame vertical sliding sash window with double glazing and paint finish.</p> <p>Condition: Poor. Operates poorly. Does not hold open. Poor paint finish.</p>	<p>Element: Internal window 01-24</p>

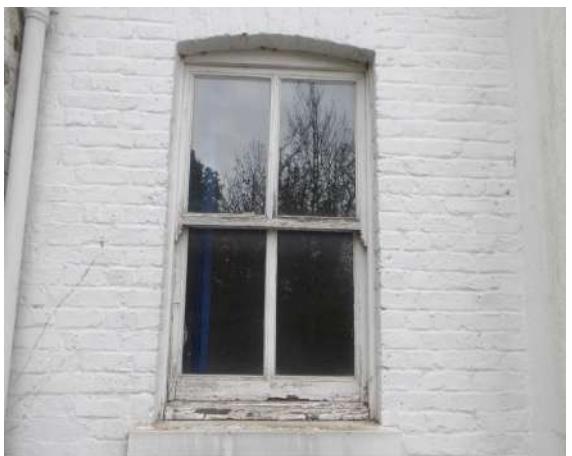
251.	<p>Location: First Floor – North elevation</p> <p>Description: Timber frame vertical sliding sash window with double glazing and paint finish.</p> <p>Condition: Fair. Poor paint finish.</p>	<p>Element: External window 01-24</p>

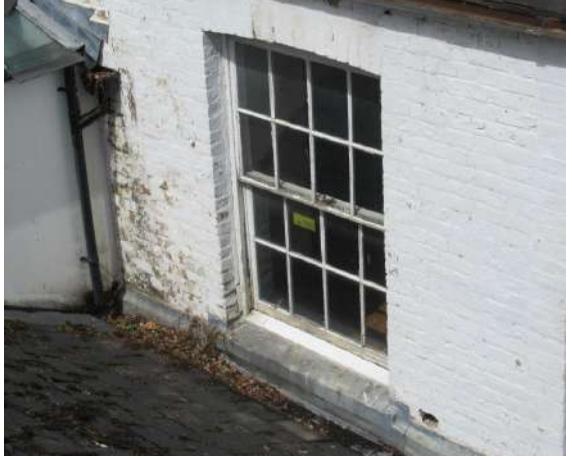
267.	<p>Location: First Floor – East elevation</p> <p>Description: Timber frame vertical sliding sash window with single glazing and paint finish.</p> <p>Condition: Poor. Poor paint finish externally</p>	<p>Element: External window 01-29</p>

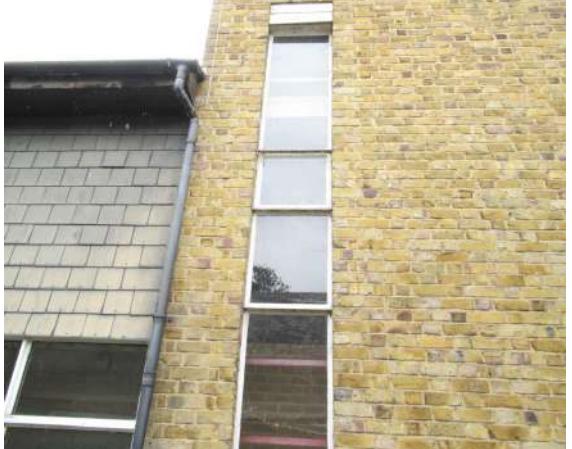
268.	<p>Location: First floor – east elevation.</p> <p>Description: Steel frame crittal window with single glazing and top hung casements.</p> <p>Condition: Poor. Poor paint finish externally.</p>	<p>Element: External window 01-30</p>

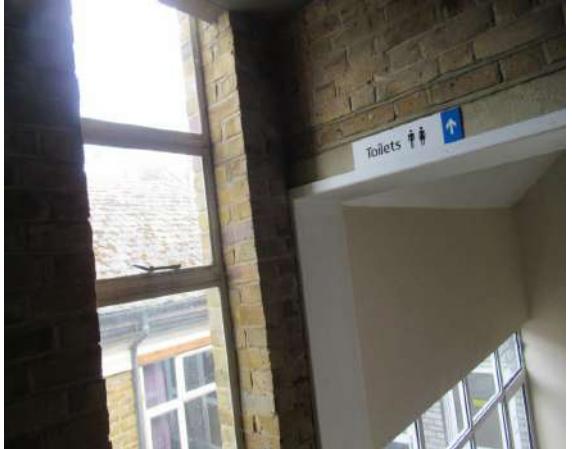
269.	<p>Location: First Floor – East elevation</p> <p>Description: Steel frame top hung Crittall window with single glazing and paint finish.</p> <p>Condition: Poor. Unable to test opening. Poor paint finish.</p>	<p>Element: Internal window 01-30</p>

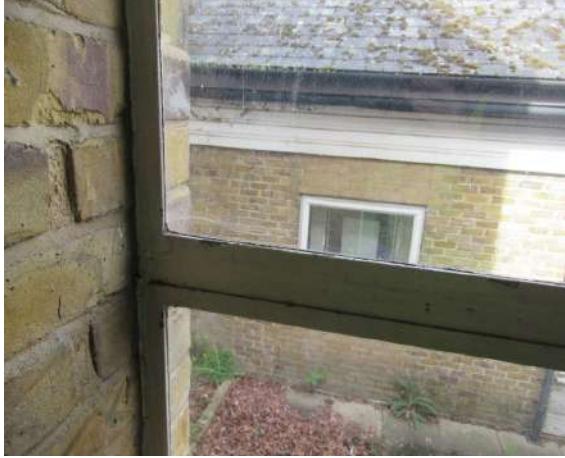
270.	<p>Location: First Floor – East elevation</p> <p>Description: Steel frame top hung Crittall window with single glazing and paint finish.</p> <p>Condition: Poor. Unable to test opening. Poor paint finish.</p>	<p>Element: Internal window 01-30</p>

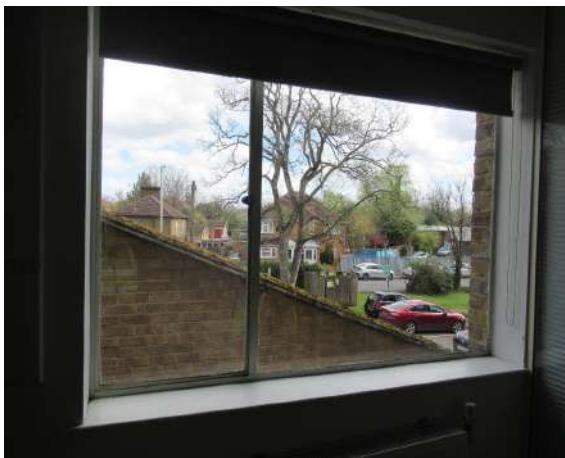
271.	<p>Location: First Floor – East elevation</p> <p>Description: Steel frame Crittall window with single glazing and paint finish.</p> <p>Condition: Poor. Poor paint finish.</p>	<p>Element: Internal window 01-31</p>

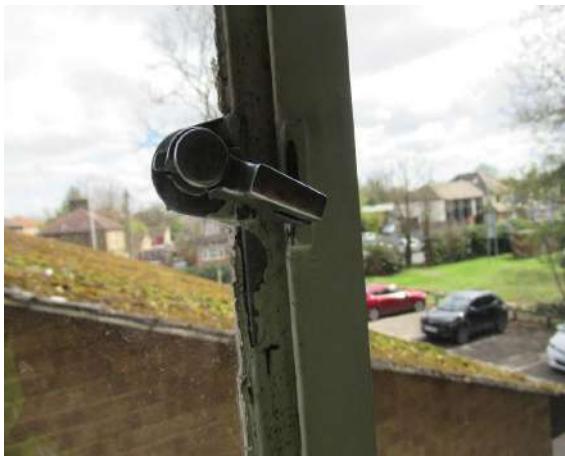
272.	<p>Location: First Floor – East elevation</p> <p>Description: As above.</p> <p>Condition: Poor. Missing handle.</p>	<p>Element: Internal window 01-31</p>

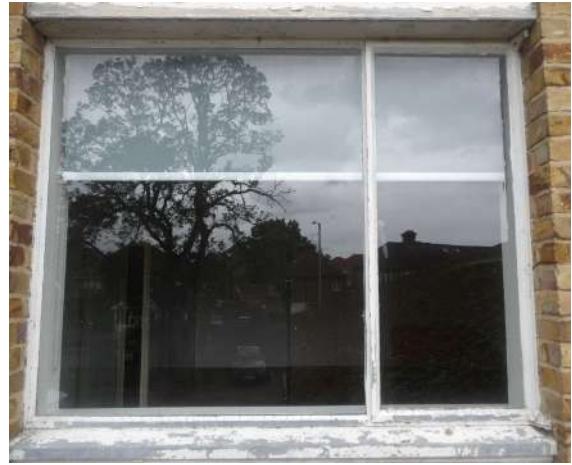
273.	<p>Location: First Floor – East elevation</p> <p>Description: As above.</p> <p>Condition: Poor. Poor paint finish externally.</p>	<p>Element: External window 01-31</p>

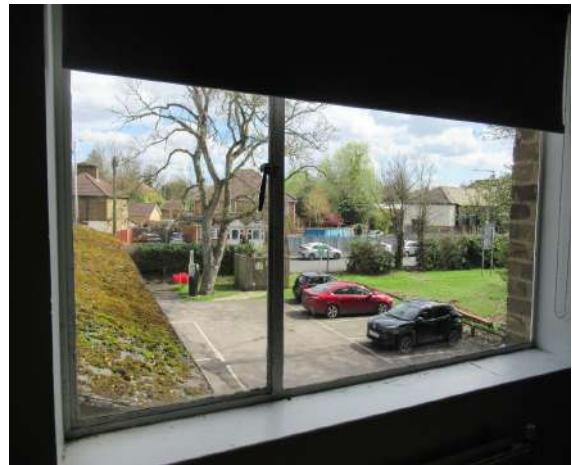
274.	<p>Location: First Floor – East elevation</p> <p>Description: Steel frame top hung Crittall window with single glazing and paint finish</p> <p>Condition: Poor. Poor paint finish.</p>	<p>Element: Internal window 01-32</p>

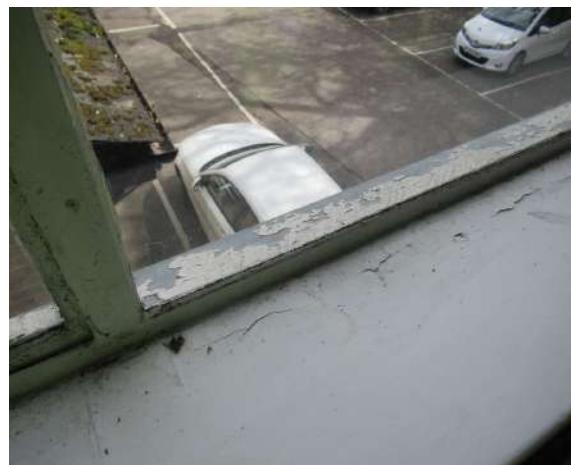
275.	<p>Location: First Floor – East elevation</p> <p>Description: As above.</p> <p>Condition: Poor. Poor paint finish to timber cill.</p>	<p>Element: Internal window 01-32</p>
