Schedule of condition

**The Furze, Hillingdon
Hospital, Pield Heath
Road, Hillingdon UB8 3NN**

Prepared for: Northmores
Prepared by: Chris Baker BSc (Hons) MRICS
Date: 18 September 2023
Reference: 120937-100/MET/CBk

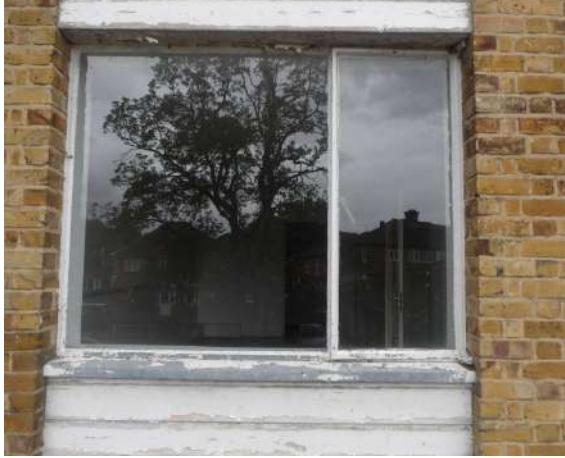
276.	<p>Location: First Floor – East elevation</p> <p>Description: As above.</p> <p>Condition: Poor. Poor paint finish externally.</p>	<p>Element: External window 01-32</p>

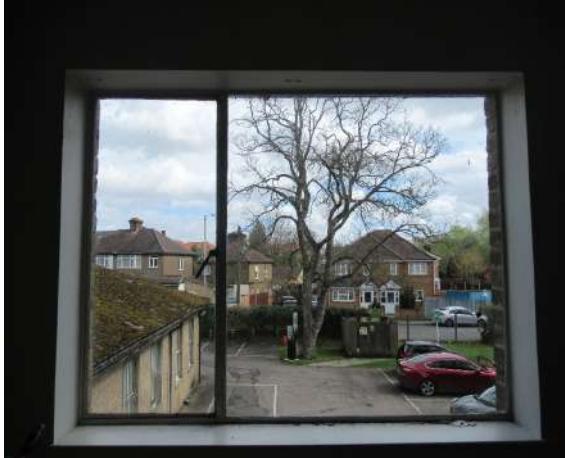
277.	<p>Location: First Floor – East elevation</p> <p>Description: Steel frame Crittall window with single glazing and paint finish.</p> <p>Condition: Poor. Poor paint finish internally.</p>	<p>Element: Internal window 01-33</p>

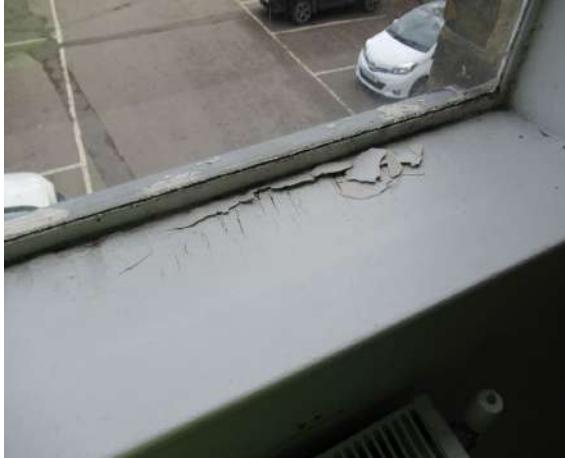
278.	<p>Location: First Floor – East elevation</p> <p>Description: As above.</p> <p>Condition: Poor. Water damage and poor paint finish to timber cill.</p>	<p>Element: Internal window 01-33</p>

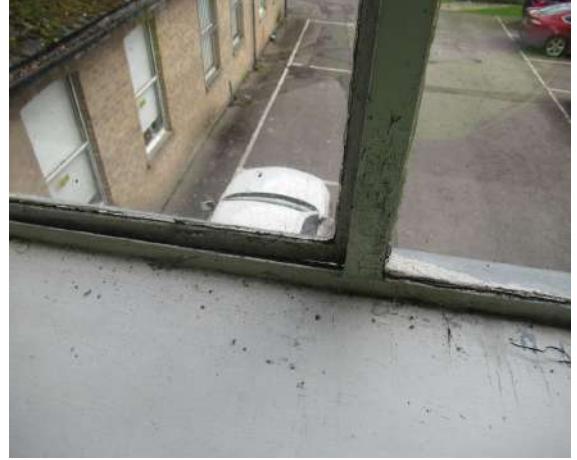
279.	Location: First Floor – East elevation	Element: Internal window 01-33
	Description: As above.

Condition: Poor. Window does not close fully.	
280.	Location: First Floor – East elevation	Element: Internal window 01-33
	Description: As above.

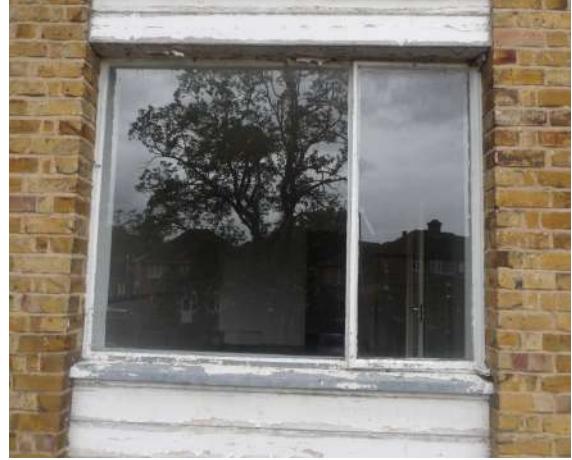
282.	Location: First Floor – East elevation	Element: External window 01-33
	Description: As above.

Condition: Poor. Poor paint finish externally.	
283.	Location: Second floor – north elevation	Element: Internal window 02-01
	Description: Steel frame tilt and turn Crittall window with single glazing, external metal cill and paint finish.

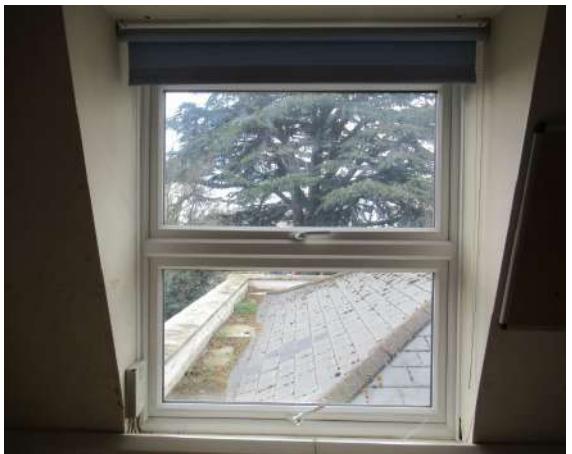
293.	<p>Location: Second floor – west elevation</p> <p>Description: PVCu frame double glazed external window with two opening sashes.</p> <p>Condition: Good.</p> <p>LHS jamb has been cut to facilitate communication cables.</p>	<p>Element: Internal window 02-06</p>

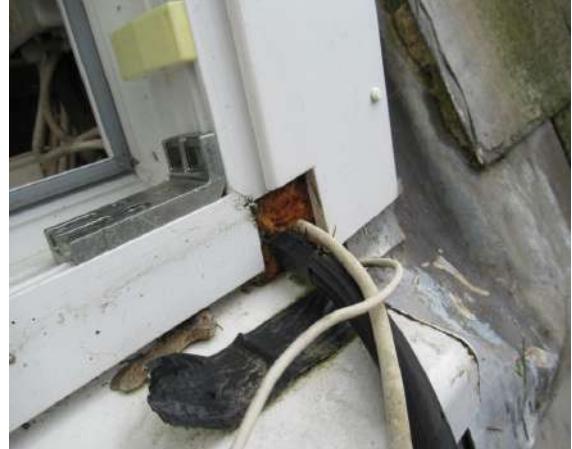
295.	<p>Location: Second floor – west elevation</p> <p>Description: As above.</p> <p>Condition: As above.</p> <p>Hole cut in window frame.</p>	<p>Element: External window 02-06</p>

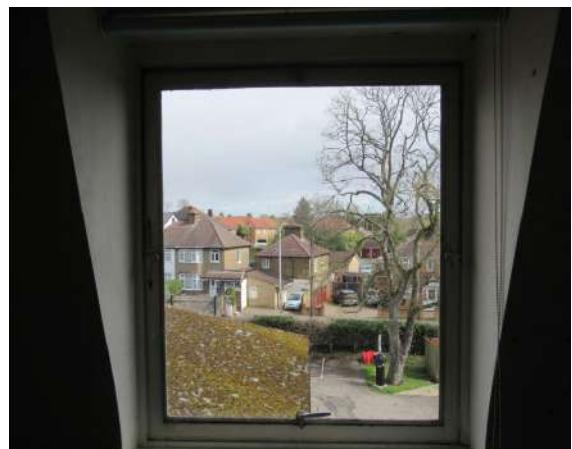
296.	<p>Location: Second floor – east elevation</p> <p>Description: Steel frame tilt and turn Crittall window with single glazing, external timber cill and paint finish.</p> <p>Condition: Poor.</p> <p>Poor paint finish internally and externally. Timber decay to timber frame to both jambs and to cill. Window operation.</p>	<p>Element: Internal window 02-07</p>

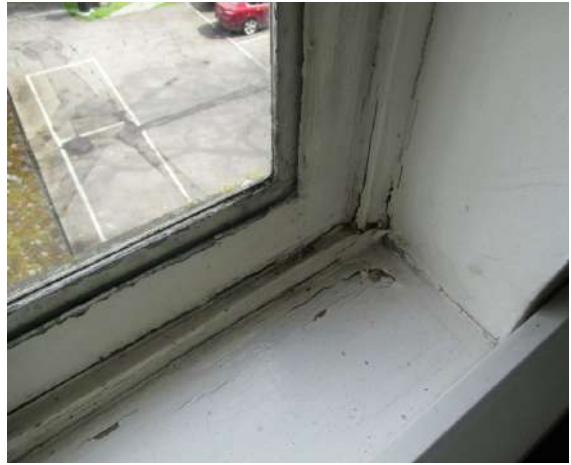
297.	Location: Second floor – east elevation	Element: Internal window 02-07
	Description: As above.

Condition: Poor. Timber decay to window jamb.	
298.	Location: Second floor – east elevation	Element: External window 02-07
	Description: As above.

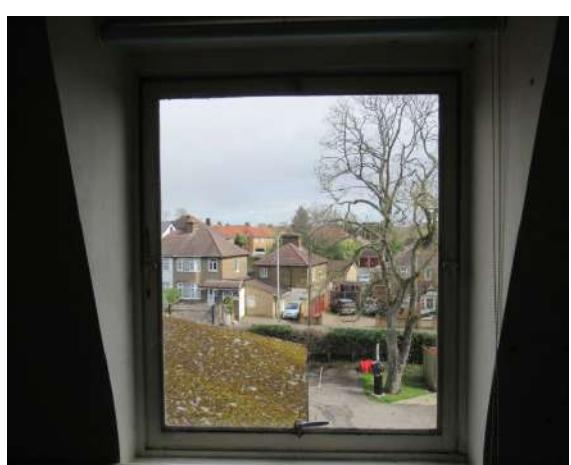
Condition: Poor. Poor paint finish internally and externally. Timber decay to timber frame to both jambs, to external sill and to internal window board. Window operation.

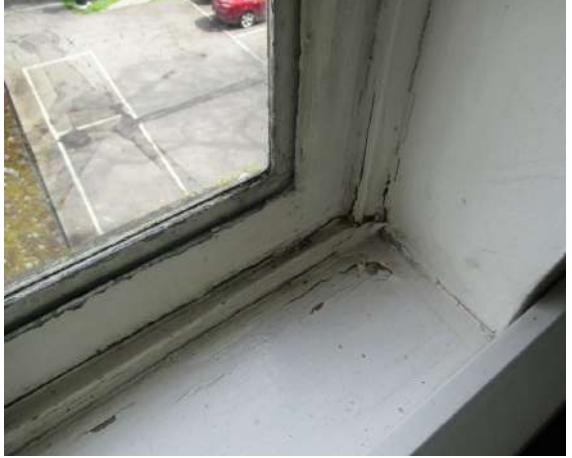
300.	<p>Location: Second floor – east elevation</p> <p>Description: As above.</p> <p>Condition: As above. Timber decay to window board and jamb</p>	<p>Element: Internal window 02-08</p>

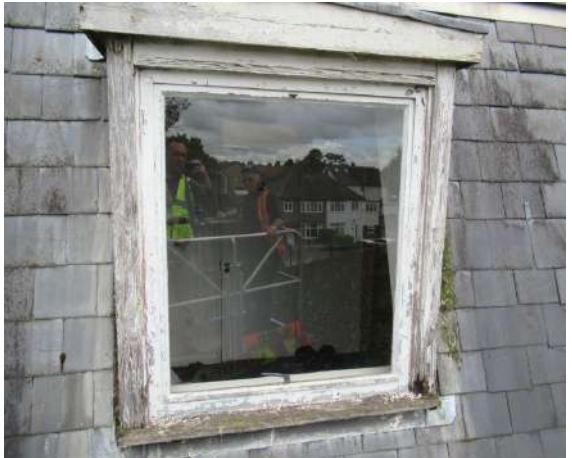
301.	<p>Location: Second floor – east elevation</p> <p>Description: As above.</p> <p>Condition: As above. Poor quality paint finish and decay to sill and jamb cover panels.</p>	<p>Element: External window 02-08</p>

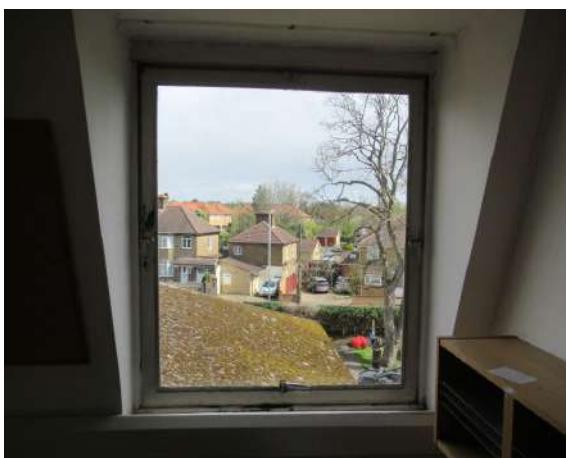
302.	<p>Location: Second floor – east elevation</p> <p>Description: Steel frame tilt and turn Crittall window with single glazing, external timber sill and paint finish.</p> <p>Condition: Poor. Poor paint finish internally and externally. Timber decay to timber frame to both jambs, to external sill and to internal window board. Window operation.</p>	<p>Element: Internal window 02-09</p>

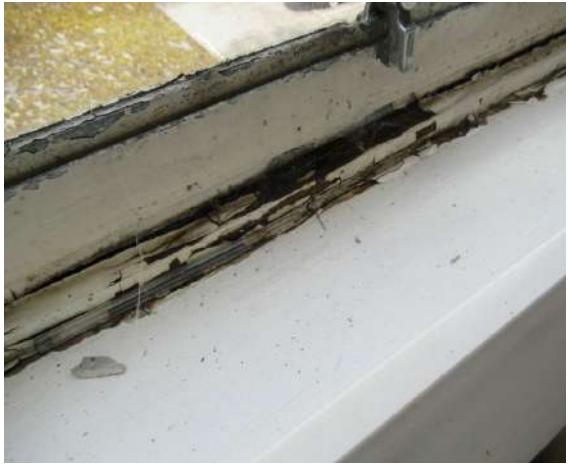
303.	<p>Location: Second floor – east elevation</p> <p>Description: As above.</p> <p>Condition: Poor. Decay to internal window board and frame</p>	<p>Element: Internal window 02-09</p>

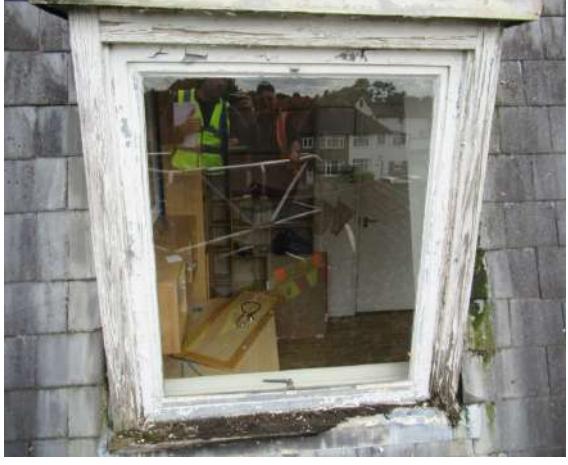
304.	<p>Location: Second floor – east elevation</p> <p>Description: As above.</p> <p>Condition: As above. Poor paint finish and timber decay to sill and frame</p>	<p>Element: External window 02-09</p>

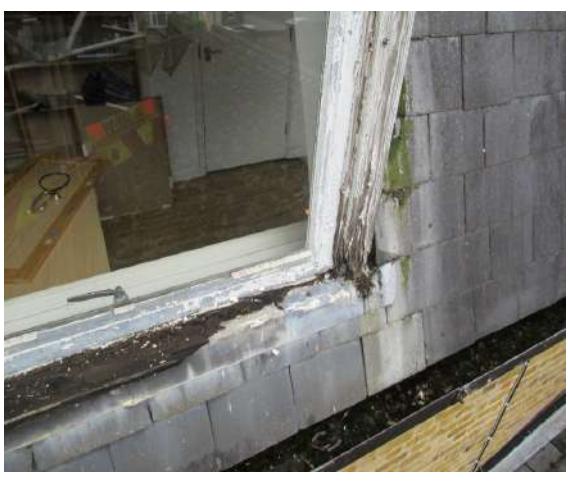
305.	<p>Location: Second floor – east elevation</p> <p>Description: As above.</p> <p>Condition: As above. Timber decay to sill and frame</p>	<p>Element: External window 02-09</p>

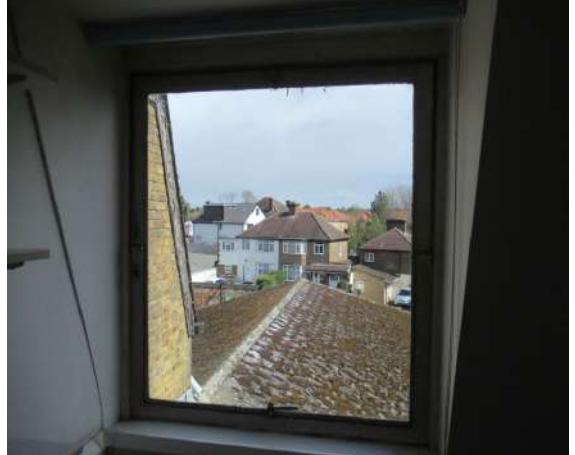
Condition: Poor. Poor paint finish internally and externally. Timber decay to timber frame to both jambs and external cill. Window operation.	
307.	Location: Second floor – east elevation	Element: External window 02-10
	Description: As above.

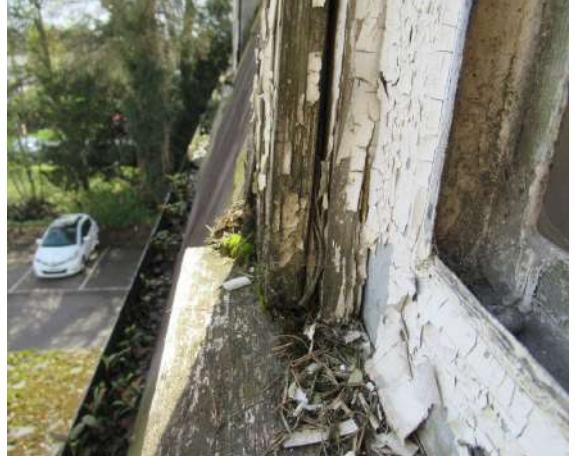
Condition: As above. Decay to window frame.

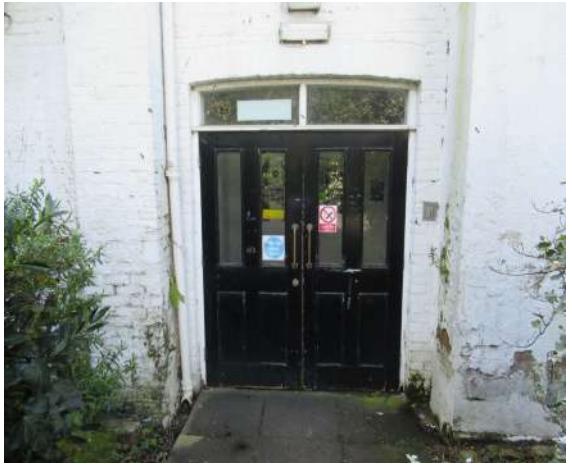
Condition: Poor. Decay to RHS frame to lower 600mm. Decay to LHS frame to lower 150mm. Missing sections of mouldings to lower panels. Poor paint finish.	
310.	Location: Ground floor – north elevation	Element: External door CIR 00-01
	Description: As above.

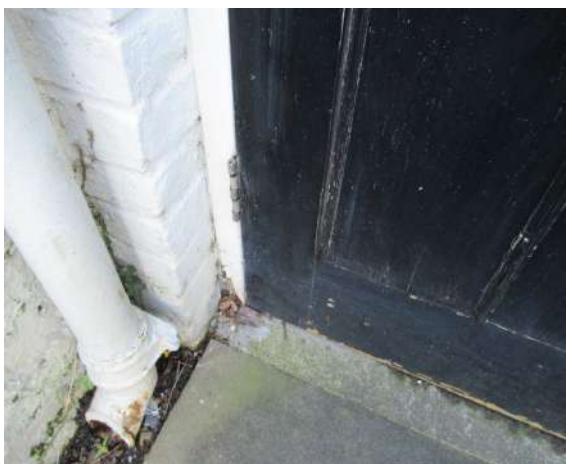
Condition: As above. Decay to LHS frame to lower 150mm	
311.	Location: Ground floor – north elevation	Element: External door CIR 00-01
	Description: As above.

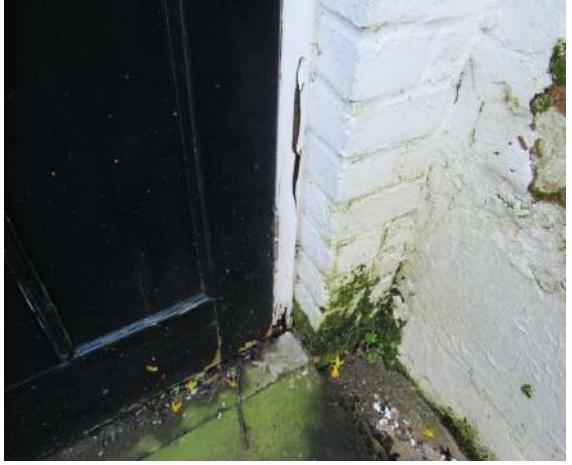
Condition: As above. Decay to RHS to lower 600mm

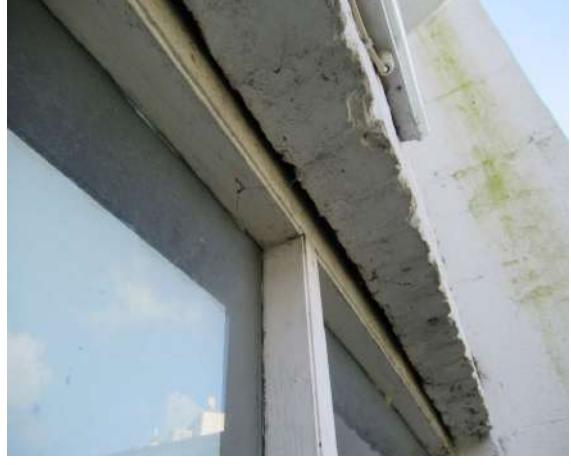
312.	<p>Location: Ground floor – north elevation</p> <p>Description: As above.</p> <p>Condition: As above. Poor pointing to perimeter of fan light frame.</p>	<p>Element: External door CIR 00-01</p>

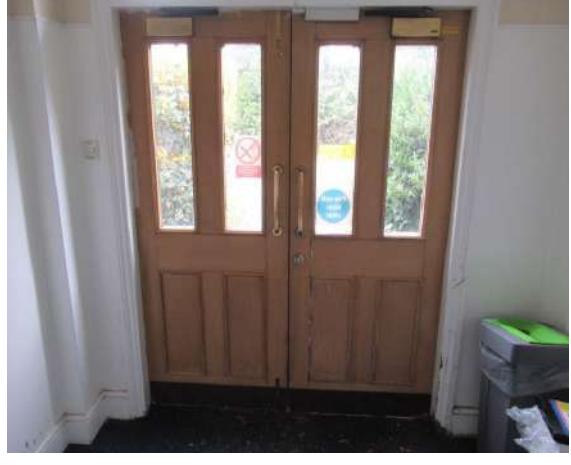
313.	<p>Location: Ground floor – north elevation</p> <p>Description: Timber panel double door with single glazed panels. Timber frame single glazed fan light above. Bronze pull handle on each leaf. Overhead door closer internally. Paint finish external, laminate internally.</p> <p>Condition: Poor. Poor internal finish. Missing mouldings to lower panels</p>	<p>Element: Internal door CIR 00-01</p>

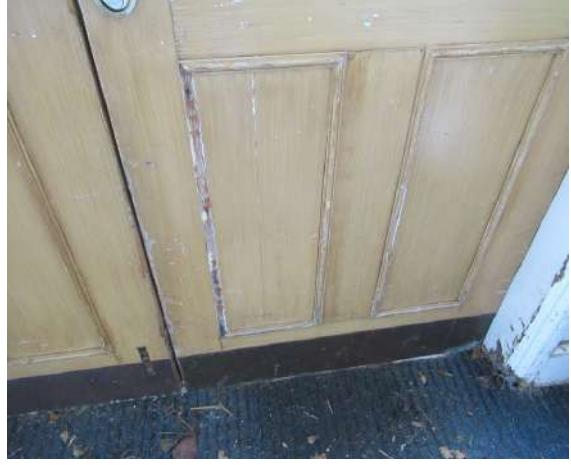
314.	<p>Location: Ground floor – north elevation</p> <p>Description: As above.</p> <p>Condition: As above. Missing mouldings to lower panels</p>	<p>Element: Internal door CIR 00-01</p>

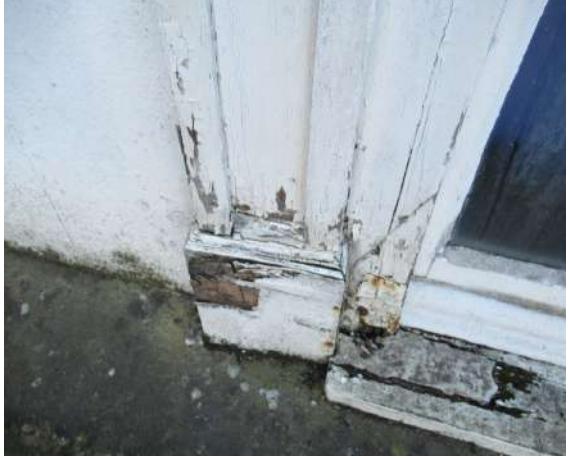
318.	<p>Location: Ground floor – north elevation</p> <p>Description: As above.</p> <p>Condition: As above. Poor quality previous repairs and decay evident to low level to the external surrounds to both sides.</p>	<p>Element: External door CA 00-01</p>

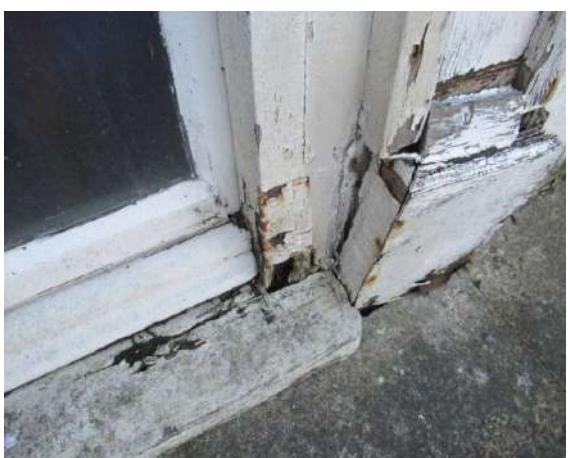
319.	<p>Location: Ground floor – north elevation</p> <p>Description: As above.</p> <p>Condition: As above. Poor quality previous repairs and decay evident to low level to the external surrounds to both sides.</p>	<p>Element: External door CA 00-01</p>

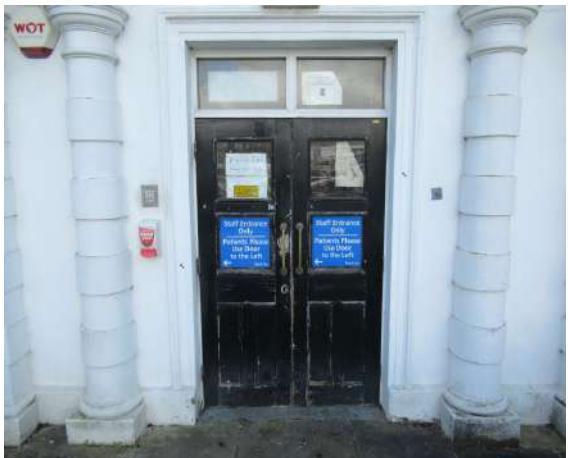
320.	<p>Location: Ground floor – north elevation</p> <p>Description: Timber panel double door with one single glazed vision panel. Timber frame single glazed fan light above. Bronze pull handle to one leaf. Overhead door closer internally. Paint finish external, laminate internally.</p> <p>Condition: Poor. Decay to LHS frame to lower 150mm. Missing and decayed sections of mouldings to lower panels. Poor paint finish. One missing pull handle. Missing cover plate to door lock. Corrosion staining to hinges.</p>	<p>Element: External door CA 00-02</p>

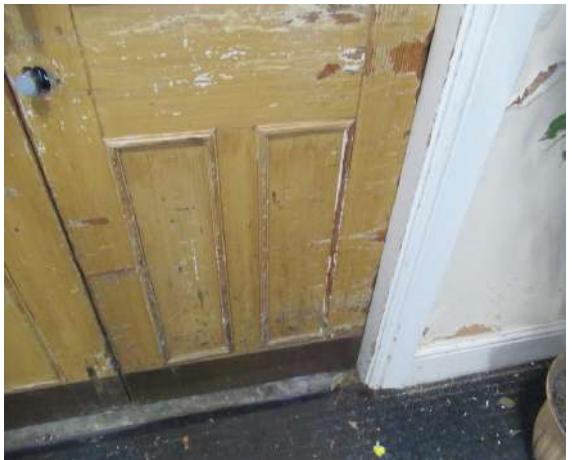
Condition: As above. Poor quality internal finish and missing sections of moulding to low level.	
326.	Location: Ground floor – north elevation	Element: Internal door CA 00-02
	Description: As above.

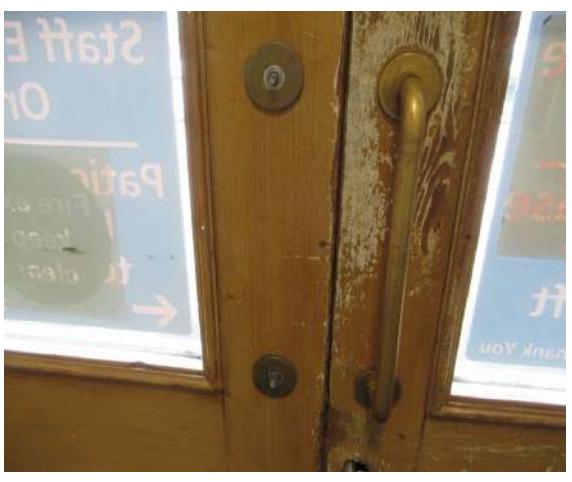
Condition: As above. One missing pull handle

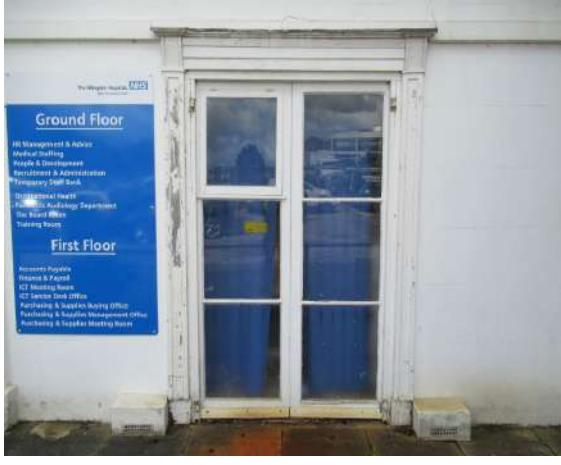
Condition: Poor. Timber decay to bottom rails to RHS leaf and frame to 150mm. Poor paint finish. Poor quality previous repairs and decay evident to low level to the external surrounds to both sides. Poor quality putty to 2no glass panels.	
328.	Location: Ground floor – north elevation	Element: External door CA 00-03
	Description: As above.

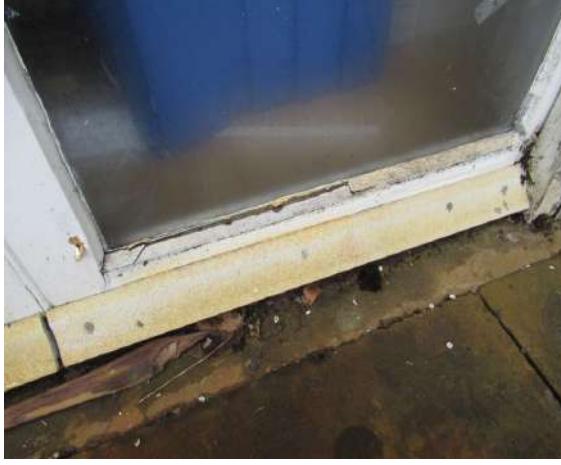
Condition: As above. Missing putty to glazing.	
329.	Location: Ground floor – north elevation	Element: External door CA 00-03
	Description: As above.

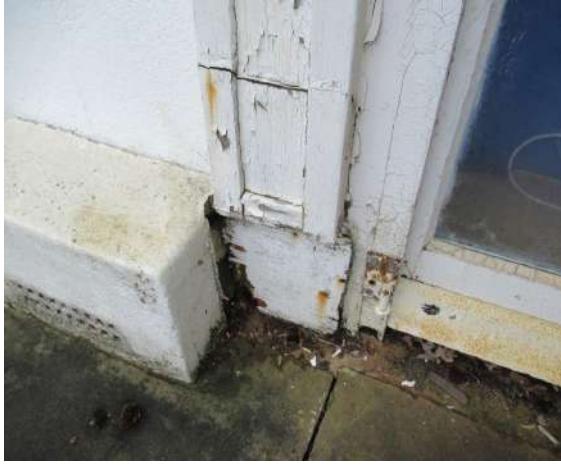
Condition: As above. Poor quality previous repairs and decay evident to low level to the external surrounds to both sides.

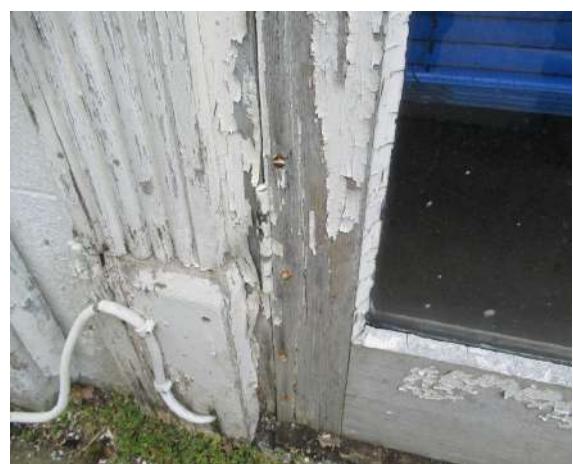
Condition: As above. Previous repair to side rail.

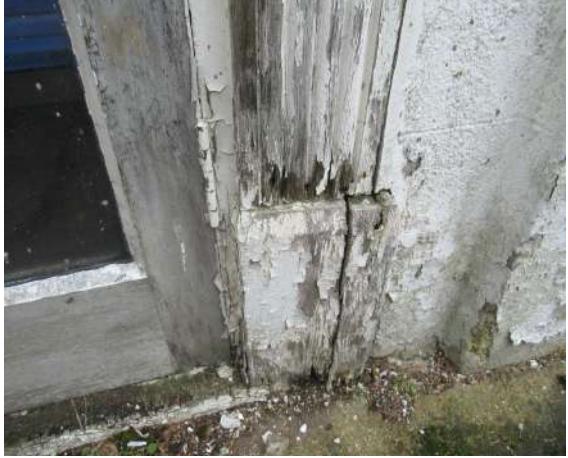
333.	<p>Location: Ground floor – west elevation</p> <p>Description: As above.</p> <p>Condition: As above. Poor quality previous repairs to side mouldings.</p>	<p>Element: External door CA 00-04</p>

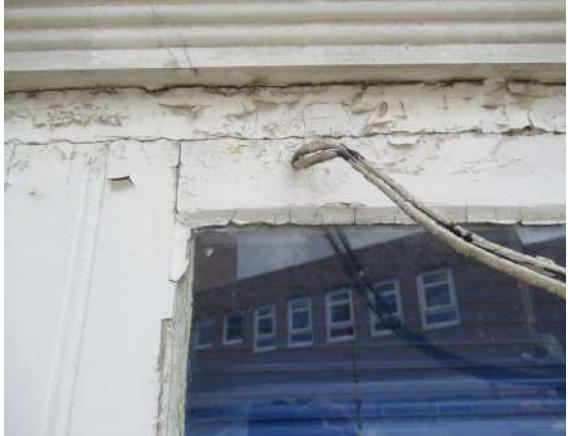
334.	<p>Location: Ground floor – west elevation</p> <p>Description: As above.</p> <p>Condition: As above. Cable penetration through door frame.</p>	<p>Element: External door CA 00-04</p>

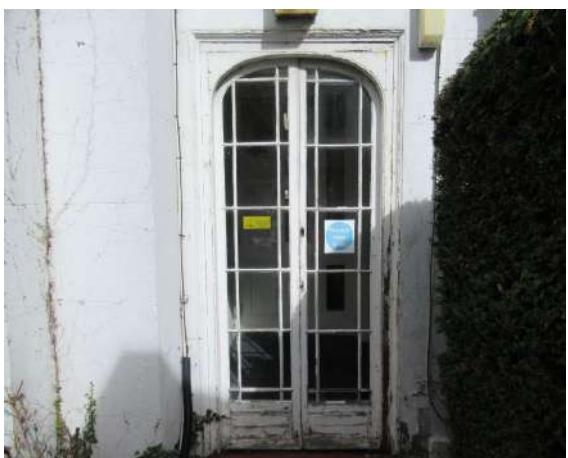
335.	<p>Location: Ground floor – south elevation</p> <p>Description: Timber frame single glazed double doors. Paint finish internally and externally. Paint timber surround externally.</p> <p>Condition: Poor. Poor quality putty to glazing. 2no missing glazing panels (70x70mm). Timber decay to lower 150mm RHS frame. Decay to architrave to the head of the door. Poor quality decorations internally and externally. Missing cover plate to lock.</p>	<p>Element: External door CA 00-05</p>

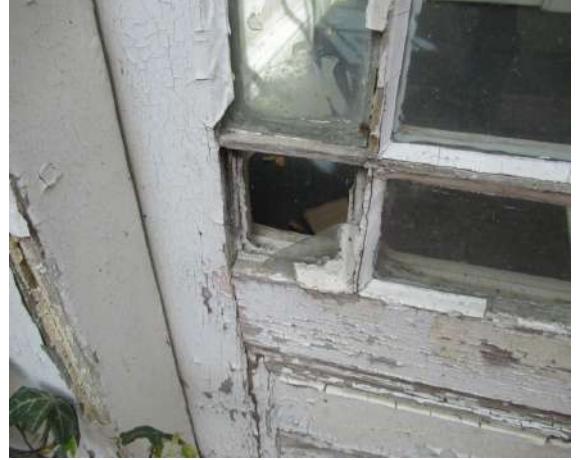
Condition: As above. 2no missing glazing panels (70x70mm). Poor quality paint finish.	
337.	Location: Ground floor – south elevation	Element: External door CA 00-05
	Description: As above.

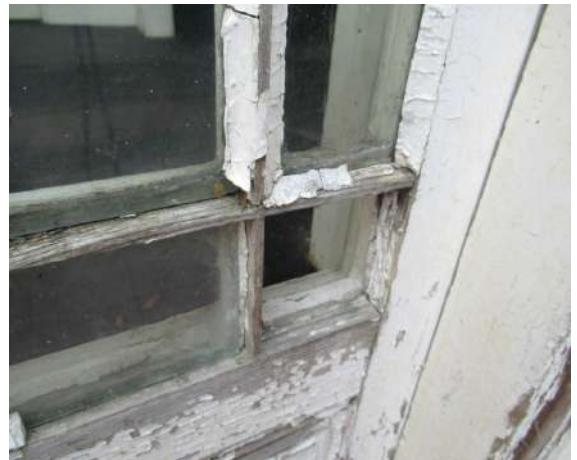
Condition: As above. Poor quality putty to glazing.	
338.	Location: Ground floor – south elevation	Element: External door CA 00-05
	Description: As above.

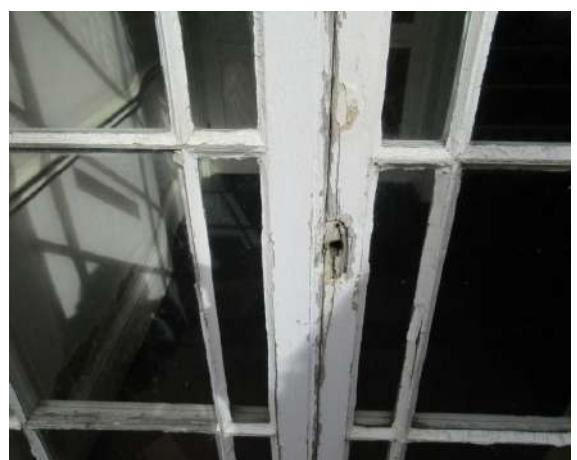
Condition: As above. Missing cover plate to lock.

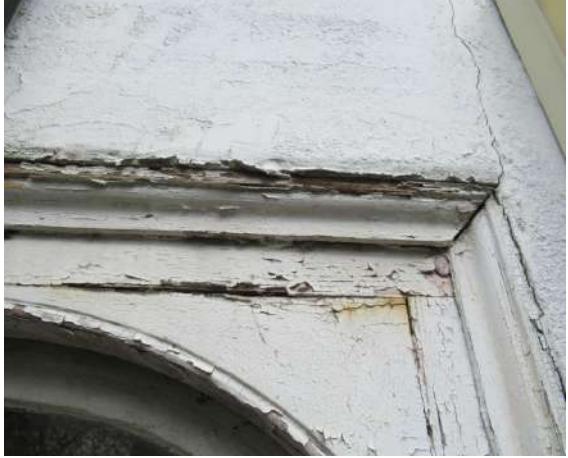
339.	<p>Location: Ground floor – south elevation</p> <p>Description: As above.</p> <p>Condition: As above. Decay to architrave to the head of the door.</p>	<p>Element: External door CA 00-05</p>

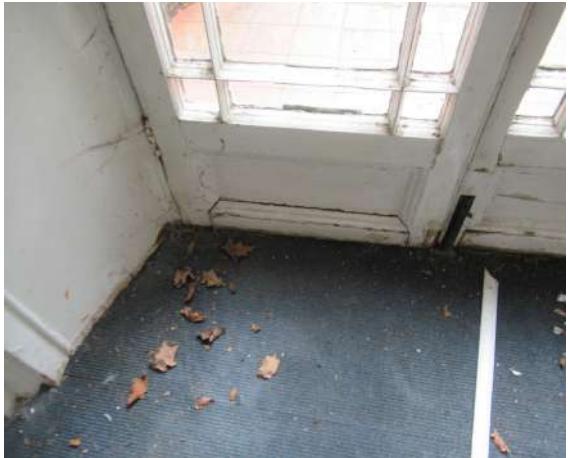
340.	<p>Location: Ground floor – south elevation</p> <p>Description: As above.</p> <p>Condition: As above. Poor quality paint finish internally.</p>	<p>Element: External door CA 00-05</p>

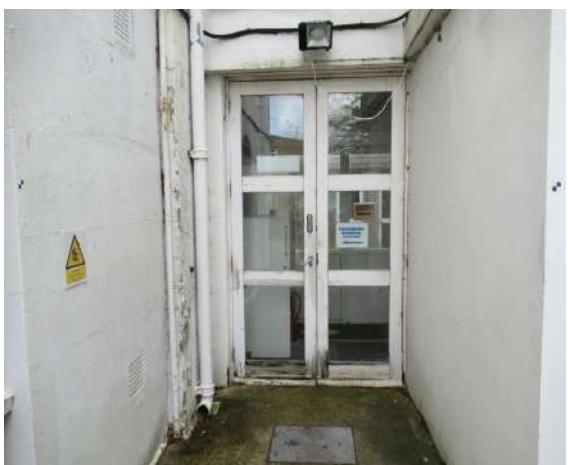
341.	<p>Location: Ground floor – west elevation</p> <p>Description: Timber frame double glazed double doors. Paint finish internally and externally.</p> <p>Condition: Poor. Decay to bottom rail, weather bar and door frame to low level. Poor quality paint finish.</p>	<p>Element: External door CIR 00-02</p>

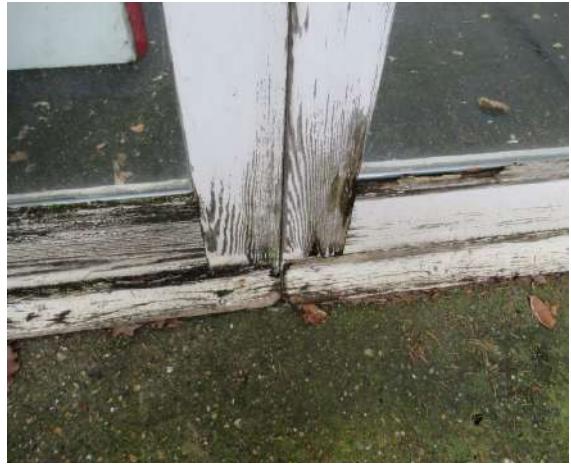
Condition: As above. Decay to bottom rail, weather bar and door frame to low level	
343.	Location: Ground floor – west elevation	Element: External door H 00-04
	Description: Timber frame double glazed double doors. Paint finish internally and externally.

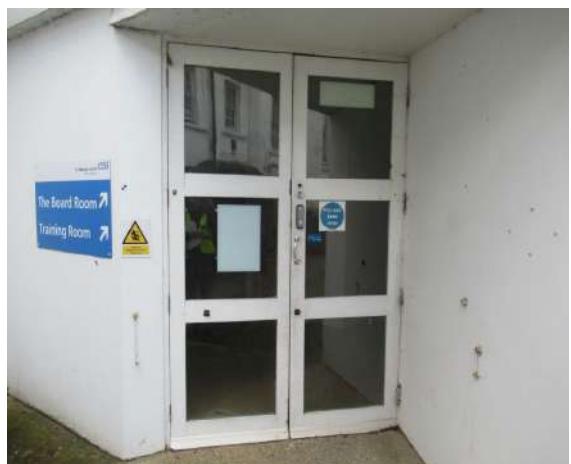
Condition: Fair. Missing cover plate to redundant door lock. Tired paint finish.	
344.	Location: Ground floor – west elevation	Element: External door H 00-04
	Description: As above.

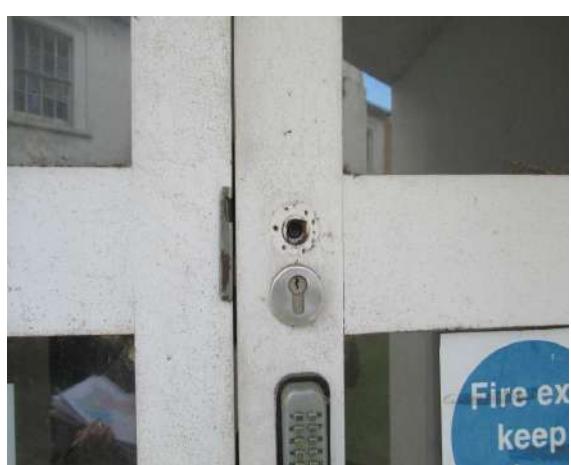
Condition: Fair. Missing cover plate to redundant door lock.

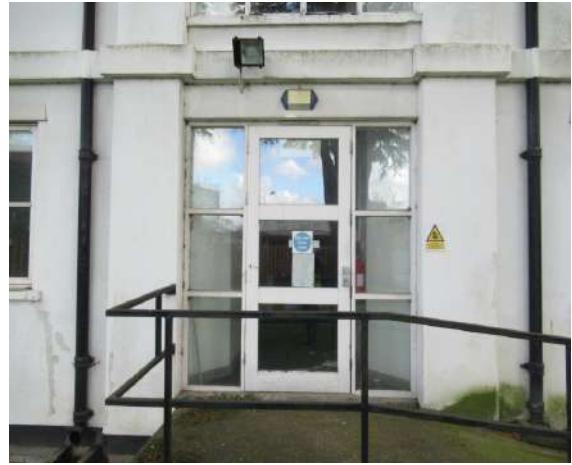
Condition: Poor. Timber decay to bottom rail. Poor paint finish.	
346.	Location: Ground floor – west elevation	Element: External door CA 00-06
	Description: As above.

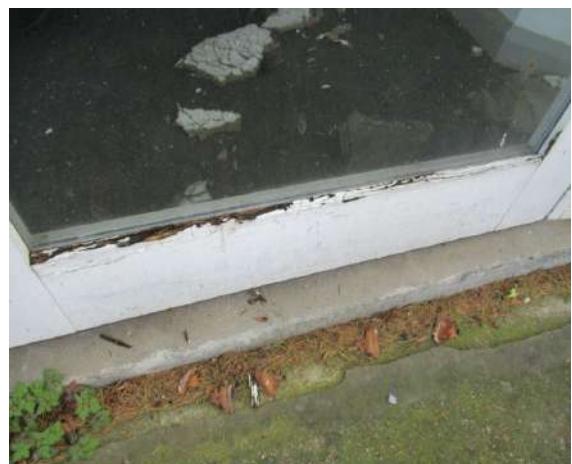
Condition: As above. Timber decay to bottom rail. Poor paint finish.	
347.	Location: Ground floor – east elevation	Element: External door H 00-01
	Description: Flush timber double doors with Georgian wired glass vision panels and fan light above.

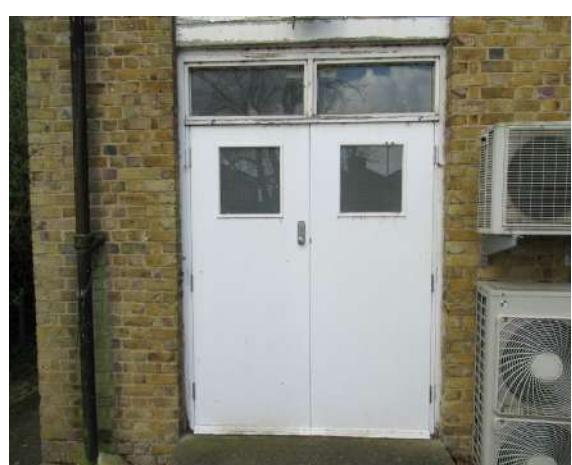
Condition: Poor. Localised decay to lower 100mm of door frame to both sides. Split timber weather bar. Poor paint finish.

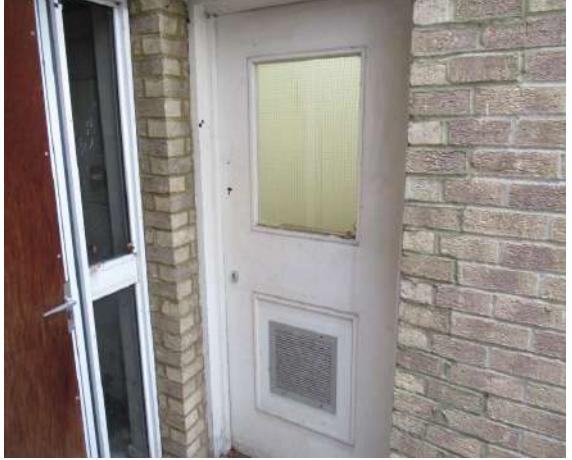
351.	<p>Location: Ground floor – south elevation</p> <p>Description: Timber panelled door with Georgian wired glass vision panel and ventilation grille to low level. Paint finish internally and externally.</p> <p>Condition: Fair. Tired paint finish.</p>	<p>Element: External door ET 00-01</p>

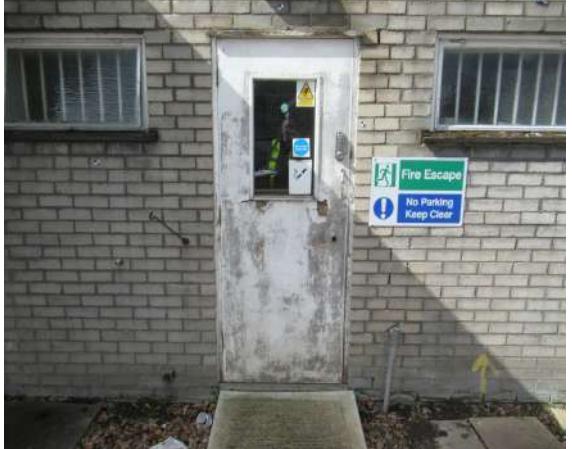
352.	<p>Location: Ground floor – south elevation</p> <p>Description: Flush timber door with Georgian wired glass vision panel and a paint finish.</p> <p>Condition: Poor. Door leaf and finish in a very poor condition.</p>	<p>Element: External door ET 00-02</p>

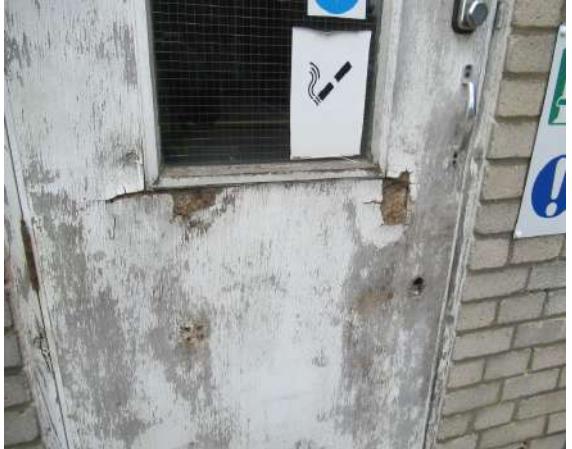
353.	<p>Location: Ground floor – south elevation</p> <p>Description: As above.</p> <p>Condition: As above.</p>	<p>Element: External door ET 00-02</p>

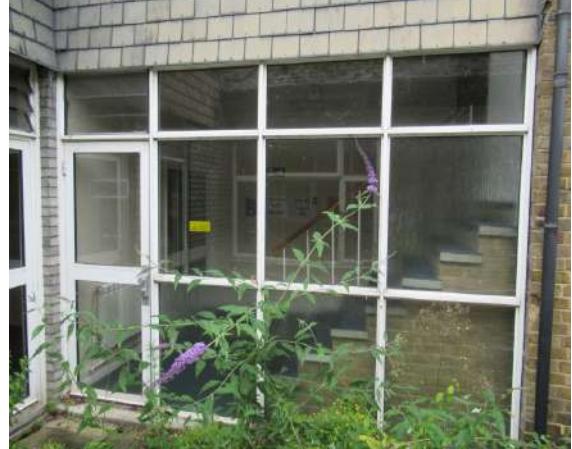
354.	<p>Location: Ground floor - courtyard</p> <p>Description: Factory finished metal frame single glazed door.</p> <p>Condition: Fair. No issues noted.</p>	<p>Element: External door – CY00-01</p>

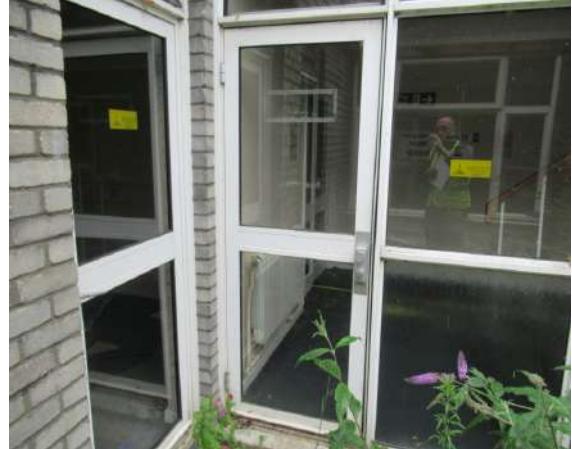
355.	<p>Location: Ground floor - courtyard</p> <p>Description: As above.</p> <p>Condition: As above.</p>	<p>Element: External door – CY00-01</p>

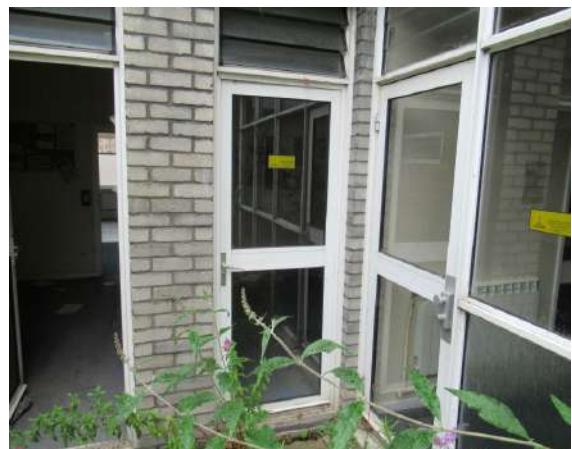
356.	<p>Location: Ground floor - courtyard</p> <p>Description: Factory finished metal frame single glazed door.</p> <p>Condition: Fair.</p>	<p>Element: External door – CY00-02</p>

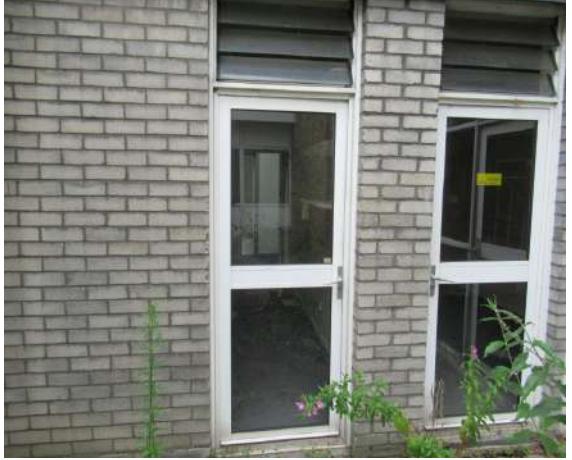
357.	Location: Ground floor – courtyard Description: Factory finished metal frame single glazed door.	Element: External door – CY00-03
	Condition: Fair.

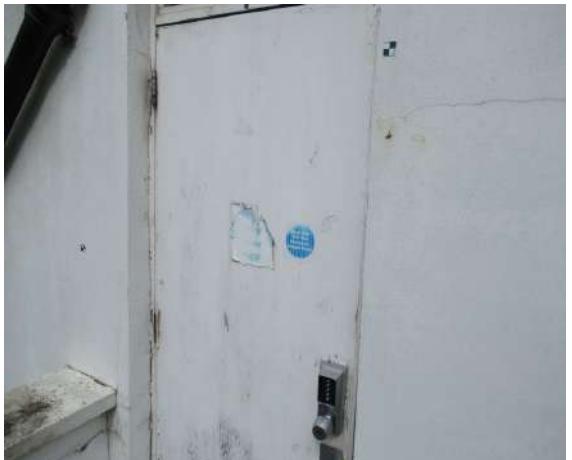
Location: First floor – south elevation Description: Flush timber door with a paint finish and a Georgian wired glass fan light.	Element: External door CA 01-01
	Condition: Poor. Poor paint finish and 1no missing hinge.

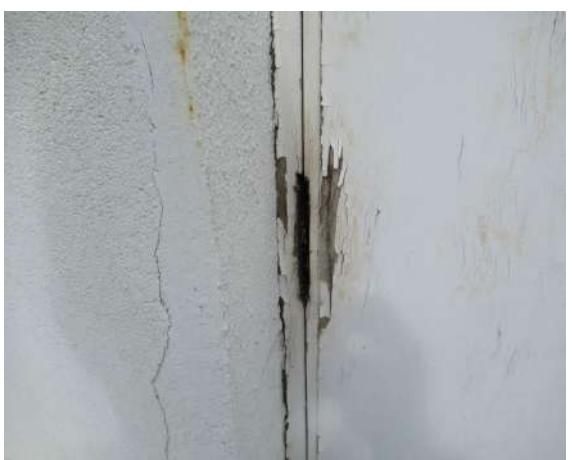
Location: First floor – south elevation Description: As above.	Element: External door CA 01-01
	Condition: As above.

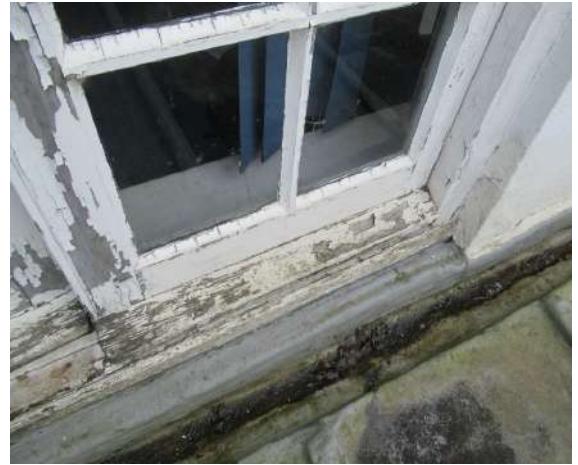
Condition: Poor. Fan light sashes do not close. Poor paint finish. Cover strip fitted to threshold.	
361.	Location: First floor – north elevation	Element: External door CA 01-02
	Description: As above.

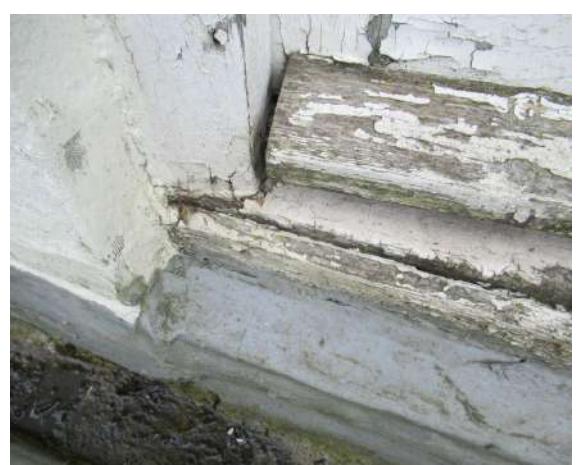
Condition: As above.	
362.	Location: First floor – north elevation	Element: External door CA 01-02
	Description: As above.

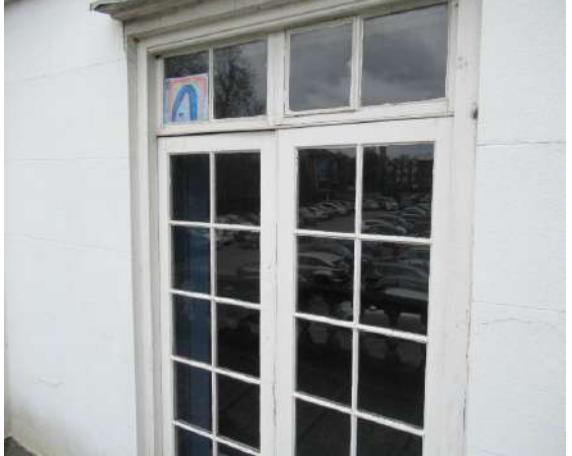
Condition: As above.

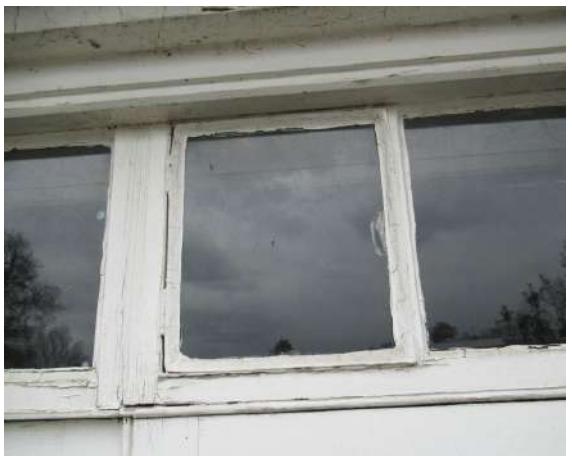
Condition: Poor. Fan light sashes do not close. Poor paint finish.	
364.	Location: First floor – north elevation	Element: External door CA 01-03
	Description: As above.

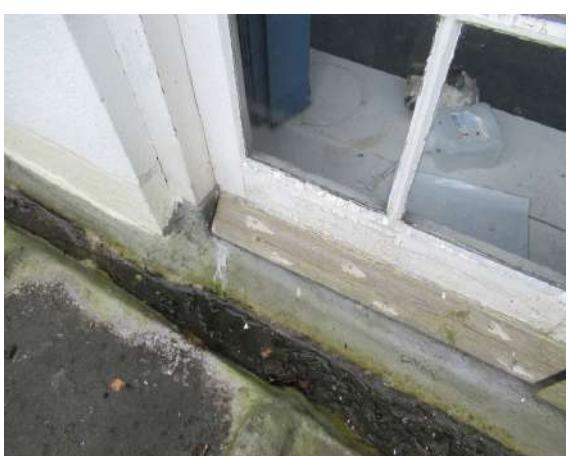
Condition: As above.	
365.	Location: First floor – north elevation	Element: External door CA 01-03
	Description: As above.

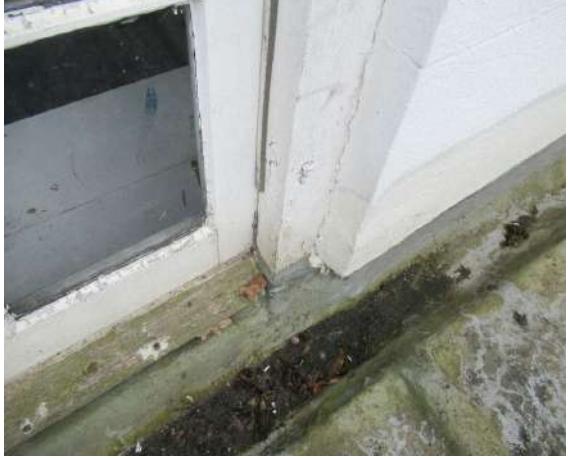
366.	<p>Location: First floor – north elevation</p> <p>Description: As above.</p> <p>Condition: As above.</p>	<p>Element: External door CA 01-03</p>

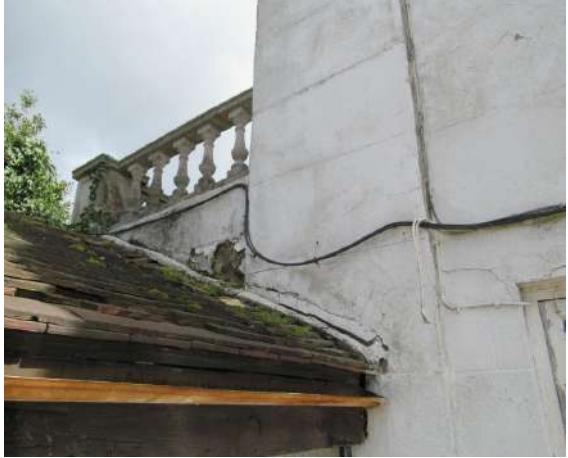
367.	<p>Location: West elevation</p> <p>Description: Stucco render with a white paint finish.</p> <p>Condition: Poor. Detached section of render to adjoining pitched roof junction.</p>	<p>Element: Render panel 01</p>

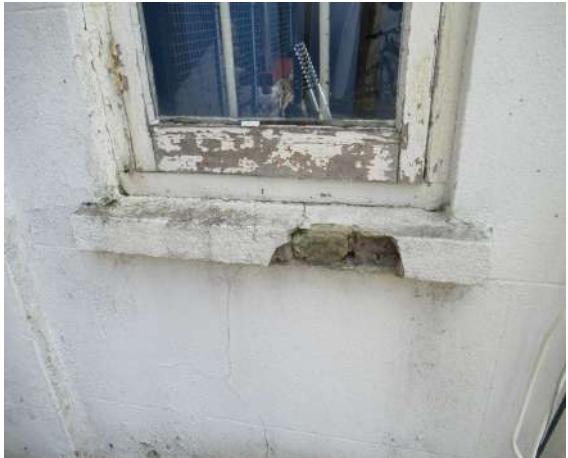
368.	<p>Location: West elevation</p> <p>Description: Stucco render with a white paint finish.</p> <p>Condition: Poor. Detached section of render to window cill.</p>	<p>Element: Render panel 01</p>

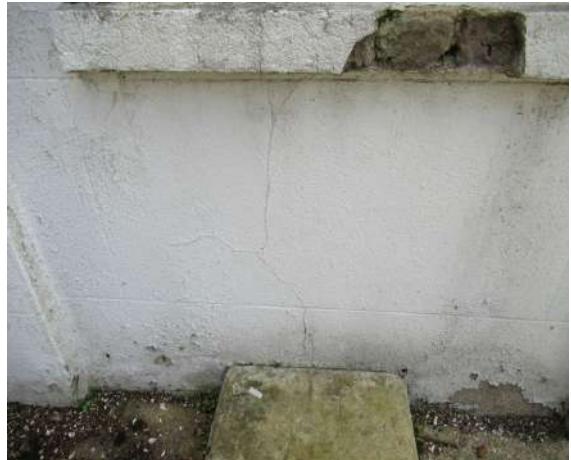
369.	Location: West elevation Description: Stucco render with a white paint finish.	Element: Render panel 01
	Condition: Poor. Category 1 fine vertical crack extending from lower window to ground level.

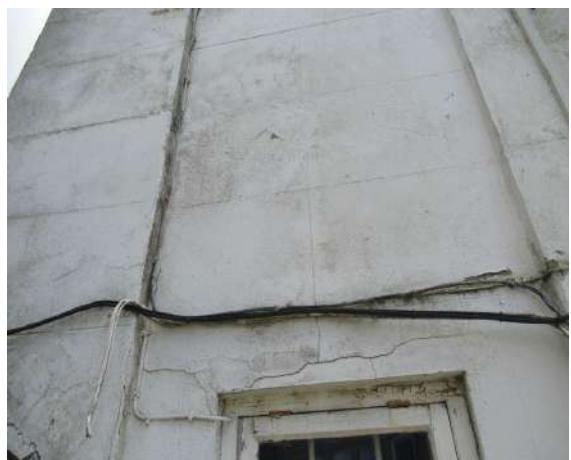
370.	Location: West elevation Description: Stucco render with a white paint finish.	Element: Render panel 01
	Condition: Poor. Numerous vertical and horizontal cracking, Category 2, from 2-3mm wide above the ground floor window.

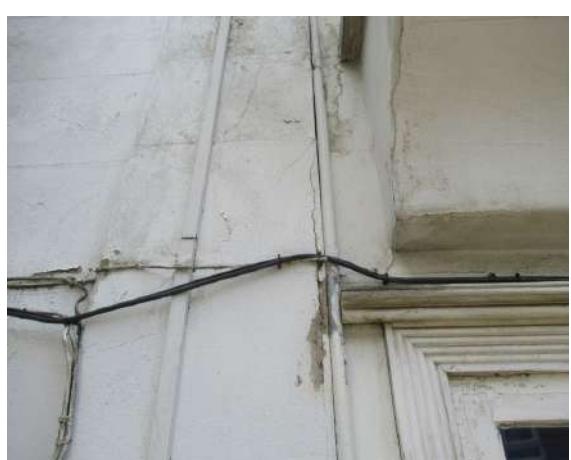
371.	Location: West elevation Description: Stucco render with a white paint finish.	Element: Render panel 01
	Condition: Poor. Category 2 vertical crack, 2-3mm wide extending above external door to the oriel window cill above.

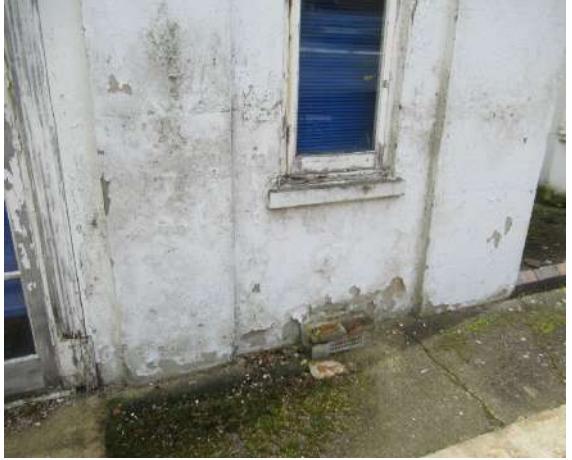
375.	Location: West elevation Description: Stucco render with a white paint finish.	Element: Render panel 01
	Condition: Poor. Blown render to low level, approximately 2.0x0.8m.

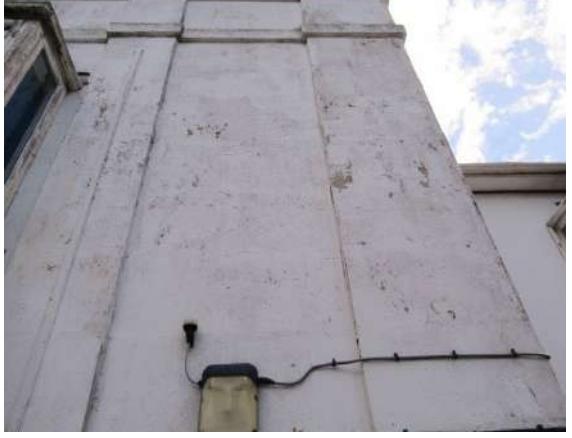
376.	Location: West elevation Description: Stucco render with a white paint finish.	Element: Render panel 01
	Condition: Poor. Poor paint finish to entire elevation.

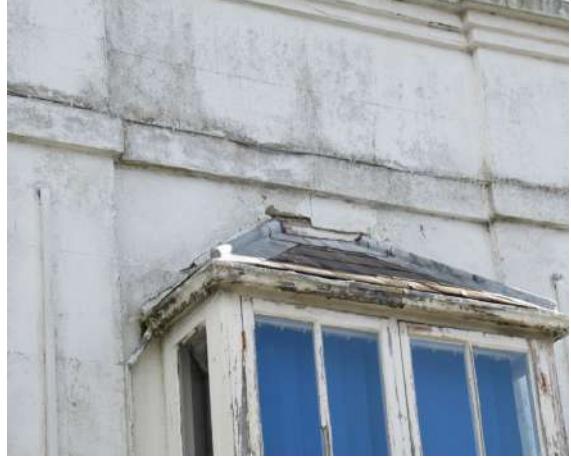
378.	Location: West elevation Description: Stucco render with a white paint finish.	Element: Render panel 01
	Condition: Poor. Detached section of render above the oriel window roof projection.
