Schedule of condition

**The Furze, Hillingdon
Hospital, Pield Heath
Road, Hillingdon UB8 3NN**

Prepared for: Northmores
Prepared by: Chris Baker BSc (Hons) MRICS
Date: 18 September 2023
Reference: 120937-100/MET/CBk

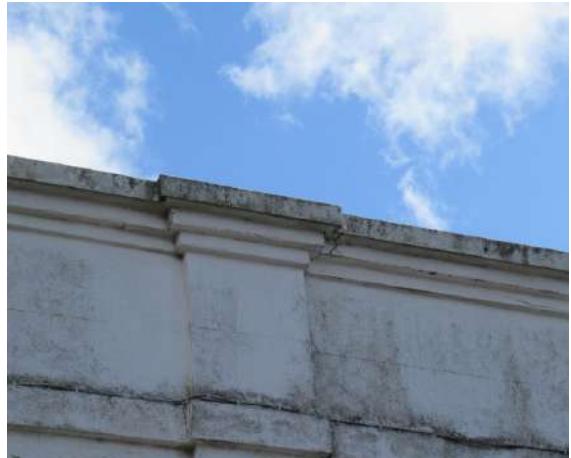
Description: Stucco render with a white paint finish.	Element: Render panel 01
	Condition: Poor. Numerous fine horizontal and vertical cracks to the parapet wall.

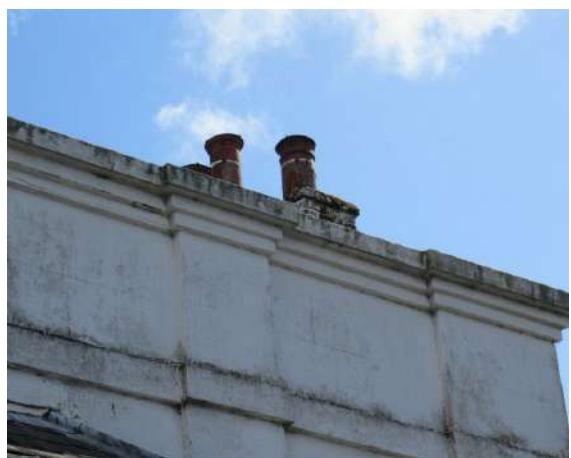
Description: As above.	Element: Render panel 01
	Condition: As above.

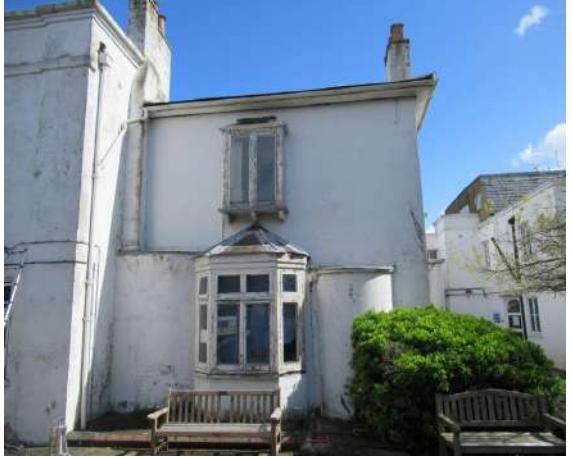
381.	Location: West elevation Description: Stucco render with a white paint finish.	Element: Render panel 02
	Condition: Poor. Numerous cracks and poor paint finish to entire panel.

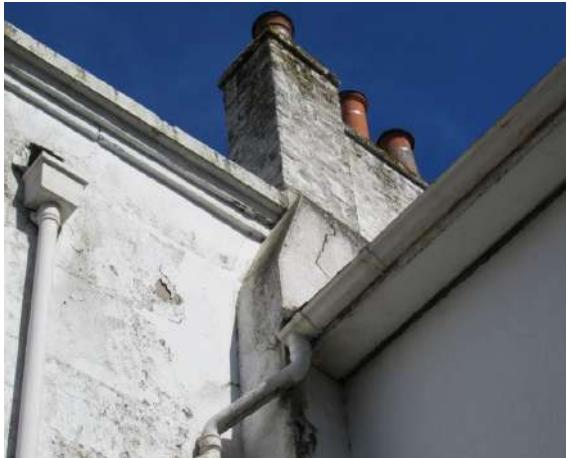
Description: Stucco render with a white paint finish.	Element: Render panel 02
	Condition: Poor. Category 3 vertical crack to base of chimney approximately 5-10mm wide.

Chimney Stack:
 Removal: Existing chimney stack conditions to be surveyed fully and a method statement for making good to be submitted.
 Contractor to provide any temporary works needed to maintain the stability of the building fabric during the works; submit proposal for review and seek further instructions to proceed.

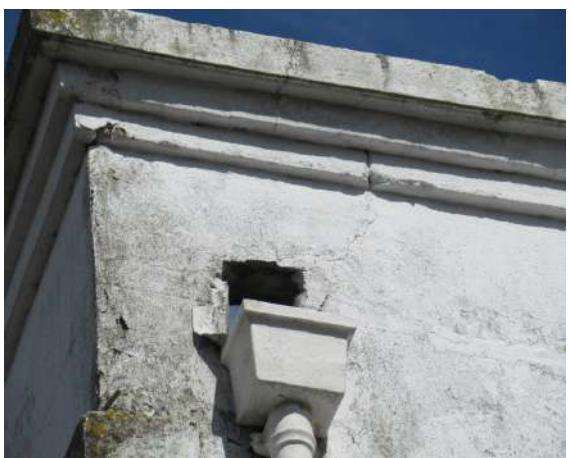
Description: Stucco render with a white paint finish.	Element: Render panel 02
	Condition: Poor. Category 2 vertical crack, approximately 2-3mm wide, extending from rainwater outlet to parapet coping.

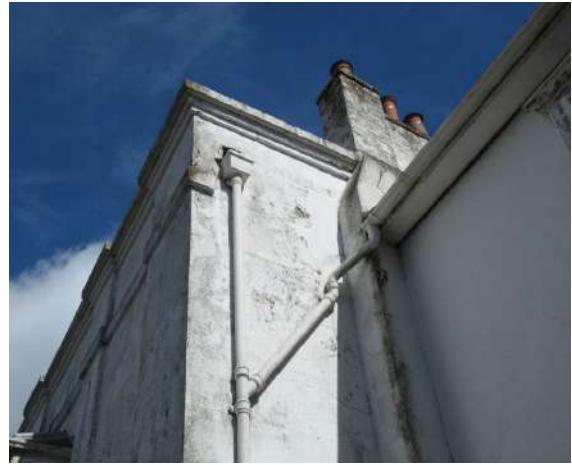
384.	<p>Location: West elevation</p> <p>Description: Stucco render with a white paint finish.</p> <p>Condition: Poor. Poor paint finish to full height.</p>	<p>Element: Render panel 02</p>

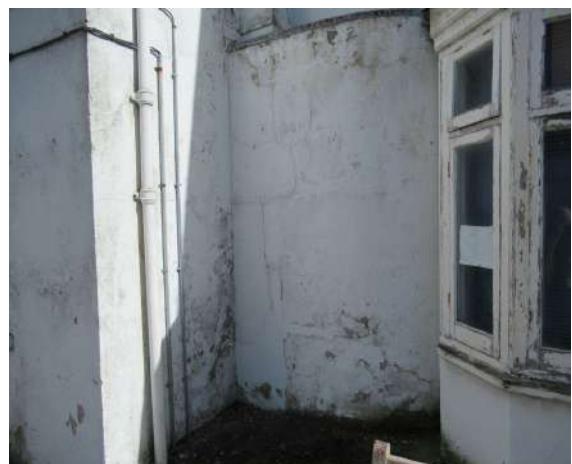
385.	<p>Location: West elevation</p> <p>Description: Stucco render with a white paint finish.</p> <p>Condition: Poor. Category 2 vertical and horizontal cracking to the full height of the panel.</p>	<p>Element: Render panel 02</p>

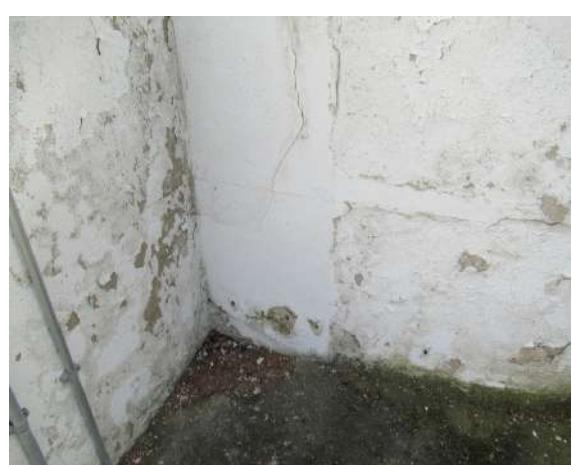
386.	<p>Location: West elevation</p> <p>Description: Stucco render with a white paint finish.</p> <p>Condition: Poor. Blown render to low level with category 2 vertical crack to render.</p>	<p>Element: Render panel 02</p>

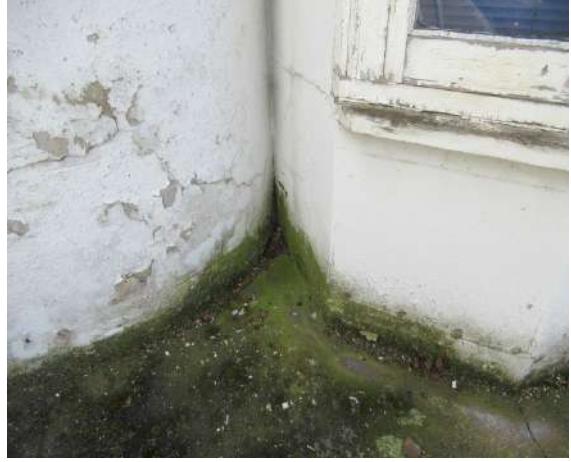
387.	Location: West elevation Description: Stucco render with a white paint finish.	Element: Render panel 02
	Condition: Poor. Blown render to low level approximately 0.75x1.5m.

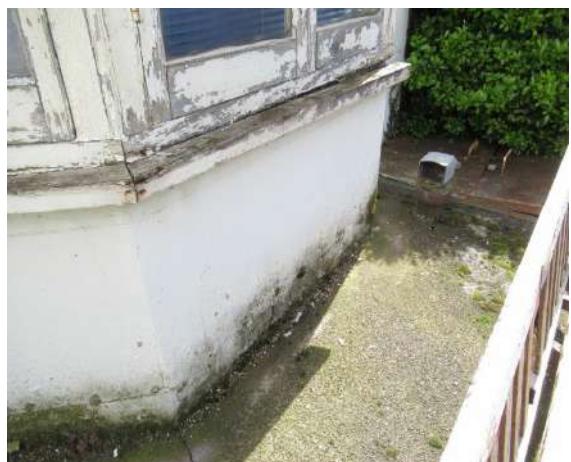
388.	Location: West elevation Description: Stucco render with a white paint finish.	Element: Render panel 02
	Condition: Poor. Blown render to low level to entire bay.

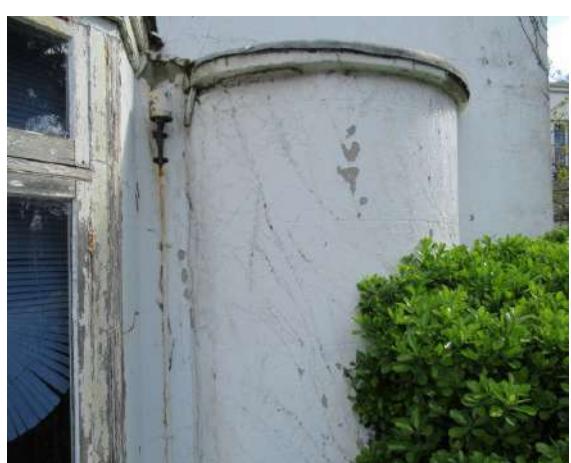
389.	Location: West elevation Description: Stucco render with a white paint finish.	Element: Render panel 02
	Condition: Poor. Poor paint finish.

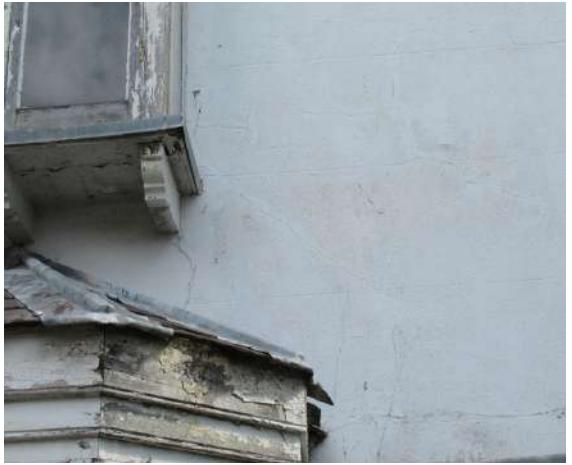
390.	Location: West elevation Description: Stucco render with a white paint finish.	Element: Render panel 02
	Condition: Poor. Category 2 vertical crack, 2-3mm wide between ground and first floor windows.

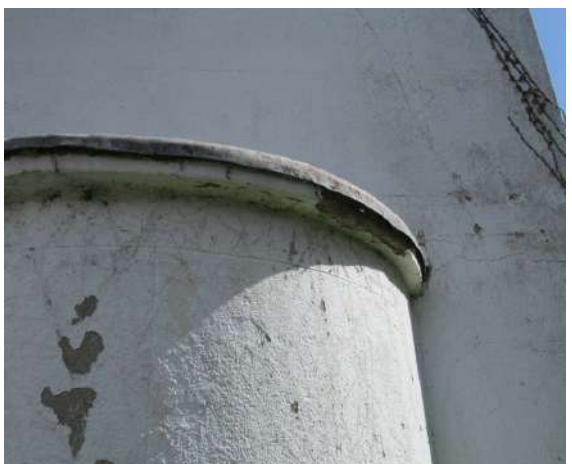
Description: Stucco render with a white paint finish.	Element: Render panel 02
	Condition: Poor. Detached section of render beneath lead flat roof.

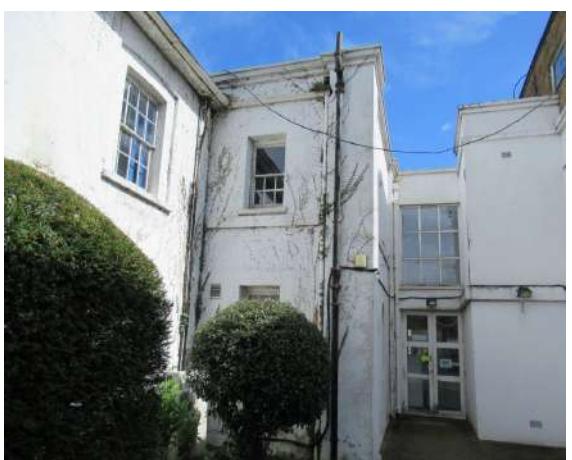
Description: Stucco render with a white paint finish.	Element: Render panel 03
	Condition: Poor. Staining from previous ivy growth. Poor paint finish.

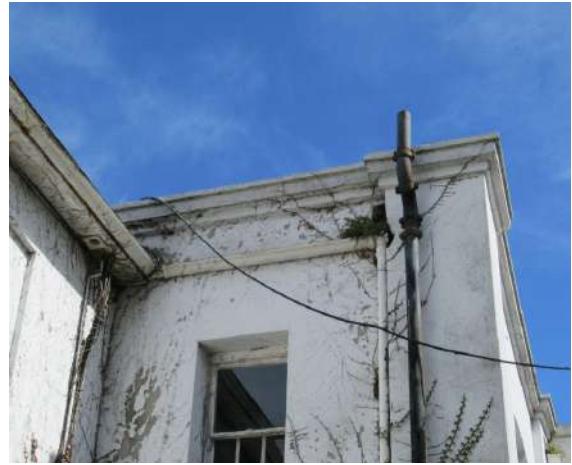
393.	Location: West elevation Description: Stucco render with a white paint finish.	Element: Render panel 03
	Condition: As above.

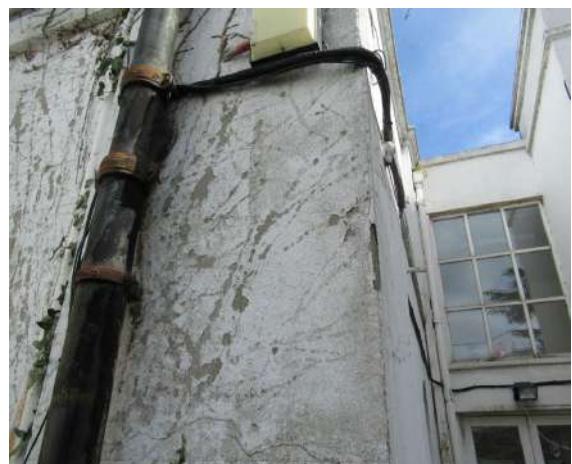
Location: West elevation Description: Stucco render with a white paint finish.	Element: Render panel 03
	Condition: As above.

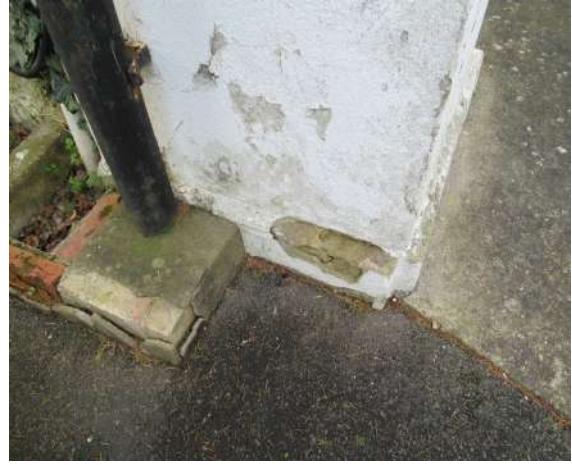
Location: West elevation Description: Stucco render with a white paint finish.	Element: Render panel 03
	Condition: Poor. Blown render to low level.

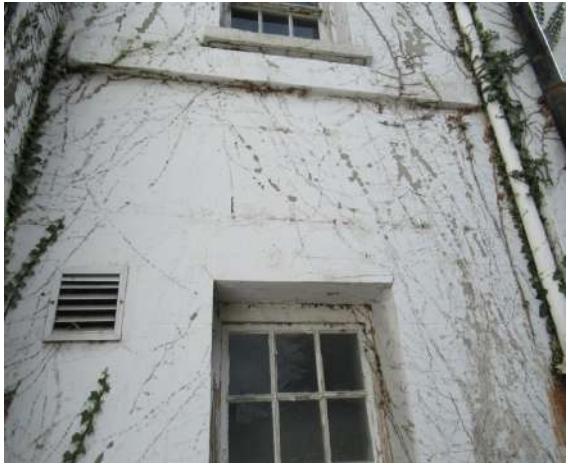
396.	Location: West elevation Description: Stucco render with a white paint finish.	Element: Render panel 03
	Condition: Poor. Category 2 vertical and horizontal cracking, 2-3mm wide, above ground floor window.

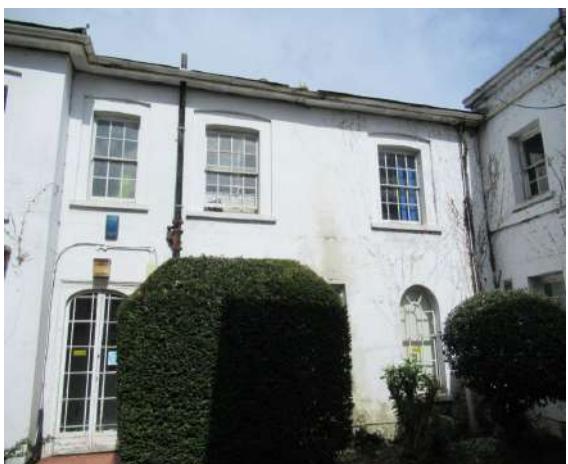
Location: South elevation Description: Stucco render with a white paint finish.	Element: Render panel 04
	Condition: Poor. Staining from previous ivy growth. Poor paint finish.

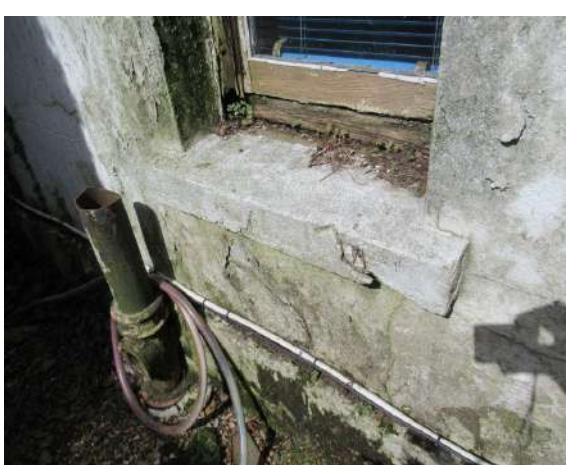
Location: South elevation Description: Stucco render with a white paint finish.	Element: Render panel 04
	Condition: Poor. Pattern cracking, cracked sill, and poor quality paint finish to low level.

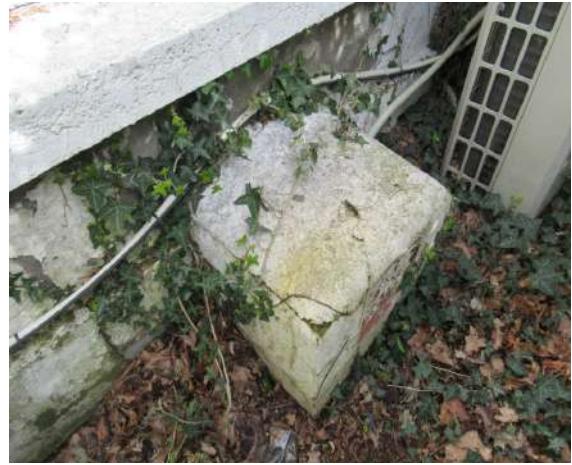
399.	Location: South elevation Description: Stucco render with a white paint finish.	Element: Render panel 04
	Condition: Poor. Category 2 crack, 2-3mm, to the low level rendered vent.

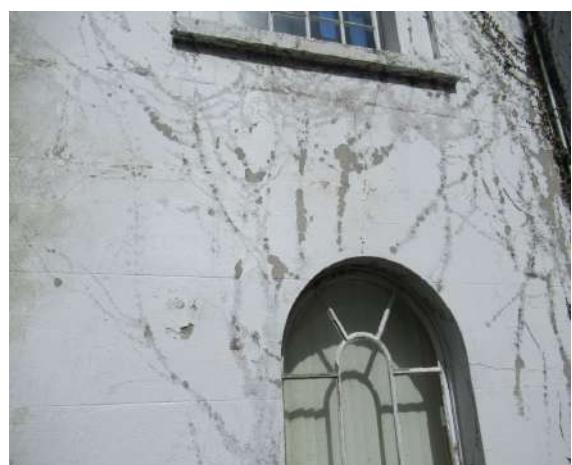
400.	Location: South elevation Description: Stucco render with a white paint finish.	Element: Render panel 04
	Condition: Poor. Numerous fine cracks above ground floor windows.

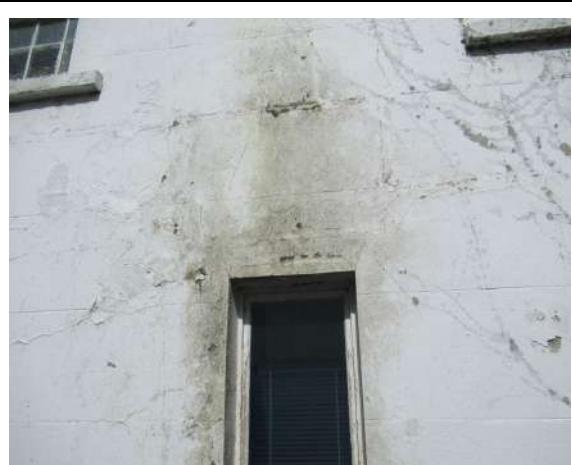
401.	Location: South elevation Description: Stucco render with a white paint finish.	Element: Render panel 04
	Condition: Poor. Render stained from leaking rainwater goods.

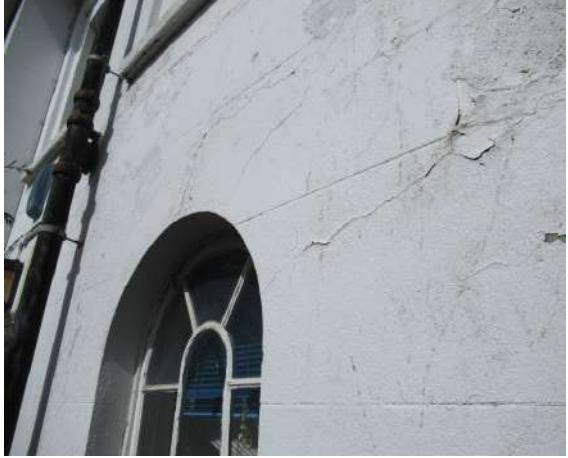
402.	<p>Location: South elevation</p> <p>Description: Stucco render with a white paint finish.</p> <p>Condition: Poor. Numerous fine cracks above ground floor windows.</p>	<p>Element: Render panel 04</p>

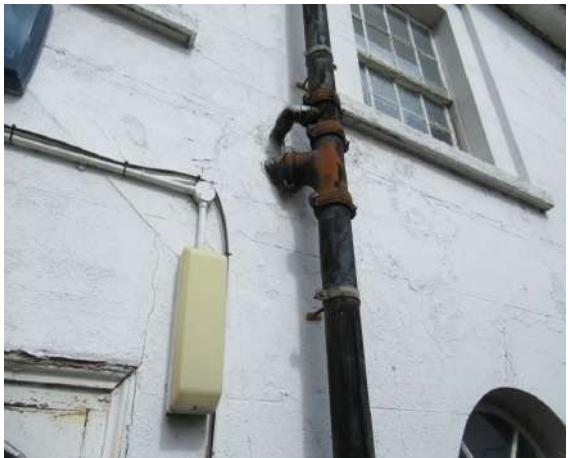
403.	<p>Location: South elevation</p> <p>Description: Stucco render with a white paint finish.</p> <p>Condition: Poor. Previously repaired section of render behind SVP pipework.</p>	<p>Element: Render panel 04</p>

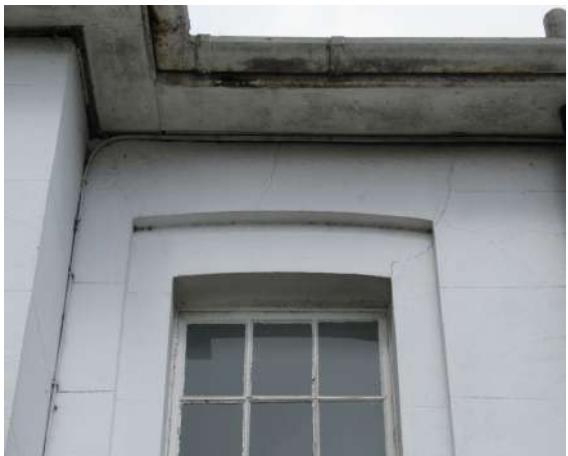
404.	<p>Location: South elevation</p> <p>Description: Stucco render with a white paint finish.</p> <p>Condition: Poor. Category 1 fine cracking above first floor window.</p>	<p>Element: Render panel 04</p>

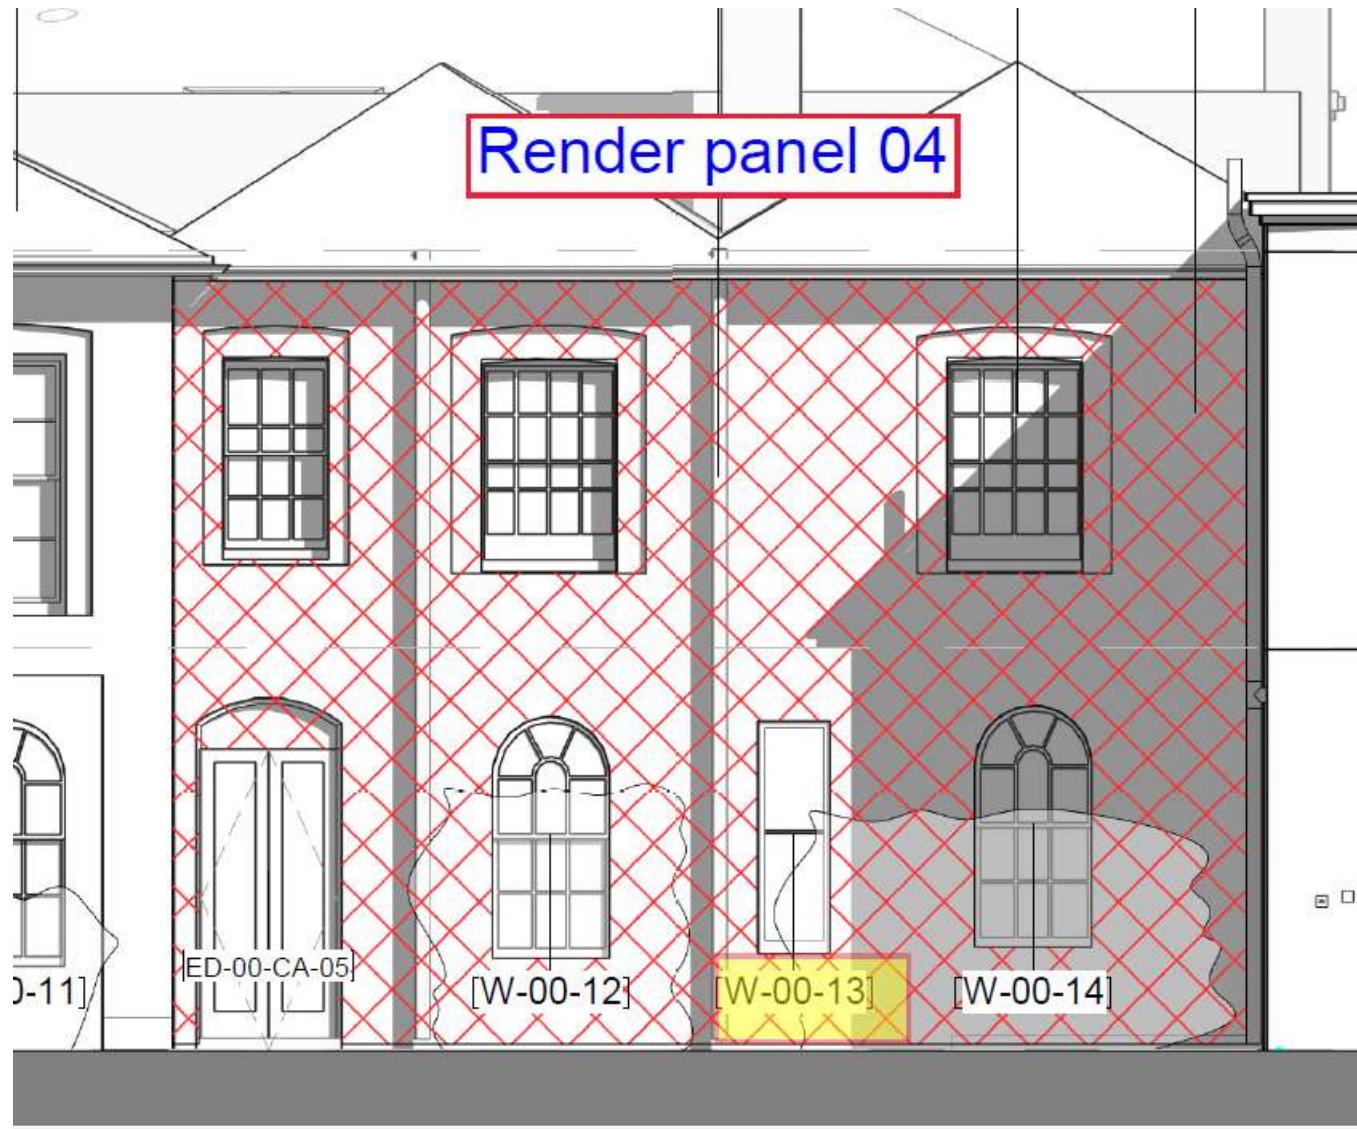
Render panel 04

Denotes areas requiring renewal.

- 1) We recommend each area of stucco is analysed to confirm the original materials and the mix ratio, the results of the analysis should be used when repairing the render.
