# Former Randall's Department Store, Uxbridge

## Fire Station Structural Assessment

Project No. 113780

April 2018

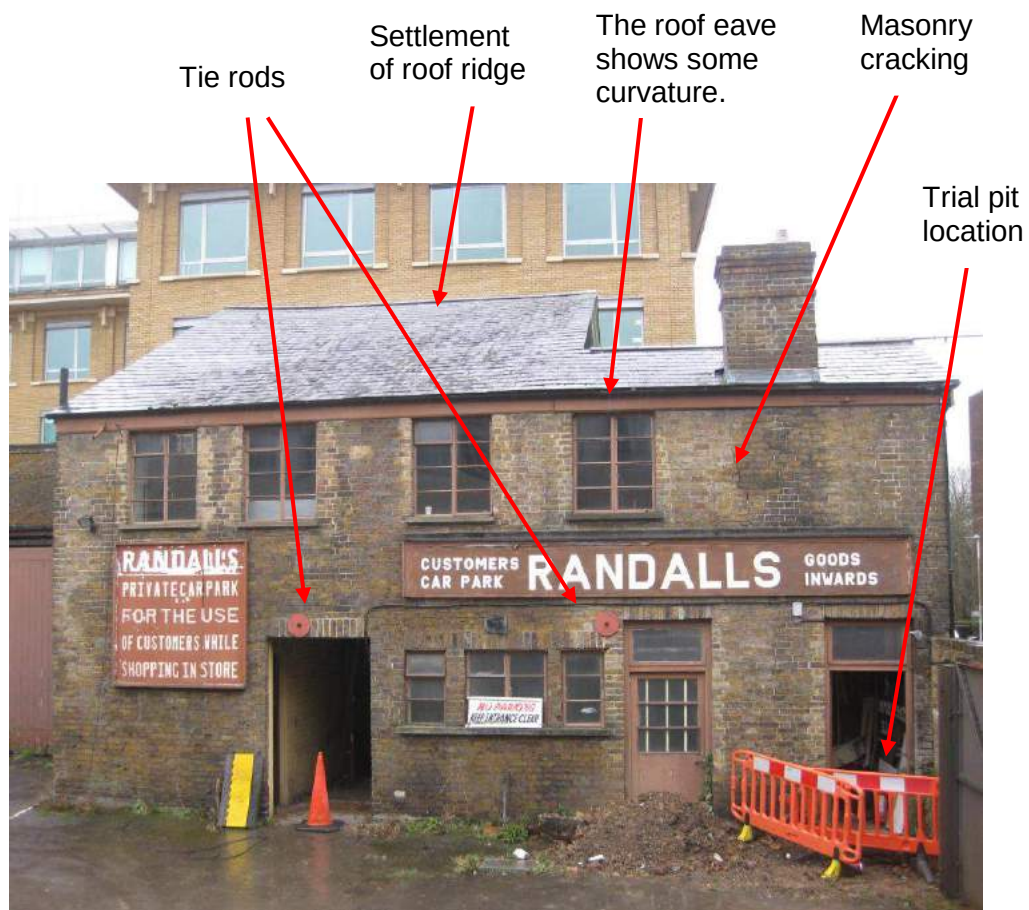
Figure 8: Side elevation

The southern wall next to Beaufort House is in poor condition and has shows evidence of bowing. The wall requires lateral restraint.

The wall in poor condition on the southern side of the building is to be restrained by an internal steel frame which is bolted through the masonry wall. The proposed frame is shown in appendix C.

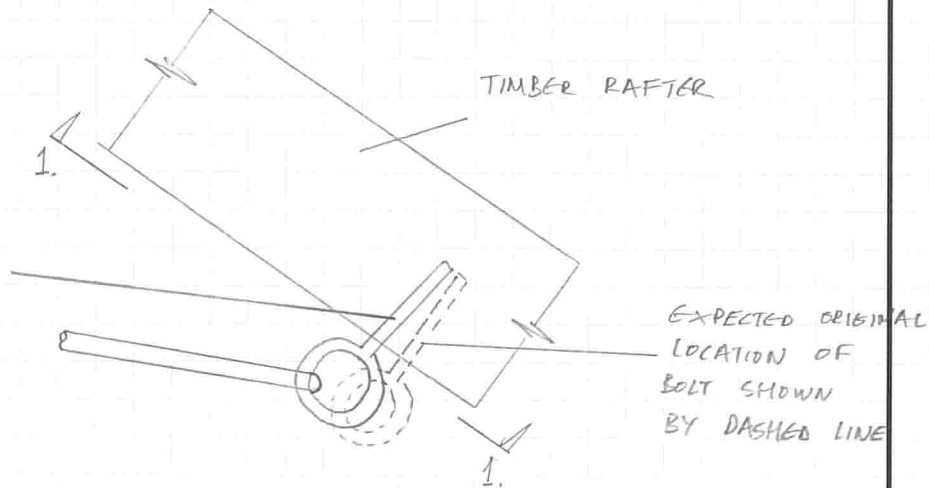
DETAIL 1  
STEEL TO TIMBER CONNECTION

A double pitched roof is present to the rear of the building which is supported by tied timber trusses. From visual inspection where the tie rod connects to the ends of the rafter, the bolted connection shows evidence of rotating, slipping and failing the timber in bearing. This may have been exacerbated by the timber becoming wet. The existing tied timber trusses cannot be retained due to their poor condition. These will be replaced with new softwood trusses as shown on drawing 113780-RVS-FH-Z3-03-DR-S-4005. Timber purlins to this area of the roof are to be replaced.

TENSION IN METAL  
TIE LOOKS TO  
HAVE CAUSED  
MOVEMENT OF  
BOLT

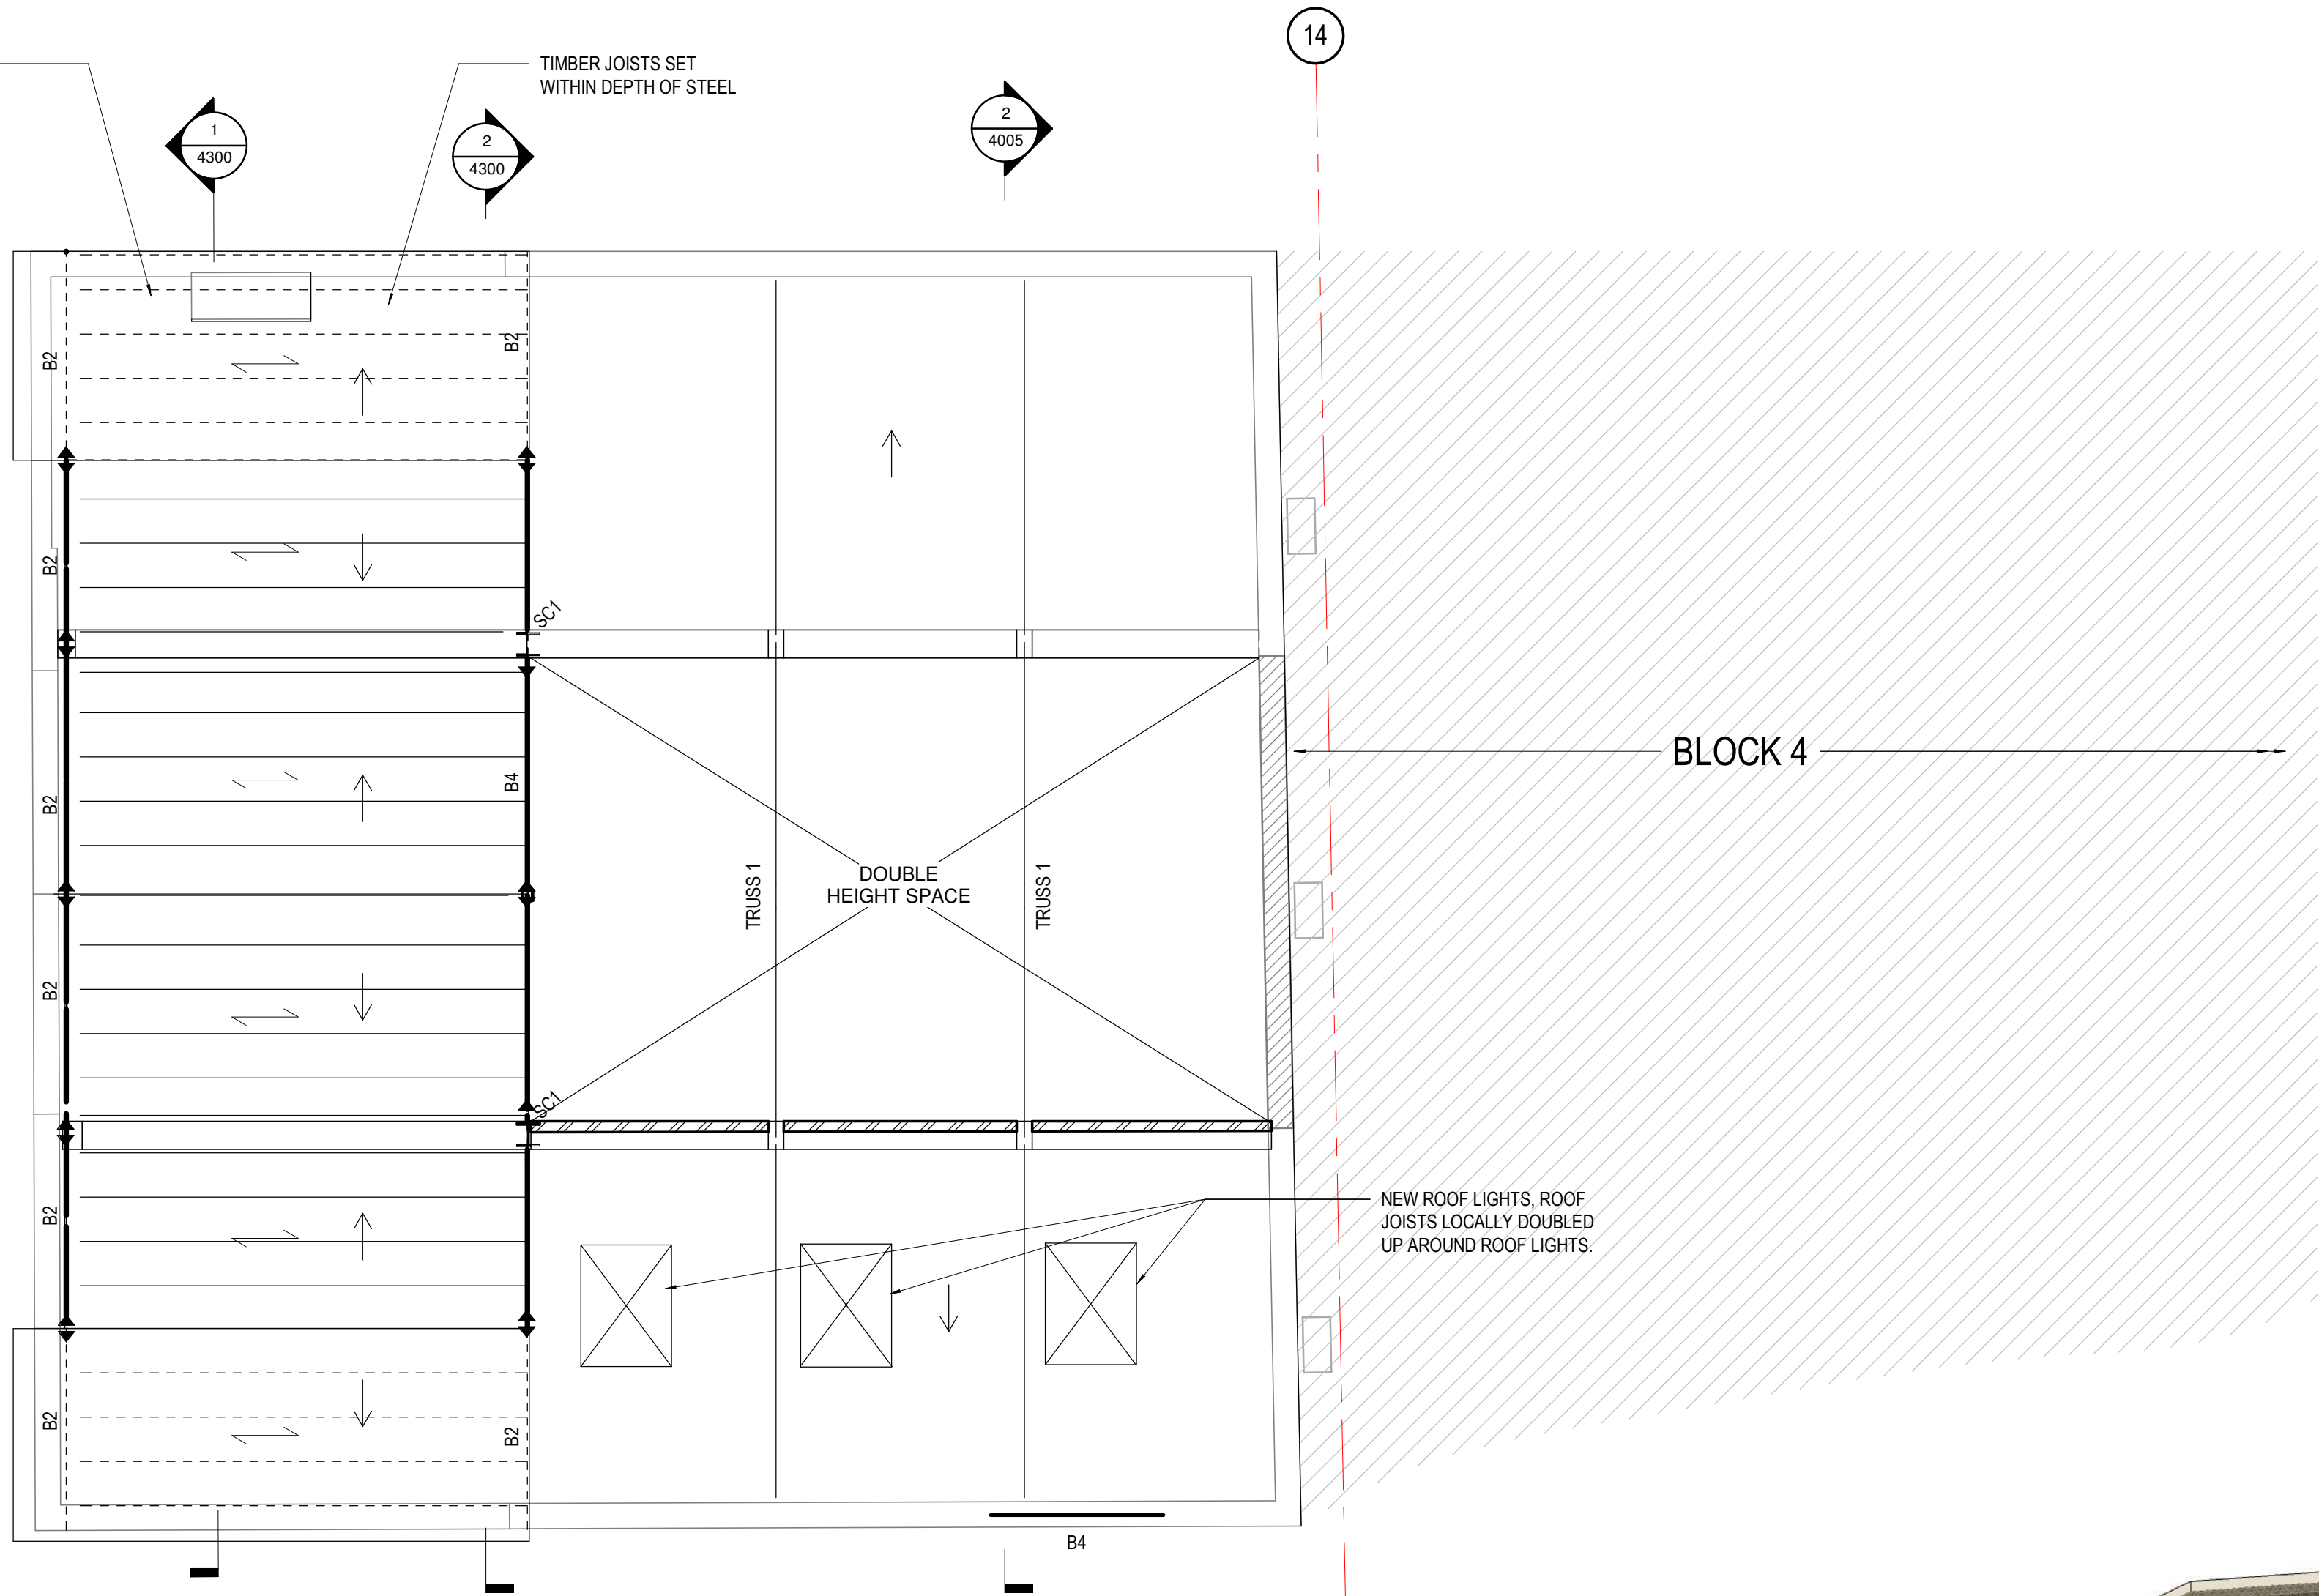
1 02 - LOWER ROOF  
1:50

EXISTING TIMBER ROOF STRUCTURE TO FRONT OF BUILDING IN POOR CONDITION AND TO BE REPLACED. NEW TIMBER STRUCTURE SPANS FRONT TO BACK ONTO STEEL END FRAMES.

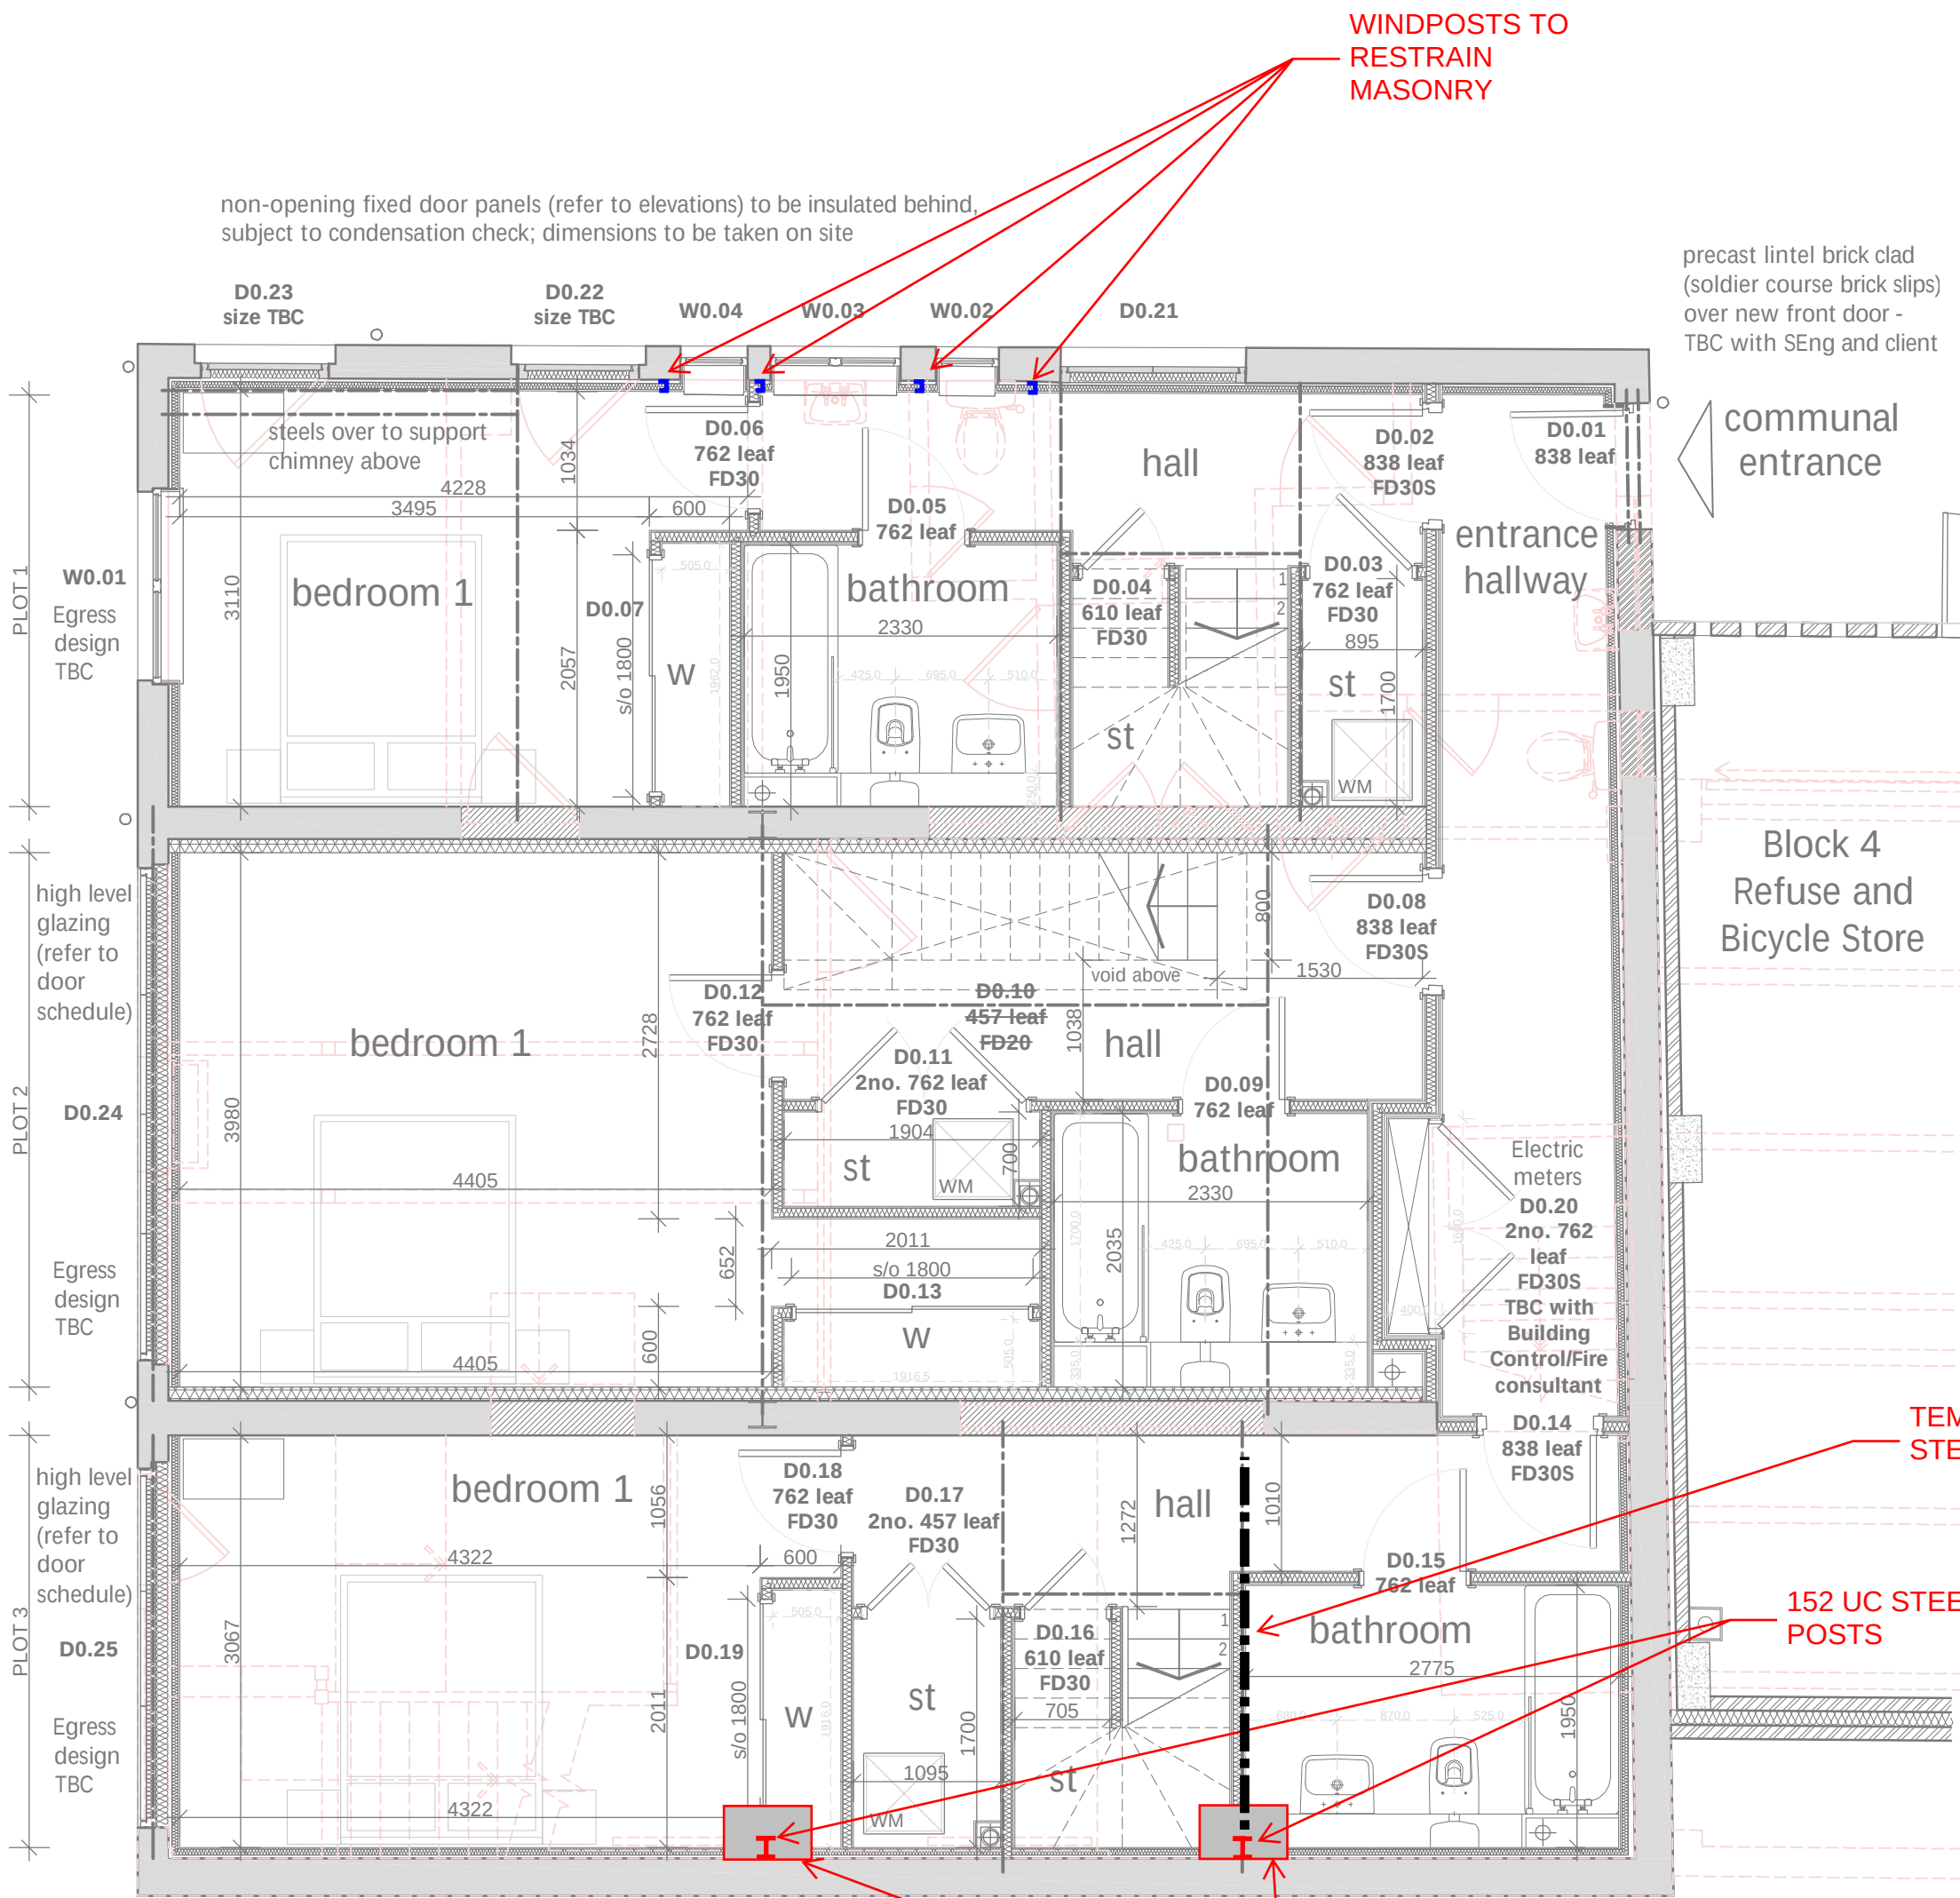
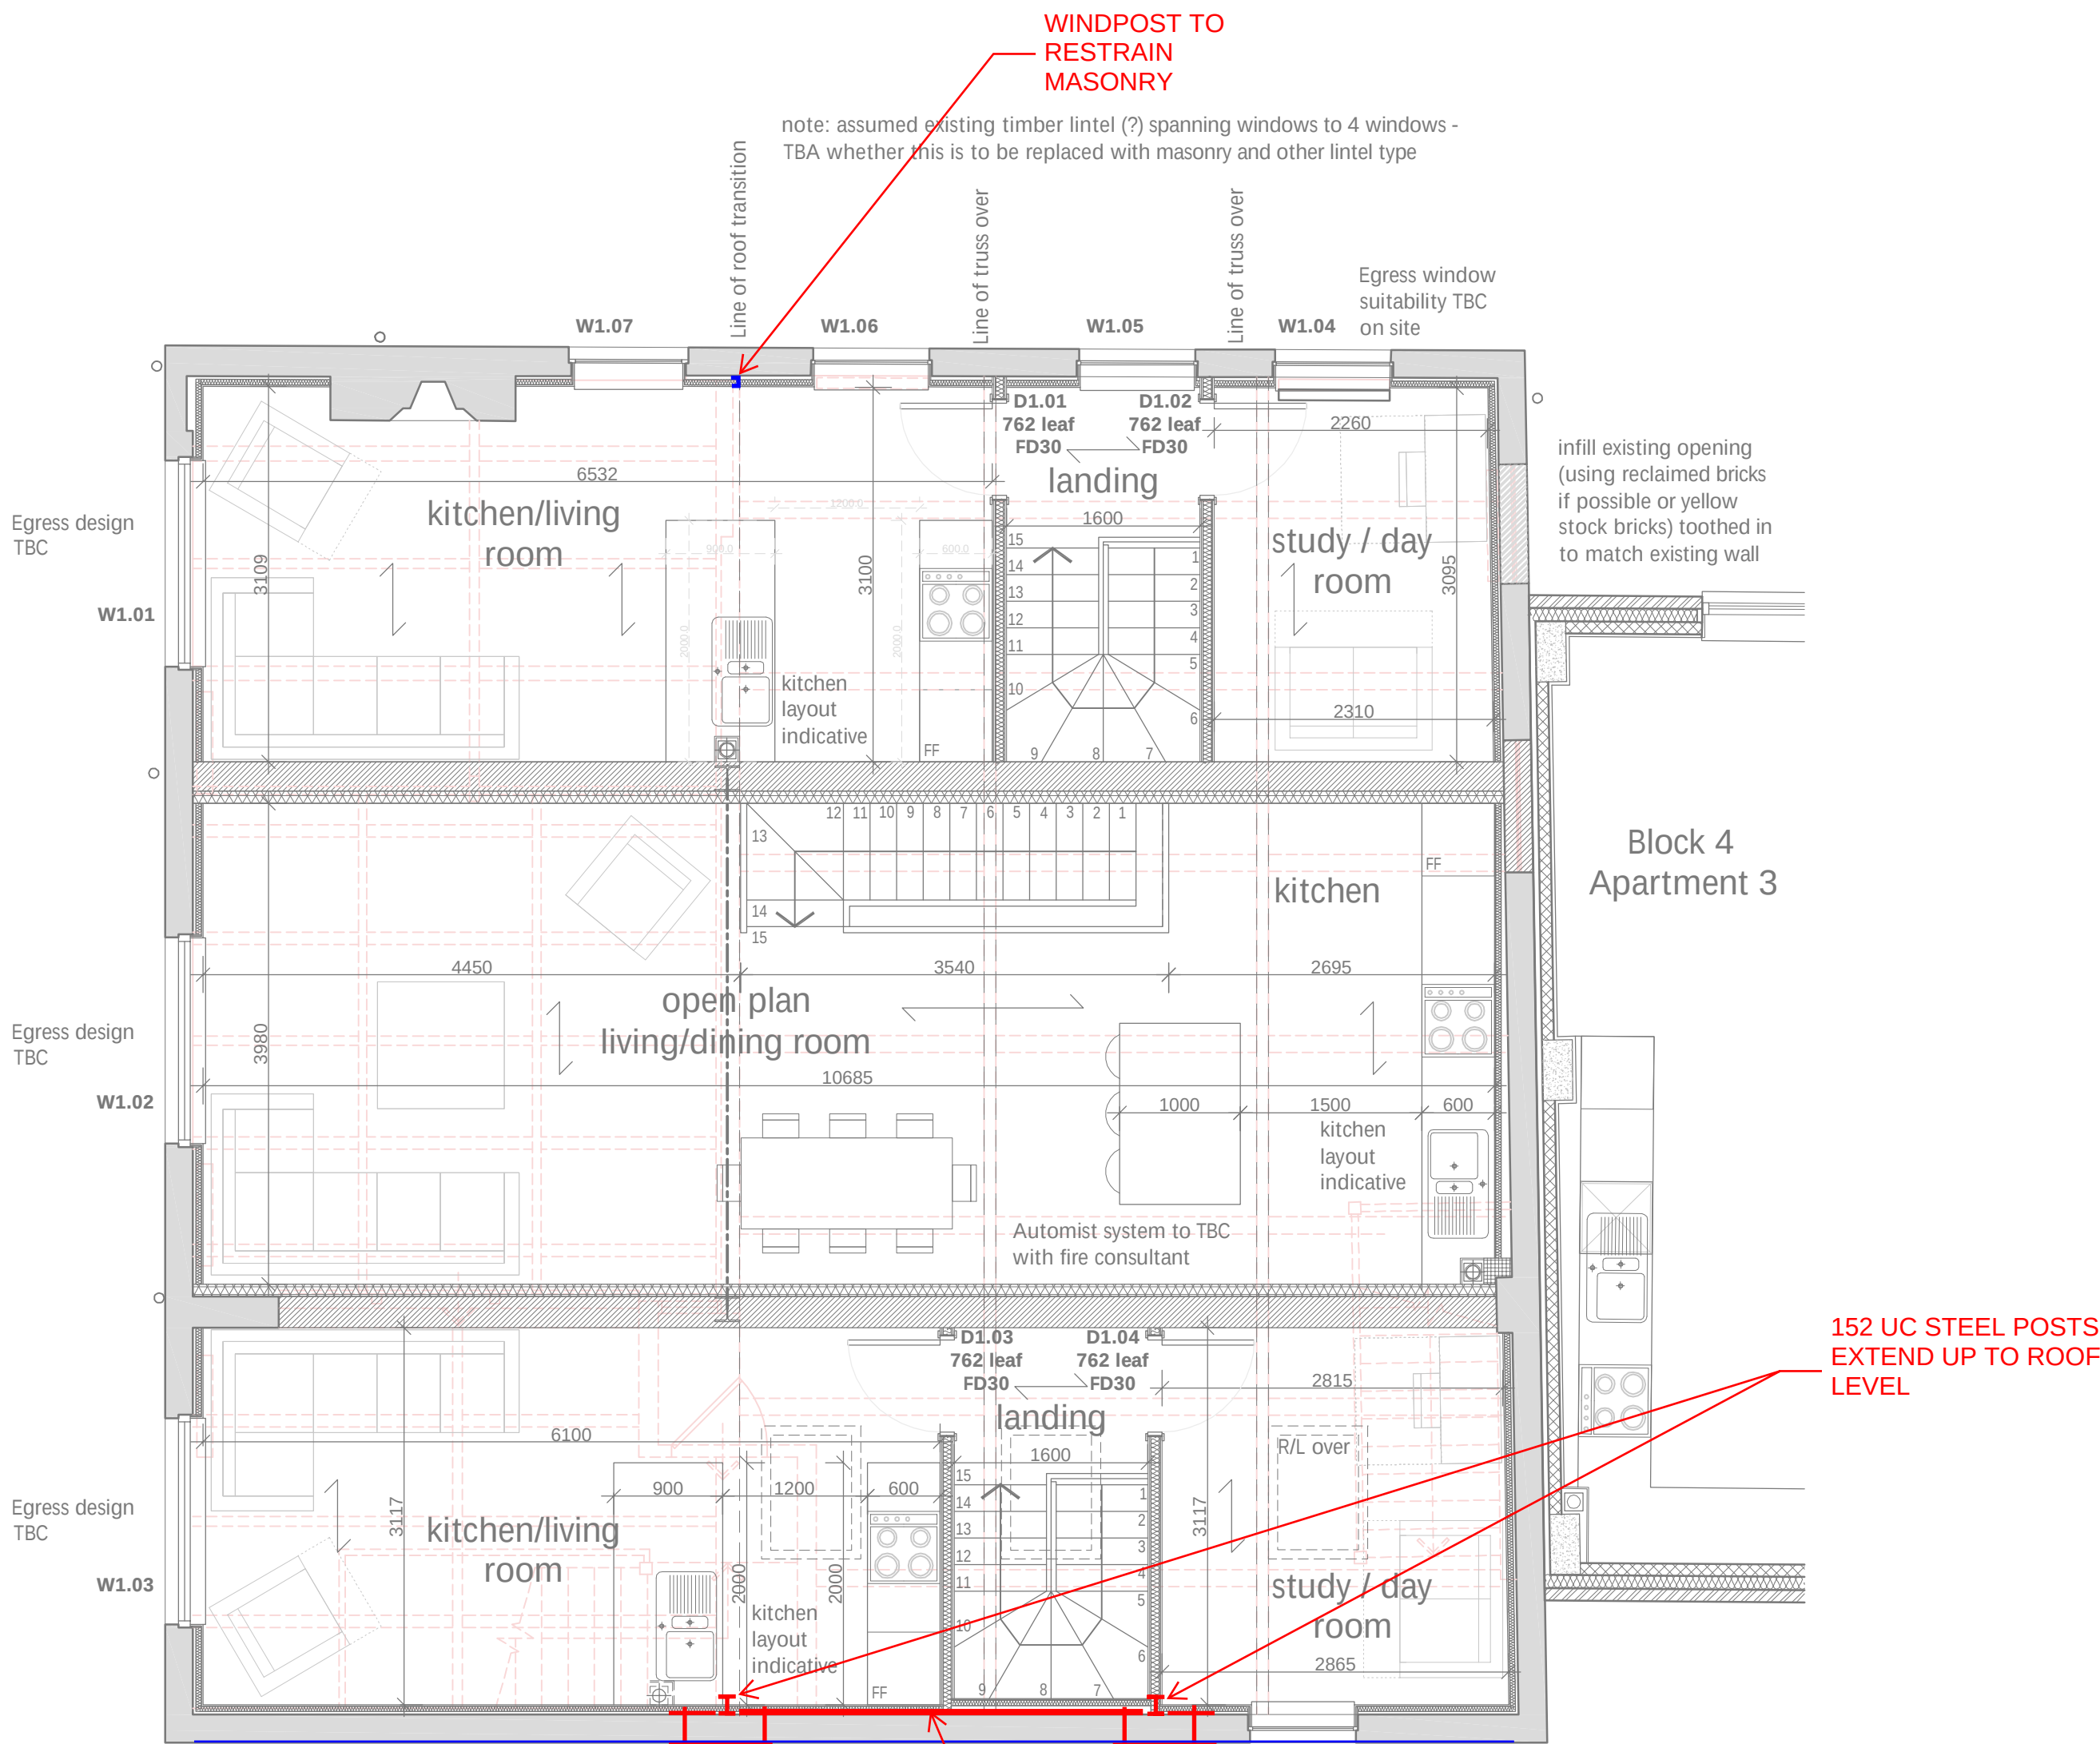
SECTION AA

PROPOSED STEELWORK TO THE WALL ON THE BEAUFORT PLACE SIDE OF THE WALL TO RESTRAIN WALL DURING THE CONSTRUCTION CASE AND ALSO TO PROVIDE RESTRAINT TO THE WALL IN THE PERMANENT CASE SINCE THE WALL SHOWS EVIDENCE OF HAVING BOWED.

POST AND  
PFC TO  
RESTRAIN  
BOWED WALL

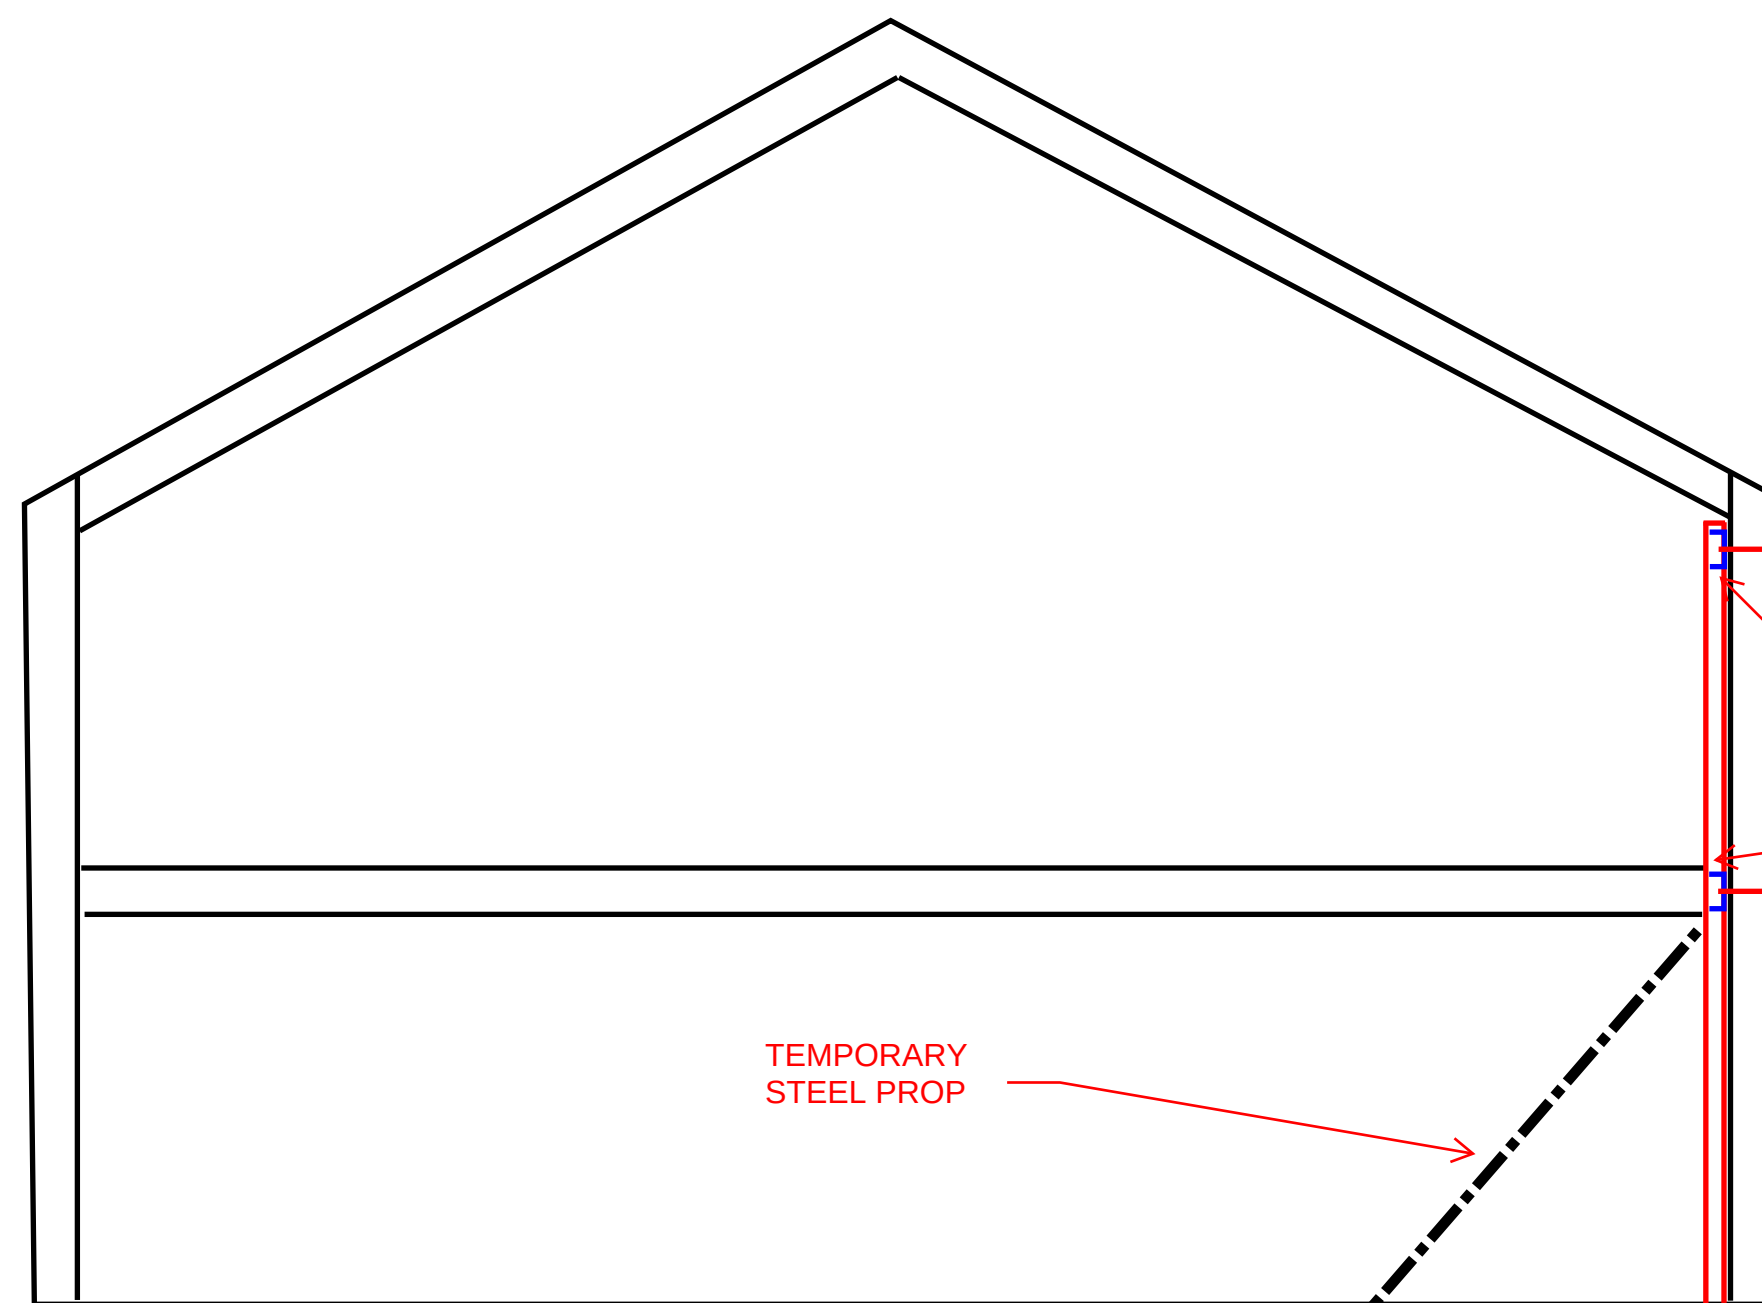
SECTION BB

POST AND  
PFC TO  
RESTRAIN  
BOWED WALL

TEMPORARY  
STEEL PROP

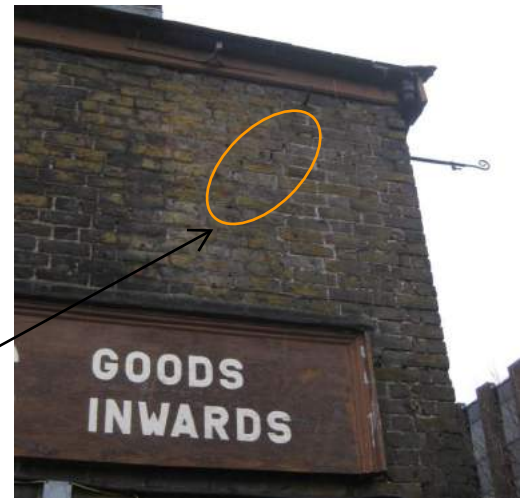
Cracks to be repaired.

Where crack repairs identified these are to be repaired with Helifix crack stitching (or equally approved product).
