ADDENDUM TECHNICAL REPORT  
Retained

| DATE OF ISSUE: | 4 <sup>th</sup> March 2019 |
| [REDACTED] | Mr and Mrs Robinson<br>24 Nicholas Way<br>Northwood<br>HA6 2TS |

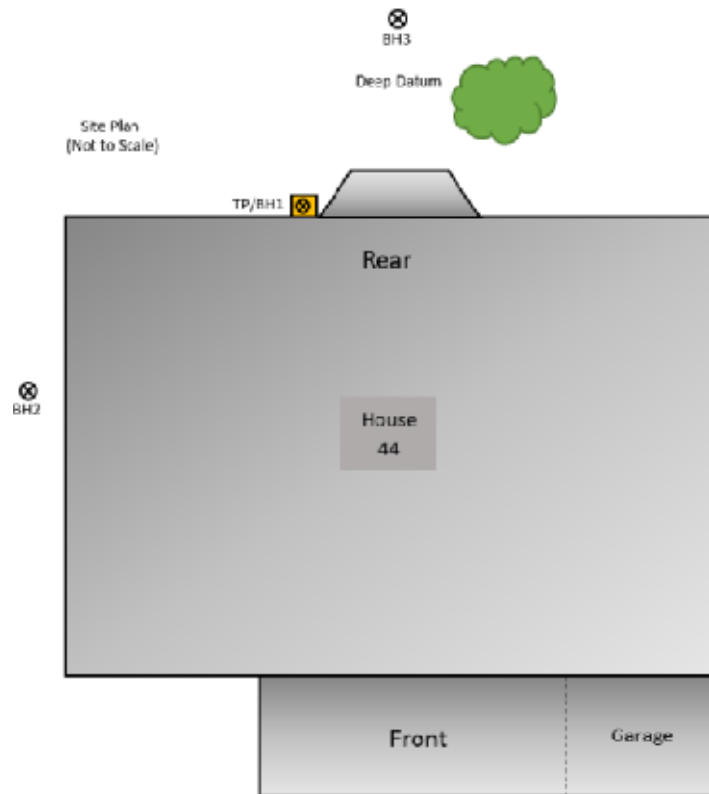
BH3 is Located approximately 5m West North West of TP/BH1 and was drilled using a windowless sample rig. The position is to be used for deep datum monitoring.

Samples of the roots were taken and sent away for laboratory testing. Those found within Trialpit/borehole 1 were identified as belonging to Quercus Oak. Additionally roots belonging to Hedra (Ivy) or the related Fatsia. Samples were not taken from Borehole 2 as this was for testing ground conditions but are most likely Quercus Oak given the size of the mature vegetation.
