## SITE INVESTIGATION FACTUAL REPORT

Report No: SI-494735

Site: 14 Watford Road  
Hillingdon

Date of Visit: 11/8/2022

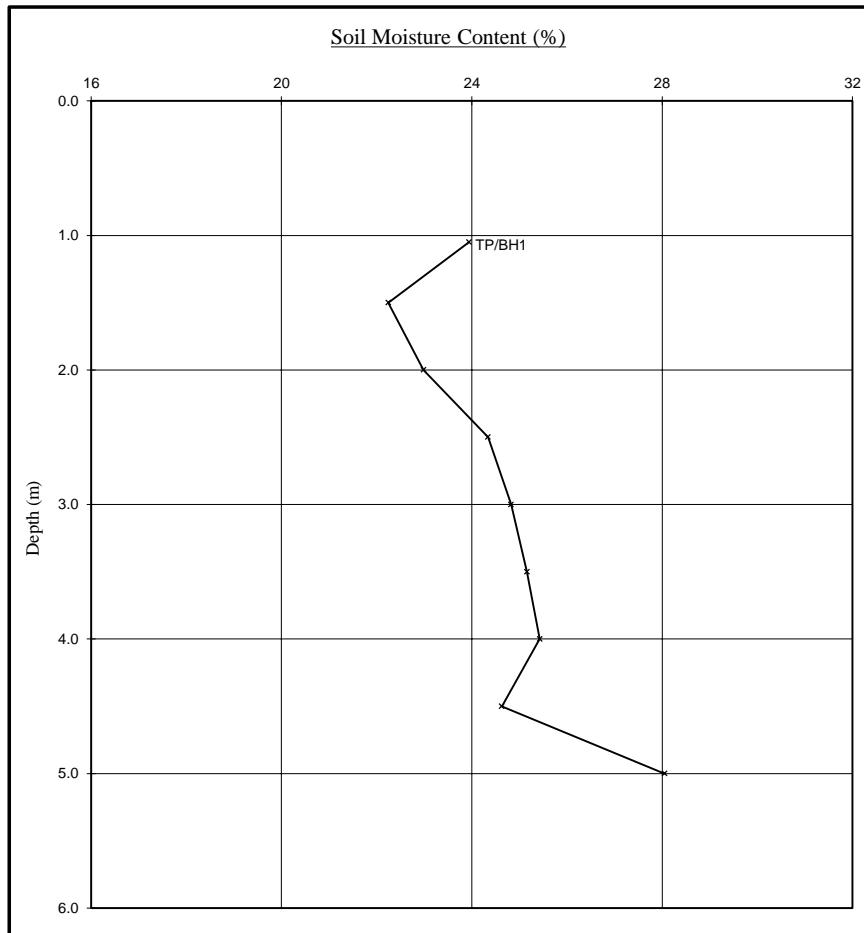
# Moisture Content Profiles

1. If plotted, 0.4 LL and PL+2 ( after Driscoll, 1983 ) should only be applied to London Clay ( and similarly overconsolidated clay) at shallow depths.
2. Unless specifically noted the profiles have not been related to a site datum.

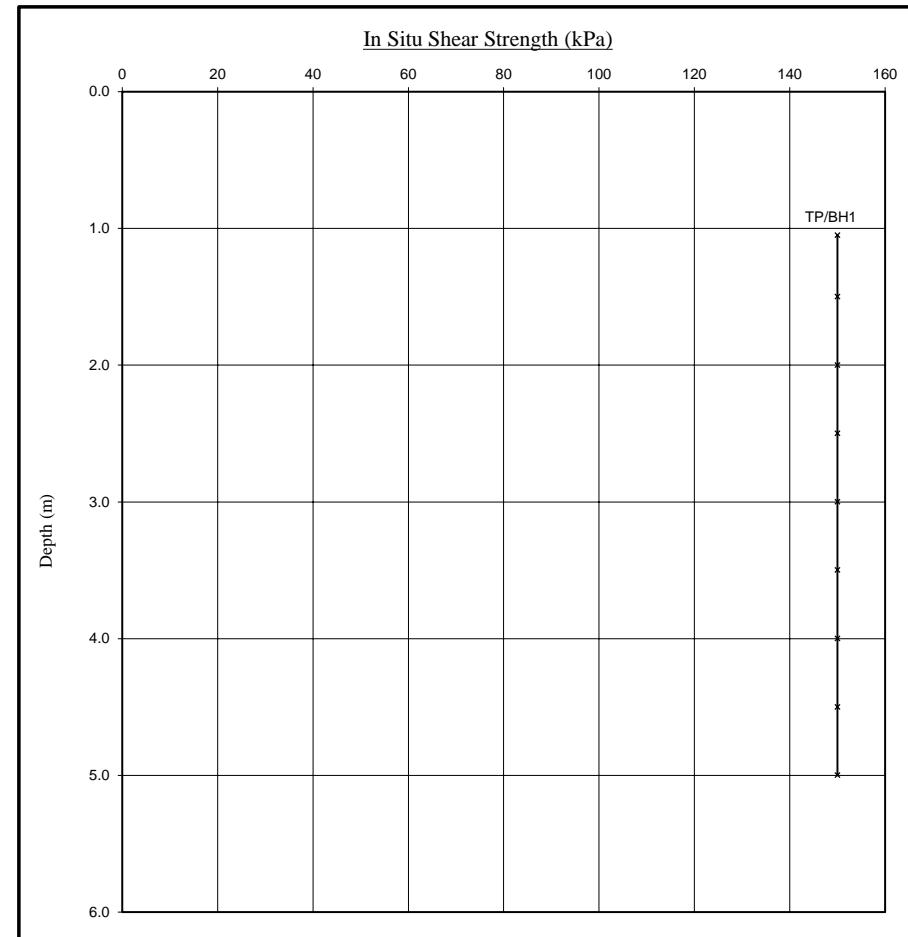
# Shear Strength Profiles

1. Unless otherwise stated, values of Shear Strength were determined in situ by CTS using a Pilcon Hand Vane the calibration of which is limited to a maximum reading of 150 kPa.
2. Unless specifically noted the profiles have not been related to a site datum.
