Initial Subsidence Report

17-20 Meadway Gardens,

Ruislip, Middlesex

Date of Report: 20th March 2024

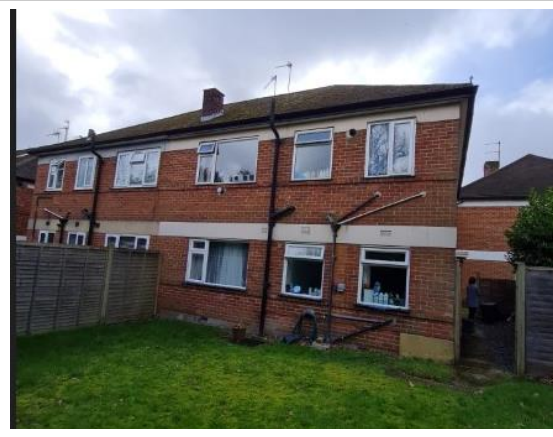
Photo 23: Rear Elevation

Rear Elevation	<p>There is a circa 2mm stepped diagonal crack radiating from the cill of the first floor left hand window extending down to the top left hand corner of the 1st floor middle window.</p> <p>There is evidence of a 1mm stepped diagonal crack radiating from the bottom left hand corner of the ground floor window extending to ground level.</p> <p>There is a 2mm diagonal crack radiating from the top left hand corner of the 1st floor left hand window extending up to the eaves level.</p> <p>There is a circa 1mm stepped diagonal crack evident radiating from the underside of the cill to the 1st floor middle window extending down to the top right hand corner of the ground floor middle window. There is evidence of previous repairs & possible presence of Helibars to this crack.</p>	2
